Preliminary Bat & Bird Assessment

Buildings at Porthmissen Farm, 2 Cuckoo Mill, Padstow, Cornwall

29th April 2021

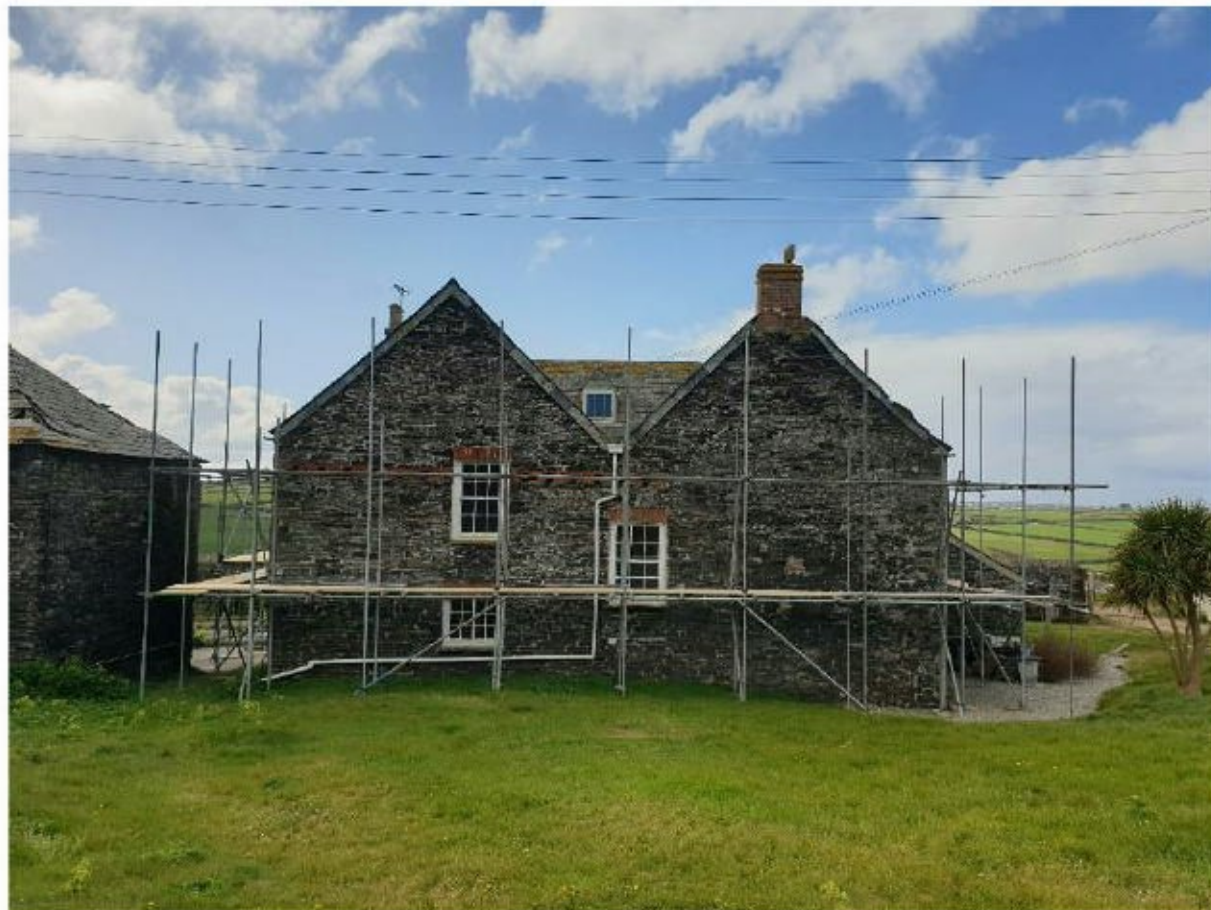
Figure 3: Northern elevation of farmhouse at Porthmissen Farm

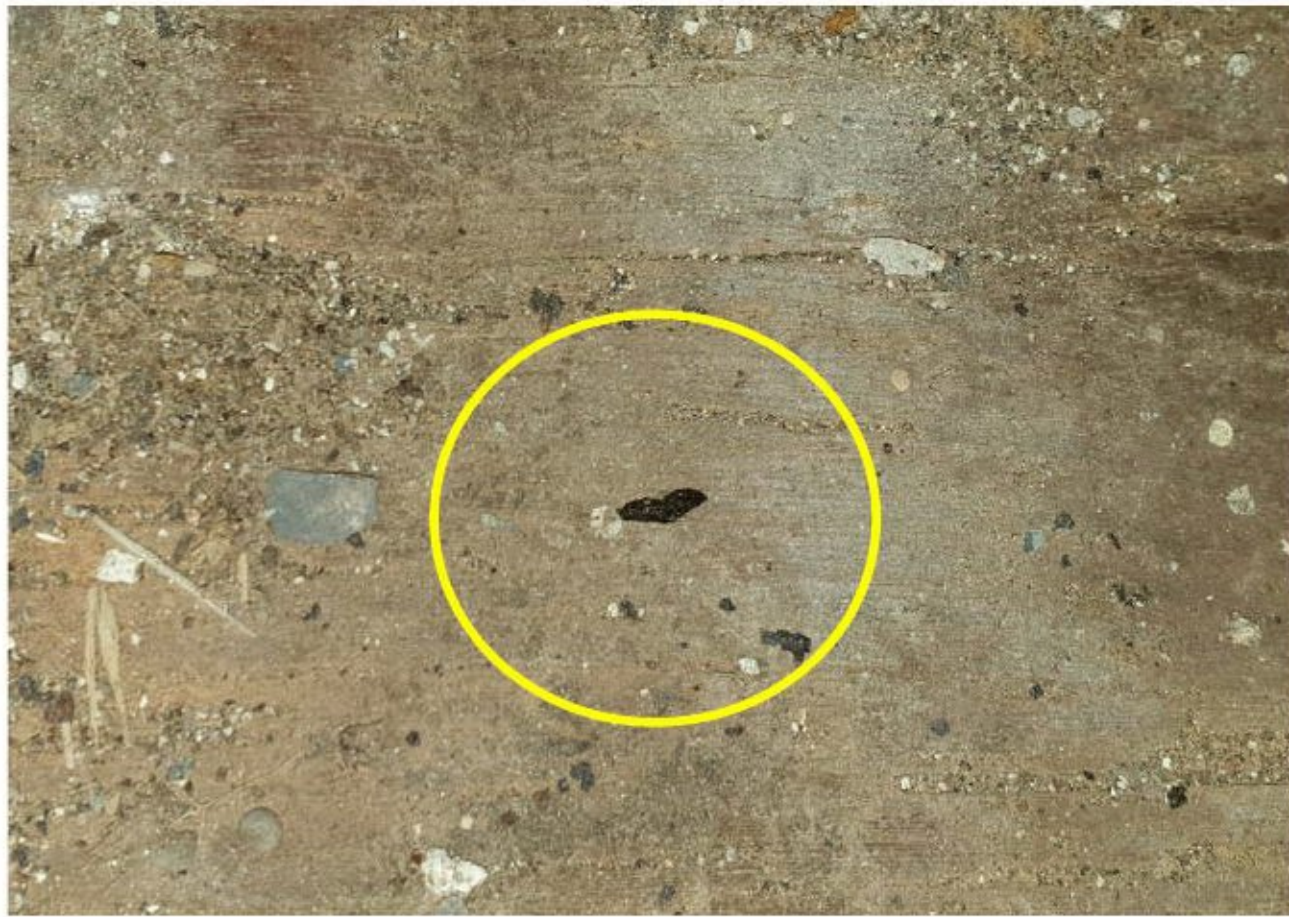
A single bat dropping was noted within one of the ground floor rooms of Barn 1, together with the presence of likely bat feeding remains (butterfly wings) indicating that bats may use the building for roosting. In addition, external features provide potential for crevice dwelling bats and potential access for bats into the interior of the barn.

Barn 1 was, therefore, assessed as being of '**moderate suitability**' to support roosting bats.

Figure 11: Bat dropping (yellow circle) found within timber trough on eastern wall of L-shaped ground floor room in Barn 1

The results indicate that the interior of the ground floor of the two-storey section of Barn 1 likely supports a brown long-eared bat roost. NB: species present must be confirmed with DNA analysis of the bat dropping. In addition, likely bat feeding remains (butterfly wings) were found within this part of the building and there are a number of external features on this building with potential to be used for roosting by crevice-dwelling bats and which could provide potential access for bats into the interior.

Renovation and modification of the farmhouse and Barn 1 must be informed with two bat emergence or re-entry surveys of each building, undertaken between May and September; one of these two emergence surveys should be carried out between May and August (Collins, 2016). The survey information will be required to inform the planning application and subsequent works. These surveys will determine the species, number of individuals, bat access points and timings of usage. **DNA analysis of the collected bat dropping from Barn 1 is required to confirm the species present.**

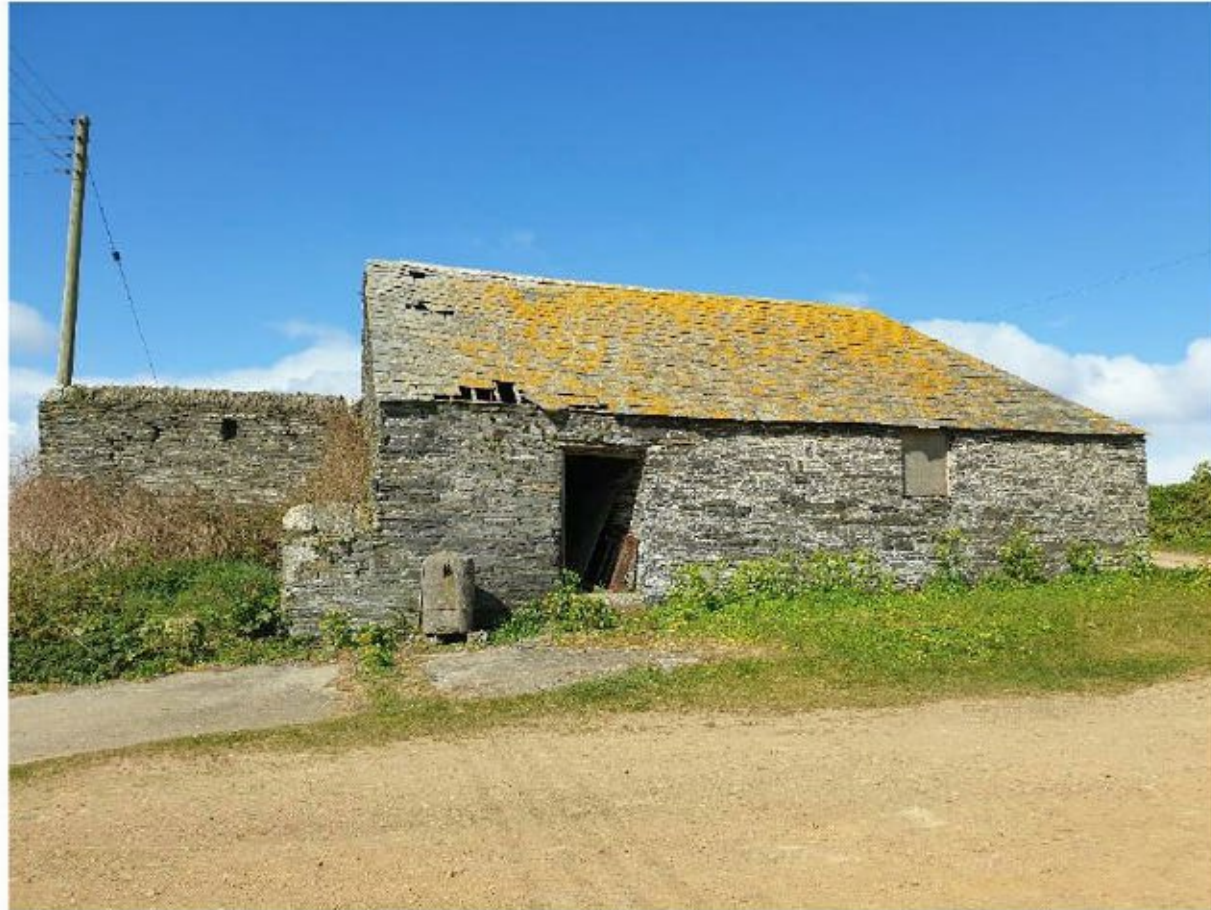
This building is to the north west of the farmhouse and consists of a single-storey stone barn with a pitched rag slate roof and clay ridge tiles (Figs. 21 & 22). The roof has a hip-end to the north and a gable end to the south. There are crevices in the external walls, gaps under hanging slates, where slates have lifted/ slipped and underneath ridge tiles, all of which provide potential roosting opportunities for crevice-dwelling bats and potential bat access into the interior. There are also gaps around the timber doors on the northern elevation, holes in the roof and open door and window apertures which provide further potential bat access.

Figure 21: Eastern elevation of Barn 3 at Porthmissen Farm

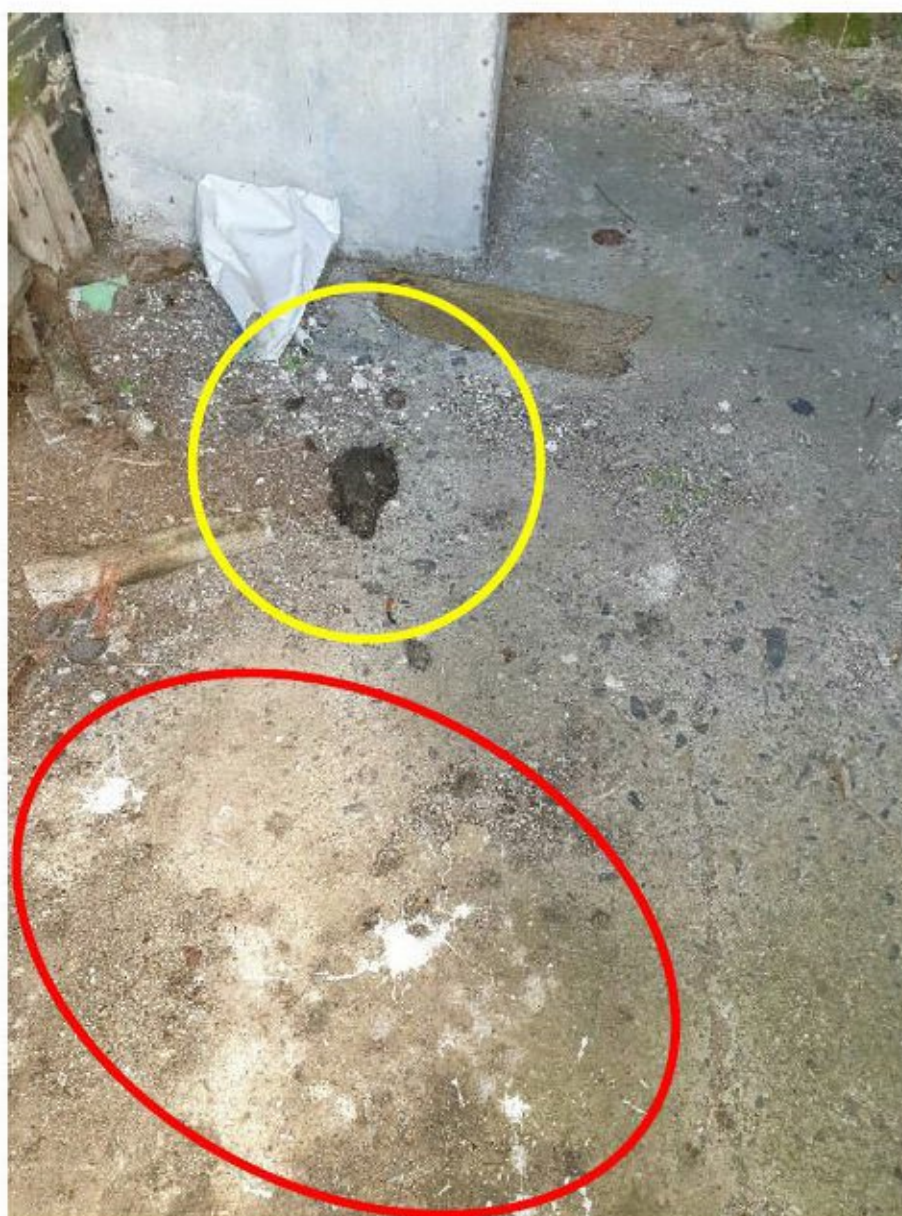
Intact and degraded barn owl (*Tyto alba*) pellets (c. 10) and areas of liming on the floor and on crossing timbers were observed on the floor of the single-storey section of Barn 1 (Fig. 24). An old, likely barn owl nest debris was noted on the mezzanine floor at the western end of this room, with a large number of rodent skeleton fragments and a small number of barn owl flight feathers noted (Fig. 25). At least one barn owl pellet was noted on the first floor of this building, although it was not possible to fully inspect this area due to the dilapidated condition of the floor. No individual barn owls were noted within the buildings and no recent evidence of barn owls nesting within the buildings was noted.

Figure 24: Barn owl pellet (yellow circle) and liming (red circle) on floor of the single-storey section of Barn 1 at Porthmissen Farm

In the absence of mitigation, conversion of Barn 1 will exclude roosting/ potentially nesting barn owl. A permanent provision for barn owl should be incorporated into the design and provided within the converted barn. This can be achieved by installing a minimum 1m² nest chamber inside the roof space. The nest chamber will require an access hole located at least 3m above ground level. The access must measure 130mm x 250mm and feature a grippable ledge beneath the exterior hole. The ledge will provide a landing and exercise platform. On the interior, the depth between the bottom of the nest box and entrance, must not be less than 450mm. The nest box exterior should be moisture insulated and feature an external human access. To comply with Building Regulations the barn owl box should be located out of the U-value envelope.

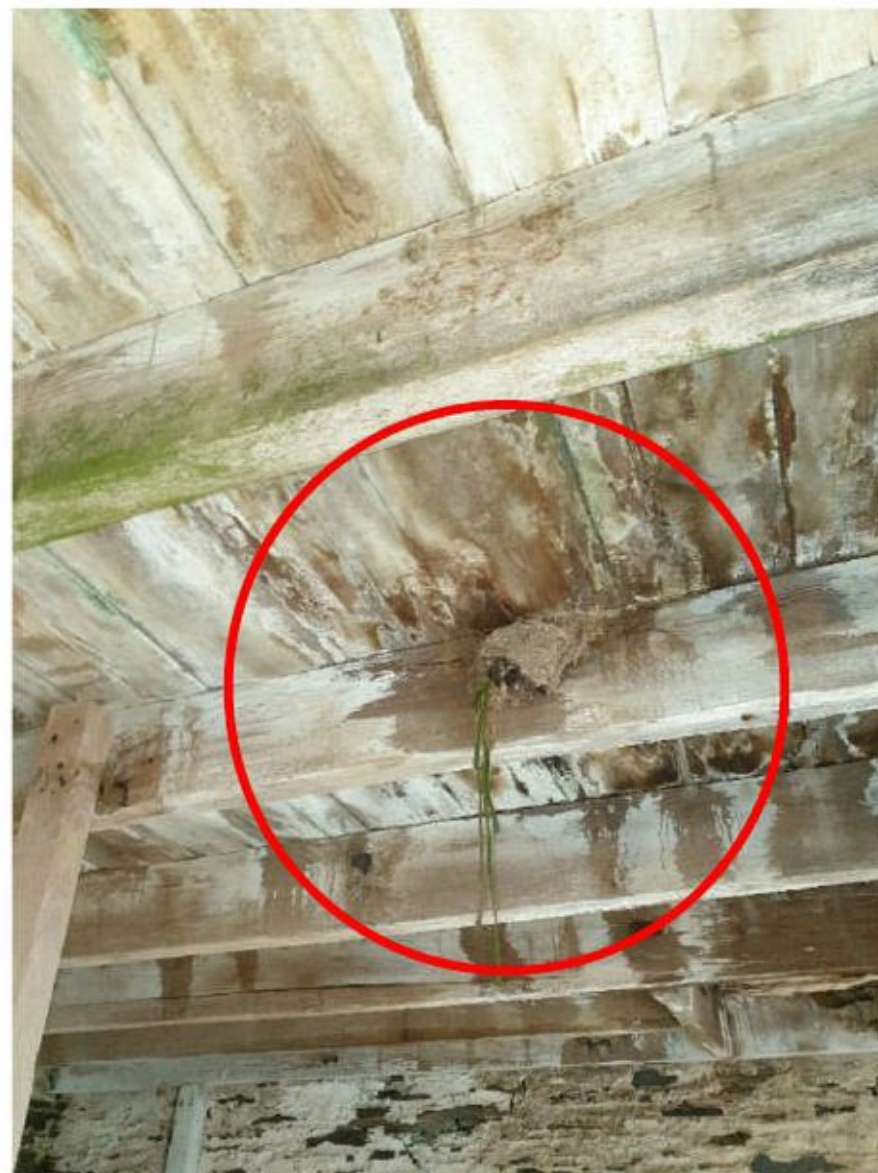
A woven bird's nest and a number of barn swallow's (*Hirundo rustica*) nests were noted within the ground floor rooms of Barn 1 and an old barn swallow's nest was noted under the ceiling of the ground floor room within Barn 2 (Figs. 26 & 27). Ivy growth on the south eastern corner of Barn 2 provides potential nesting habitat for birds (Fig. 16).

Figure 27: Swallow's nest within Barn 1

Evidence of nesting barn swallows was observed within Barns 1 and 2; alternative provision for nesting swallows should be made within the converted buildings or an alternative building within the site. Suitable products include No. 10 Schwegler Swallow Nest. Suitable products are available at <https://www.nhbs.com>, and <https://www.wildcare.co.uk/>.
