Preliminary Bat & Bird Assessment

Buildings at Porthmissen Farm, 2 Cuckoo Mill, Padstow, Cornwall

29th April 2021

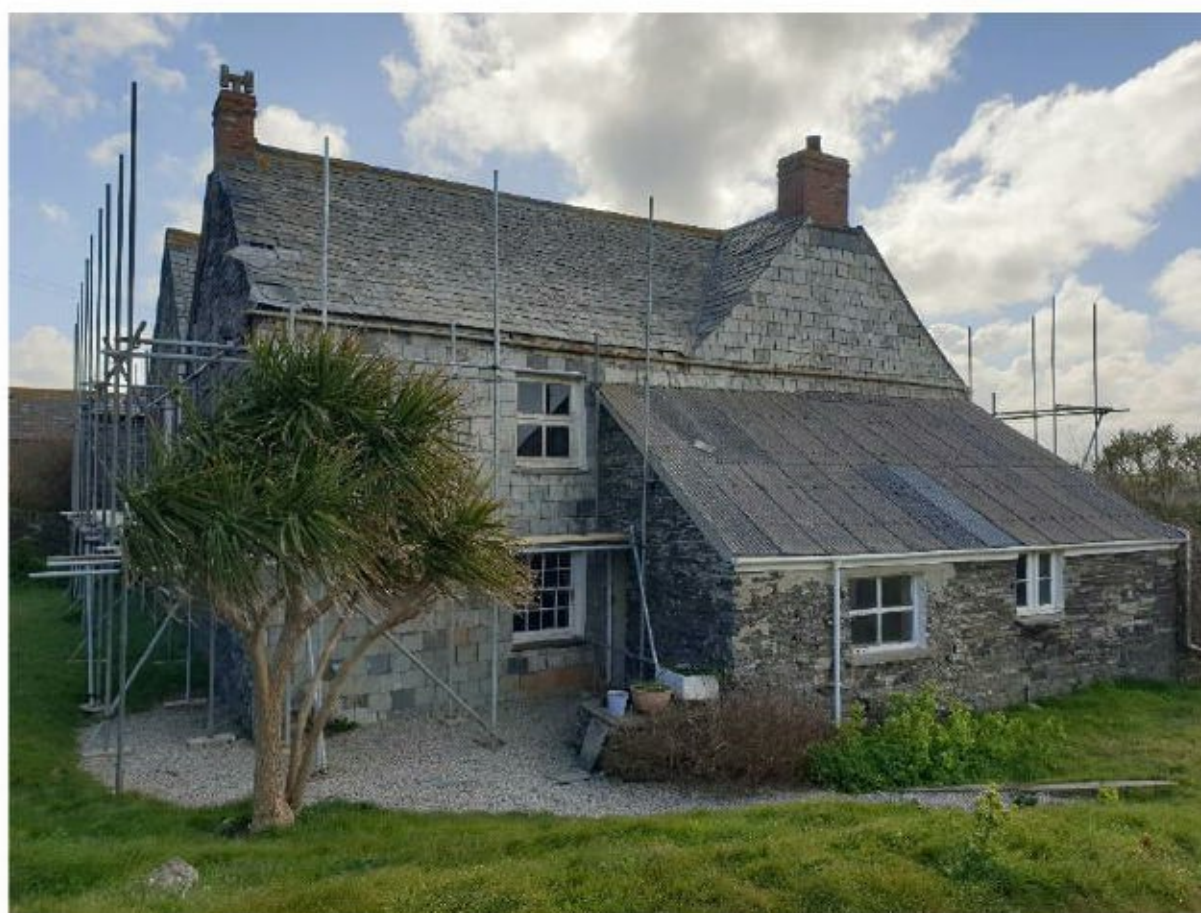
Figure 4: Western elevation of farmhouse at Porthmissen Farm

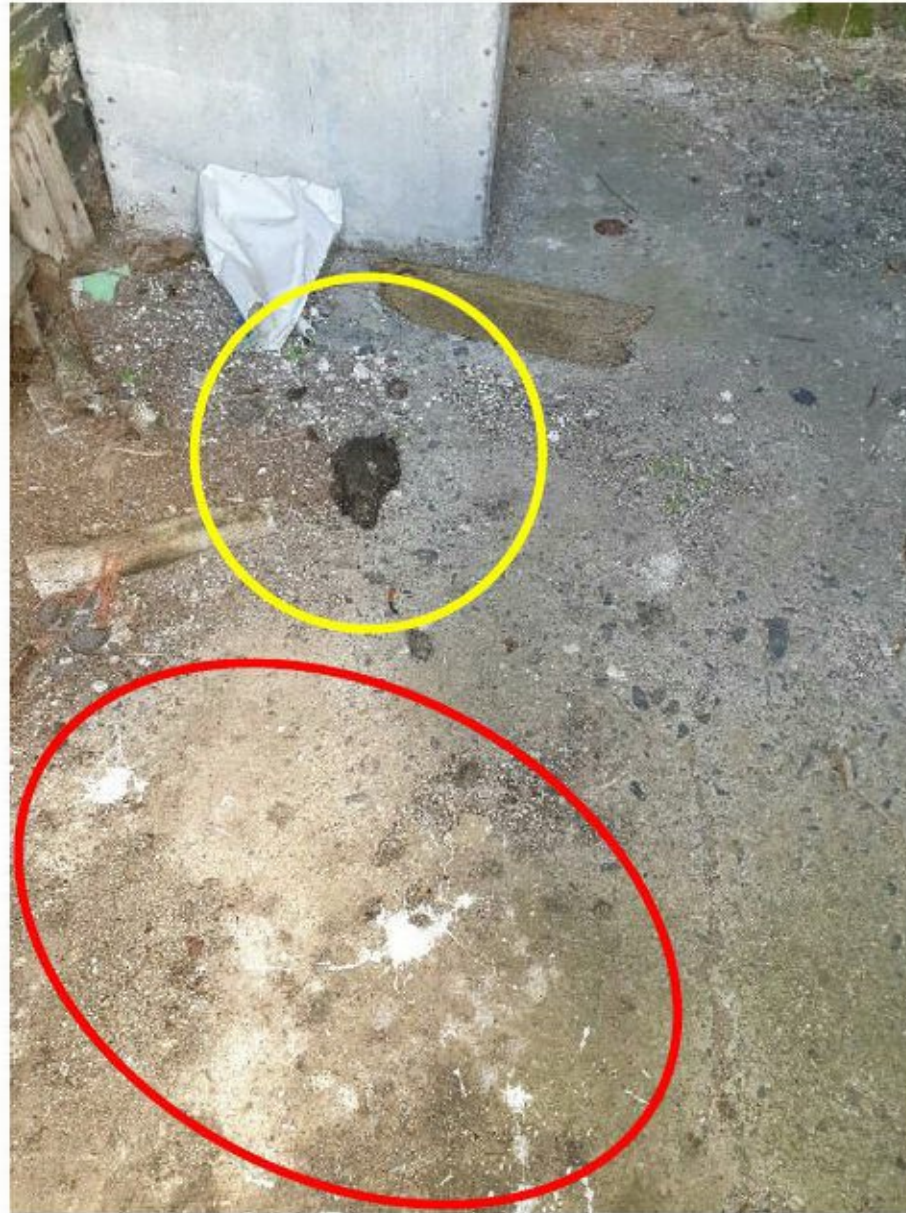
Intact and degraded barn owl (*Tyto alba*) pellets (c. 10) and areas of liming on the floor and on crossing timbers were observed on the floor of the single-storey section of Barn 1 (Fig. 24). An old, likely barn owl nest debris was noted on the mezzanine floor at the western end of this room, with a large number of rodent skeleton fragments and a small number of barn owl flight feathers noted (Fig. 25). At least one barn owl pellet was noted on the first floor of this building, although it was not possible to fully inspect this area due to the dilapidated condition of the floor. No individual barn owls were noted within the buildings and no recent evidence of barn owls nesting within the buildings was noted.

Figure 24: Barn owl pellet (yellow circle) and liming (red circle) on floor of the single-storey section of Barn 1 at Porthmissen Farm

In the absence of mitigation, conversion of Barn 1 will exclude roosting/ potentially nesting barn owl. A permanent provision for barn owl should be incorporated into the design and provided within the converted barn. This can be achieved by installing a minimum 1m² nest chamber inside the roof space. The nest chamber will require an access hole located at least 3m above ground level. The access must measure 130mm x 250mm and feature a grippable ledge beneath the exterior hole. The ledge will provide a landing and exercise platform. On the interior, the depth between the bottom of the nest box and entrance, must not be less than 450mm. The nest box exterior should be moisture insulated and feature an external human access. To comply with Building Regulations the barn owl box should be located out of the U-value envelope.
