## **Preliminary Bat & Bird Assessment**

Buildings at Porthmissen Farm, 2 Cuckoo Mill, Padstow, Cornwall

29<sup>th</sup> April 2021

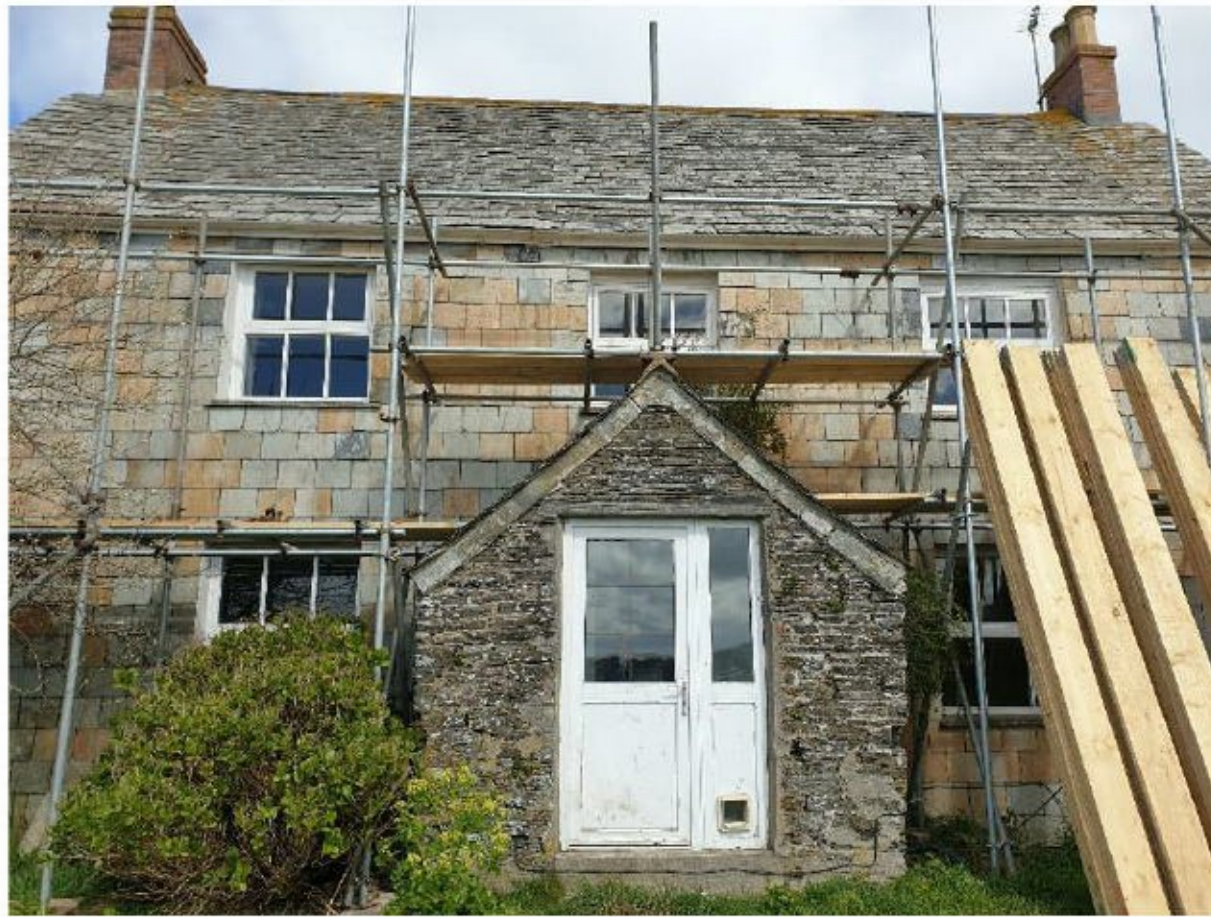
Figure 2: Southern elevation of farmhouse at Porthmissen Farm

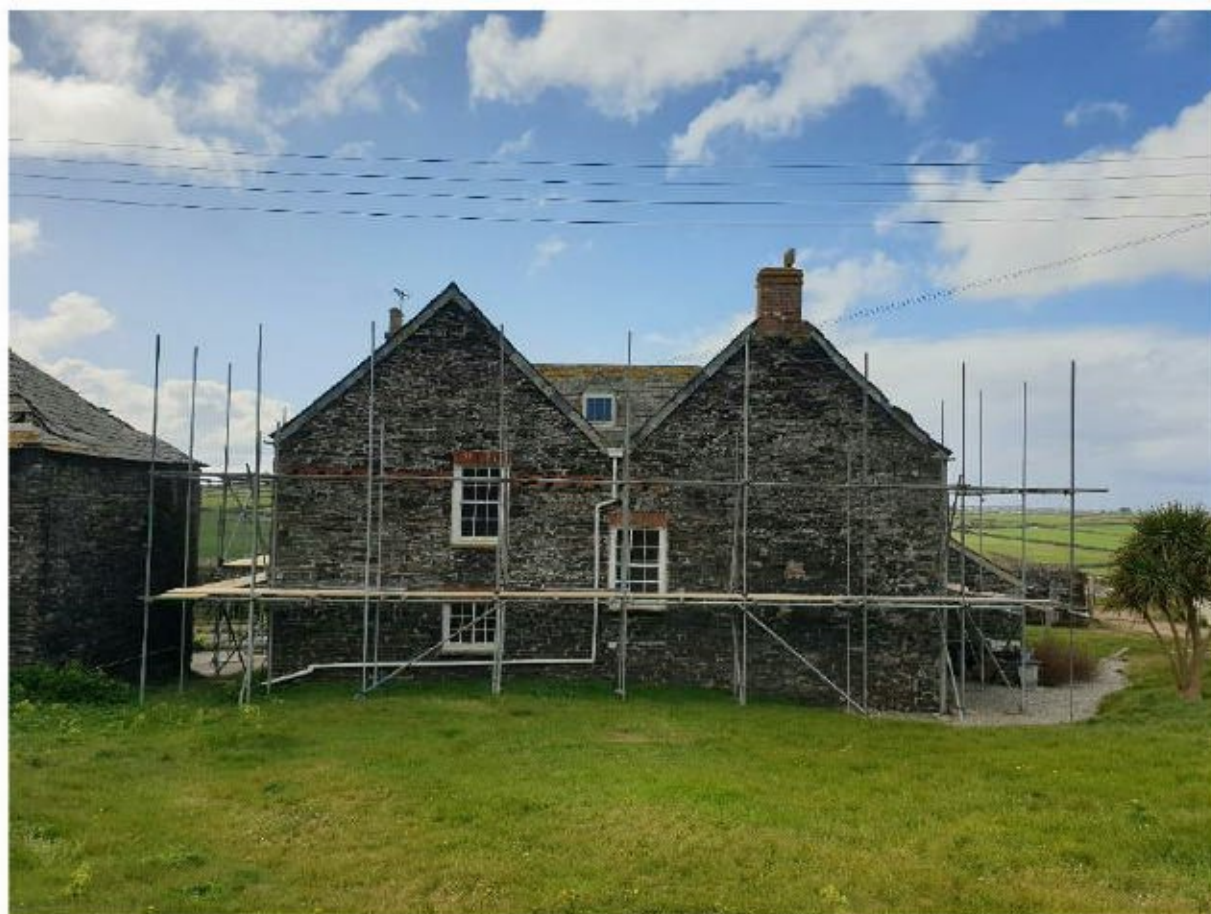
Figure 3: Northern elevation of farmhouse at Porthmissen Farm

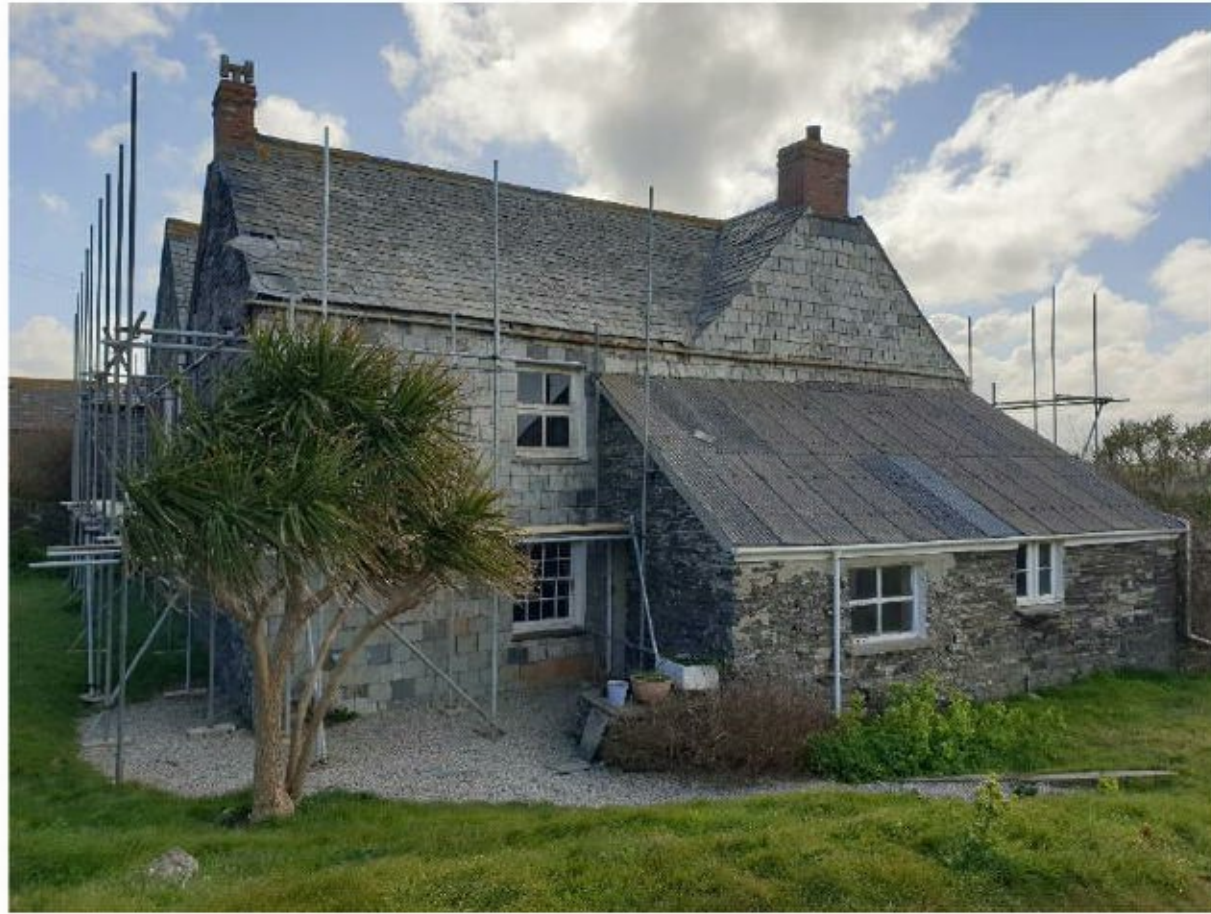
Figure 4: Western elevation of farmhouse at Porthmissen Farm

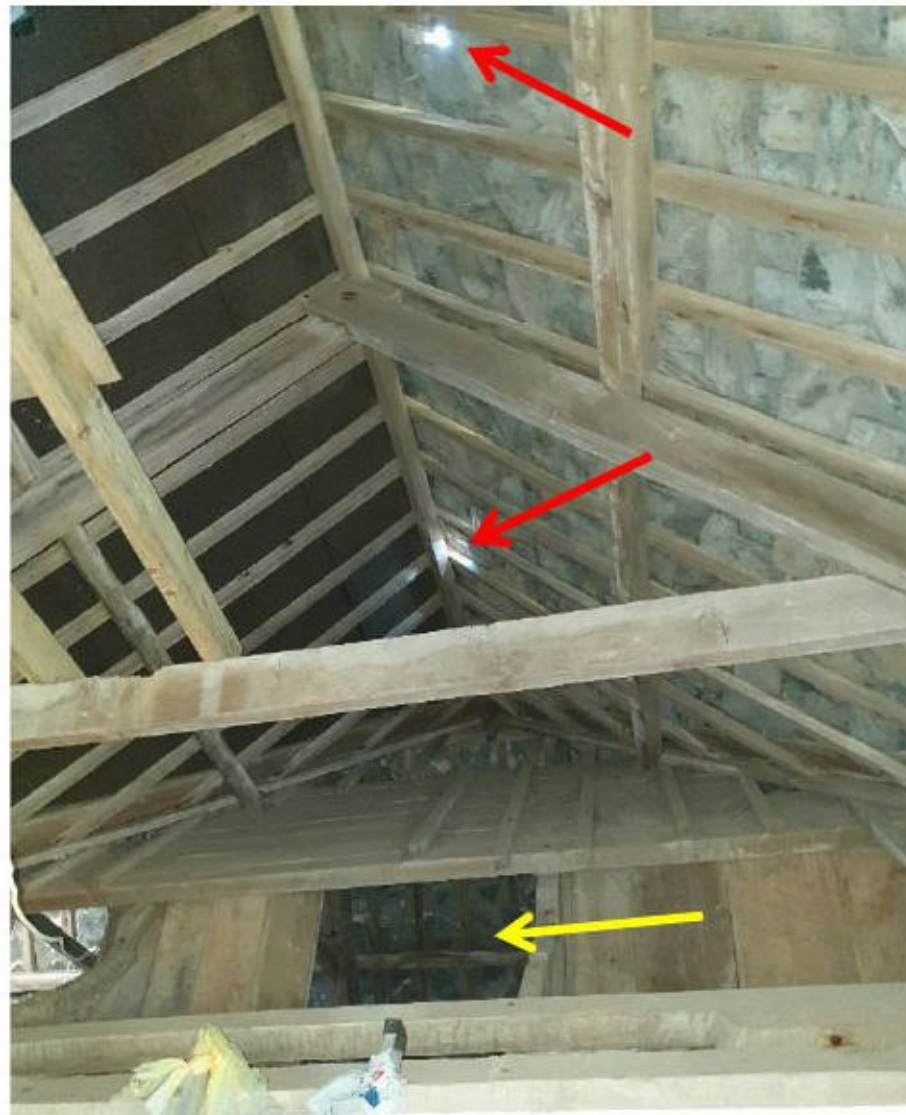
Access to the southern roof void is possible through a gap above the height of the ceiling between the first floor rooms below, connecting the interior of the property to the southern roof void above (Figs. 6 & 7). The interior of this roof void is light, due to the gap leading to the open first floor room and due to the presence of a window in the centre of the northern elevation of this roof. There is thick mineral fibre loft insulation on the floor and the underside of the roof is unlined. The gable end walls are part bare stone and part plastered. It was not possible to fully inspect the southern roof void due to the thick loft insulation covering the ceiling joists. There appears to be a small timber enclosed area at the eastern end of this void. It is not known if this void connects internally to the void over the north eastern section and there is no loft hatch present to access this roof void.

Figure 6: Interior of open roof void within north western section of farmhouse, showing holes in roof (red arrows) and gap leading to southern void (yellow arrow) (viewed from below towards the south)

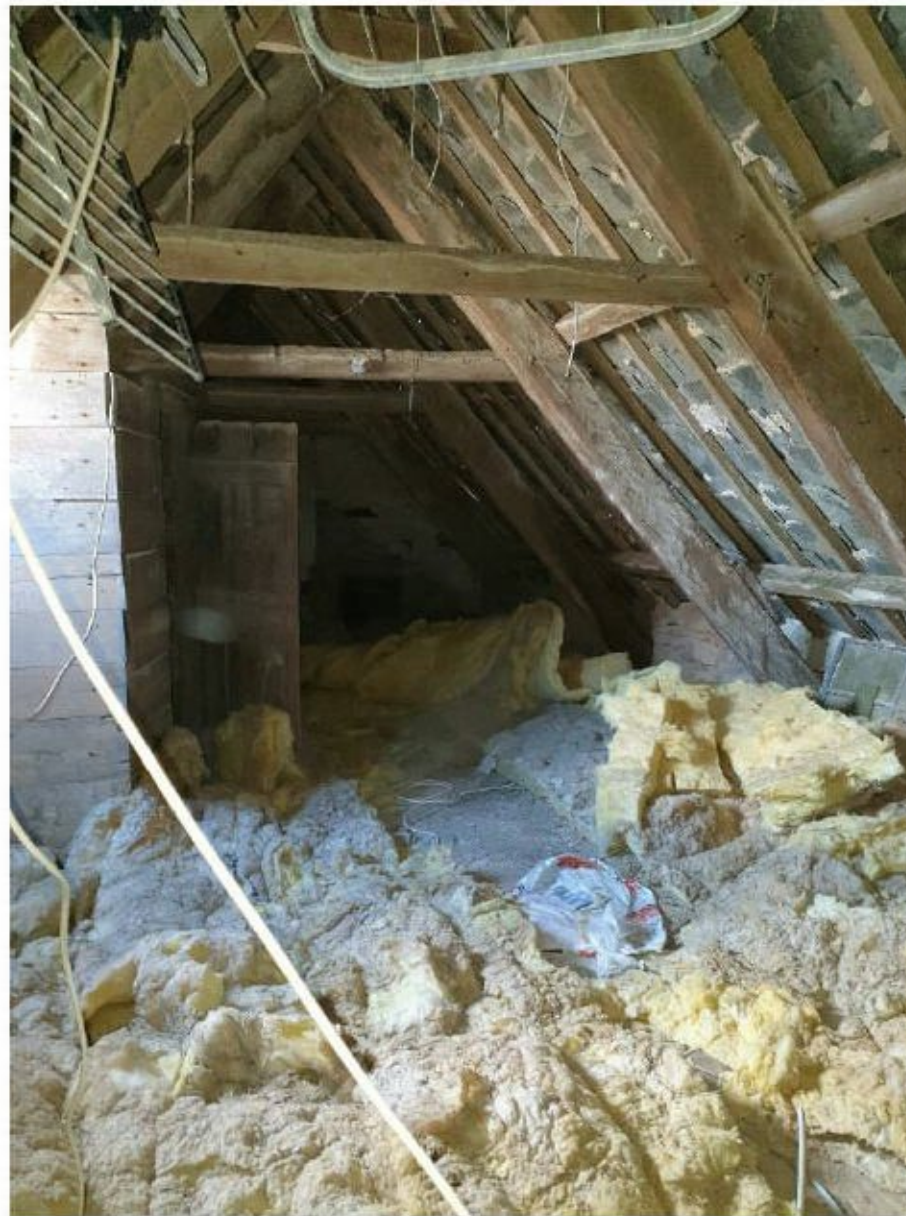
Figure 7: Interior of southern roof void (viewed towards the east)

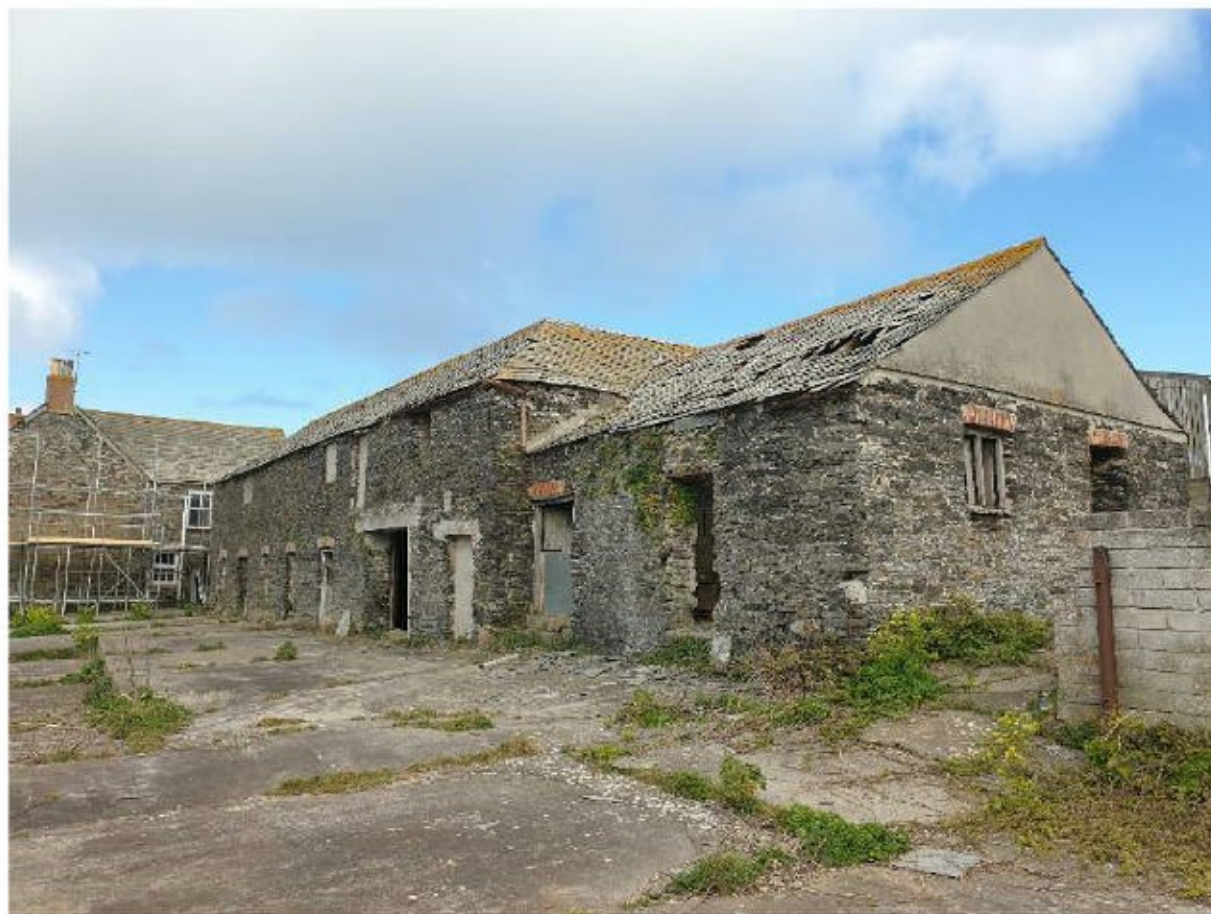
Figure 8: Southern and eastern elevations of Barn 1 at Porthmissen Farm

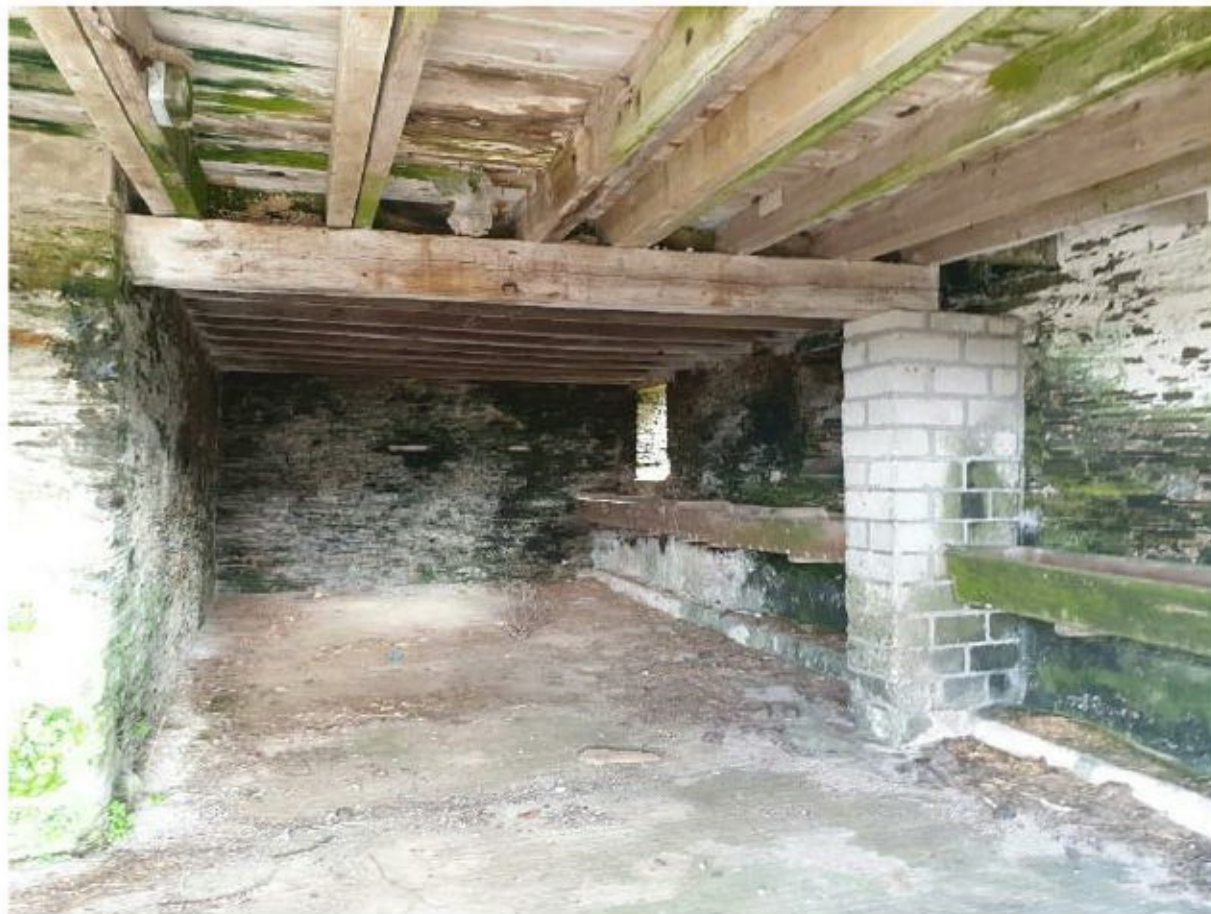
Figure 10: Interior of L-shaped room on ground floor of Barn 1 (viewed towards the north)

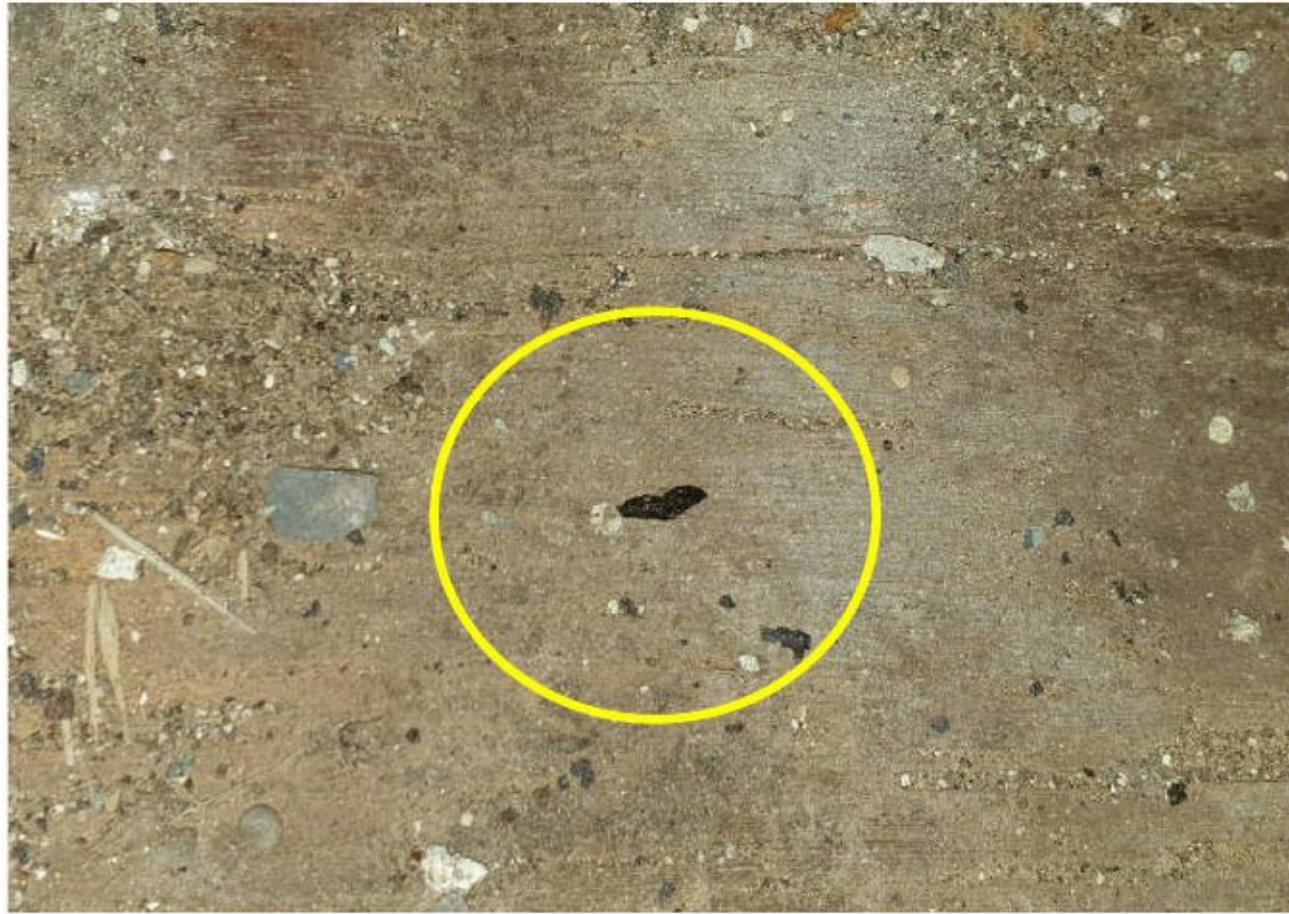
A single bat dropping was noted within one of the ground floor rooms of Barn 1, together with the presence of likely bat feeding remains (butterfly wings) indicating that bats may use the building for roosting. In addition, external features provide potential for crevice dwelling bats and potential access for bats into the interior of the barn.

Figure 11: Bat dropping (yellow circle) found within timber trough on eastern wall of L-shaped ground floor room in Barn 1

The results indicate that the interior of the ground floor of the two-storey section of Barn 1 likely supports a brown long-eared bat roost. NB: species present must be confirmed with DNA analysis of the bat dropping. In addition, likely bat feeding remains (butterfly wings) were found within this part of the building and there are a number of external features on this building with potential to be used for roosting by crevice-dwelling bats and which could provide potential access for bats into the interior.

**Renovation and modification of the farmhouse and Barn 1 must be informed with two bat emergence or re-entry surveys of each building, undertaken between May and September; one of these two emergence surveys should be carried out between May and August (Collins, 2016).** The survey information will be required to inform the planning application and subsequent works. These surveys will determine the species, number of individuals, bat access points and timings of usage. **DNA analysis of the collected bat dropping from Barn 1 is required to confirm the species present.**

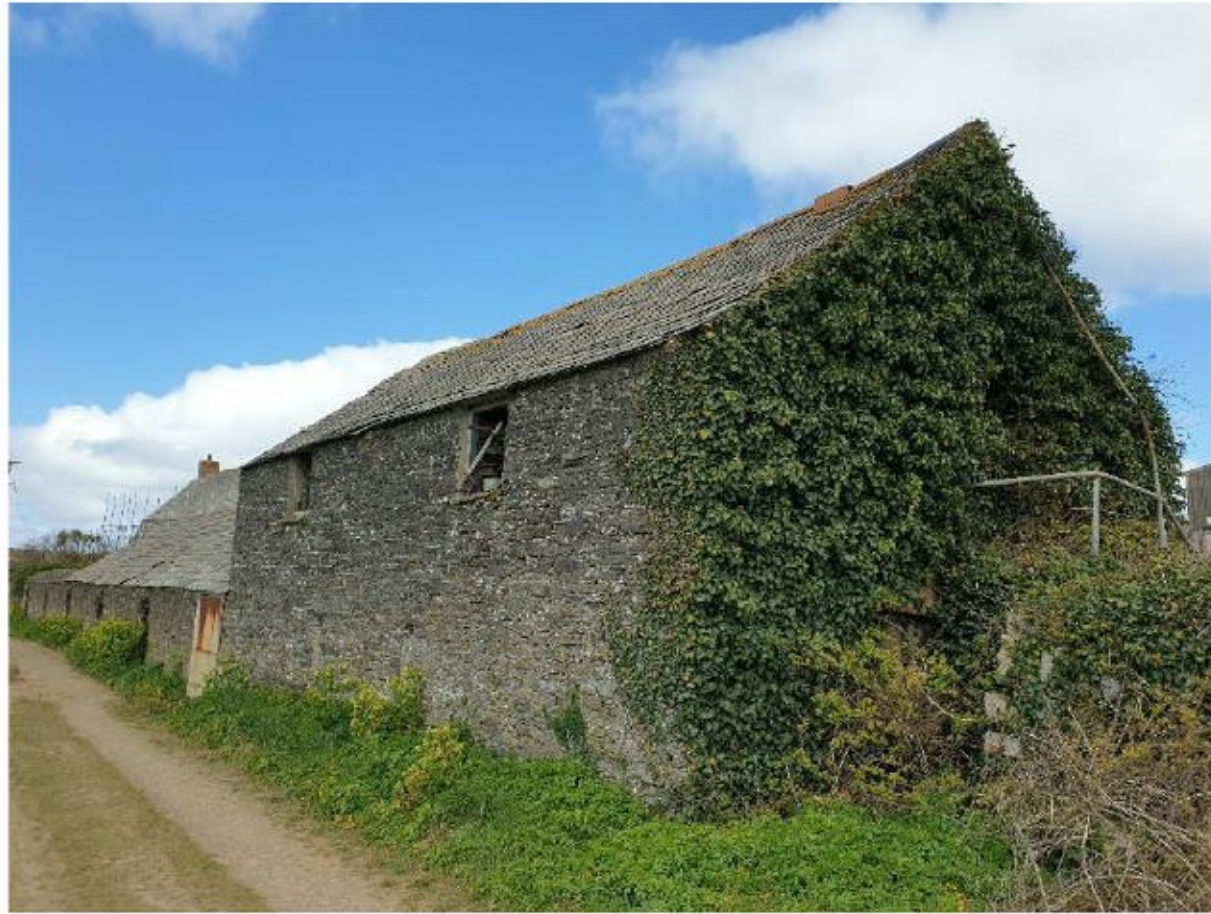
This building is to the south of Barn 1 across a concrete yard and is constructed from stone, brick and concrete block (Figs. 15 & 16). It consists of a part two-storey, part single-storey building with a pitched rag slate roof and clay ridge tiles over each section. There is an external stone staircase at the eastern end leading up to an open doorway, although this part of the building is overgrown with thick vegetation hindering access. There are holes in the roof where slates have lifted, the single-storey section is open-front along its northern elevation and the two-storey section has open window and door apertures, all of which enable potential bat access into the interiors. There are also gaps under lifted slates and ridge tiles which provide potential roost sites for crevice dwelling bats. There are metal gates across some of the northern elevation of the single-storey section. There is ivy growth on the south eastern corner of the barn which could obscure further potential bat roost features (Fig. 16).

Figure 16: Southern and eastern elevations of Barn 2 at Porthmissen Farm, showing ivy growth

A precautionary approach should be adopted during works. Works to the buildings, including removal of ivy, should be avoided during the bird nesting season (March to September inclusive)

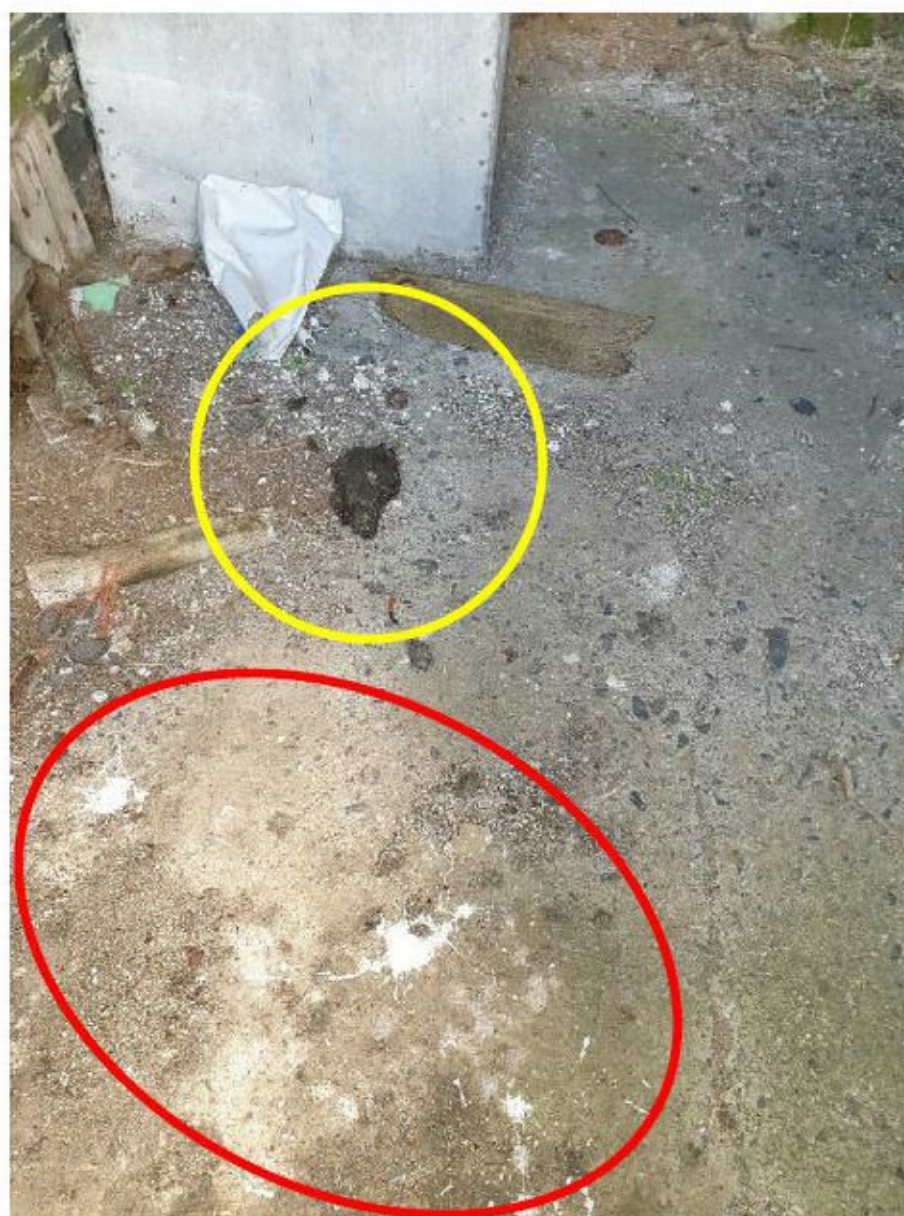
Intact and degraded barn owl (*Tyto alba*) pellets (c. 10) and areas of liming on the floor and on crossing timbers were observed on the floor of the single-storey section of Barn 1 (Fig. 24). An old, likely barn owl nest debris was noted on the mezzanine floor at the western end of this room, with a large number of rodent skeleton fragments and a small number of barn owl flight feathers noted (Fig. 25). At least one barn owl pellet was noted on the first floor of this building, although it was not possible to fully inspect this area due to the dilapidated condition of the floor. No individual barn owls were noted within the buildings and no recent evidence of barn owls nesting within the buildings was noted.

Figure 24: Barn owl pellet (yellow circle) and liming (red circle) on floor of the single-storey section of Barn 1 at Porthmissen Farm

Evidence of barn owl was observed within the single-storey section of Barn 1 and within the first floor of this barn, in the form of intact (recent) and degraded barn owl pellets (at least 10) and liming on the floor of the single-storey room, together with an old, likely barn owl nest debris which was noted on the mezzanine floor at the western end of this room. In addition, at least one barn owl pellet was found on the floor within the first-floor room of this barn. It is likely that barn owls roost within Barn 1 and potentially Barn 2, although the buildings do not appear to be in current or recent use for nesting by this species. However, as a precaution, works to Barns 1 and 2 must be preceded with a pre-works inspection for nesting barn owl, irrespective of time of year. NB: Barn owl can breed at any time of year. If nesting barn owls are present, works must be delayed until nesting activity has ceased and/or the dependant young have fledged.

In the absence of mitigation, conversion of Barn 1 will exclude roosting/ potentially nesting barn owl. A permanent provision for barn owl should be incorporated into the design and provided within the converted barn. This can be achieved by installing a minimum 1m<sup>2</sup> nest chamber inside the roof space. The nest chamber will require an access hole located at least 3m above ground level. The access must measure 130mm x 250mm and feature a grippable ledge beneath the exterior hole. The ledge will provide a landing and exercise platform. On the interior, the depth between the bottom of the nest box and entrance, must not be less than 450mm. The nest box exterior should be moisture insulated and feature an external human access. To comply with Building Regulations the barn owl box should be located out of the U-value envelope.

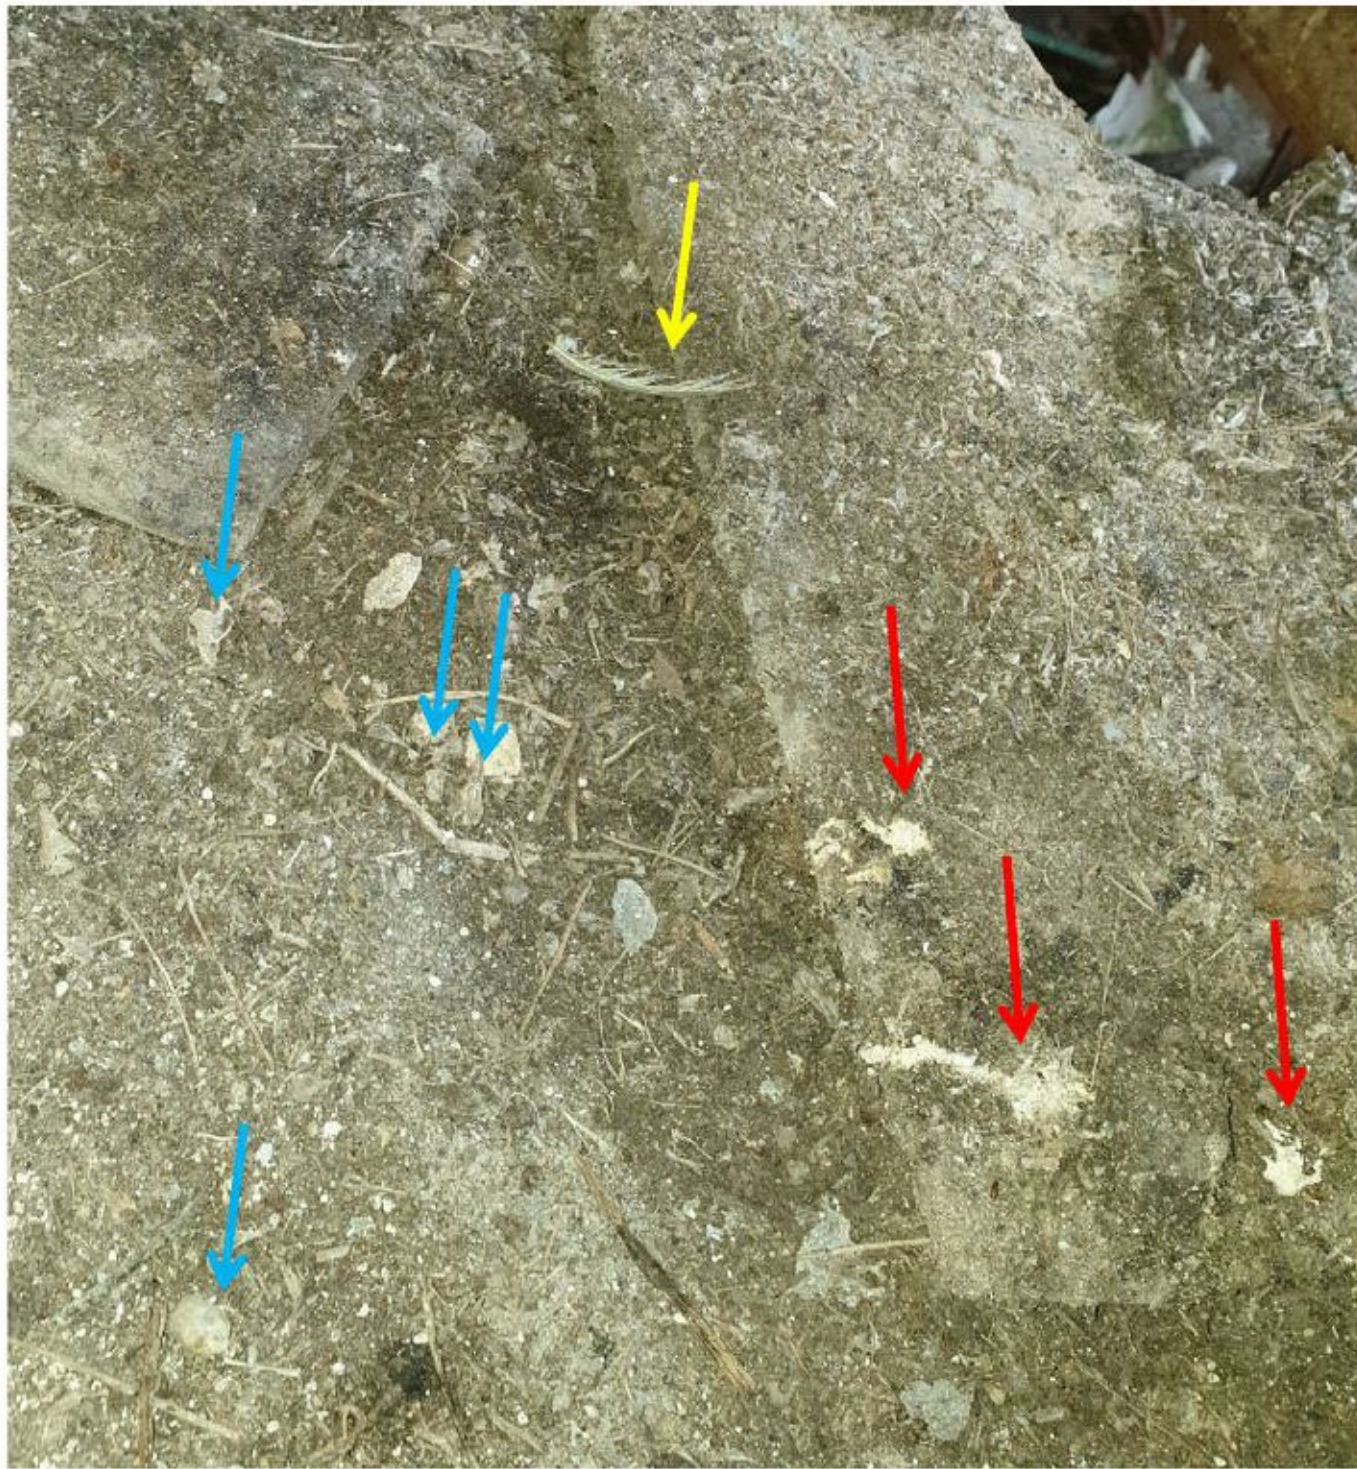
Figure 25: Old likely barn owl nest debris on mezzanine floor within single-storey section of Barn 1, showing rodent skeleton fragments (blue arrows), liming (red arrows) and barn owl feather (yellow arrow)

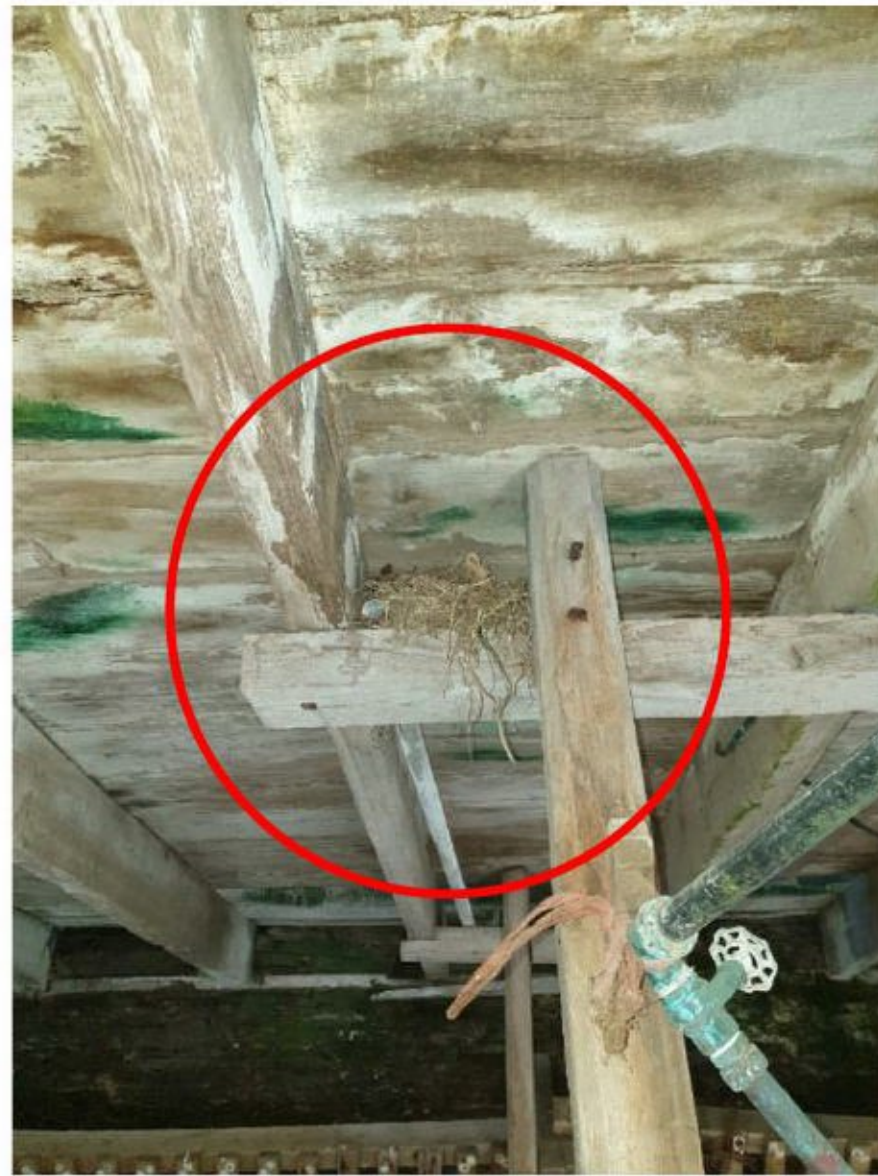
A woven bird's nest and a number of barn swallow's (*Hirundo rustica*) nests were noted within the ground floor rooms of Barn 1 and an old barn swallow's nest was noted under the ceiling of the ground floor room within Barn 2 (Figs. 26 & 27). Ivy growth on the south eastern corner of Barn 2 provides potential nesting habitat for birds (Fig. 16).

Figure 26: Woven bird's nest within Barn 1

Evidence of nesting barn swallows was observed within Barns 1 and 2; alternative provision for nesting swallows should be made within the converted buildings or an alternative building within the site. Suitable products include No. 10 Schwegler Swallow Nest. Suitable products are available at <https://www.nhbs.com>, and <https://www.wildcare.co.uk/>.

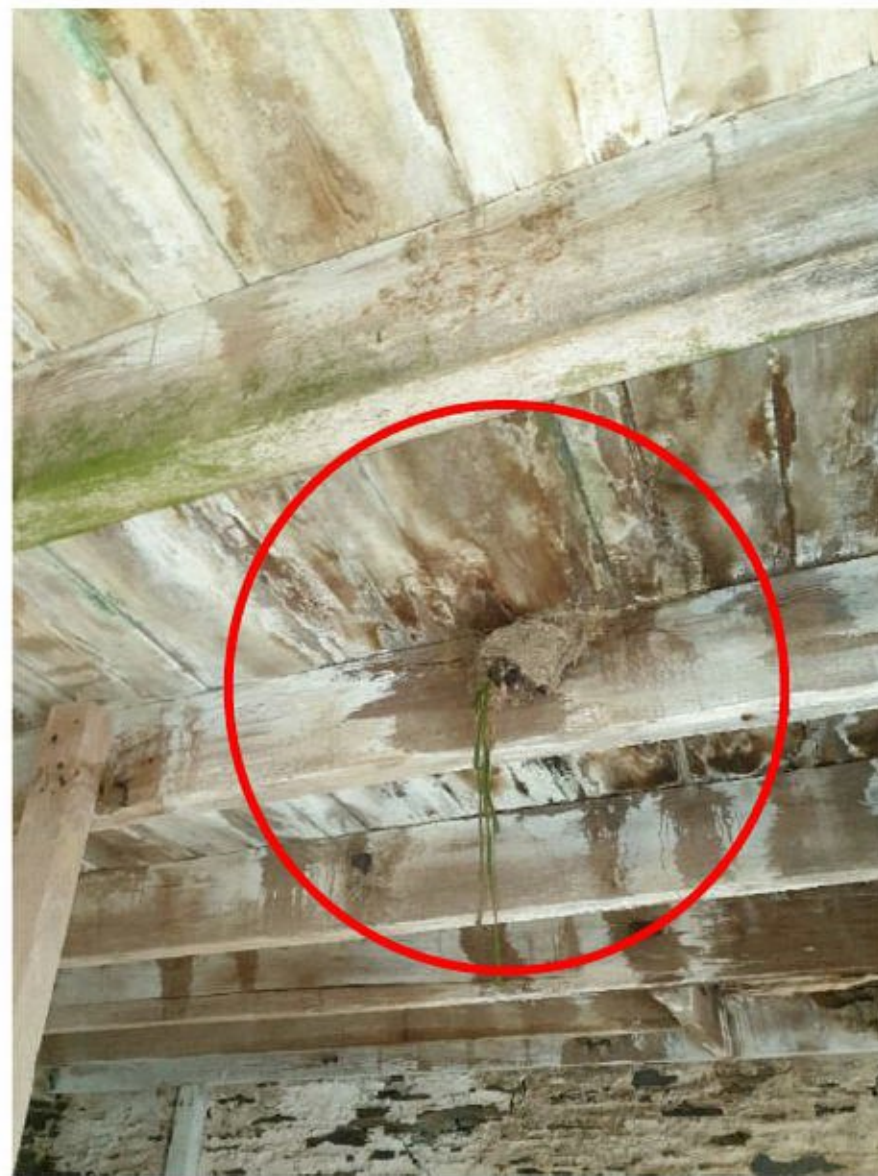
Figure 27: Swallow's nest within Barn 1
