ARBORICULTURAL IMPACT ASSESSMENT

Site:	700 St Johns Road, St Johns Nursery Site Earls Hall Drive, Clacton-On-Sea, Essex, CO16 8BJ
Client:	Kelsworth Ltd
Date	3rd June 2021
Our Ref:	EAS-004v4
Planning Ref:	18/01779/FUL

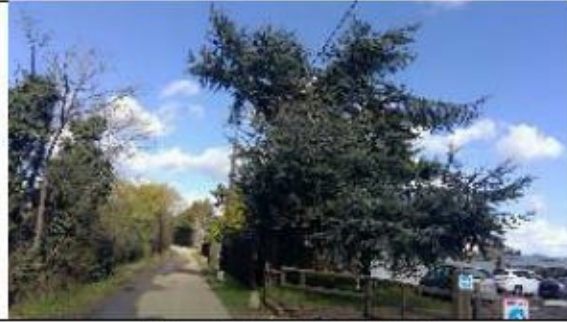
T1 - Cedar (Blue Atlas)

Tree No.	Species	Ht (m)	CS N	CS E	CS S	CS W	DBH (mm)	No of Stems	RPA (m2)	RPR (m)	BS Cat	Age Class	Life Expect.	Observations	Recommendations
T1	Cedar (Blue Atlas)	11	8	8	7	5	500	1	113.1	6.0	C2	Mature	20-39	Poor form (asymmetric canopy), shape and condition. Subject to historic crown management, reduced from power cables. Dense crown, minor dead wood throughout crown.	Crown reduce and reshape by 1.5m to reshape to no more than 30% by crown volume.
T2	Cedar of Lebanon	11	5	5	5	5	330	1	49.3	4.0	B2	Early Mature	40+	Average form, shape and condition. No significant recent crown management. Dense crown, moderate dead wood throughout crown. Hanging snapped branch in lower crown.	Remove dead wood >5cm diameter throughout the crown and snapped branches overhanging the site.
T3	Birch (Silver)	12	4	4	4	4	350	1	55.4	4.2	B2	Early Mature	20-39	Average form, shape and condition. No significant recent crown management. Dense crown, minor dead wood throughout crown. Lower limbs pruned to stubs over car park.	No works.

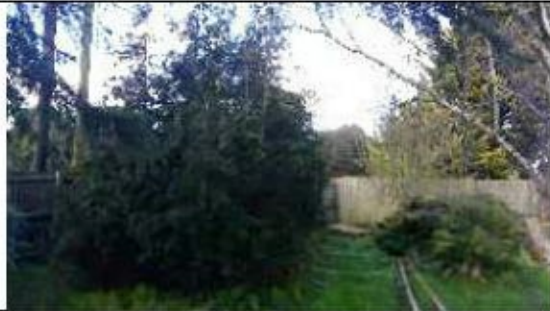
T4 - Cypress (Lawson)

Tree No.	Species	Ht (m)	CS N	CS E	CS S	CS W	DBH (mm)	No of Stems	RPA (m2)	RPR (m)	BS Cat	Age Class	Life Expect.	Observations	Recommendations
T4	Cypress (Lawson)	6	3	3	3	3	400	10	72.4	4.8	C2	Early Mature	10-19	Poor multiple stemmed form, shape and condition. No significant recent crown management. Dense crown, minor dead wood throughout crown.	No works.
T5	Hawthorn	4	3	3	3	3	100	1	4.5	1.2	C2	Semi-Mature	20-39	Average form, shape and condition. No significant recent crown management. Dense crown, minor dead wood.	No works.
T6	Cypress (Golden Monterey)	12	4	4	4	4	450	2	91.6	5.4	C2	Mature	10-19	Average form, shape and condition. No significant recent crown management - previously cut back from power cables. Dense crown, minor dead wood throughout lower crown.	No works.
T7	Cherry	5	2.5	2.5	2.5	2.5	100	1	4.5	1.2	C2	Semi-Mature	10-19	Poor suppressed form, shape and condition. No significant recent crown management. Open crown, minor dead wood throughout crown.	No works.

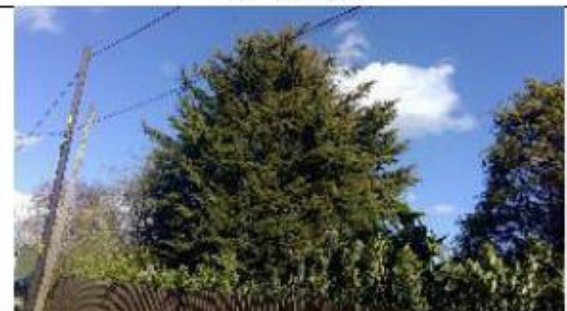
TG1 - Cypress (Lawson)

Tree No.	Species	Ht (m)	CS N	CS E	CS S	CS W	DBH (mm)	No of Stems	RPA (m2)	RPR (m)	BS Cat	Age Class	Life Expect.	Observations	Recommendations
TG1	Cypress (Lawson)	14	6	6	6	6	350	4	55.4	4.2	B2	Early Mature	20-39	Average form, shape and condition. No significant recent crown management. Dense crowns, minor dead wood throughout crowns. X 4 trees growing close together in group.	No works.
SG1	Mixed species shrubs: Elaeagnus, Cypress	6	3	3	3	3	100	10	4.5	1.2	C2	Early Mature	20-39	Average form, shape and condition. No significant recent crown management. Dense crowns, minor dead wood throughout crowns.	No works.
T12	Elder	6	3	3	3	3	200	4	18.1	2.4	C2	Mature	10-19	Poor form, shape and suppressed condition. No significant recent crown management. Open crown, moderate dead wood throughout.	No works.
T13	Cherry	11	6	6	6	6	500	1	113.1	6.0	B2	Mature	10-19	Average form, shape and condition. No significant recent crown management. Dense crown, moderate dead wood throughout crown. Ivy clad crown and stem, unable to fully inspect.	Remove dead wood >5cm diameter throughout the crown. Sever Ivy at 2m from ground level and remove section. Re-inspect.

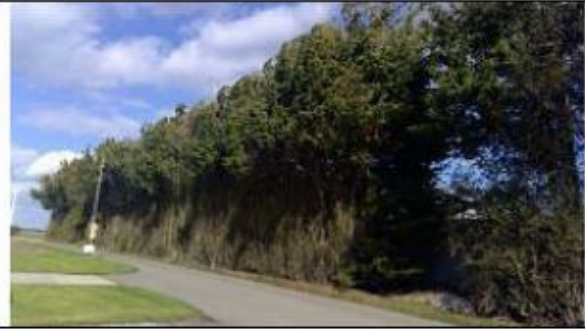
TG2 - Cypress (Lawson)

- 1.4.2 The removal and replacement of the tired and poor condition leyland hedge / screen along Earls Hall Drive, TG2 & TG3, which have been heavily cut back on the road side leaving that side of the screen brown and given the species unlikely to grow back. Several of the trees in this screen are suppressed and have died.

TG2	Cypress (Lawson)	12	3	3	3	3	300	35	40.7	3.6	C2	Mature	10-19	Poor form, shape and condition linear boundary screen. Subject to historic crown management: lifted & cut back from farm access road. Sparse crowns showing signs of stress with crown retrenchment.	No works.

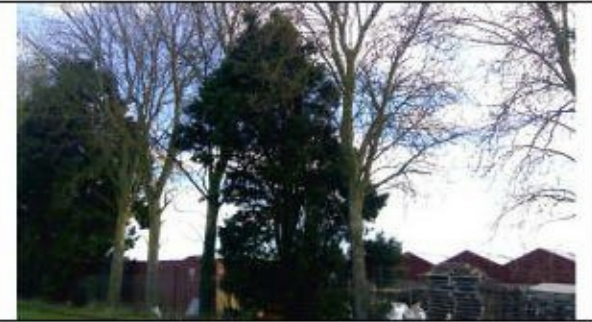
T21 - Cypress (Leyland)

T21	Cypress (Leyland)	10	4	4	4	4	450	1	91.6	5.4	C2	Mature	10-19	Average form, shape and condition. No significant recent crown management - cut back on field side crown. Dense crown, moderate dead wood throughout crown.	No works.

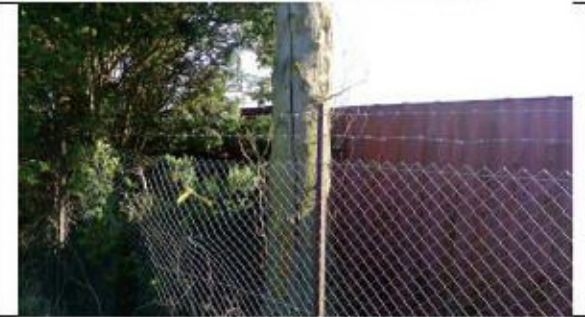
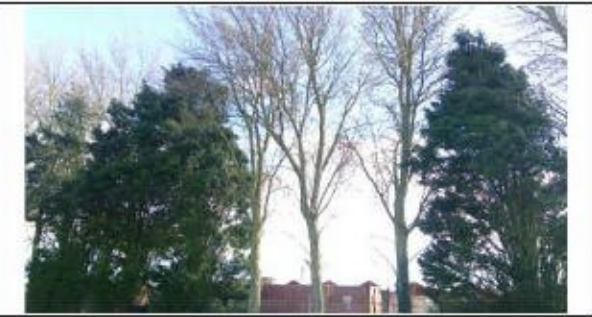
T24 - Poplar (Hybrid Black)

T24	Poplar (Hybrid Black)	20	6	6	6	6	400	1	72.4	4.8	U	Mature	<10	Average form, shape and condition. Unable to fully inspect due to restricted access. No significant recent crown management. Open crown with moderate crown deadwood. Trunk epicormic growth. Fresh and open helical trunk split for 6m on main trunk to crown break.	Fell to ground level and treat.

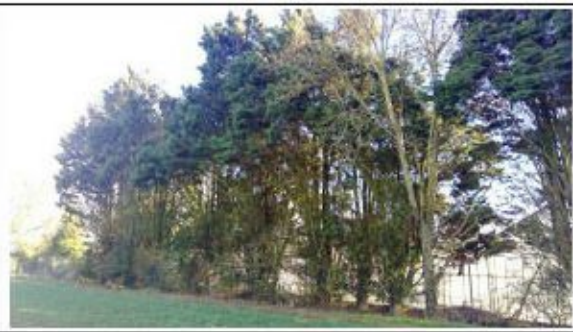
TG4 - Cypress (Leyland)

TG4	Cypress (Leyland)	16	4	4	4	4	450	8	91.6	5.4	C2	Mature	10-19	Average form linear shape and condition boundary screening group. No significant recent crown management - cut back on field side. Dense crowns, moderate dead wood.	Remove dead wood >5cm diameter throughout the crown.

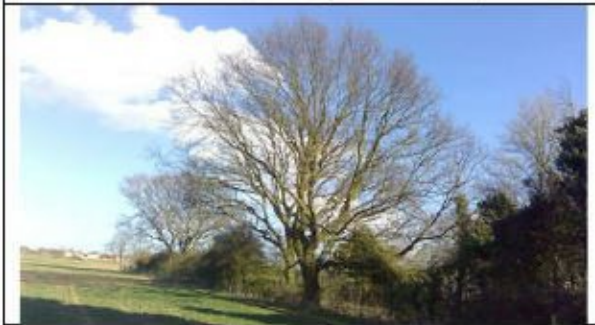
T57 - Oak (English)

Tree No.	Species	Ht (m)	CS N	CS E	CS S	CS W	DBH (mm)	No of Stems	RPA (m2)	RPR (m)	BS Cat	Age Class	Life Expect.	Observations	Recommendations
T57	Oak (English)	18	10	10	10	10	850	1	326.9	10.2	B1	Mature	40+	Average form, shape and condition. No significant recent crown management. Dense crown, moderate dead wood throughout crown. Unable to fully inspect due to restricted access.	Remove dead wood >5cm diameter throughout the crown.
TG5	Cypress (Leyland)	6	1	1	1	1	100	10	4.5	1.2	U	Semi-Mature	<10	Dead ivy covered trees with some windblown.	Fell to ground level and treat.
T58	Oak (English)	18	10	10	10	10	500	1	113.1	6.0	B1	Mature	40+	Average form, shape and condition. No significant recent crown management. Dense crown, moderate dead wood throughout crown. Unable to fully inspect due to restricted access.	Remove dead wood >5cm diameter throughout the crown.
T59	Oak (English)	18	1	6	8	7	400	1	72.4	4.8	C2	Early Mature	40+	Poor suppressed form, shape and condition. No significant recent crown management. Dense crown, moderate dead wood throughout crown. Unable to fully inspect due to restricted access.	Remove dead wood >5cm diameter throughout the crown.

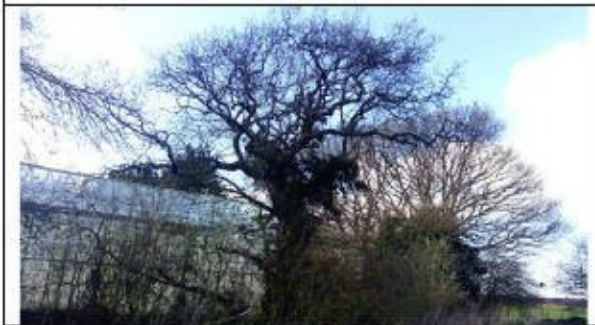
T60 - Oak (English)

Tree No.	Species	Ht (m)	CS N	CS E	CS S	CS W	DBH (mm)	No of Stems	RPA (m2)	RPR (m)	BS Cat	Age Class	Life Expect.	Observations	Recommendations
T60	Oak (English)	10	5	5	5	5	950	1	408.3	11.4	B1	Mature	40+	Hedgerow pollard form, shape and condition. No significant recent crown management. Dense low crown, moderate dead wood throughout crown. Unable to fully inspect due to restricted access. Ivy clad crown and stem, unable to fully inspect.	Remove dead wood >5cm diameter throughout the crown. Sever Ivy at 2m from ground level and remove section. Re-inspect.
T61	Poplar (Hybrid Black)	22	5	5	5	5	950	2	408.3	11.4	B1	Mature	40+	Average form, shape and condition. No significant recent crown management. Dense crown, moderate dead wood throughout crown. Unable to fully inspect due to restricted access. Co dominant tree with moderate included unions. Basal & Trunk limb epicormic growth.	Remove dead wood >5cm diameter throughout the crown. Remove epicormic growth to a height of 4m.

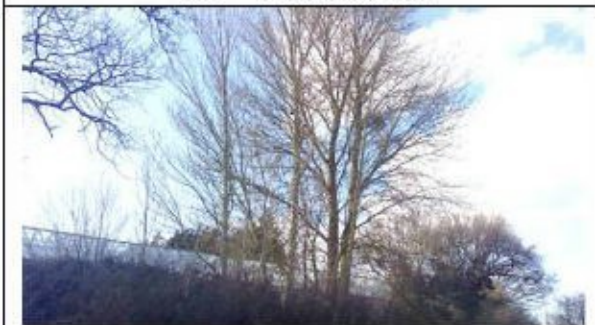
TG6 - Poplar (Hybrid Black)

TG6	Poplar (Hybrid Black)	15	4	4	4	4	200	5	18.1	2.4	C2	Early Mature	10-19	Average form, shape and condition roor suckers. No significant recent crown management. Dense crown, minor dead wood	Fell to ground level and treat.

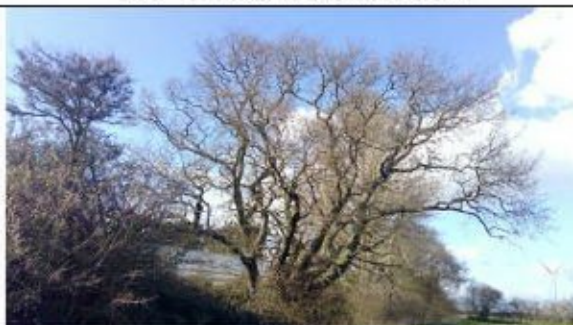
T62 - Oak (English)

Tree No.	Species	Ht (m)	CS N	CS E	CS S	CS W	DBH (mm)	No of Stems	RPA (m2)	RPR (m)	BS Cat	Age Class	Life Expect.	Observations	Recommendations
T62	Oak (English)	18	10	10	10	10	2000	5	707.0	15.0	B1	Over Mature	40+	Veteran, lapse pollard form, shape and condition. No significant recent crown management. Dense crown, moderate dead wood throughout crown. Unable to fully inspect due to restricted access.	Remove dead wood >5cm diameter throughout the crown.
T63	Hawthorn	6	3	3	3	3	250	1	28.3	3.0	C2	Mature	10-19	Average hedge form , shape and condition. No significant recent crown management. Dense crown, low dead wood	No works.
T64	Hawthorn	6	3	3	3	3	250	1	28.3	3.0	C2	Mature	10-19	Average hedge form , shape and condition. No significant recent crown management. Dense crown, low dead wood	No works.
T65	Oak (English)	8	4	4	4	4	350	1	55.4	4.2	B2	Early Mature	40+	Good form, shape and condition. No significant recent crown management. Dense crown, low dead wood throughout crown.	No works.
