Land at Hoodlands Farm, Harry Stoke

Tyler
Grange

Arboricultural Impact
Assessment
16th July 2021

11857_R05_JP_HM

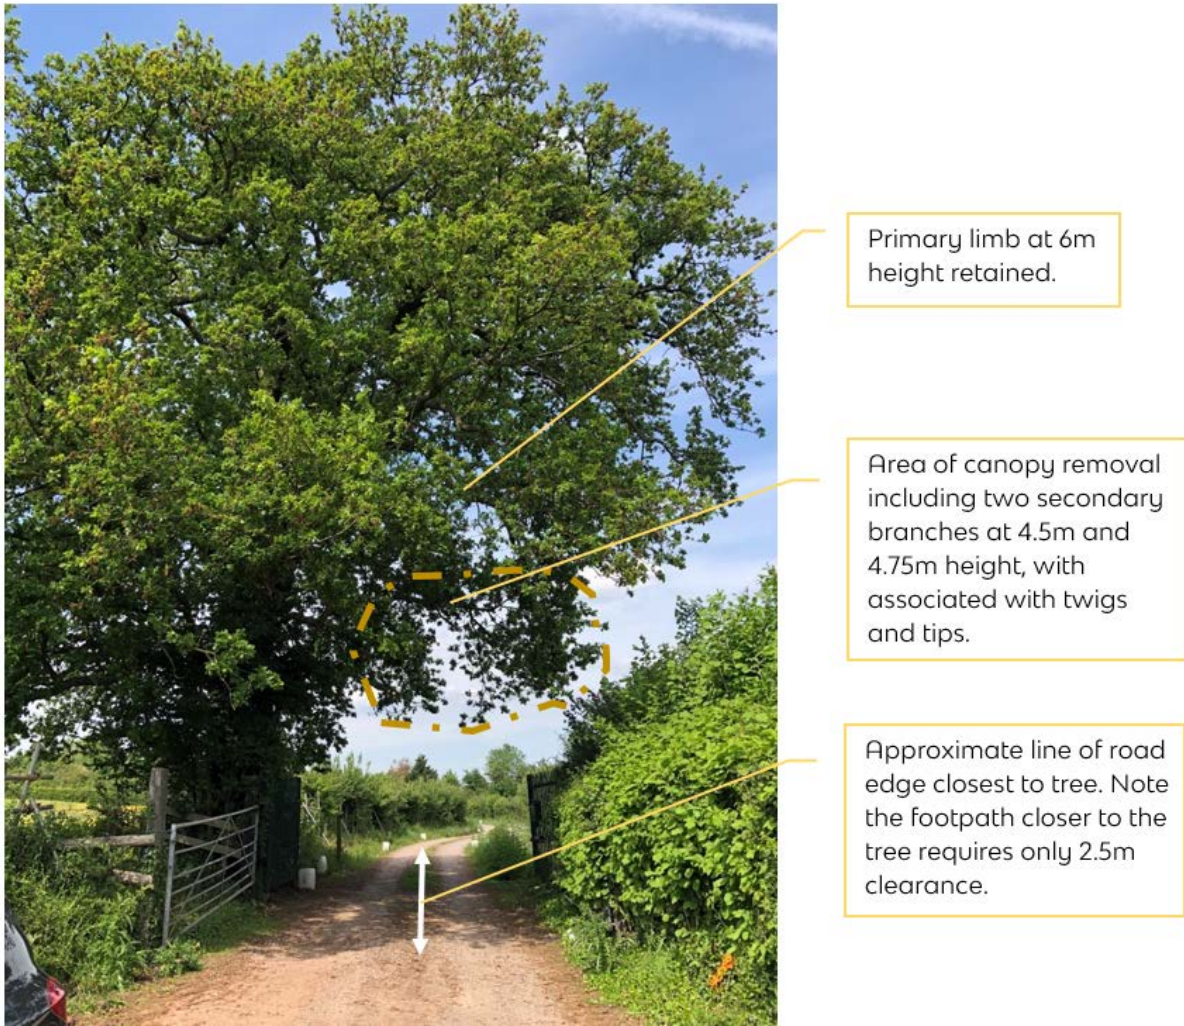
Figure 3. Image of tree T15 with canopy clearance requirements.

- 3.18. The proposed access road level will be a maximum of 47.500. The existing track surface beneath the canopy of the tree is measured between 46.91 and 47.05. There will therefore be an increase in road height of up to 500mm beneath the canopy of the tree to facilitate the build-up of a 200mm no-dig construction within the RPA.

- 3.17. It is understood that the proposed access will be implemented before the arrival of the modular homes, and therefore the clearance required must be taken from the finished level of the proposed access beneath the tree. The impact of any tree pruning works must also be viewed alongside the requirement for a no-dig surface to protect the rooting environment of the tree.

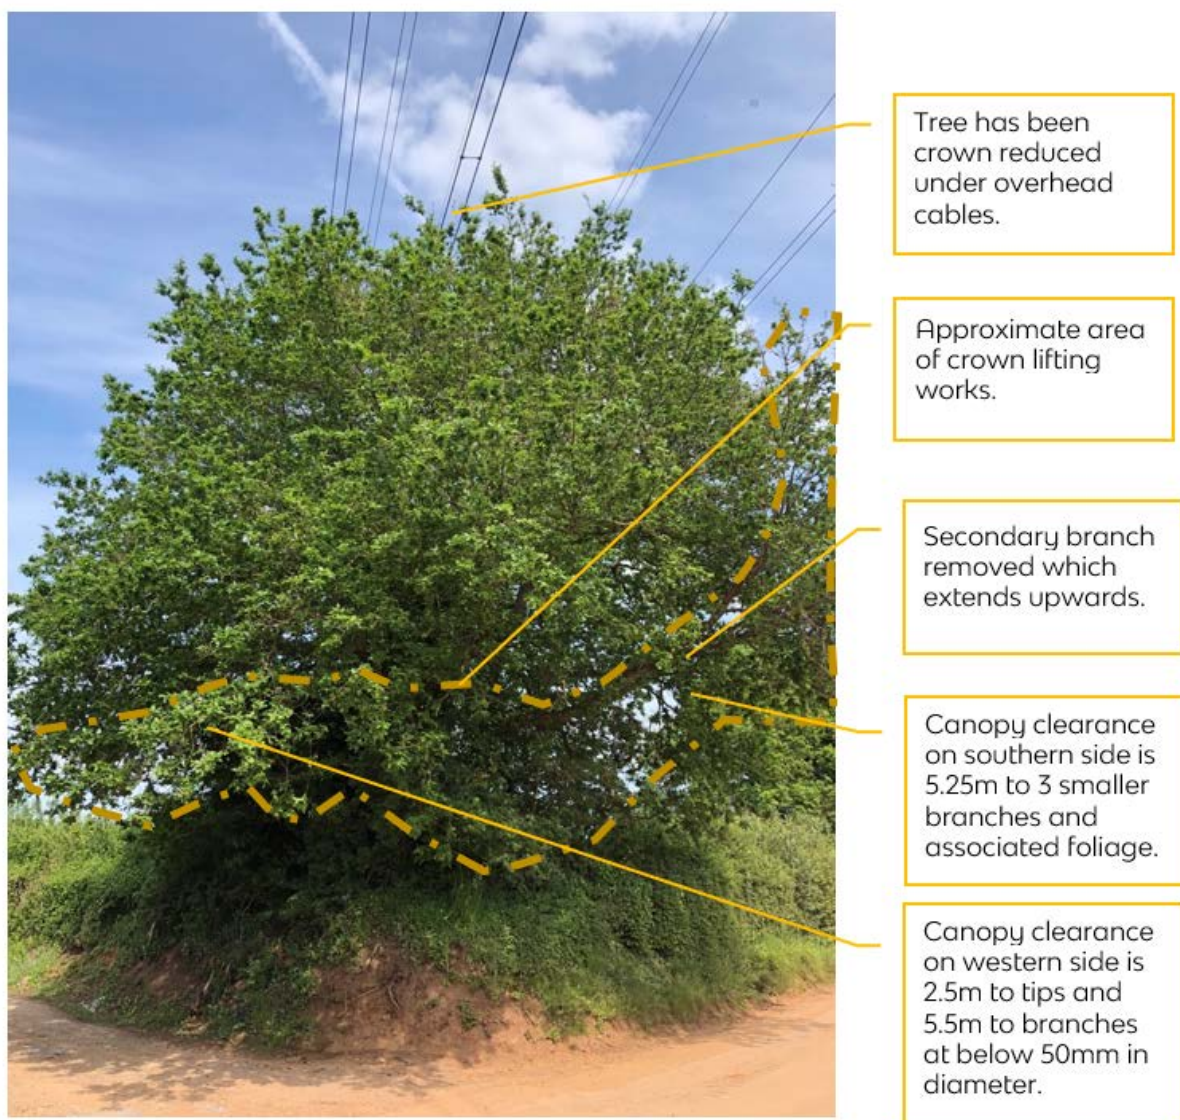
Figure 4. Image of tree T16 with canopy clearance requirements.

- 3.21. Tree T16 is located at the top edge of a steep bank sloping upwards from Hambrook Lane and the existing access track. The canopy overhangs into Hambrook Lane and to the west over the existing access track.

- 3.22. The proposed access road level will be a maximum of 46.600 beneath the canopy of the tree. The existing track surface beneath the canopy of the tree is measured at 46.000. There will therefore be an increase in road height of up to 600mm beneath the canopy of the tree to facilitate a 200mm no-dig construction within the RPA. It is important to note that the increase in road levels has been maximised to reduce the 'cut effect' into the bank on which the tree is located. Bringing the road levels higher means there is a reduced amount of cut into the bank as addressed later in this report. The impact on tree canopy is considered less sensitive to the tree's health than the impact on tree roots that may be present within the bank.

- 3.23. The canopy clearance of the tree, as measured to its south and west over Hambrook Lane and the track is detailed in Figure 4 below. This assessment shows that only the lower proportion of the

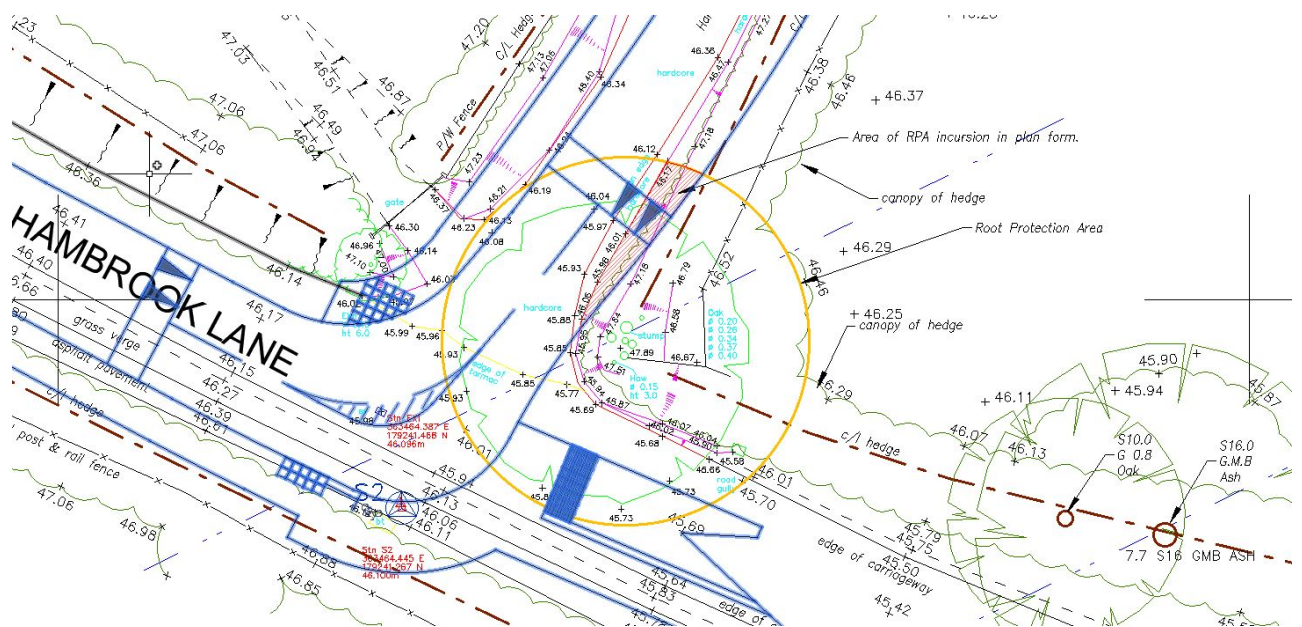
Figure 6. Overlay of proposed access alignment and topographical survey for tree T16. The area of incursion into the bank is shown with a red hatched area.

3.41. The extent of unsurfaced RPA (i.e. the bank) that will be impacted by the edge of the proposed road amounts to 4% of the overall RPA footprint. This represents a very low proportion of the

RPA and the depth of the incursion will also be minimised. The point of incursion is near to the tree's stem which may impact larger tree roots unless suitable mitigation is provided.

3.40. The principle of designing the access to avoid impacts to the tree was to avoid impacts into the bank on the eastern side of the access as far as possible. The constraints to aligning the access to the west (away from the tree / bank) include transport standards for the width of the footpath and road, the forward visibility / tracking required from the junction heading west to / from Hambrook Lane, and the land ownership on the western side of the access. Following an in-depth review of the access alignment, it has been located as far west away from the tree as possible within the constraints of transport standards and the land ownership. This results in an unavoidable incursion within the bank on the eastern side of the access track as shown in Figure 6 below.

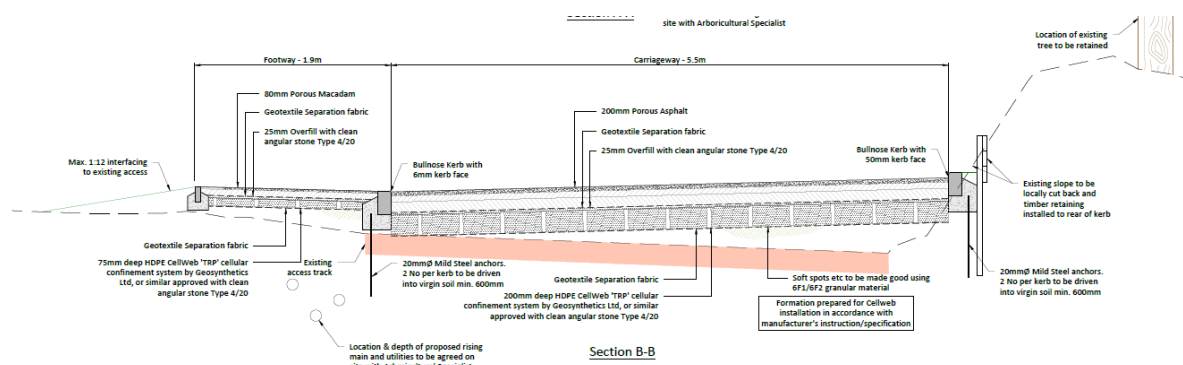
Figure 7. Extract of cross sections prepared by Structa for access road next to tree T16.

- 3.43. As illustrated above, the proportion of incursion into the bank adjacent to the tree has been minimised by increasing the level of the road. The incursion will be limited to the kerb haunching which represents a localised excavation at face of the bank only which will be 'scooped' out from the bank. A non-invasive timber retaining feature is also proposed to avoid regrading of the upper parts of the bank which may otherwise impact tree roots. The steel anchors securing the haunching will be locally driven into the bank, avoiding an excavation required using a conventional method.

- 3.42. Due to the location of the incursion within the bank, the level of the road has been increased in order to reduce the extent of 'cut' into the bank. Increasing the level of the road allows a proportion of the bank to be incorporated beneath the access road build-up (see extract of cross-sections at Figure 7 below).
