Arboricultural Report

Tree Survey
Arboricultural Impact Assessment
& Tree Protection Plan

New Gatehouse
Redwood
Penshurst Road
Kent
TN11 8HY

AR/102821

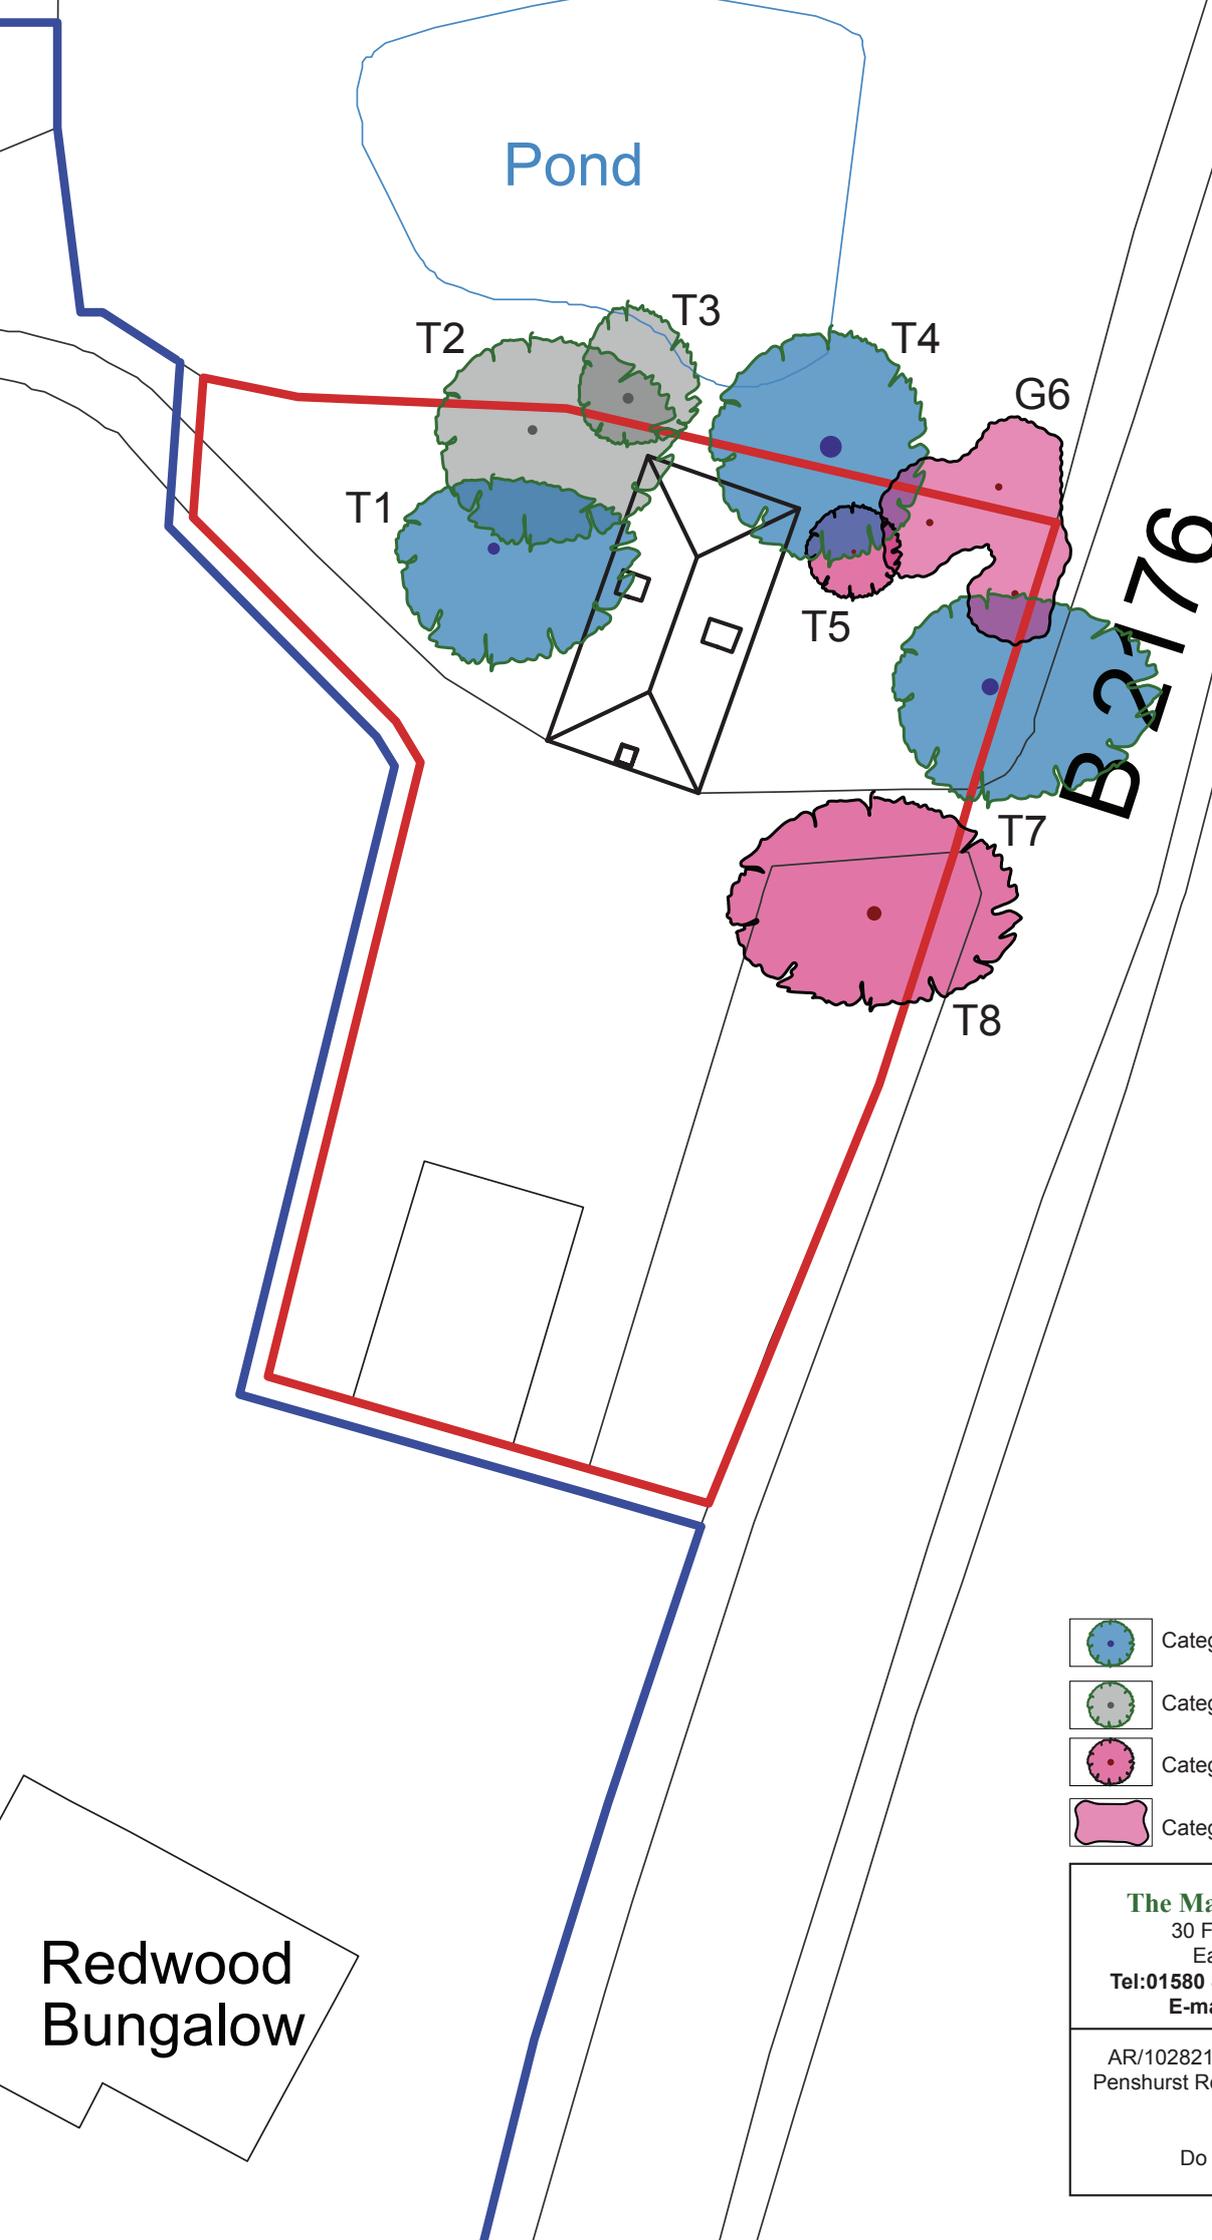
AR/102821 – New Gatehouse - Redwood
Penshurst Road, Tonbridge, Kent, TN11 8HY
Existing Tree Plan
June 2021
Do not scale from drawing

8.1 I surveyed seven individual trees and one group of trees in May 2021. These have been plotted on the existing tree plan at Appendix A, and described within the schedule at Appendix C.

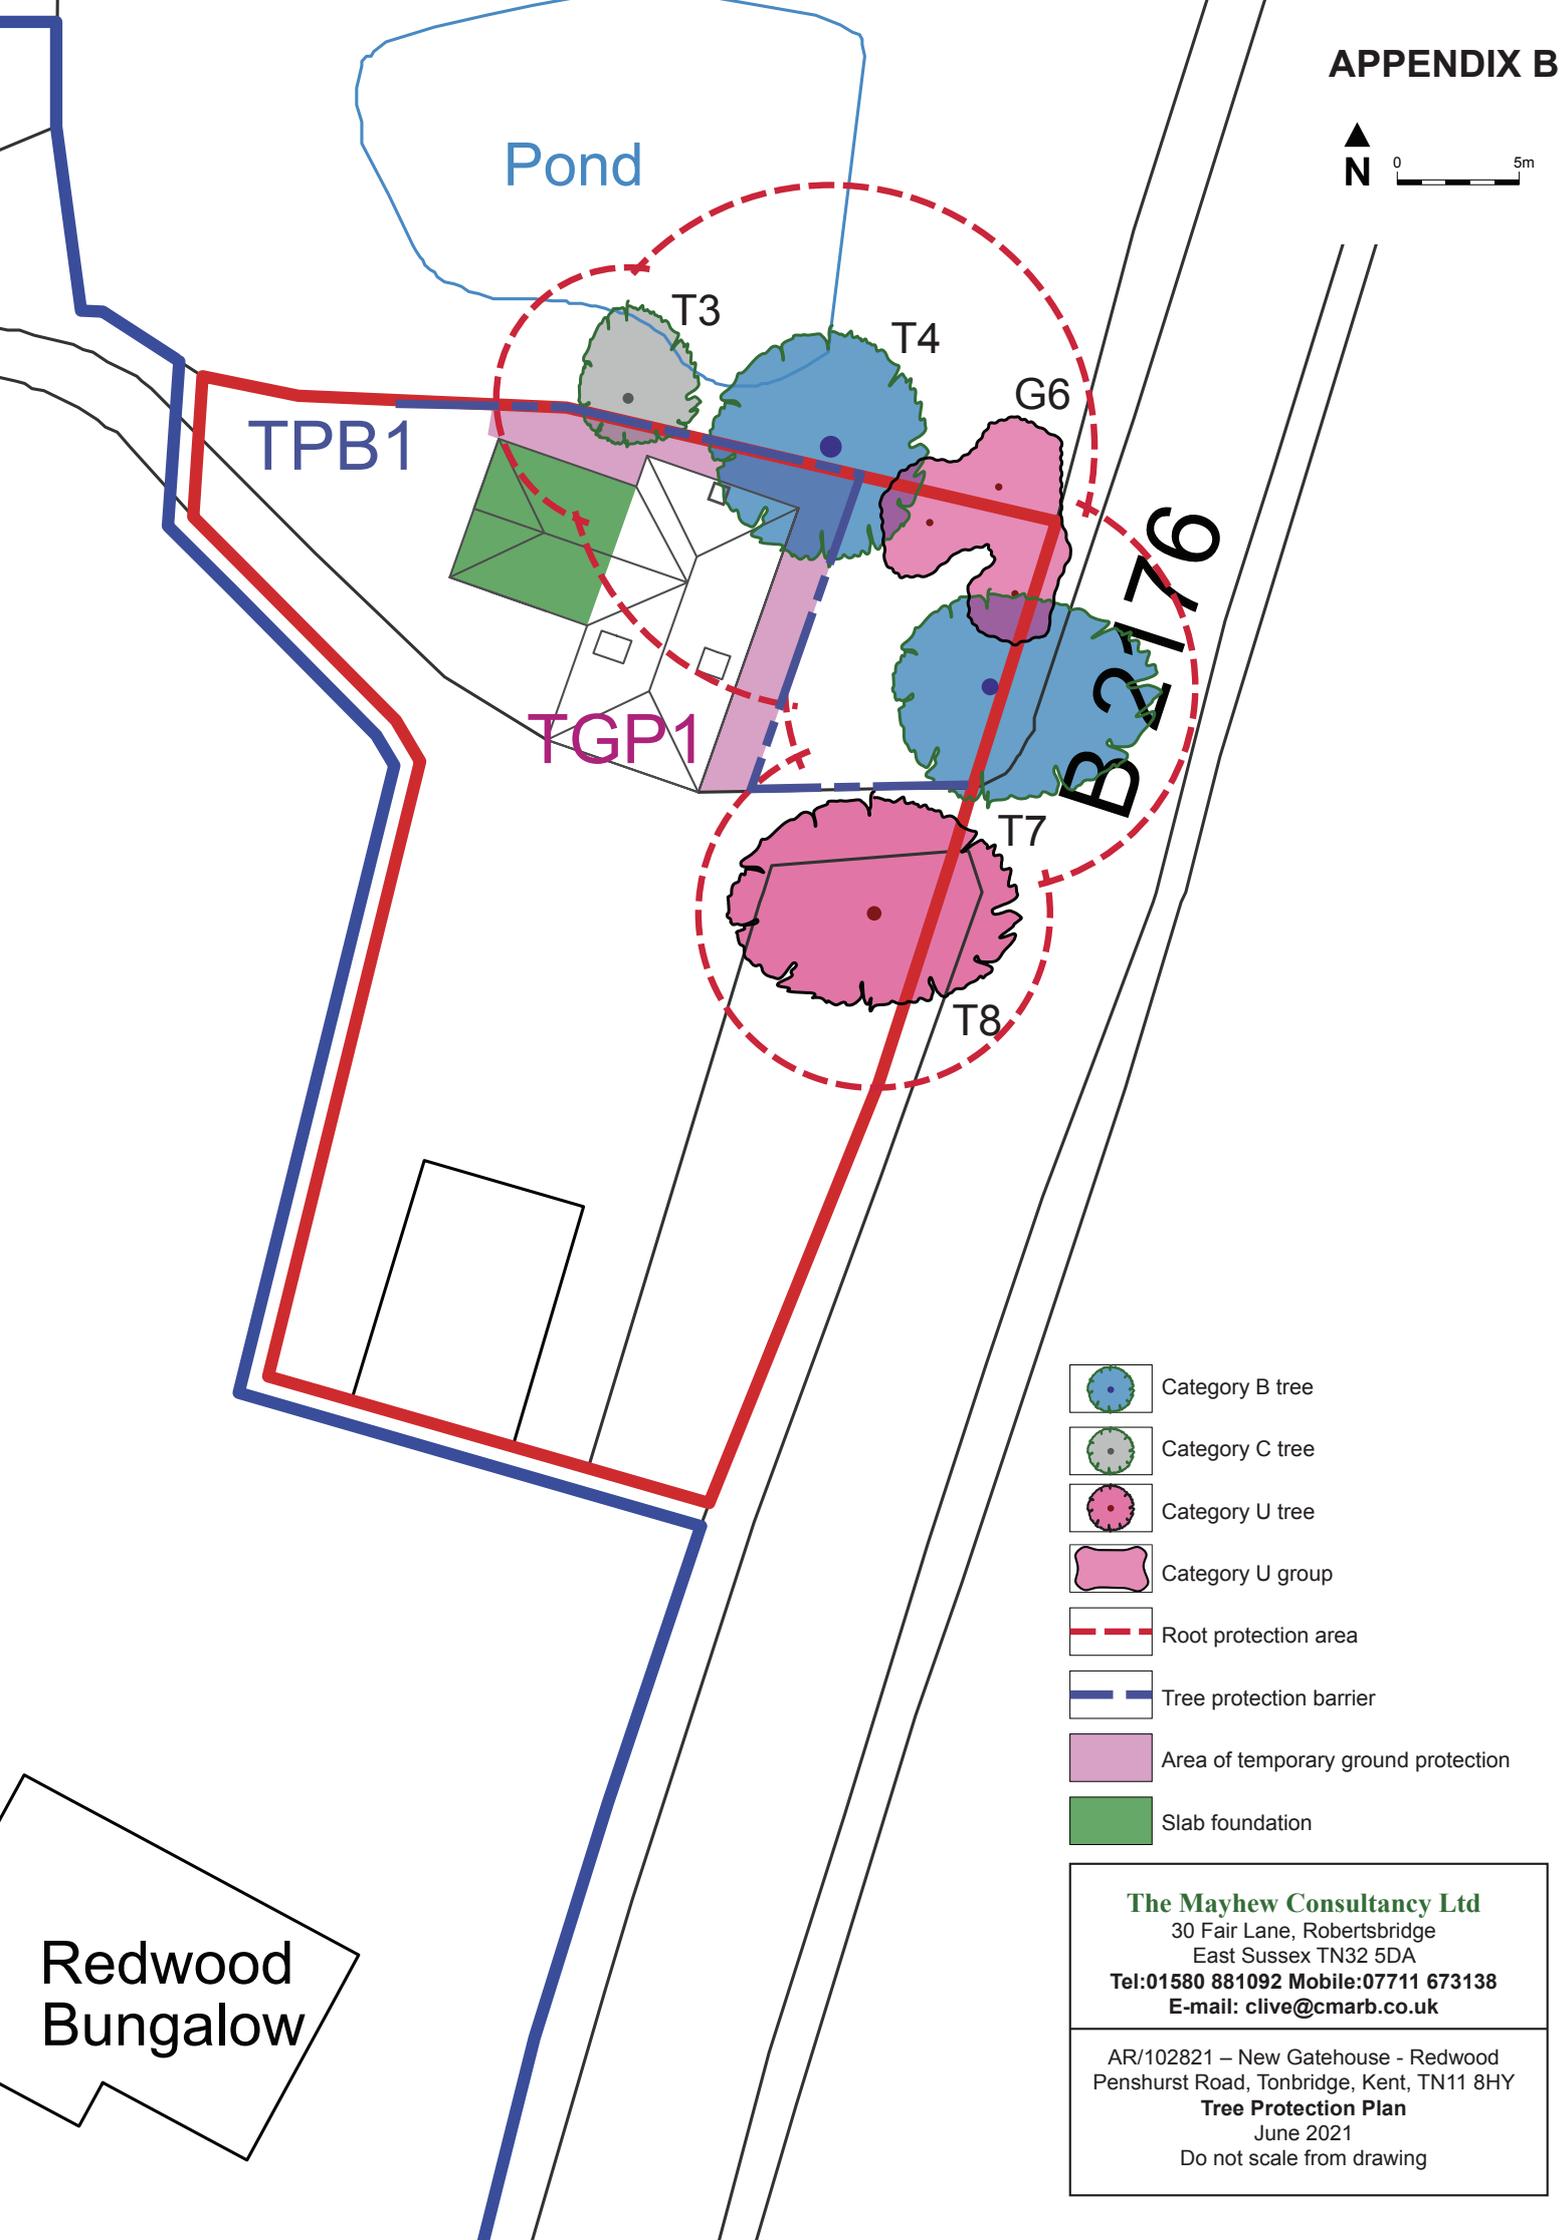
AR/102821 – New Gatehouse - Redwood
 Penhurst Road, Tonbridge, Kent, TN11 8HY
Tree Protection Plan
 June 2021
 Do not scale from drawing

- **TPB 1** - This barrier effectively encloses the site to the north and east. It is designed to protect the RPAs and stems of trees beyond the barrier from potential damage as a result of construction activity.

- **TGP 1** – This area of ground protection is located to the east and north of the existing building and its proposed extension. It is designed to provide protection to the RPAs of adjacent trees to the north and east.

11.5.1 The western extension will encroach into the RPAs of retained trees to the north. The footprint of this extension has been illustrated in green at Appendix B.

- 11.3.2 **The subject site:** The requirement for one Tree Protection Barrier has been identified and this has been illustrated at Appendix B.

11.4.2 **The subject site:** A requirement for one area of temporary ground protection has been identified and this has been illustrated in pink at Appendix B.

11.5.2 Roots from adjacent trees may be present beneath the footprint of the extension. Those roots would be afforded a degree of protection by constructing the structure off an above ground type foundation. While the final design of such a foundation would need to be determined by a suitably qualified engineer, it is likely that a slab foundation would be deemed most suitable. The principle behind the foundation's design and installation should be:

- That it involves the minimum degree of excavation works
- That no strip trenching should be undertaken
- That an impermeable separation membrane is incorporated between the underside of the foundation and the remaining soil in order to prevent contamination. See paragraph 7.4 of BS 5837:2012 for additional information.
