The Bartholomew Building, The Square

Eynsham, Oxfordshire

Design and Heritage Statement

August 2021

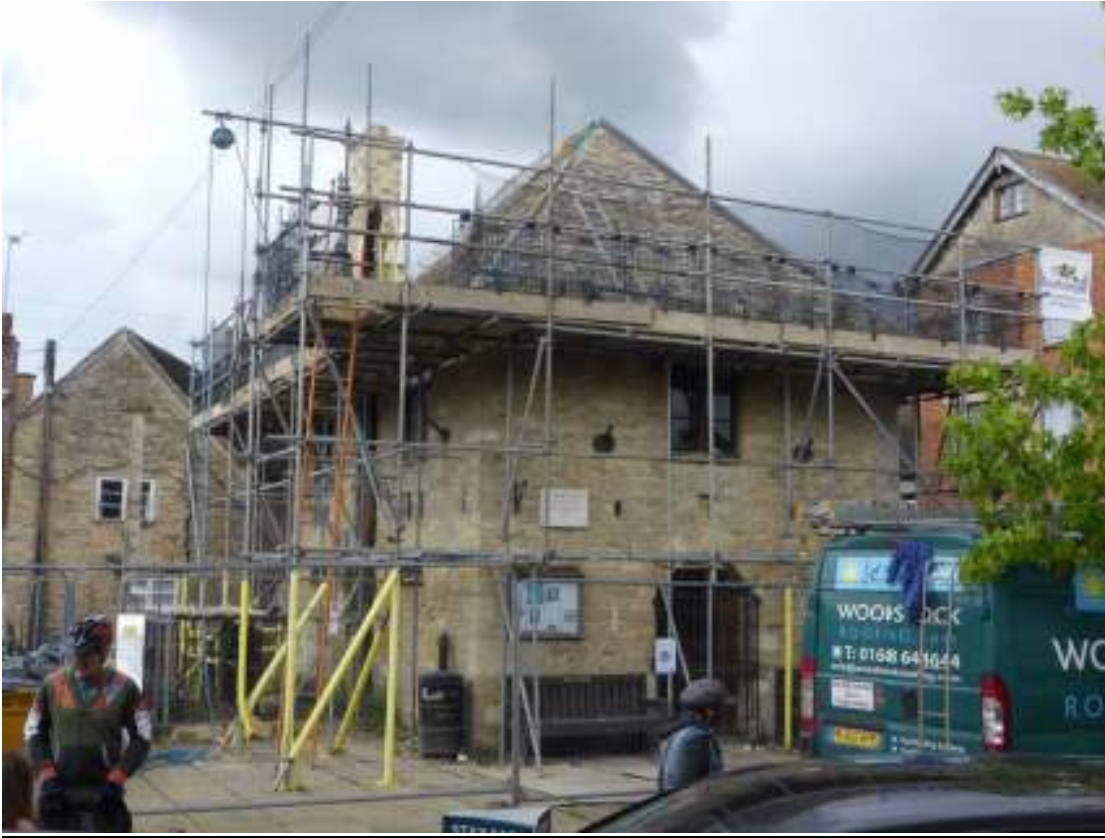
General view of the Bartholomew Building, presently scaffolded

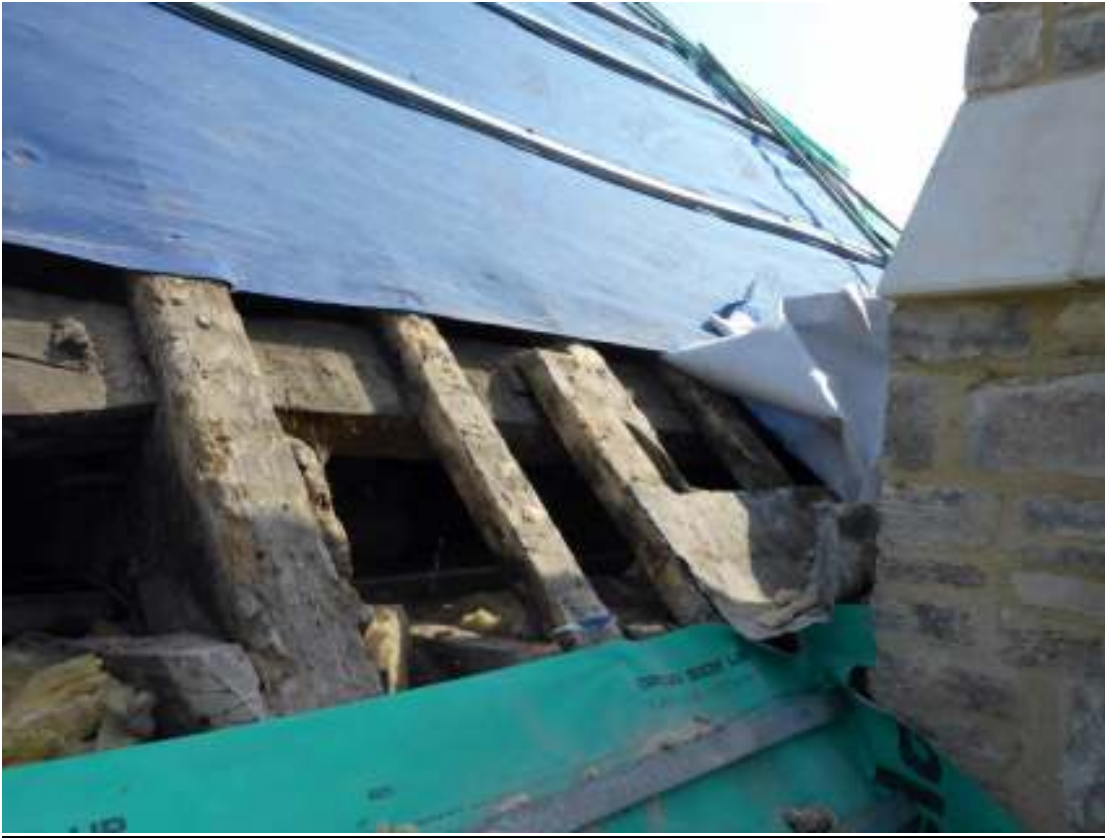
Original roof timbers visible. No alterations have been carried out to the roof timbers

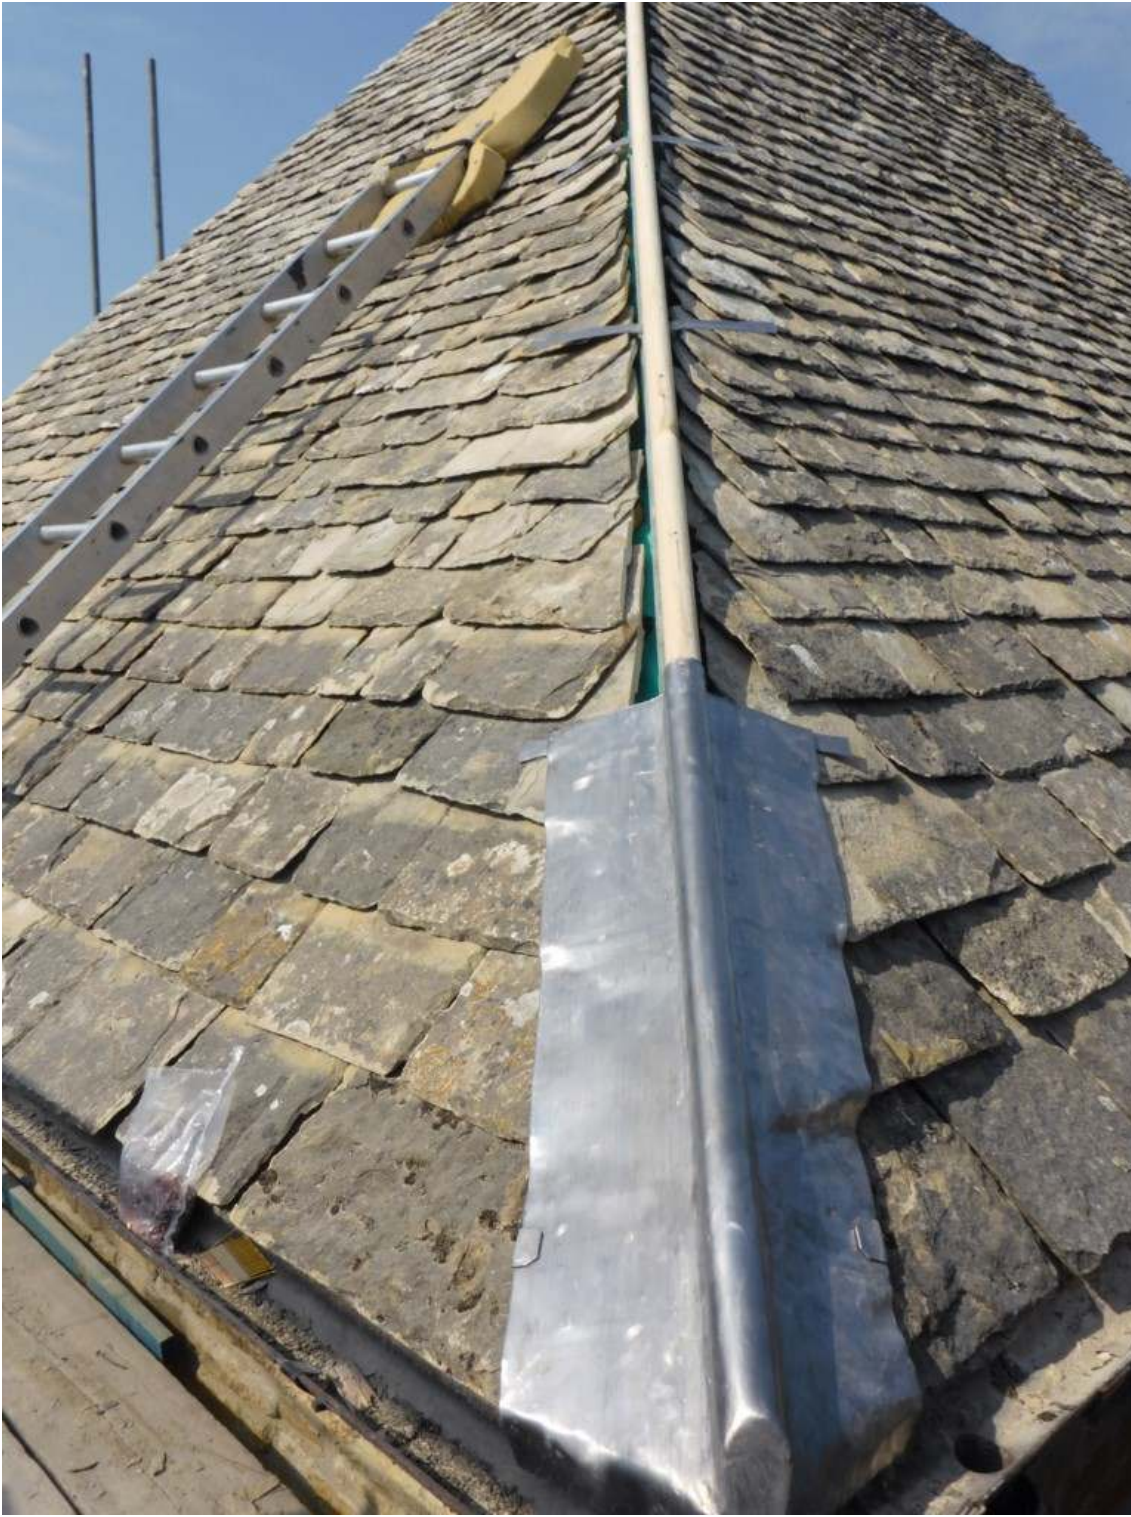
Lead hips, work in progress

- 6.12 The hips sections have been replaced installing:-
- a. A traditional timber roll over the breathable membrane
 - b. The timber roll dressed with code 5 lead over that timber roll
 - c. Securing with copper and lead straps to prevent unfolding in extreme heat, all being installed in accordance with the Lead Sheet Association guidelines
- 6.13 The replacement roof covering works have progressed and the external walls are starting to dry, confirming the defective roof installation from the 1970's was the cause of the issue.
- 6.14 No works have been carried out the loft structure.
- 6.15 As we have replaced the roof with salvaged slate being of the same type and introduced lead hips, which will have along life, the impact on the building is considered to be 'Negligible' by reference to the table in section 5.0.

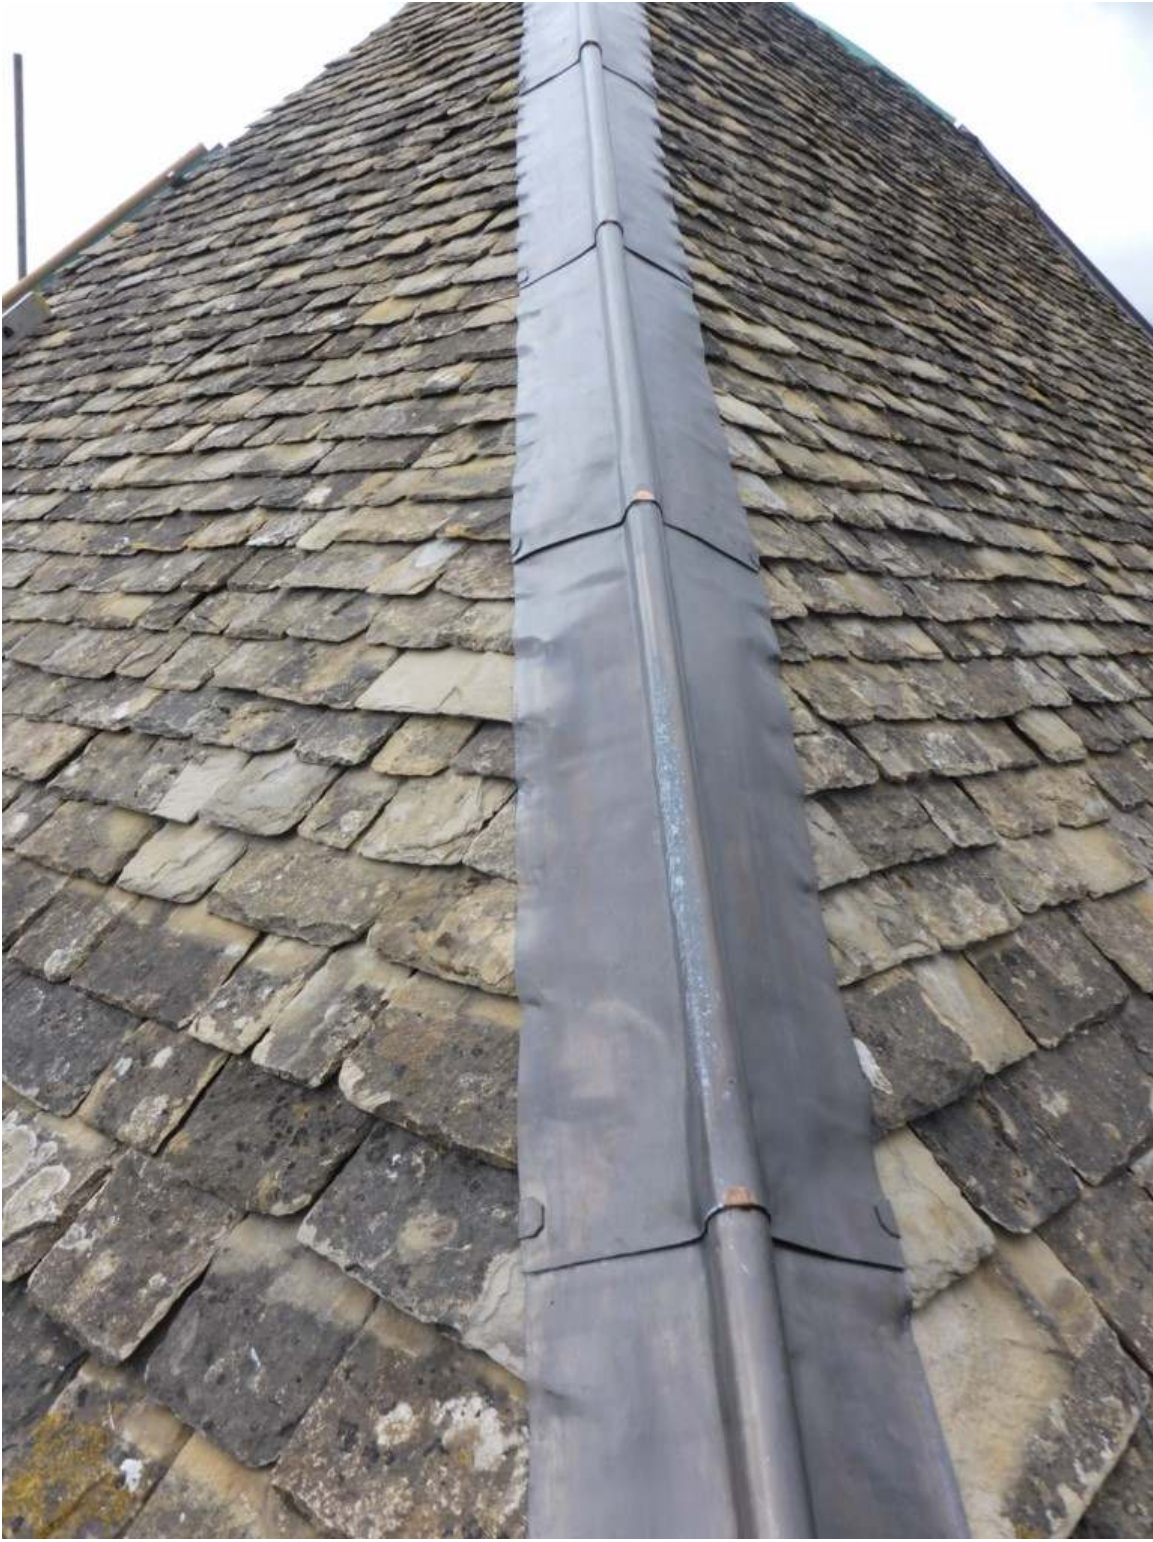
Completed lead hip
