## TREE SURVEY REPORT

Oak Lodge, Weeley Heath, Tendring

July 2021

Prepared by:  
Kirsten Bowden MA (Hons) CMLI Dip Arb L4 (ABC)

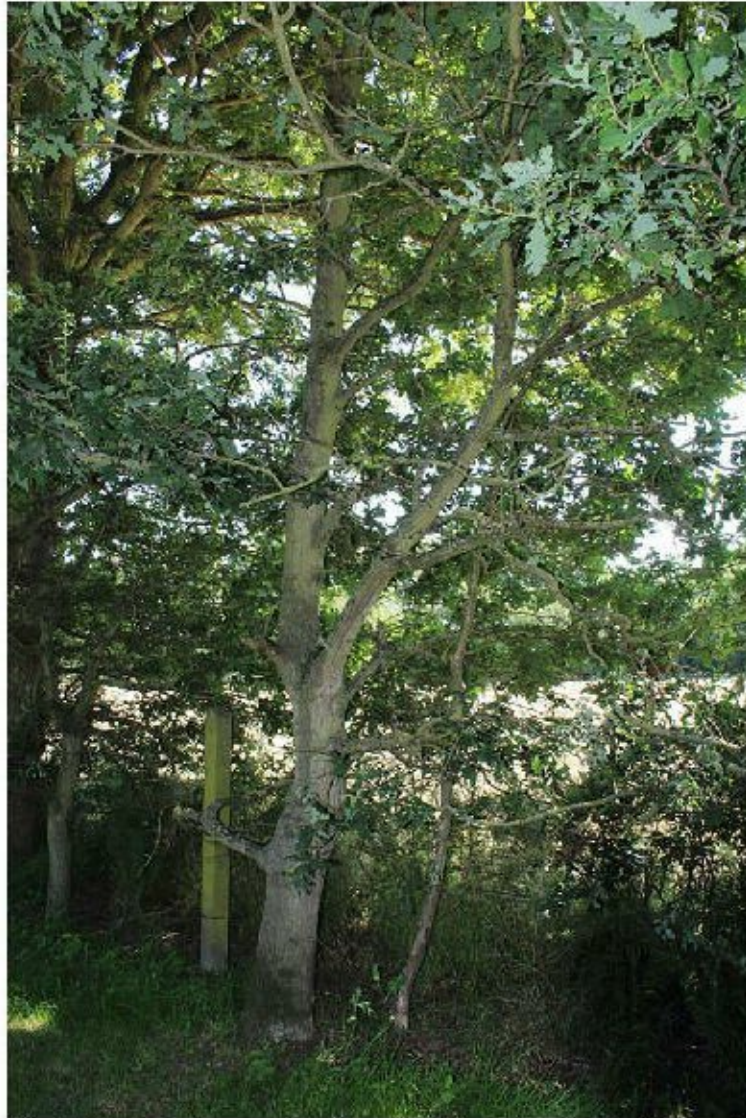
**Photo 01:** Growing under the canopies of adjacent trees, T4 is competing for light and space, but it is in good condition with a clear main leader.

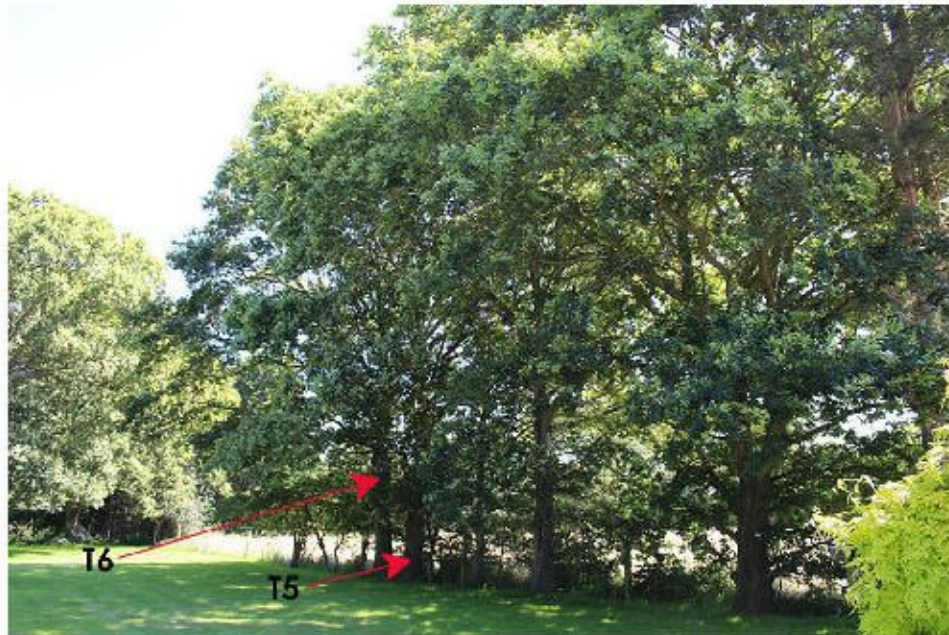
**Photo 02:** Growing as a pair in the hedge line at the end of the row of trees, T5 and T6 are very close to one another, which has compromised their overall form, but not their health and vigour. T4

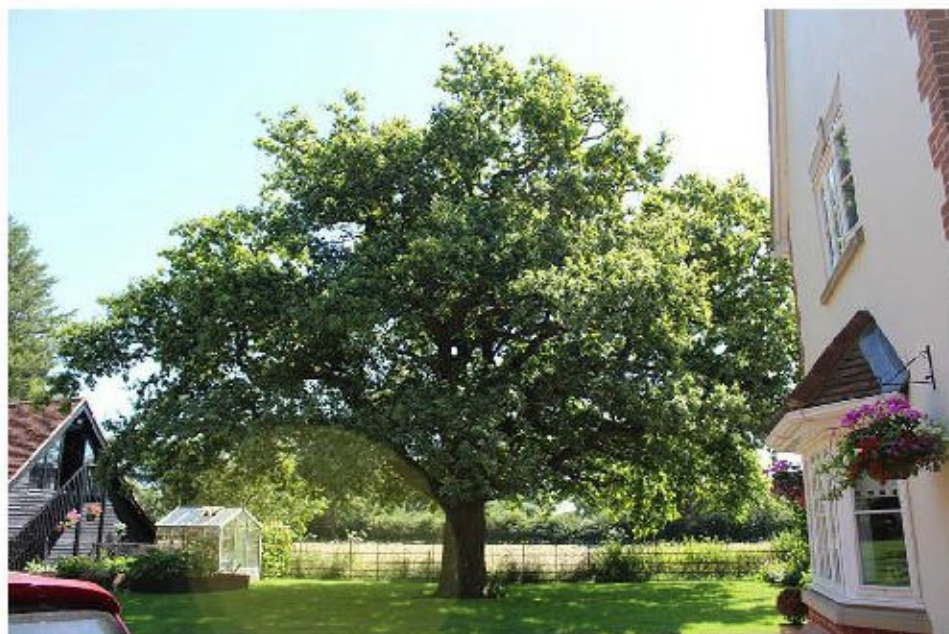
**Photo 03:** T7 is a large free-standing tree to the south of the garage building. It is protected by a Tree Preservation Order. The overall form is well balanced, but there are some signs of mildew on the leaves.

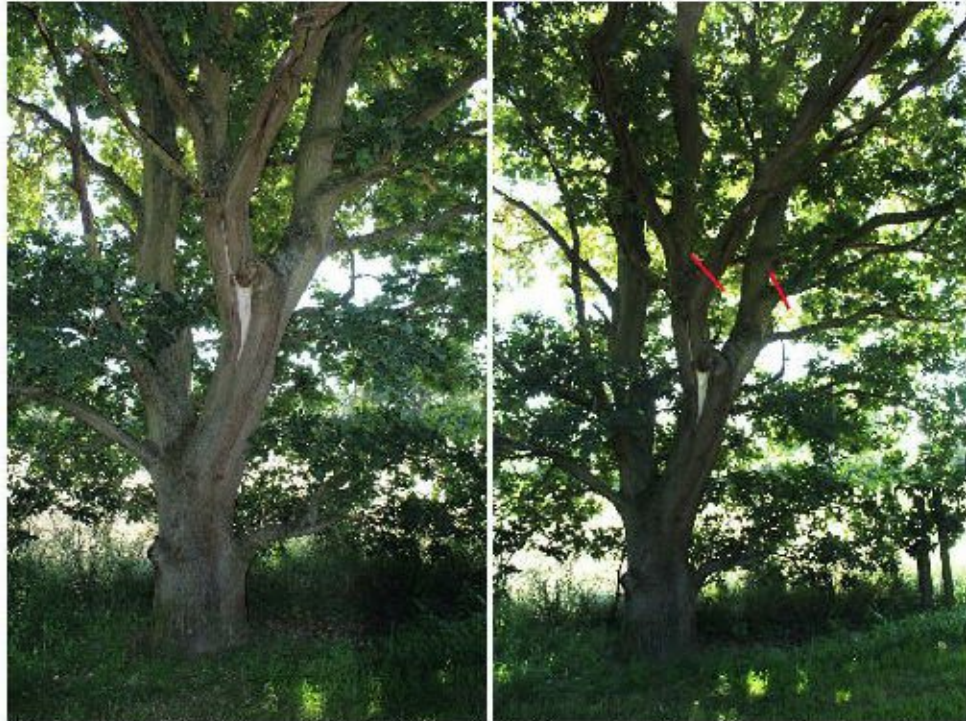
**Photos 04 & 05:** T3 is a well established Oak tree, but it appears to have been struck by lightning at some point. Whilst the damage is occluding well, it has created a cavity and the potential for accelerated decay. The red lines on photo 05 (right) illustrate the points at which the branches identified for removal should be cut back too.

- 9.4 T1 is proposed for removal, which will give T2 more space to grow. Two limbs have been identified for removal in order to raise the crown and this is clearly illustrated in Photo 05. One of these limbs appears to have been damaged by lightning and is dead at the end. The rest of the tree is healthy and should be able to tolerate this minor pruning work, which should be done in mid to late winter.

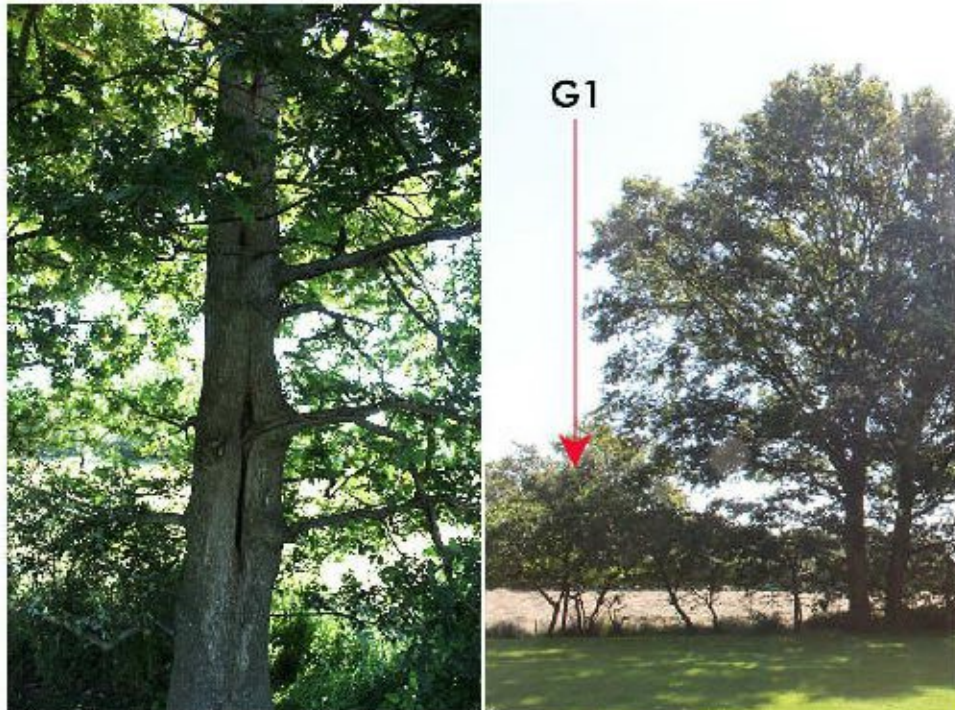
T3 Oak	10	440	2	3	5	5	M	0.5	1.5	20+	G	F	Long horizontal wound down the main stem with cavity within. Wound occluding well and not of concern. Some minor dieback in crown, but general vigour good.	B2 Retain and protect.	88	5.3
T4 Oak	7	230	2	4	3	3	E M	0.5	1.5	20+	G	G	Growing under the canopy of T3 and T5. The form has been compromised.	T4 Retain and protect.	24	2.8

**Photos 06 & 07:** There is a long horizontal wound on T3 which has clearly been there for a while and it is occluding well. This may have been due to lightning and there is no other sign of stress or decay otherwise in the tree. G1 (right) is a small group of cherries. These are established trees which are overshadowed by the adjacent Oak trees.

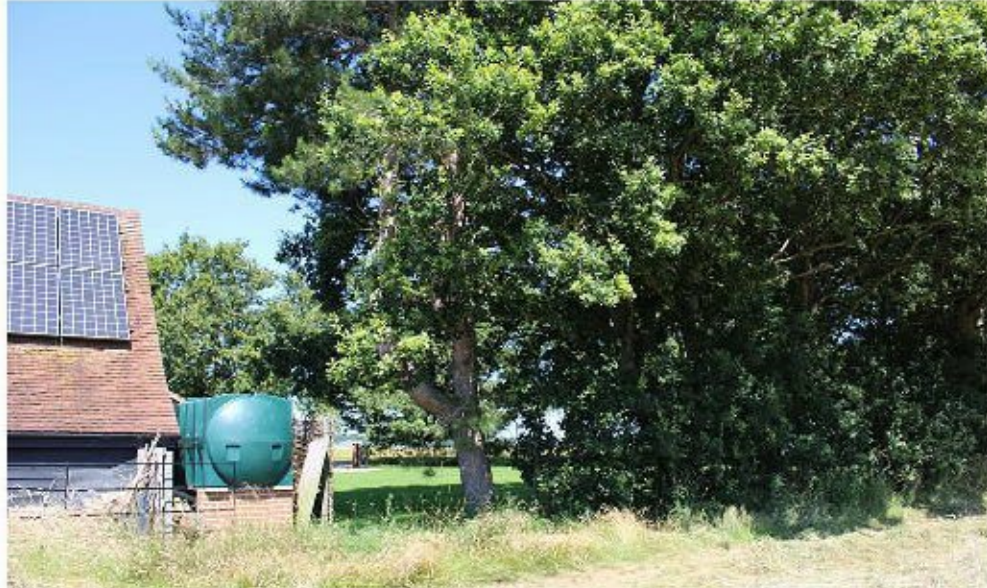
**Photo 08:** Growing at the end of the line and closest to the existing garage building, T1 is a mature Scots Pine. It is competing for light with the neighbouring tree and it has competing leaders.

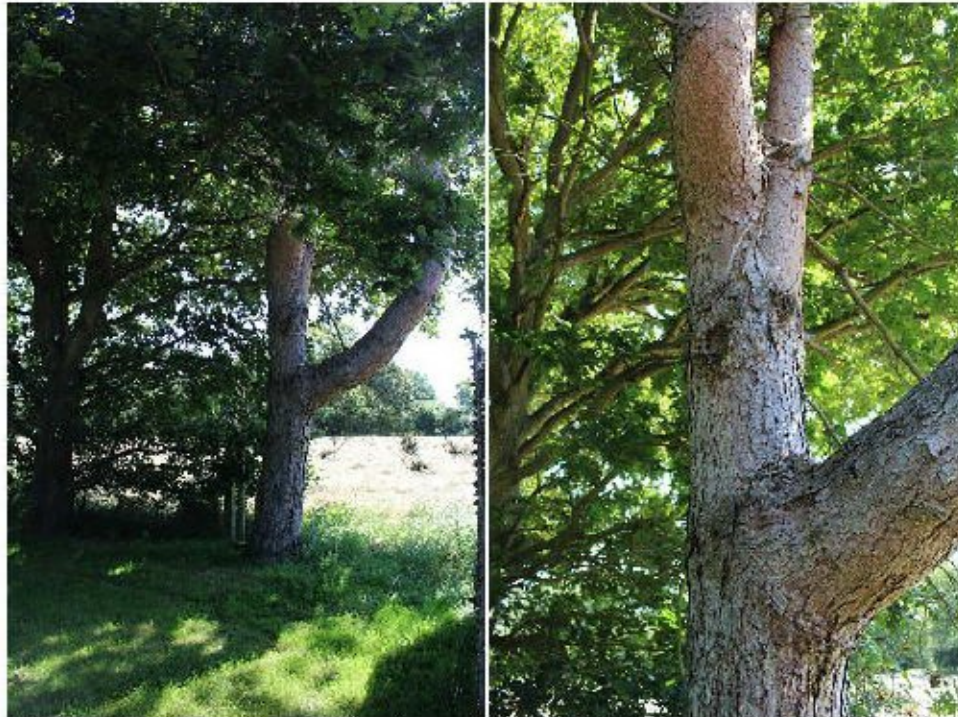
**Photos 09 & 10:** T1 is growing adjacent to the existing garage and is proposed for removal due to its position.

- 9.3 As part of the proposals it is proposed to remove T1. No other trees would need to be removed.

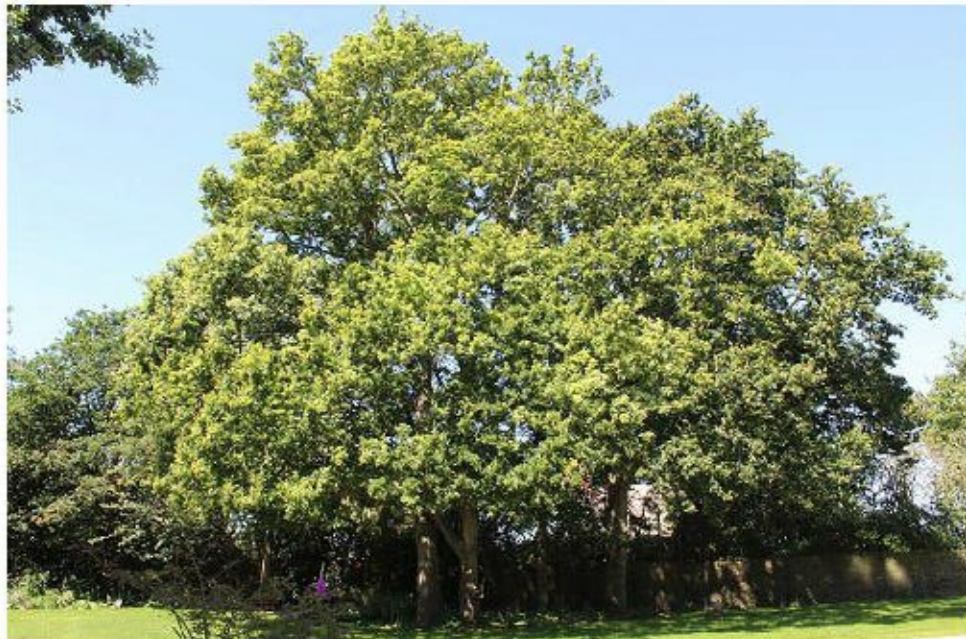
**Photo 11:** The group of trees between the driveway and the highway are protected by a TPO. They provide screening and also have amenity value as they are visible from the road. They are growing as a group and should therefore be managed as such. No work is proposed as part of this application.

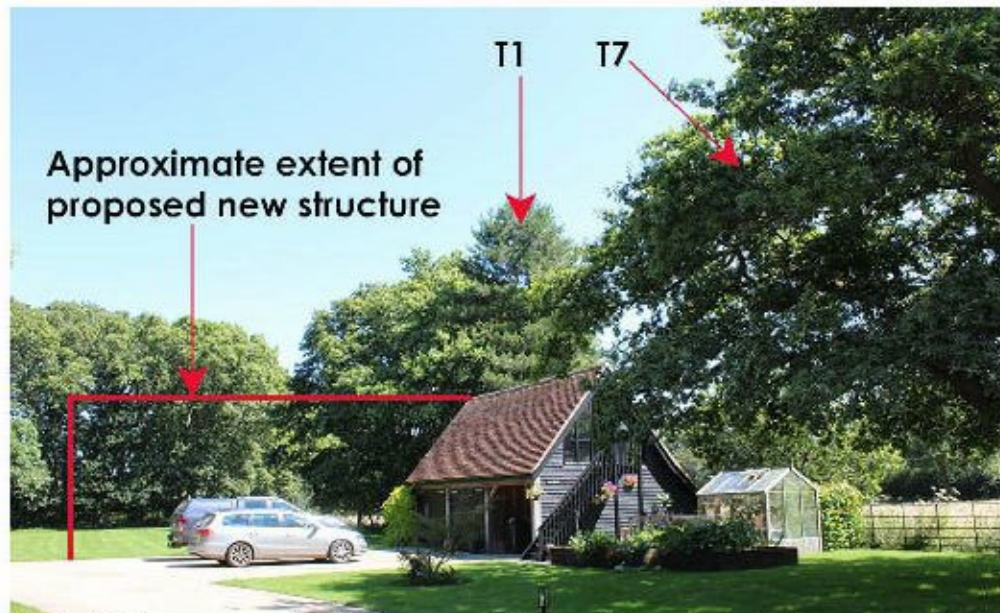
**Photo 12:** The proposed extension would extend into a grassed lawn area. The trees are in open ground with no constraints to the rest of their rooting area and it is therefore unlikely that the proposals would have any significant impact on their health.
