Former Mepal
Outdoor Centre,
A142 Ireton's
Way,
Ely,
Cambridgeshire

Water Vole and Otter Report

August 2021

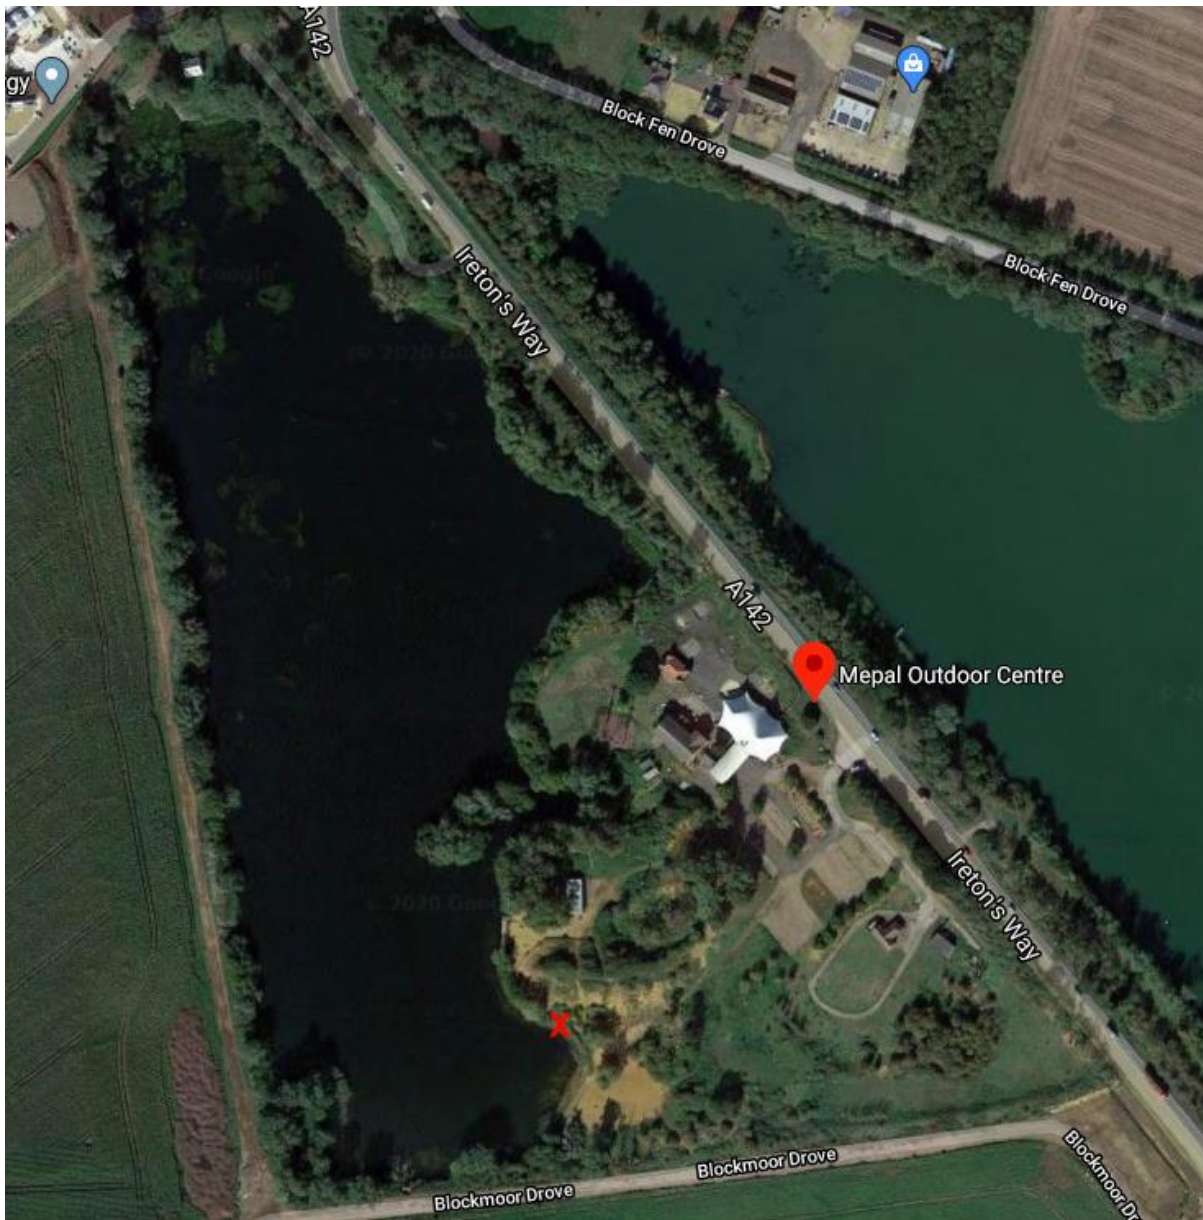
5.3. Evidence of otter field signs were found and recorded on the south-eastern banks of the lake (Appendix I). These signs included spraint (Appendix II), trails (Appendix III), slides (Appendix IV), and feeding remains (Appendix V).

Appendix I: The marked location of where otter field signs were recorded around the lake.

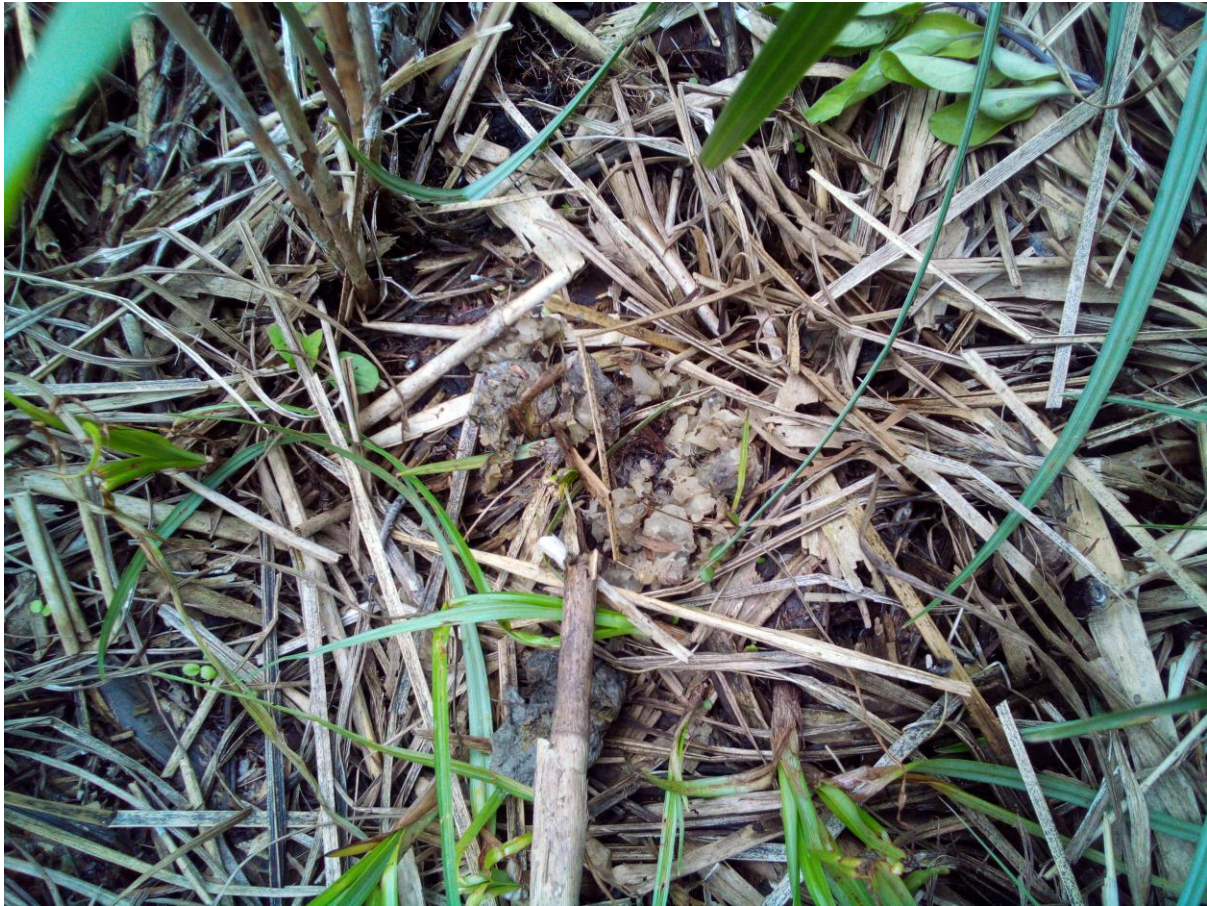
6.1. The survey conducted on the 12th of June 2020 was to determine the presence or likely absence of otter and water vole on site. Evidence of otter activity was confirmed by otter field signs present. As a single otter spraint was found, it could indicate that this habitat is only occasionally used by otters. However, as there are local intermittent records of otters in close proximity to the site, including road traffic accidents, otters are still active in the locality.

Appendix II: Broken up otter spraint.

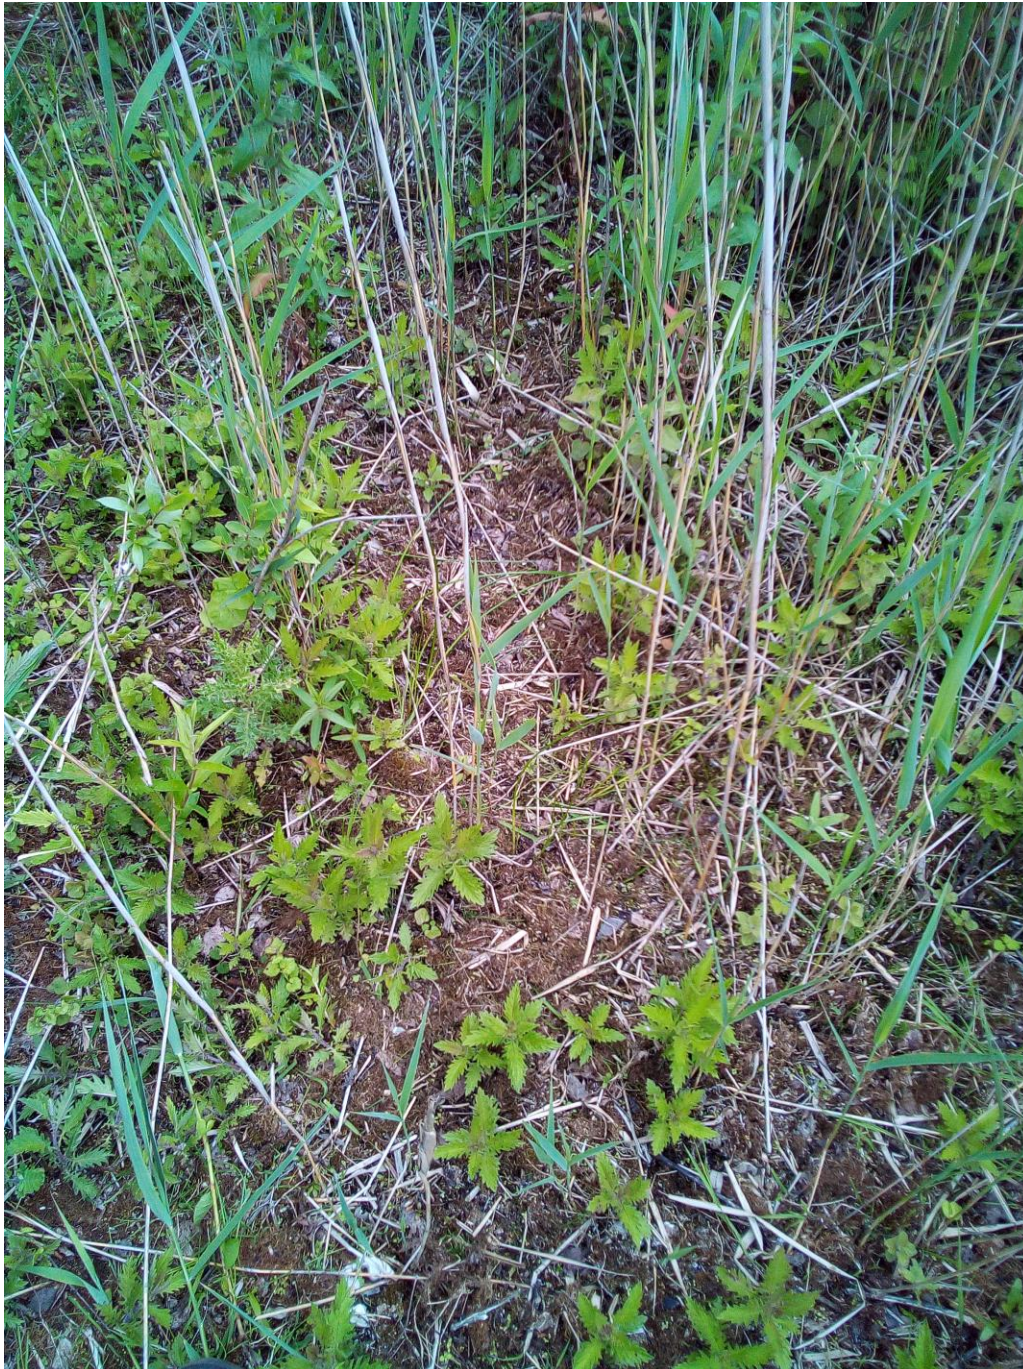
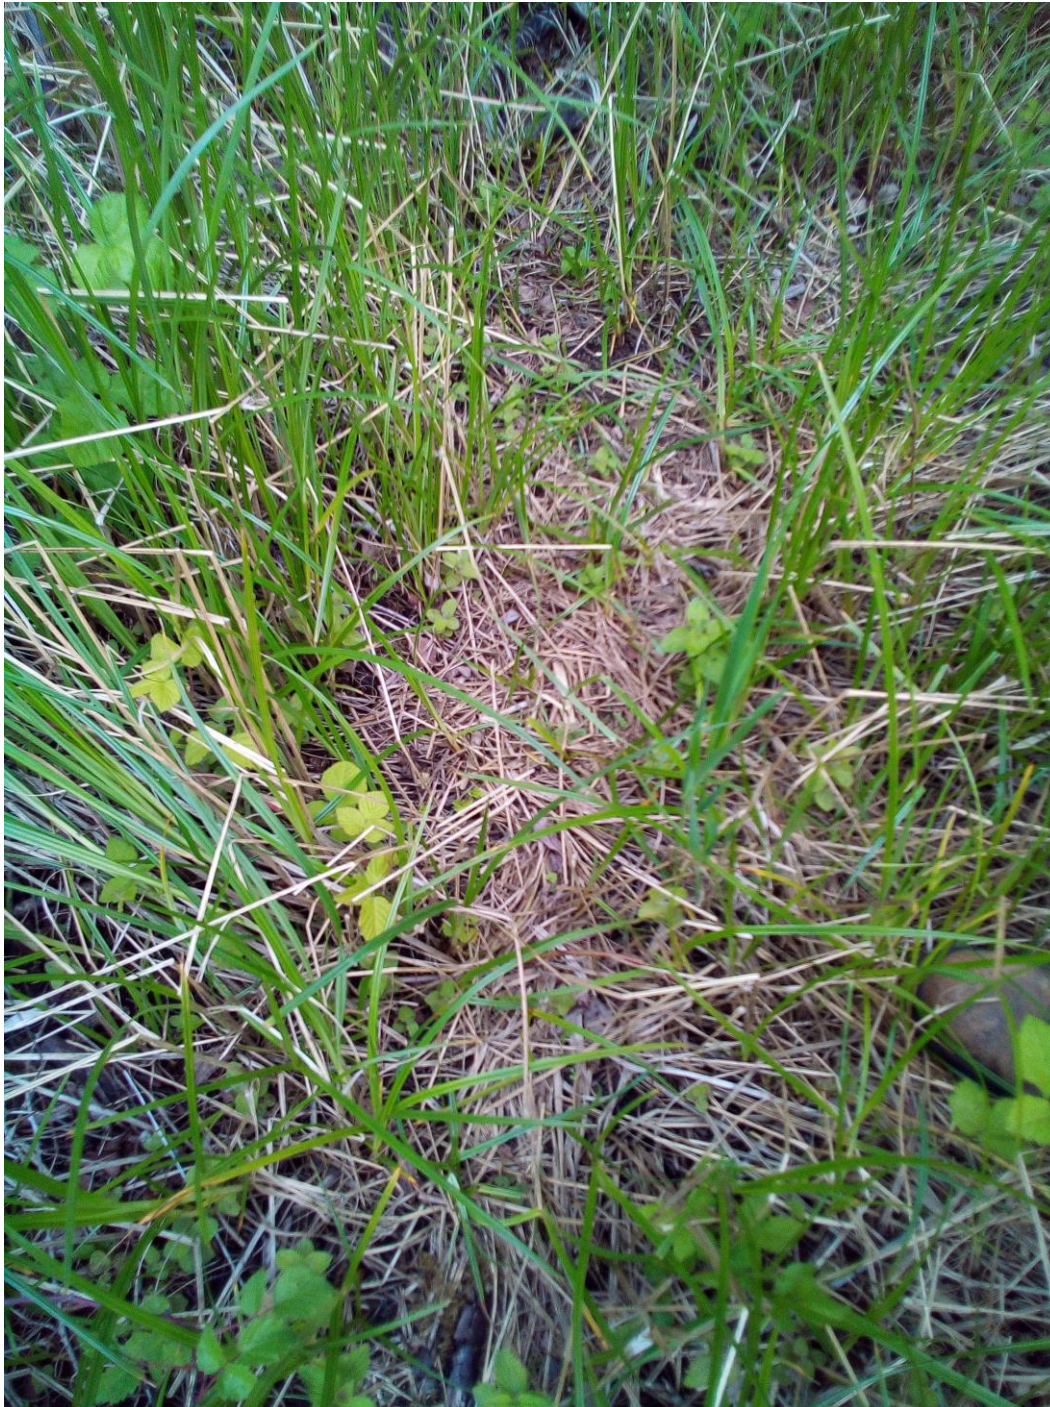
Appendix III: Potential otter trails through vegetation.

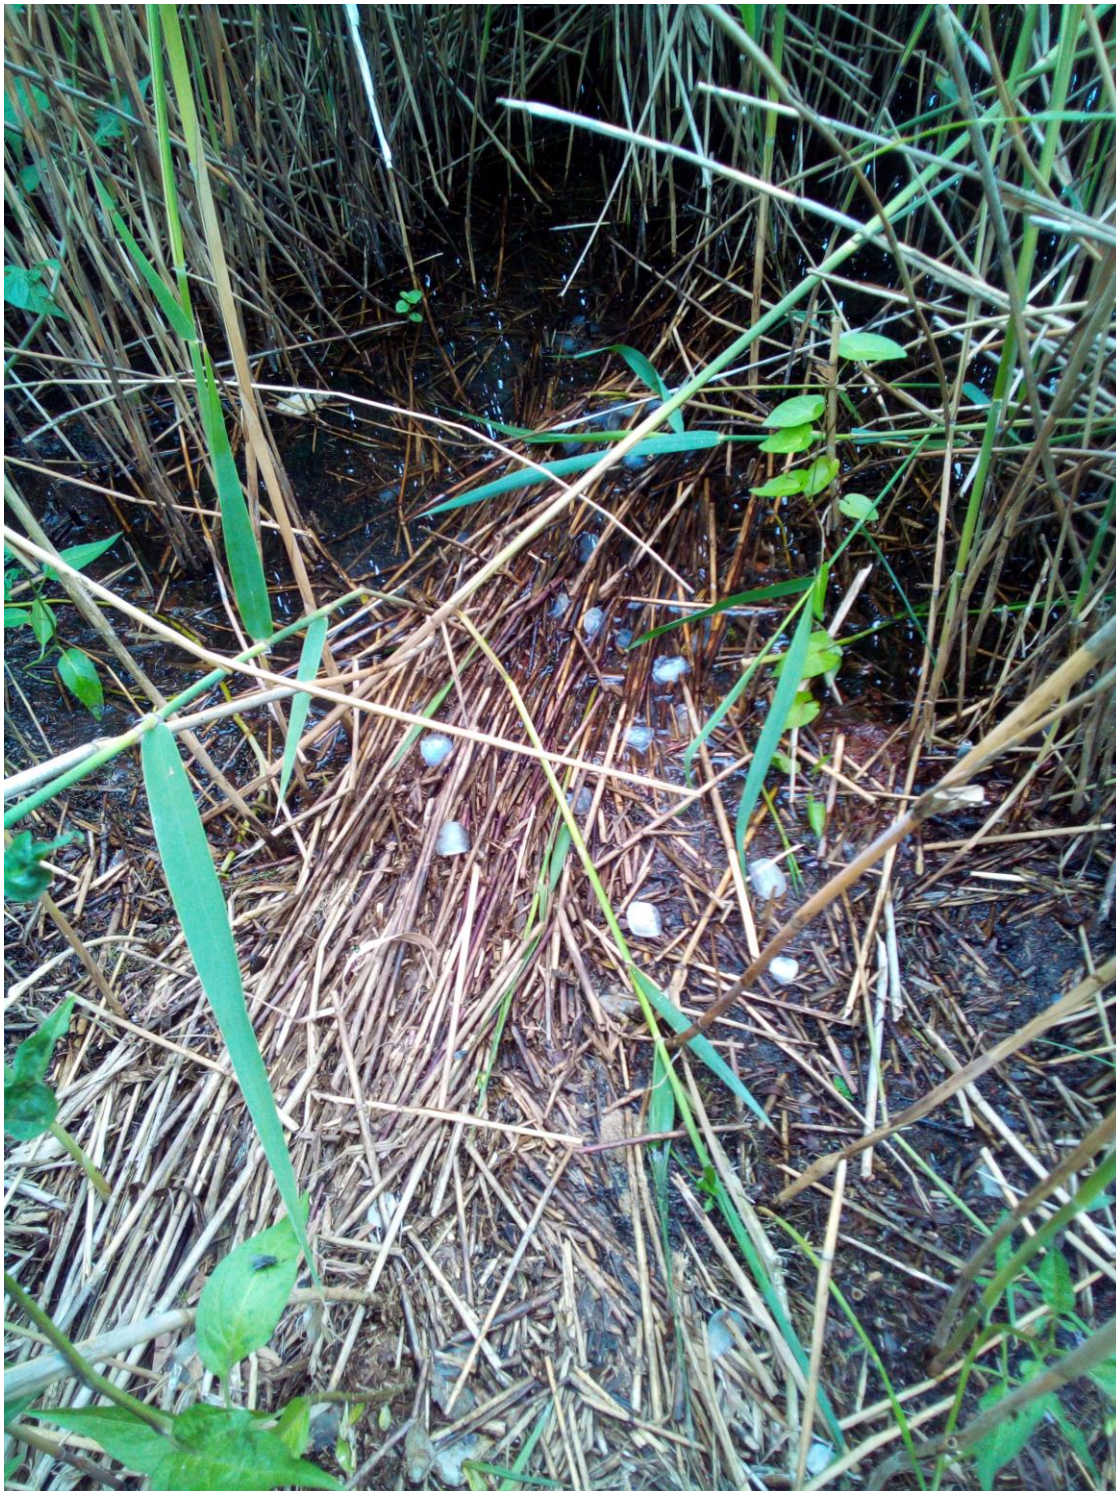
5.4. All field signs of otter were present within 10m of each other on the south-east banks of the lake. Feeding remains included an otter kill of a common carp (*Cyprinus carpio*) which is known to be present in the lake. Additionally, fish scales were also found in and around the slide where the otter had dragged the common carp onto the banks of the lake.

Appendix IV: Otter slide with feeding remains (Common carp scales) present.

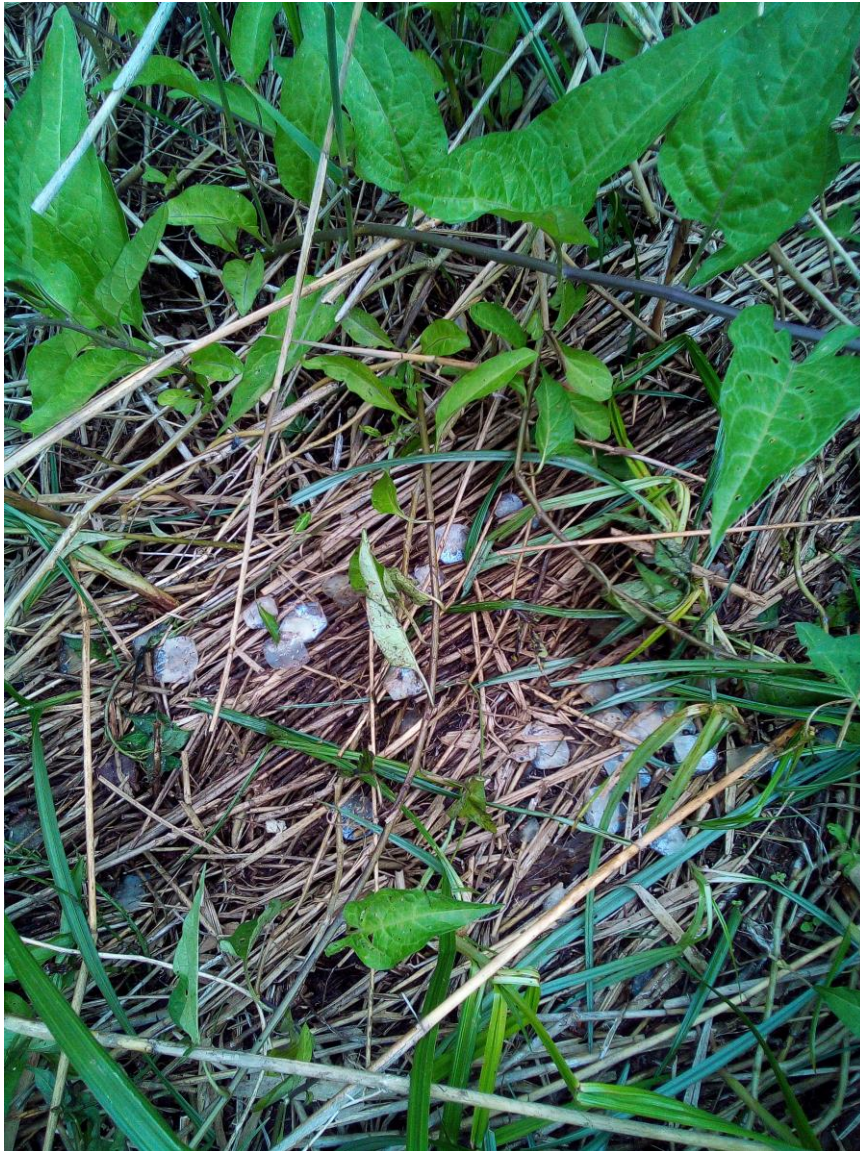
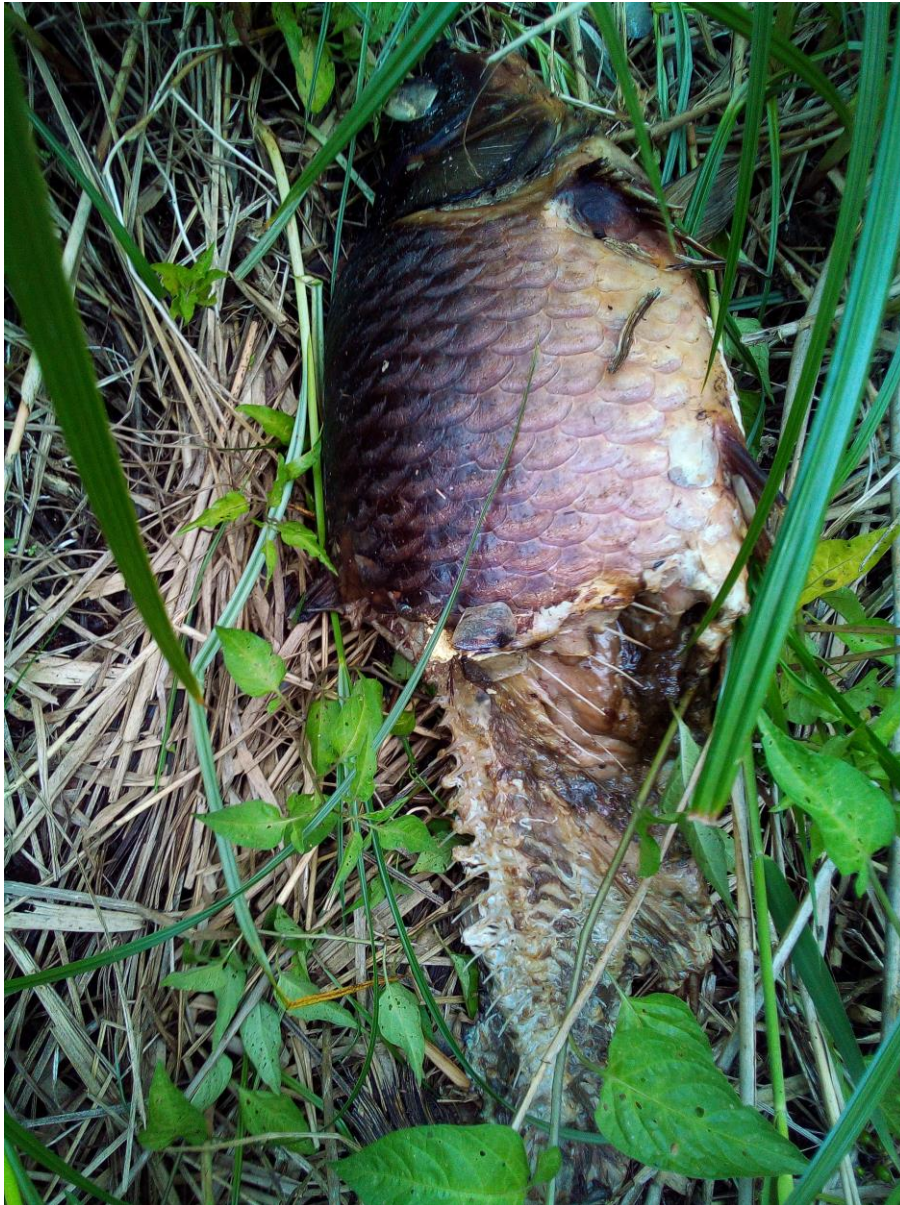
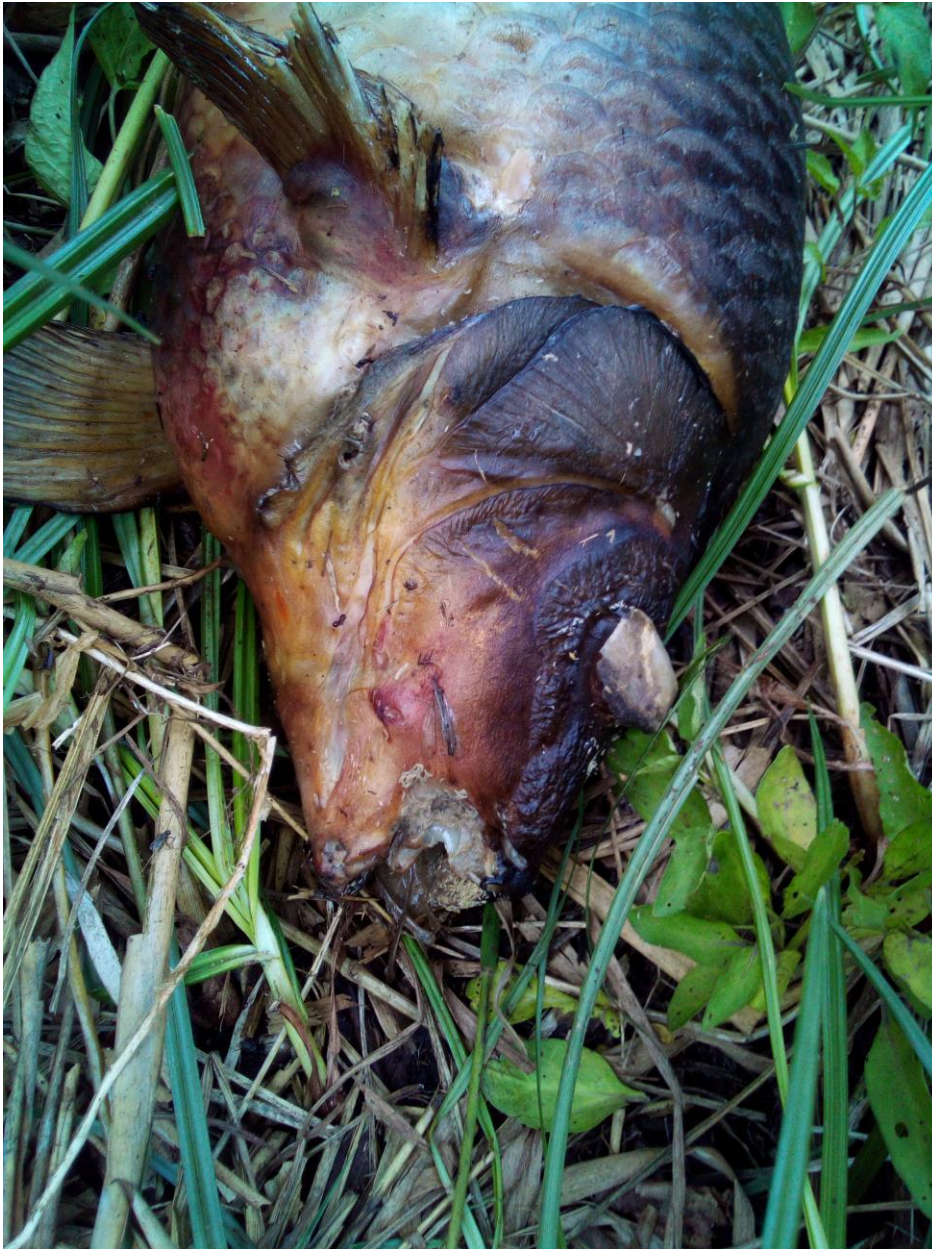
Appendix V: Otter feeding remains of fish scales and a dead common carp.
