## Arboricultural Impact Assessment

For Trees At St James' Church

Castle Eden

Beaumont Brown Architects

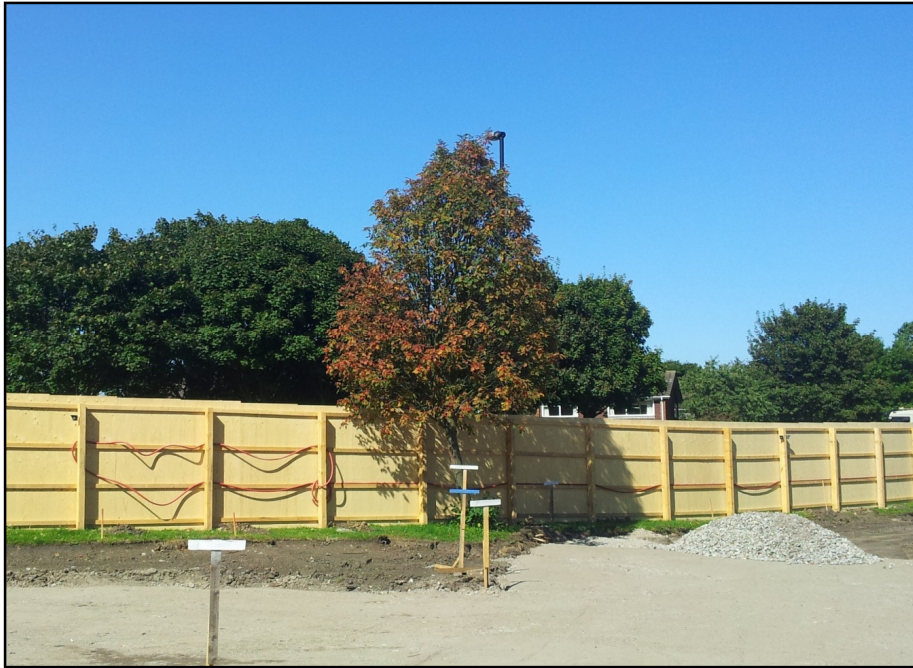
Figure 3- Ground level changes

4.6.4 The above photograph shows a *Sorbus* tree, approximately one week after the ground level was reduced on one side by around 150mm. Notice the yellowed foliage in contrast with the lush green canopies behind. This tree is unlikely to survive and will require removal.

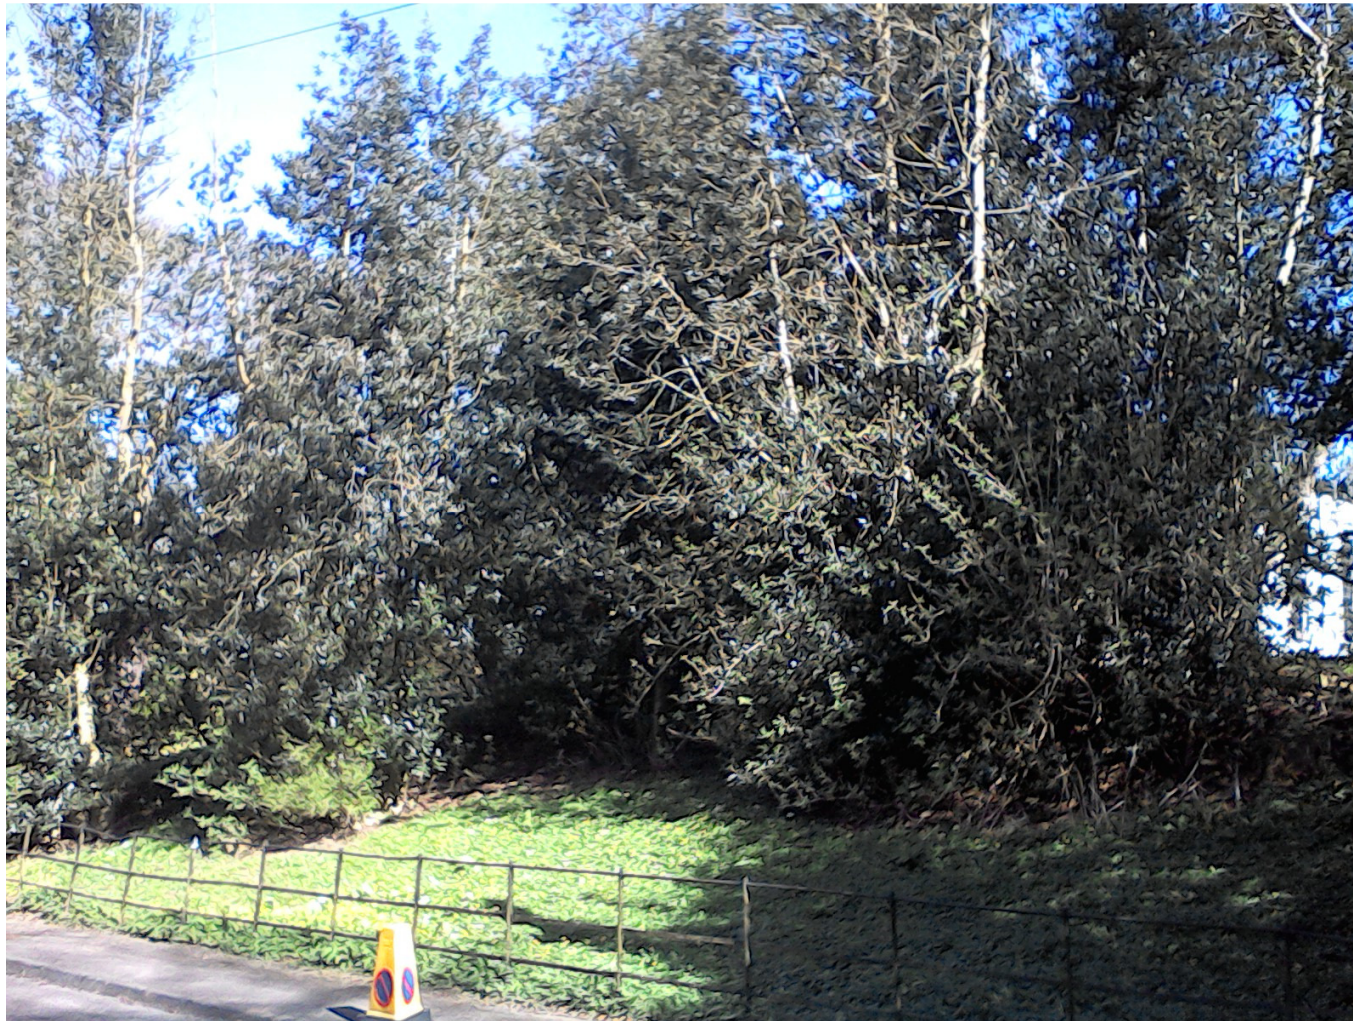
<b>Groups</b>																						
Group 1	Ilex aquifolium (Holly), Sambucus nigra (Elder)	10	4	4	4	4	220	-	0	0(N)	Mature	Fair	Fair	2.64	20+	B-Moderate	Mother stems died and thrown up suckers	Remove group	Low	10	12	C
Group 2	Ilex aquifolium (Holly), Sambucus nigra (Elder)	10	3	3	3	3	220	-	0	0(N)	Mature	Fair	Fair	2.64	20+	B-Moderate	4 clumps. Several dead stems. Multiple stems at ground level. Dieback in crown.	Remove group to facilitate the development	Low	10	12	A

*Photograph 1 - Group 1 and 2 (location of additional parking in foreground)*

- Group 2 will need to be removed to facilitate the construction of the new parking bays.
- Trees 1, 2, 5, 12 and 13 should be removed due to structural defects and a limited safe useful life expectancy.

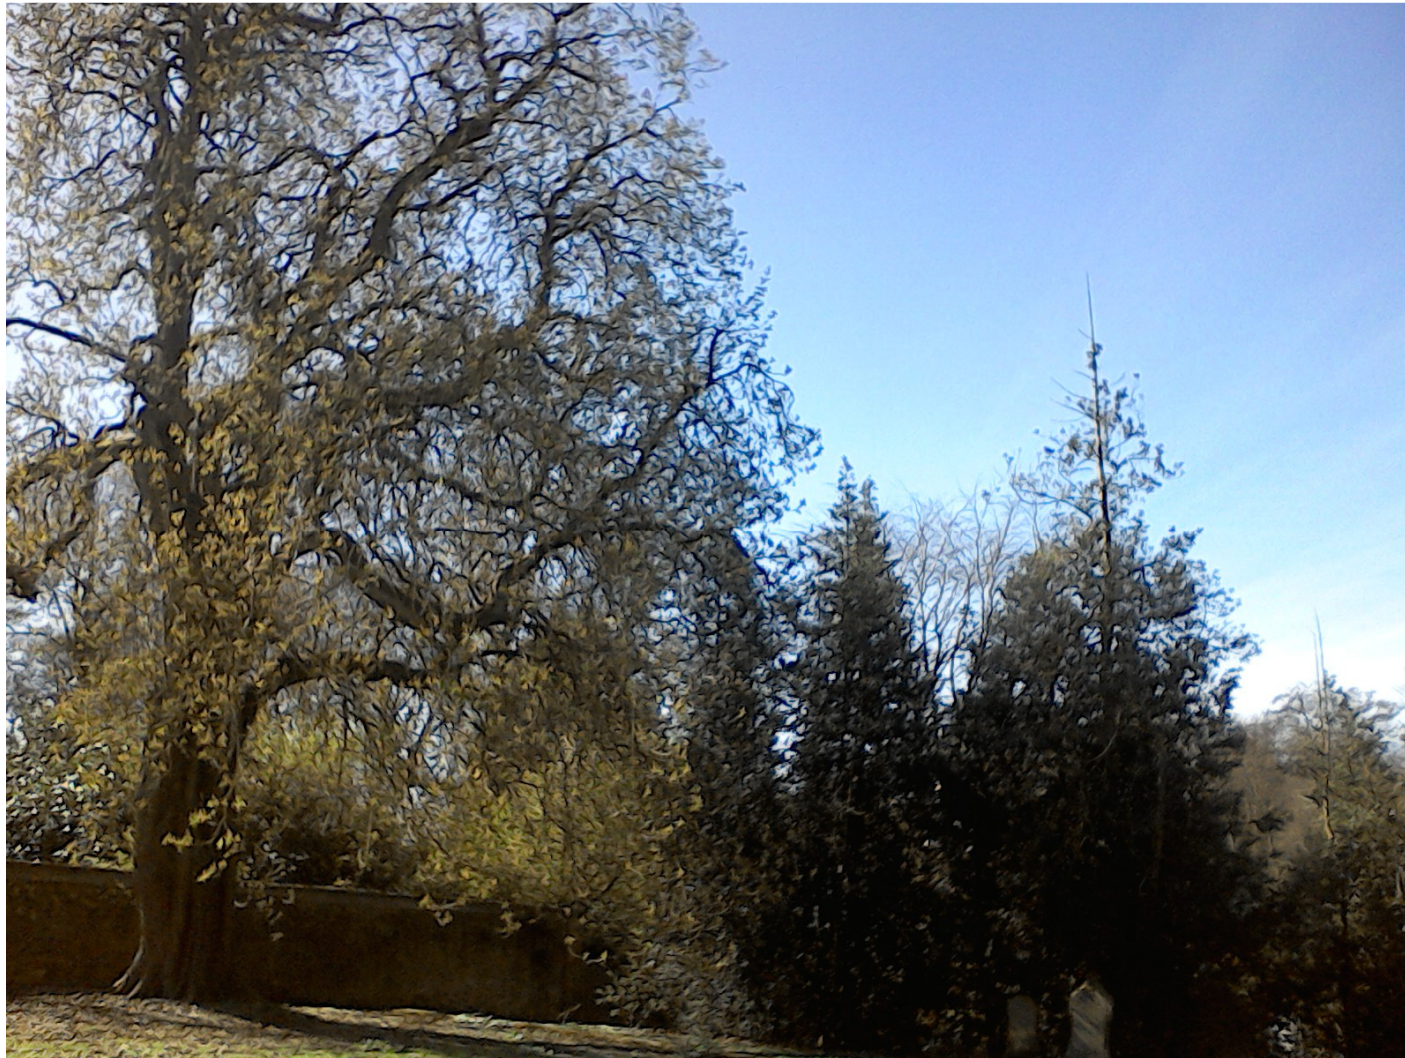
*Photograph 2 - T3 with group 1 to the right*
