Adonis Ecology

Report for Preliminary Roost Assessment at Rushbrooke Farm, Milden to Support a Planning Application

Project Ref: 1505

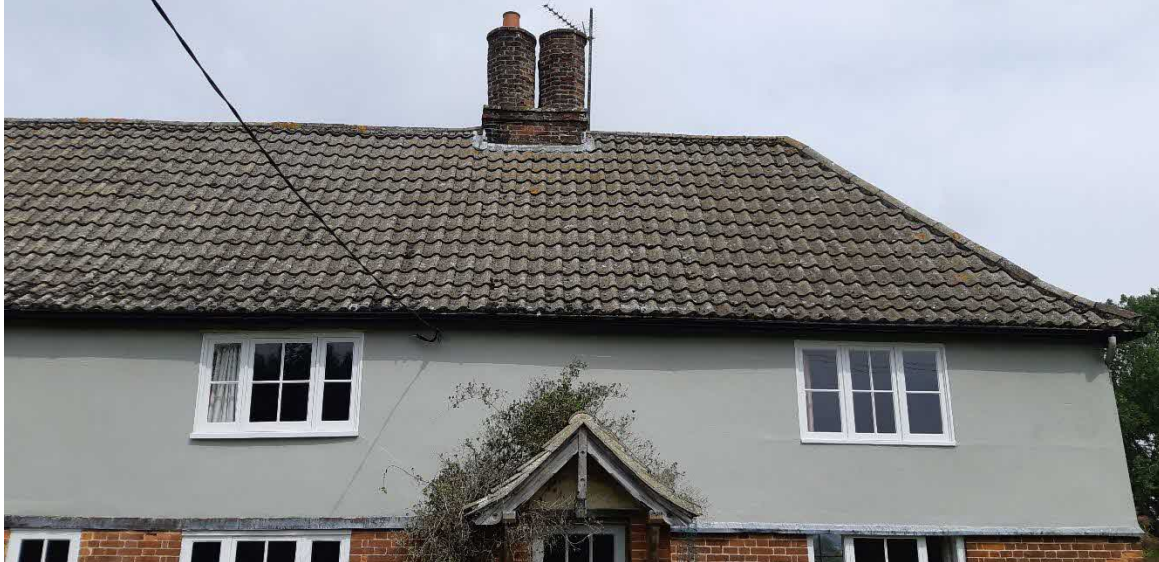
3.3.1 The house was a two-storey building of which one part was of a newer date. The roof was pitched with pan tiles (see Photograph 1 in Appendix 1). Crevices and gaps that could be suitable for bats were present:

Photograph 1: Front of house

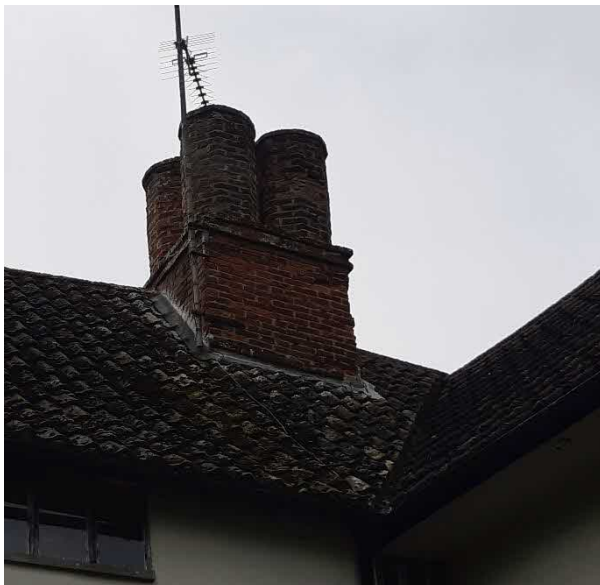
- between tiles just below the ridge;
- at several places where the cement was missing from the corrugations of the bottom row of tiles;
- on the chimney where mortar was missing at places;
- around the chimney base where the lead flashing had lifted (see Photograph 2 in Appendix 1); and
- around an exhaust outlet where the flashing had lifted as well.

Photograph 2: Back of house, lifted lead flashing at base of chimney

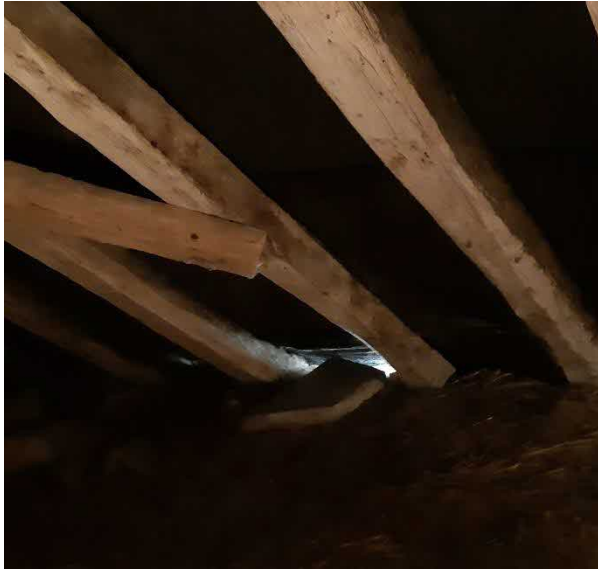
3.3.2 The newer part of the building had soffits which looked well sealed. The older part of the building had no soffits and there were clear gaps at the eaves providing plenty of access to the loft space inside (see Photograph 3 in Appendix 1).

Photograph 3: Gaps at the eaves, western loft space, providing easy access

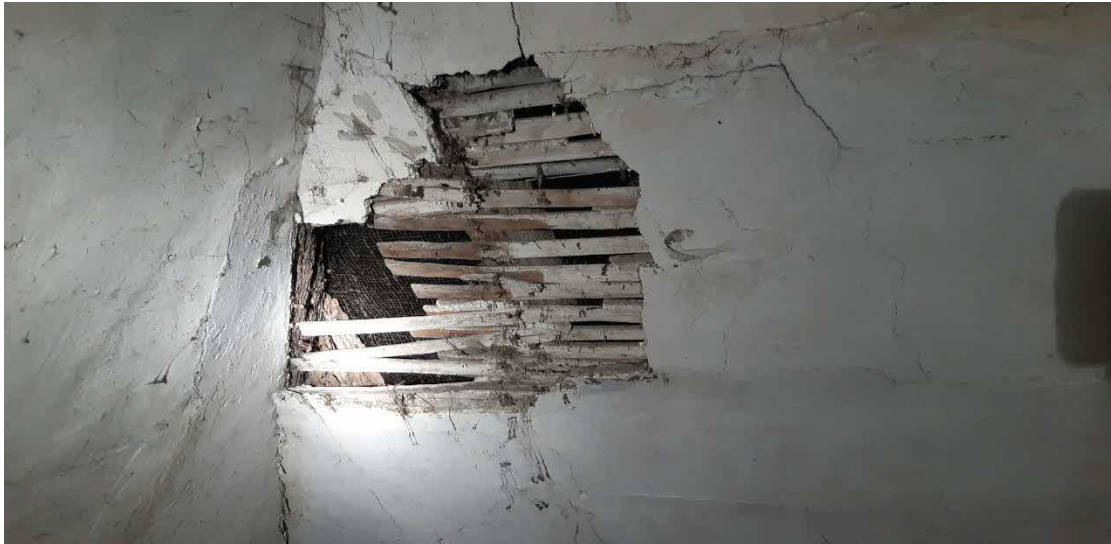
- 3.3.4 The room at the eastern part of the loft space was lined with bitumen felt as well as being plastered so there was no visible ridge and only very limited places for bats hang from in the room itself. However, there were large holes in the plastering in several places providing access for bats to roost behind the plastering (see Photograph 4 in Appendix 1). There were no cross beams, leaving an open space for bats to fly around, the room was not very cobwebbed, and there was direct access from the outside at the eaves where the plastering were broken (see Photograph 5 in Appendix 1). Several bat dropping were found in this room, believed to be mainly from brown long-eared bats.

Photograph 4: Room at the eastern part of the loft, broken plaster

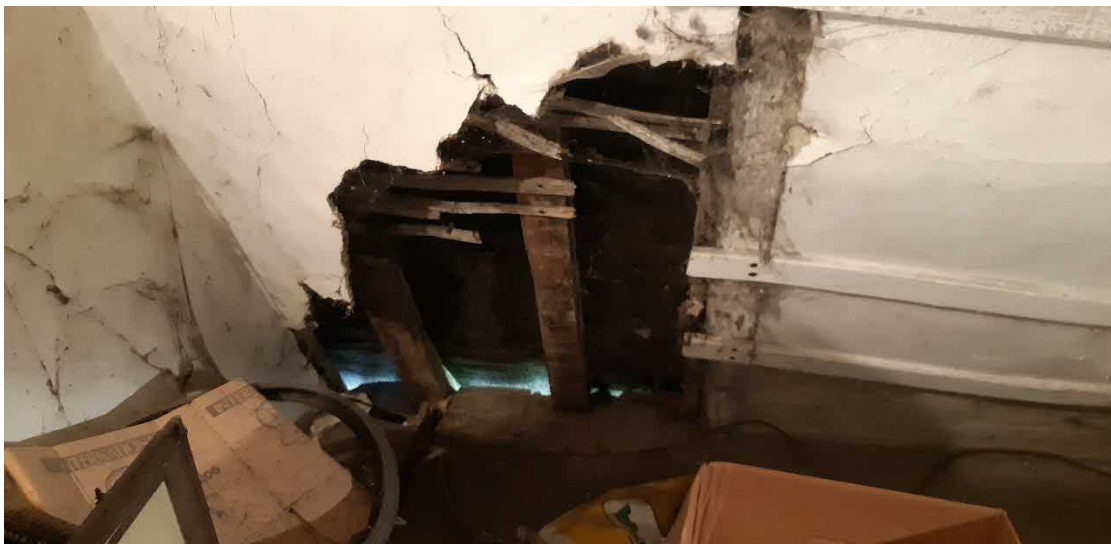
Photograph 5: Gap in the eaves in the eastern room

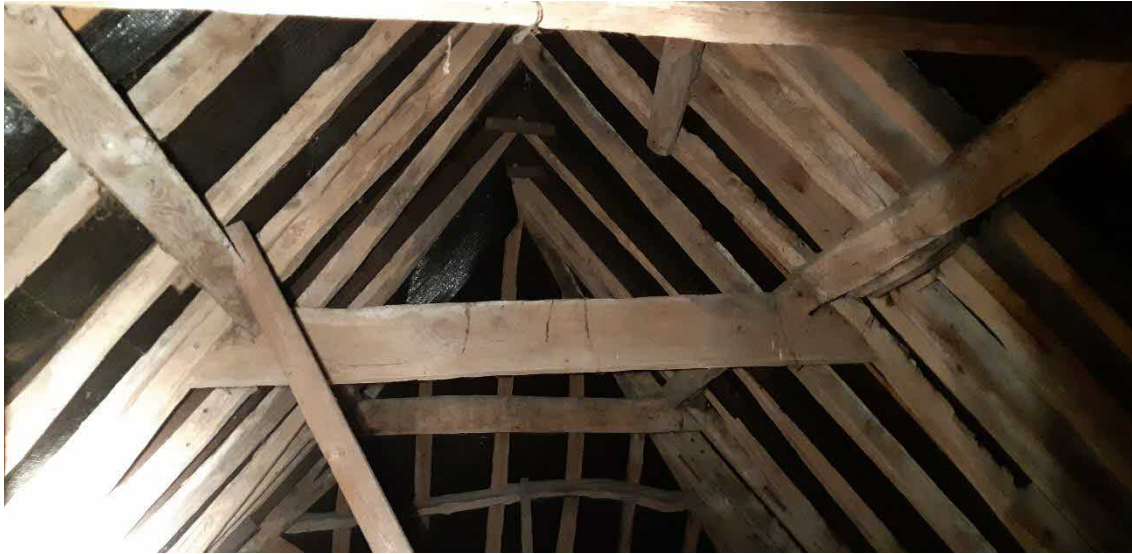
- 3.3.5 The western loft space was lined with bitumen felt throughout and was un-plastered. There were some limited cross beams, still leaving a sizeable clear space for bats to fly around in (see Photograph 6 in Appendix 1). There were clear access points at the eaves in several places and relatively few cobwebs, especially at the ridge. There were a few clusters of bat droppings underneath the roof ridge, approximately 50-150 in each cluster (see Photograph 7 in Appendix 1), though the entire loft space had scattered bat droppings throughout. One brown long-eared bat was found roosting at the ridge (see Photograph 8 in Appendix 1).

Photograph 6: The void in the western loft space

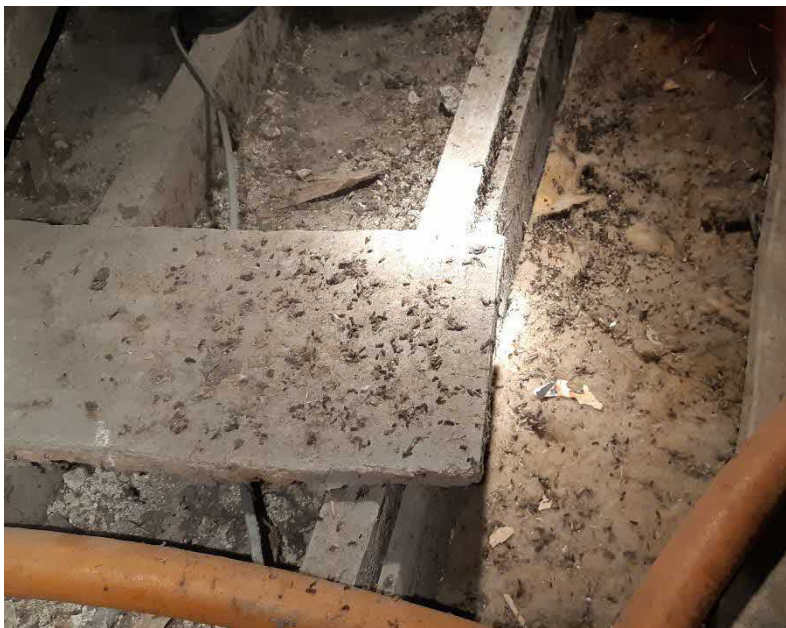
Photograph 7: A cluster of bat droppings, western loft space

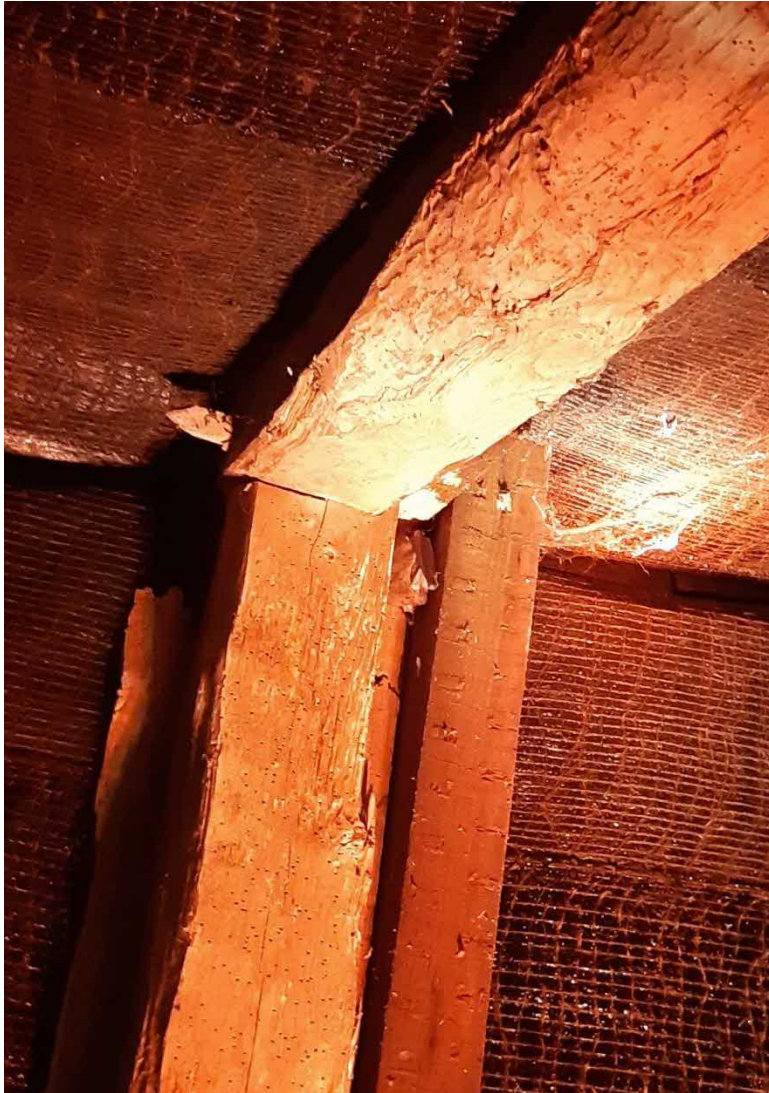
Photograph 8: Roosting brown long-eared bat between beams at roof ridge

- 5.1.1 In accordance with the Bat Conservation Trust Good Practice Guidelines, three nocturnal survey visits of the house, two dusk and one dawn survey, are recommended to confirm the number of bats and bat species using the space in order to determine the best way forward in compliance with wildlife legislation.
