BAT PRESENCE / ABSENCE SURVEY

Land off Cropper Road

Blackpool

UES reference: UES03391/04

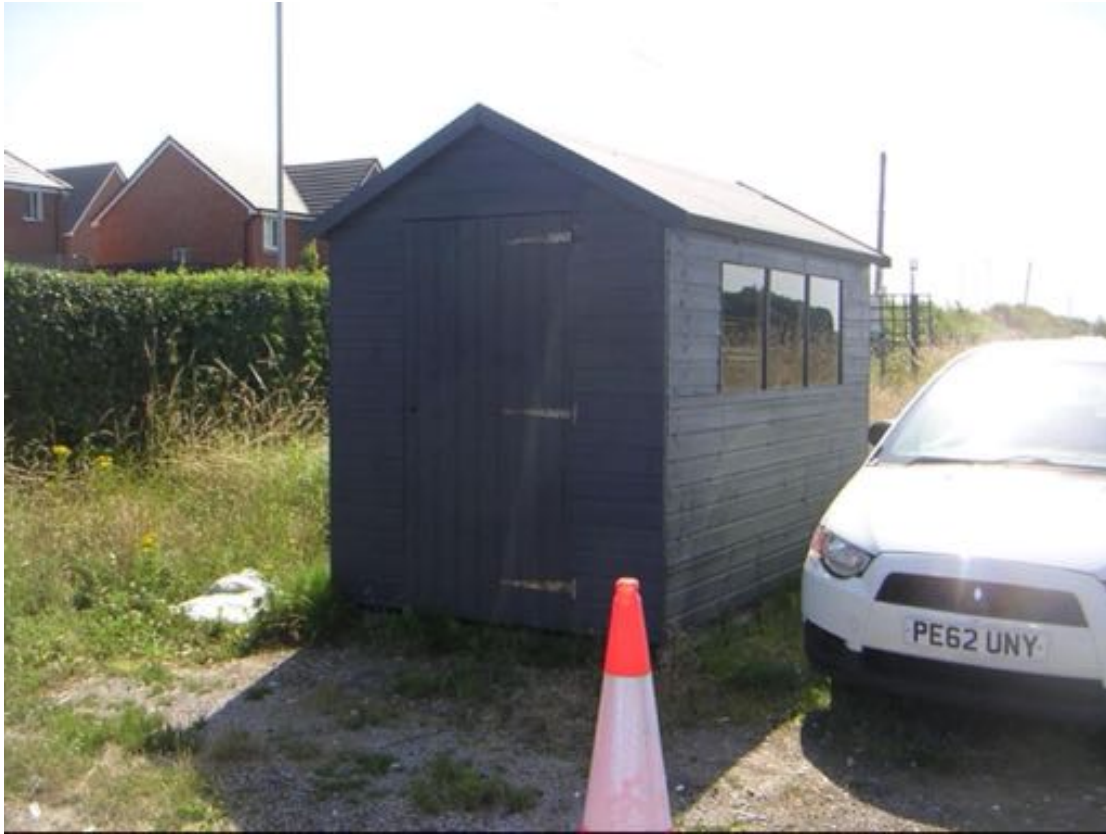
Building 1 is a wooden storage shed located immediately adjacent to the eastern site boundary (Photo 1), it is approximately 2m x 3m in size. The building has a pitched roof which is lined with bitumen roofing felt. The walls are constructed from wooden timber panels which have been painted. There are glass windows present on the western aspect of the building. Overall the shed is in excellent condition and tightly sealed.

Photo 1 – Northern and western aspects of Building 1.

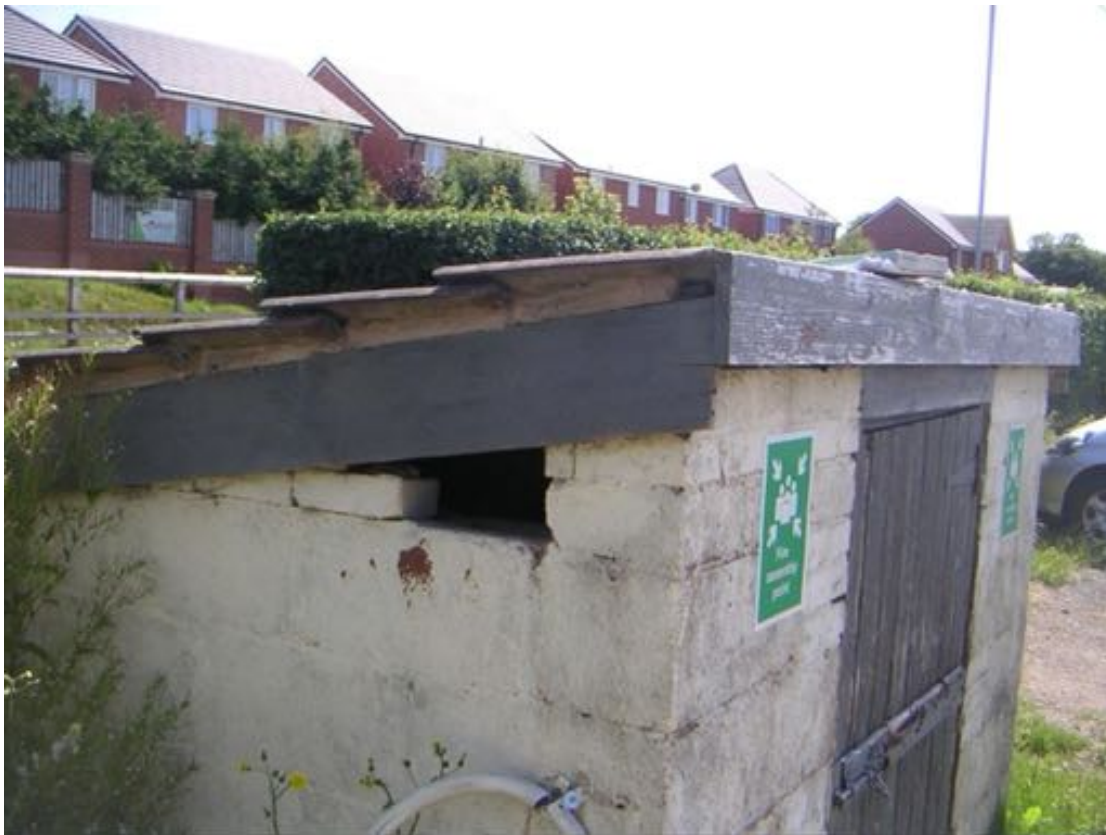
Building 2 is an electricity control building, approximately 2m high, with an area of 4m². The building has a mono-pitched roof, clad with interlocking concrete tiles (Photo 2). A low number of gaps were noted on the eastern aspect of the building, where the end roof tiles have mortar missing, however these were fully inspected using a high-powered torch and no evidence of roosting bats was recorded. There are wooden barge boards present on all aspects of the building which are in poor condition, with gaps noted behind the barge boards (Photo 3). However, these were fully inspected using a high powered torch and no evidence of roosting bats was recorded. The walls are constructed from breeze blocks, which are generally in excellent condition, however a brick was noted to be missing on the northern aspect of the building, allowing access internally. There is one wooden door on the southern aspect of the

Photo 2 – Northern and western aspects of Building 2, which is located within the northern corner of the site.

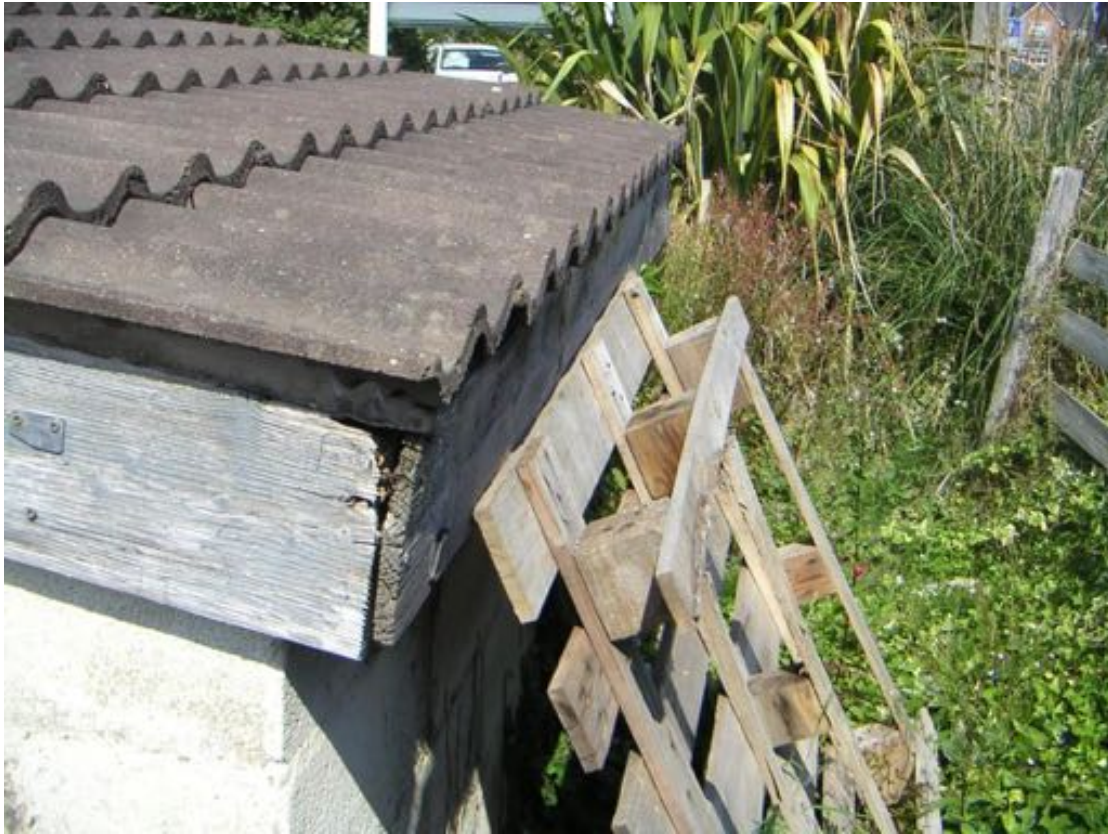
Photo 3 – View of gaps in the wooden barge boards on the southern and eastern aspects of Building 2.

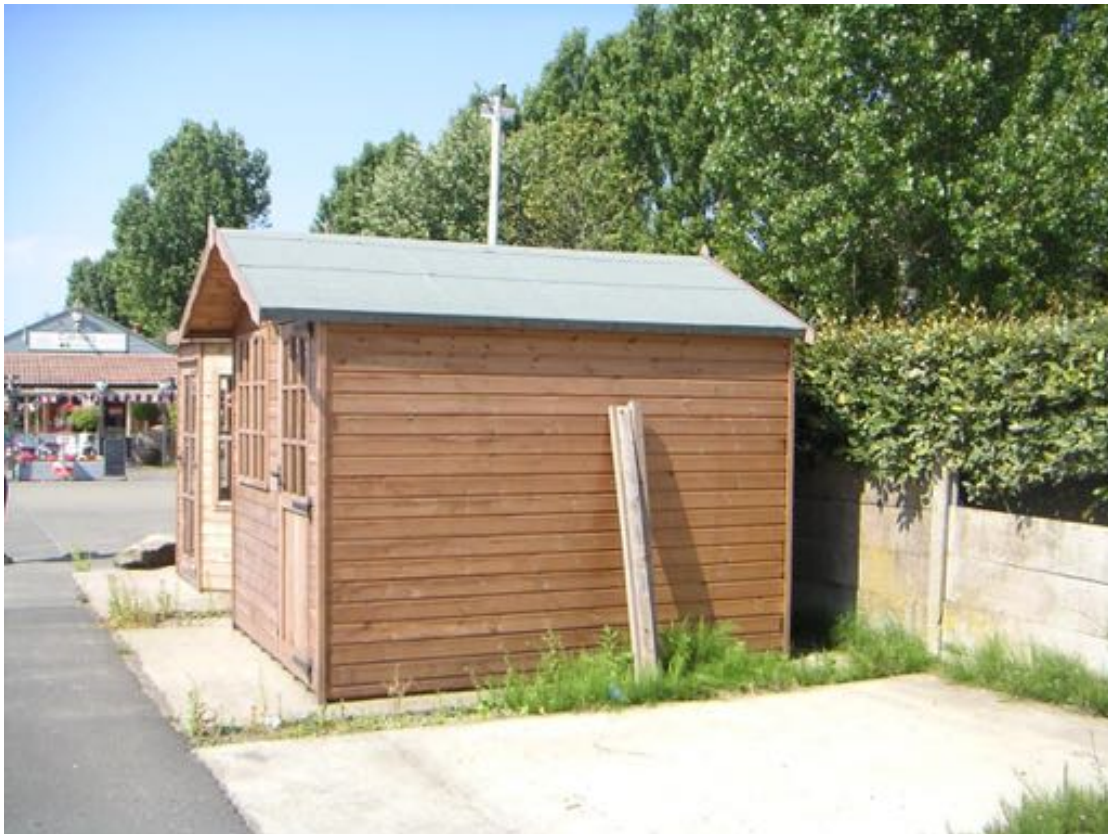
Photo 4 –Eastern aspect of Building 3.

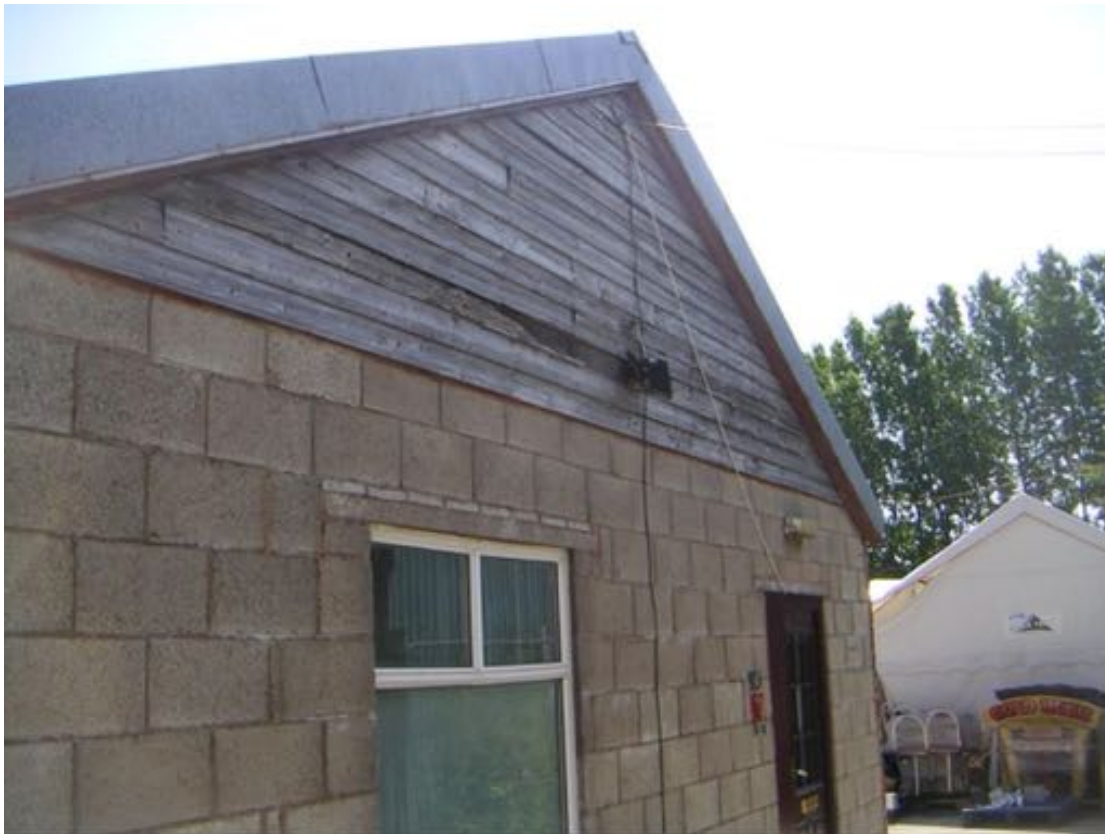
Photo 11 – Western aspect of Building 9, view of wooden boxed soffit and wooden cladding.

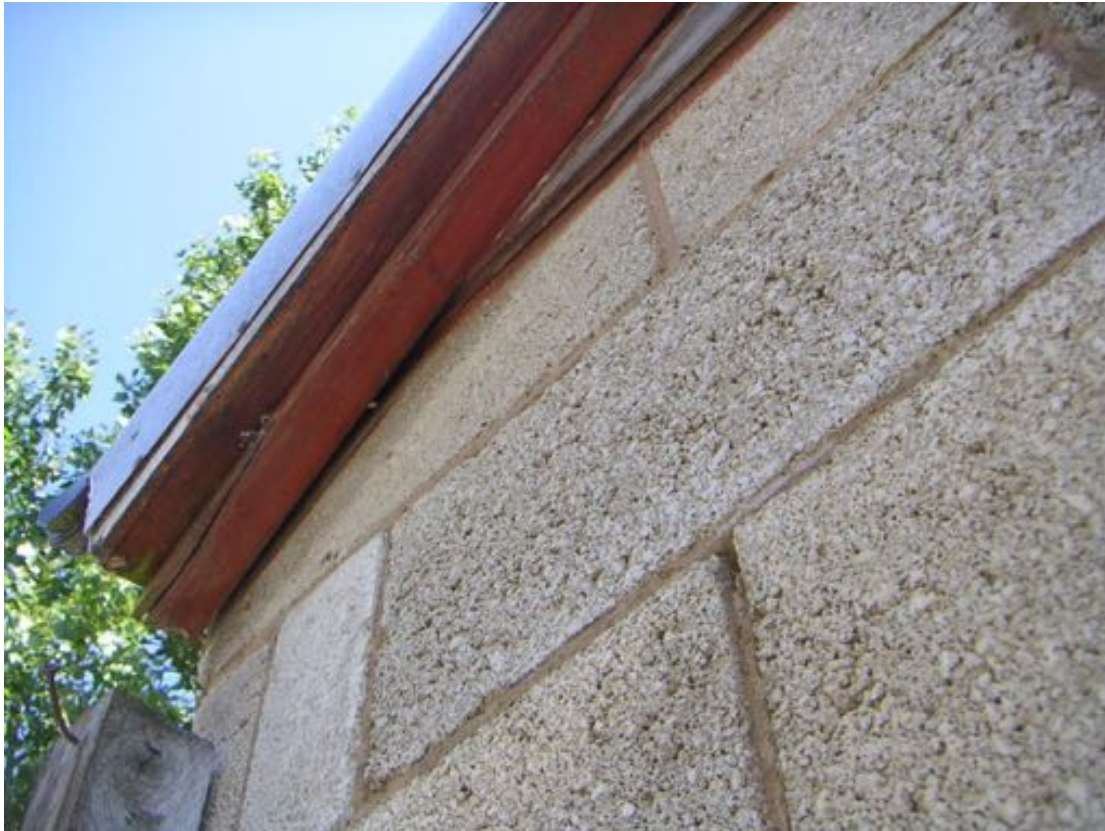
Buildings 9 and 10 are a row of interconnected buildings which are split into separate businesses. **Building 9** is constructed from a mixture of brick and breeze block and is located on the western aspect of Building 10. The building has a pitched roof, clad with corrugated metal sheets, which are in excellent condition (Photo 10). There is a wooden boxed soffit and wooden cladding on the western aspect of the building. The wooden cladding is in excellent condition and tightly sealed but there are gaps where the boxed soffit meets the wall and wooden cladding (Photo 11 and 12). The gaps were inspected with a high powered torch and endoscope, but due to the size and shape of the feature it could not be fully inspected. A small number of gaps were noted in the brickwork on the southern aspect of the building (Photo 13), but these were fully inspected with a high-powered torch and found to be superficial. Similarly, one gap was noted in the breeze block wall on the northern aspect of the building, where mortar was missing (Photo 14), but this gap was fully inspected using an endoscope and no evidence of roosting bats was recorded.

Photo 12 – Example gaps where the wooden boxed soffit meets the wall on Building 9.

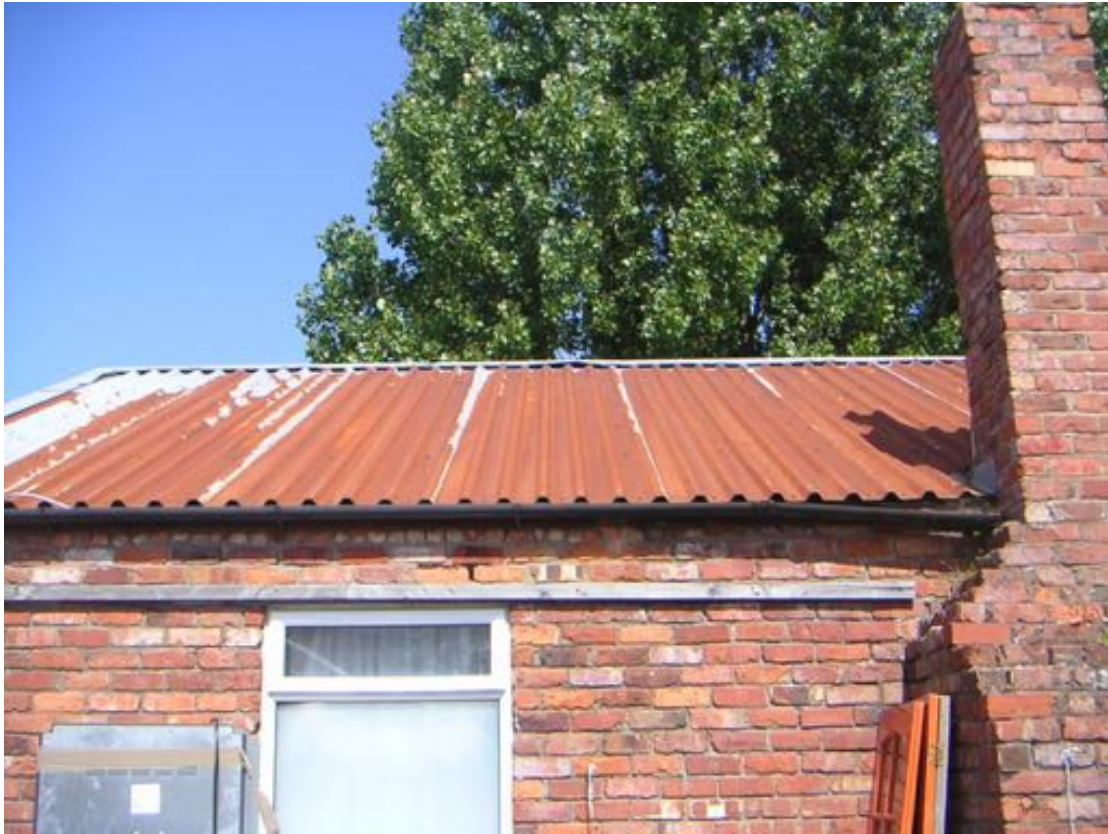
Photo 13 – Southern aspect of Building 9, gaps in brickwork which were fully inspected and found to be superficial.

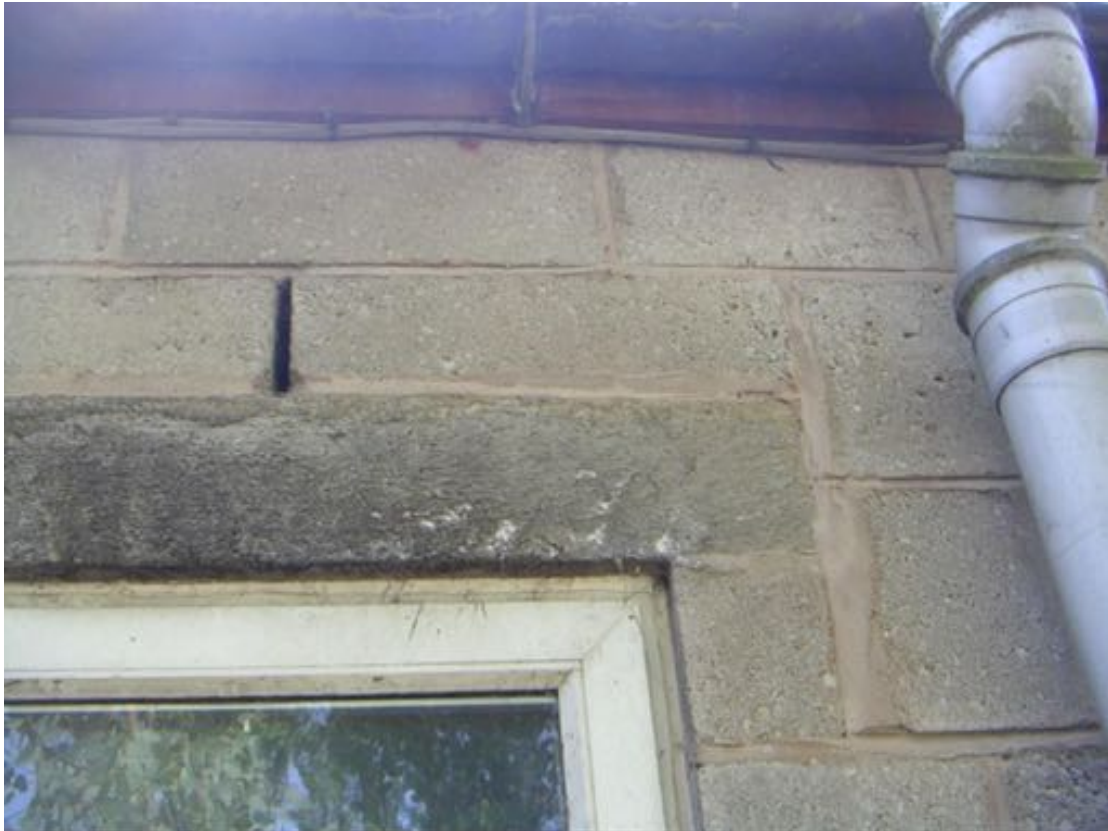
Photo 14 – Northern aspect of Building 9, with one gap recorded in where mortar is missing.

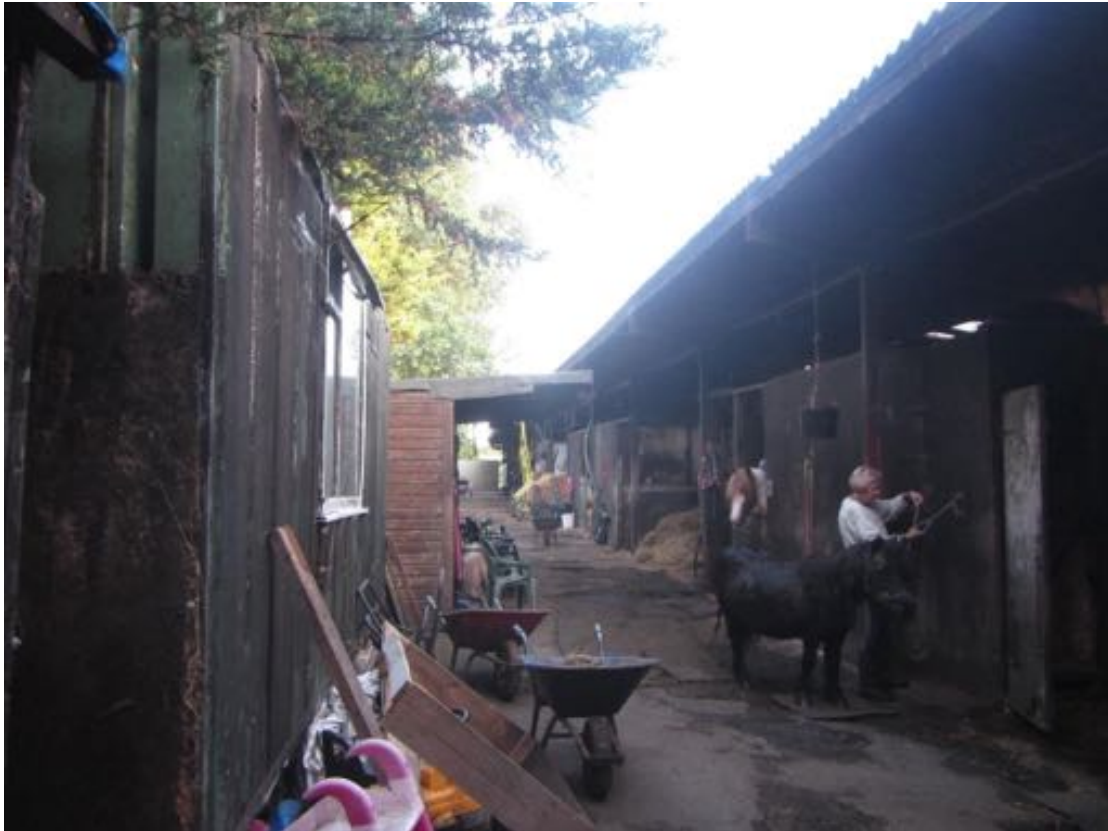
Building 12 is a single storey horse stables located within the western section of the site. The building is currently used to house horses and as such, is subject to regular disturbance. The building is constructed from a timber frame with corrugated metal exteriors, see Photo 20 and 21. The roof is lined with a mixture of wooden cladding and corrugated asbestos sheets, some of which are slightly lifted. As such, there are small cavities between the wooden cladding and corrugated asbestos sheets. These gaps provide some roosting opportunities for bats, however the roosting potential of these features is limited due to their small size, the exposure to light and frequent disturbance. There is bitumen flashing present on the southern aspect of the building which is slightly lifted and will provide opportunities for a small number of bats to roost occasionally. Furthermore, there are wooden barge boards present on the western aspect of the building which are slightly lifted; these were fully inspected with a high powered torch and no evidence of roosting bats was recorded. The eastern aspect of the building is open fronted with large open doorways and windows, allowing access into the internal areas of the building (Photo 22).

Photo 22 – Eastern aspect of Building 12, open fronted stables.

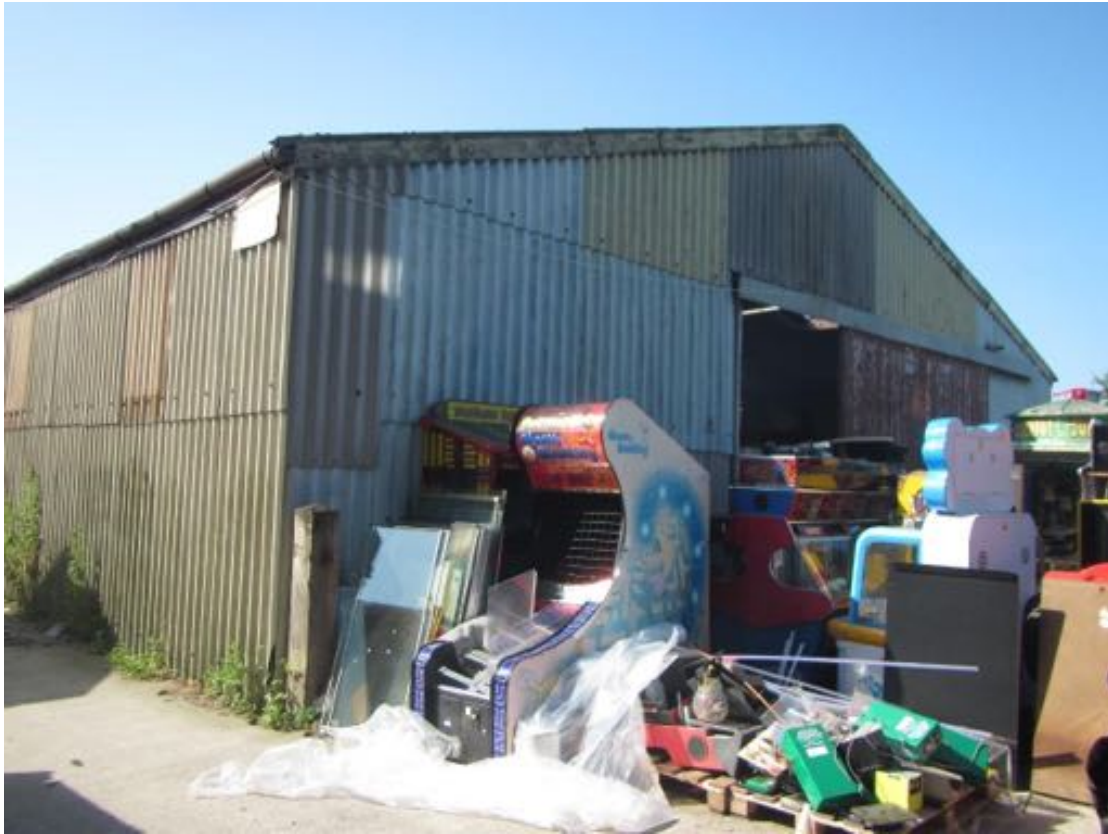
Building 13 is a large barn constructed from corrugated metal sheeting with a corrugated metal roof (Photo 23). The roof is generally in good condition but there is asbestos flashing present on the northern and southern aspects of the building, which are slightly lifted and may provide occasional roosting opportunities for a small number of bats. There are wooden barge boards present on the western and eastern aspects of the building which are also lifted in places (Photo 24). Finally, there are small gaps where the corrugated metal sheet walls overlap; these were fully inspected and no evidence of roosting bats was identified. There are no windows in the building and the door is a large wooden sliding barn door, which is tightly sealed.

Photo 23 – Northern aspect of Building 13.

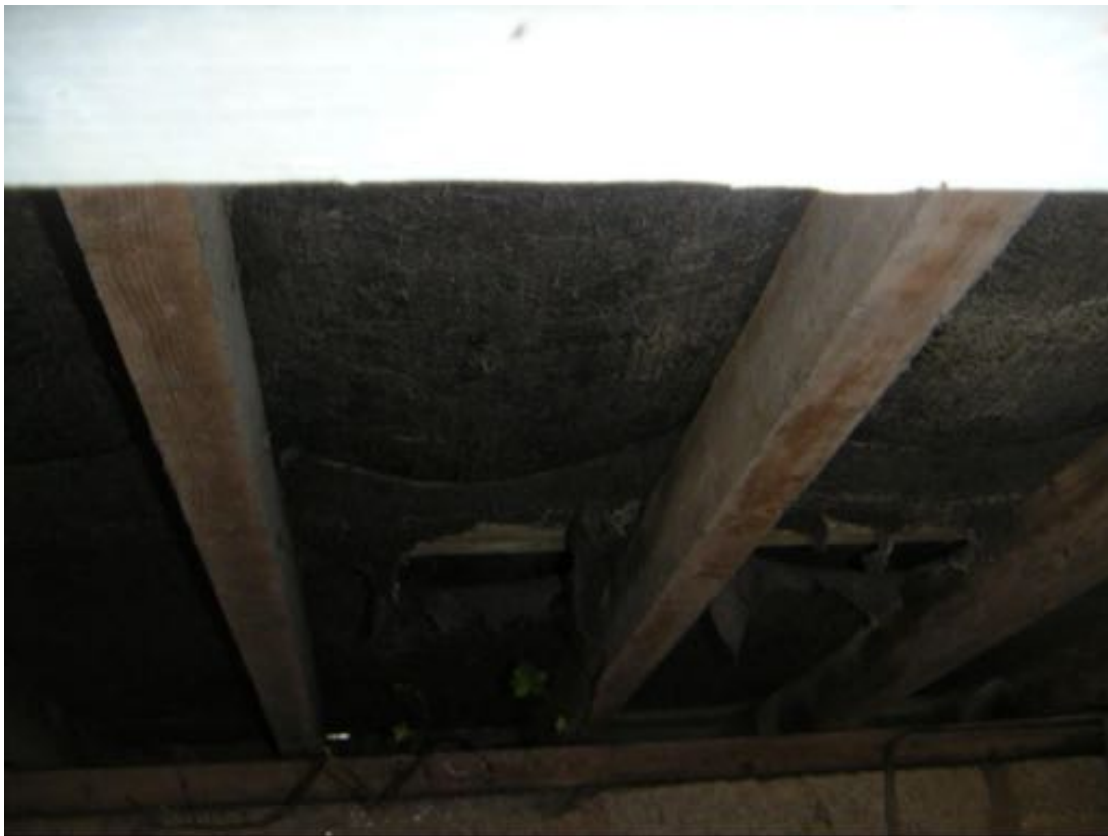
Building 2 has no loft void but the roof is constructed from a wooden timber frame, which is lined with bitumen roofing felt. The roofing felt is in poor condition and ripped in several places (Photo 28). The internal breeze block walls are generally in good condition but there is access into the building via a missing brick on the northern aspect. However, no evidence of roosting bats was recorded within the building and due to the height and location of the building it is considered to offer limited suitability to roosting bats.

Photo 28 – Internal view of Building 2.

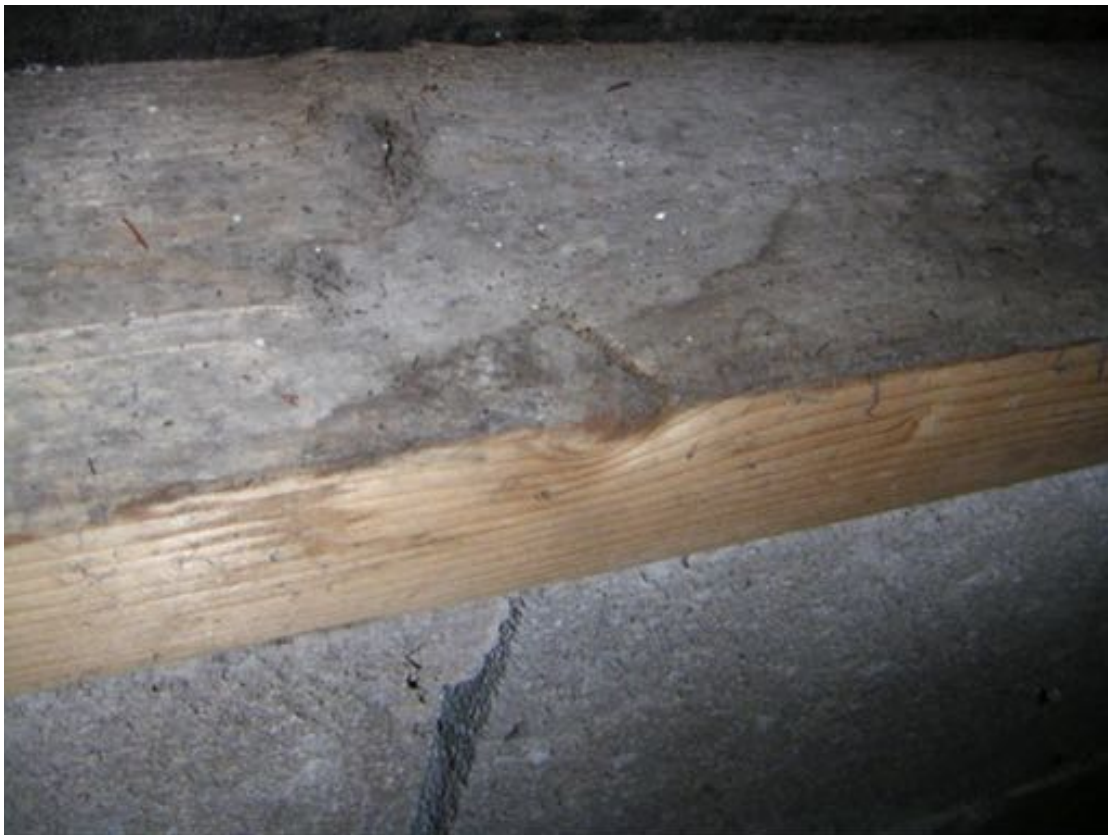
Photo 30 – View of gap where mortar is missing between breeze blocks on wall within the northern section of Building 10.

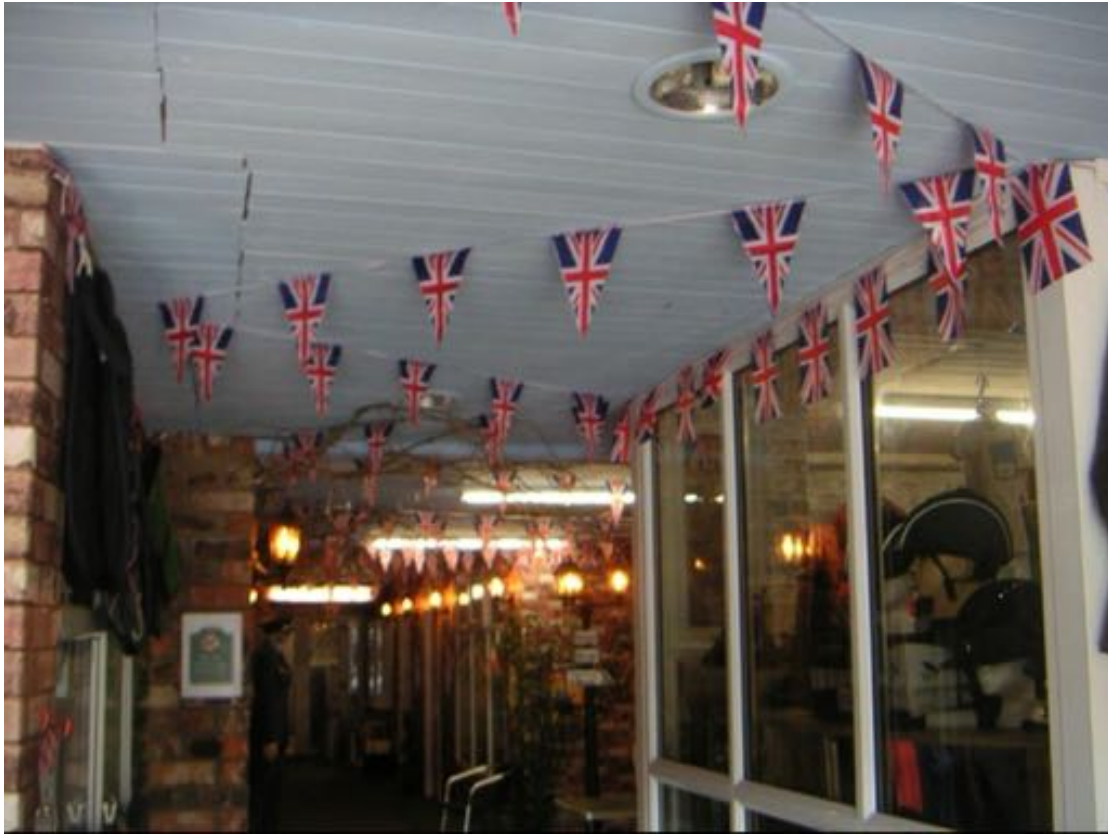
A wooden ceiling has been installed below the central pitch of the building, which has no loft hatch, see Photo 31. Therefore, this section of the building could not be fully inspected, but it is anticipated to be a similar to the northern and southern sections of the building. The internal walls of the building are exposed brick or clad with wood or plastic panelling, all of which is in excellent condition.

Photo 31 – Internal view of central section of Building 10.

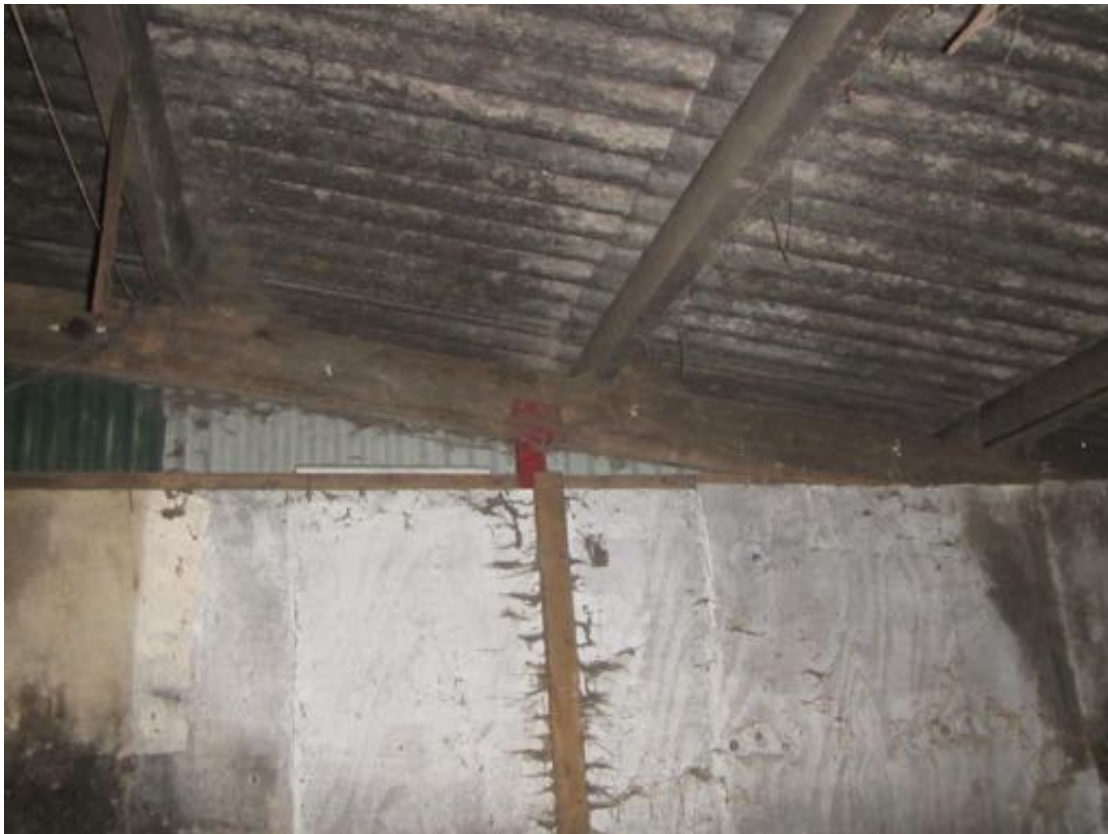
Building 12 has no loft void but internal walls are constructed from corrugated metal, some of which are lined with wooden boards, see Photo 33. As such, there are small cavities between the internal wooden boards and exterior corrugated metal walls. Additional internal PRFs were noted on the roof where the asbestos corrugated sheets overlap and between the wooden timber frame. However, the building is well lit and subject to high levels of disturbance, reducing its suitability for roosting bats.

Photo 33 – Internal view of Building 12.
