ARBORICULTURAL IMPACT ASSESSMENT

Client: Redsun Projects

Site: The Croft
Caldbeck Road
Bromborough

Ref.: THL-R21/23

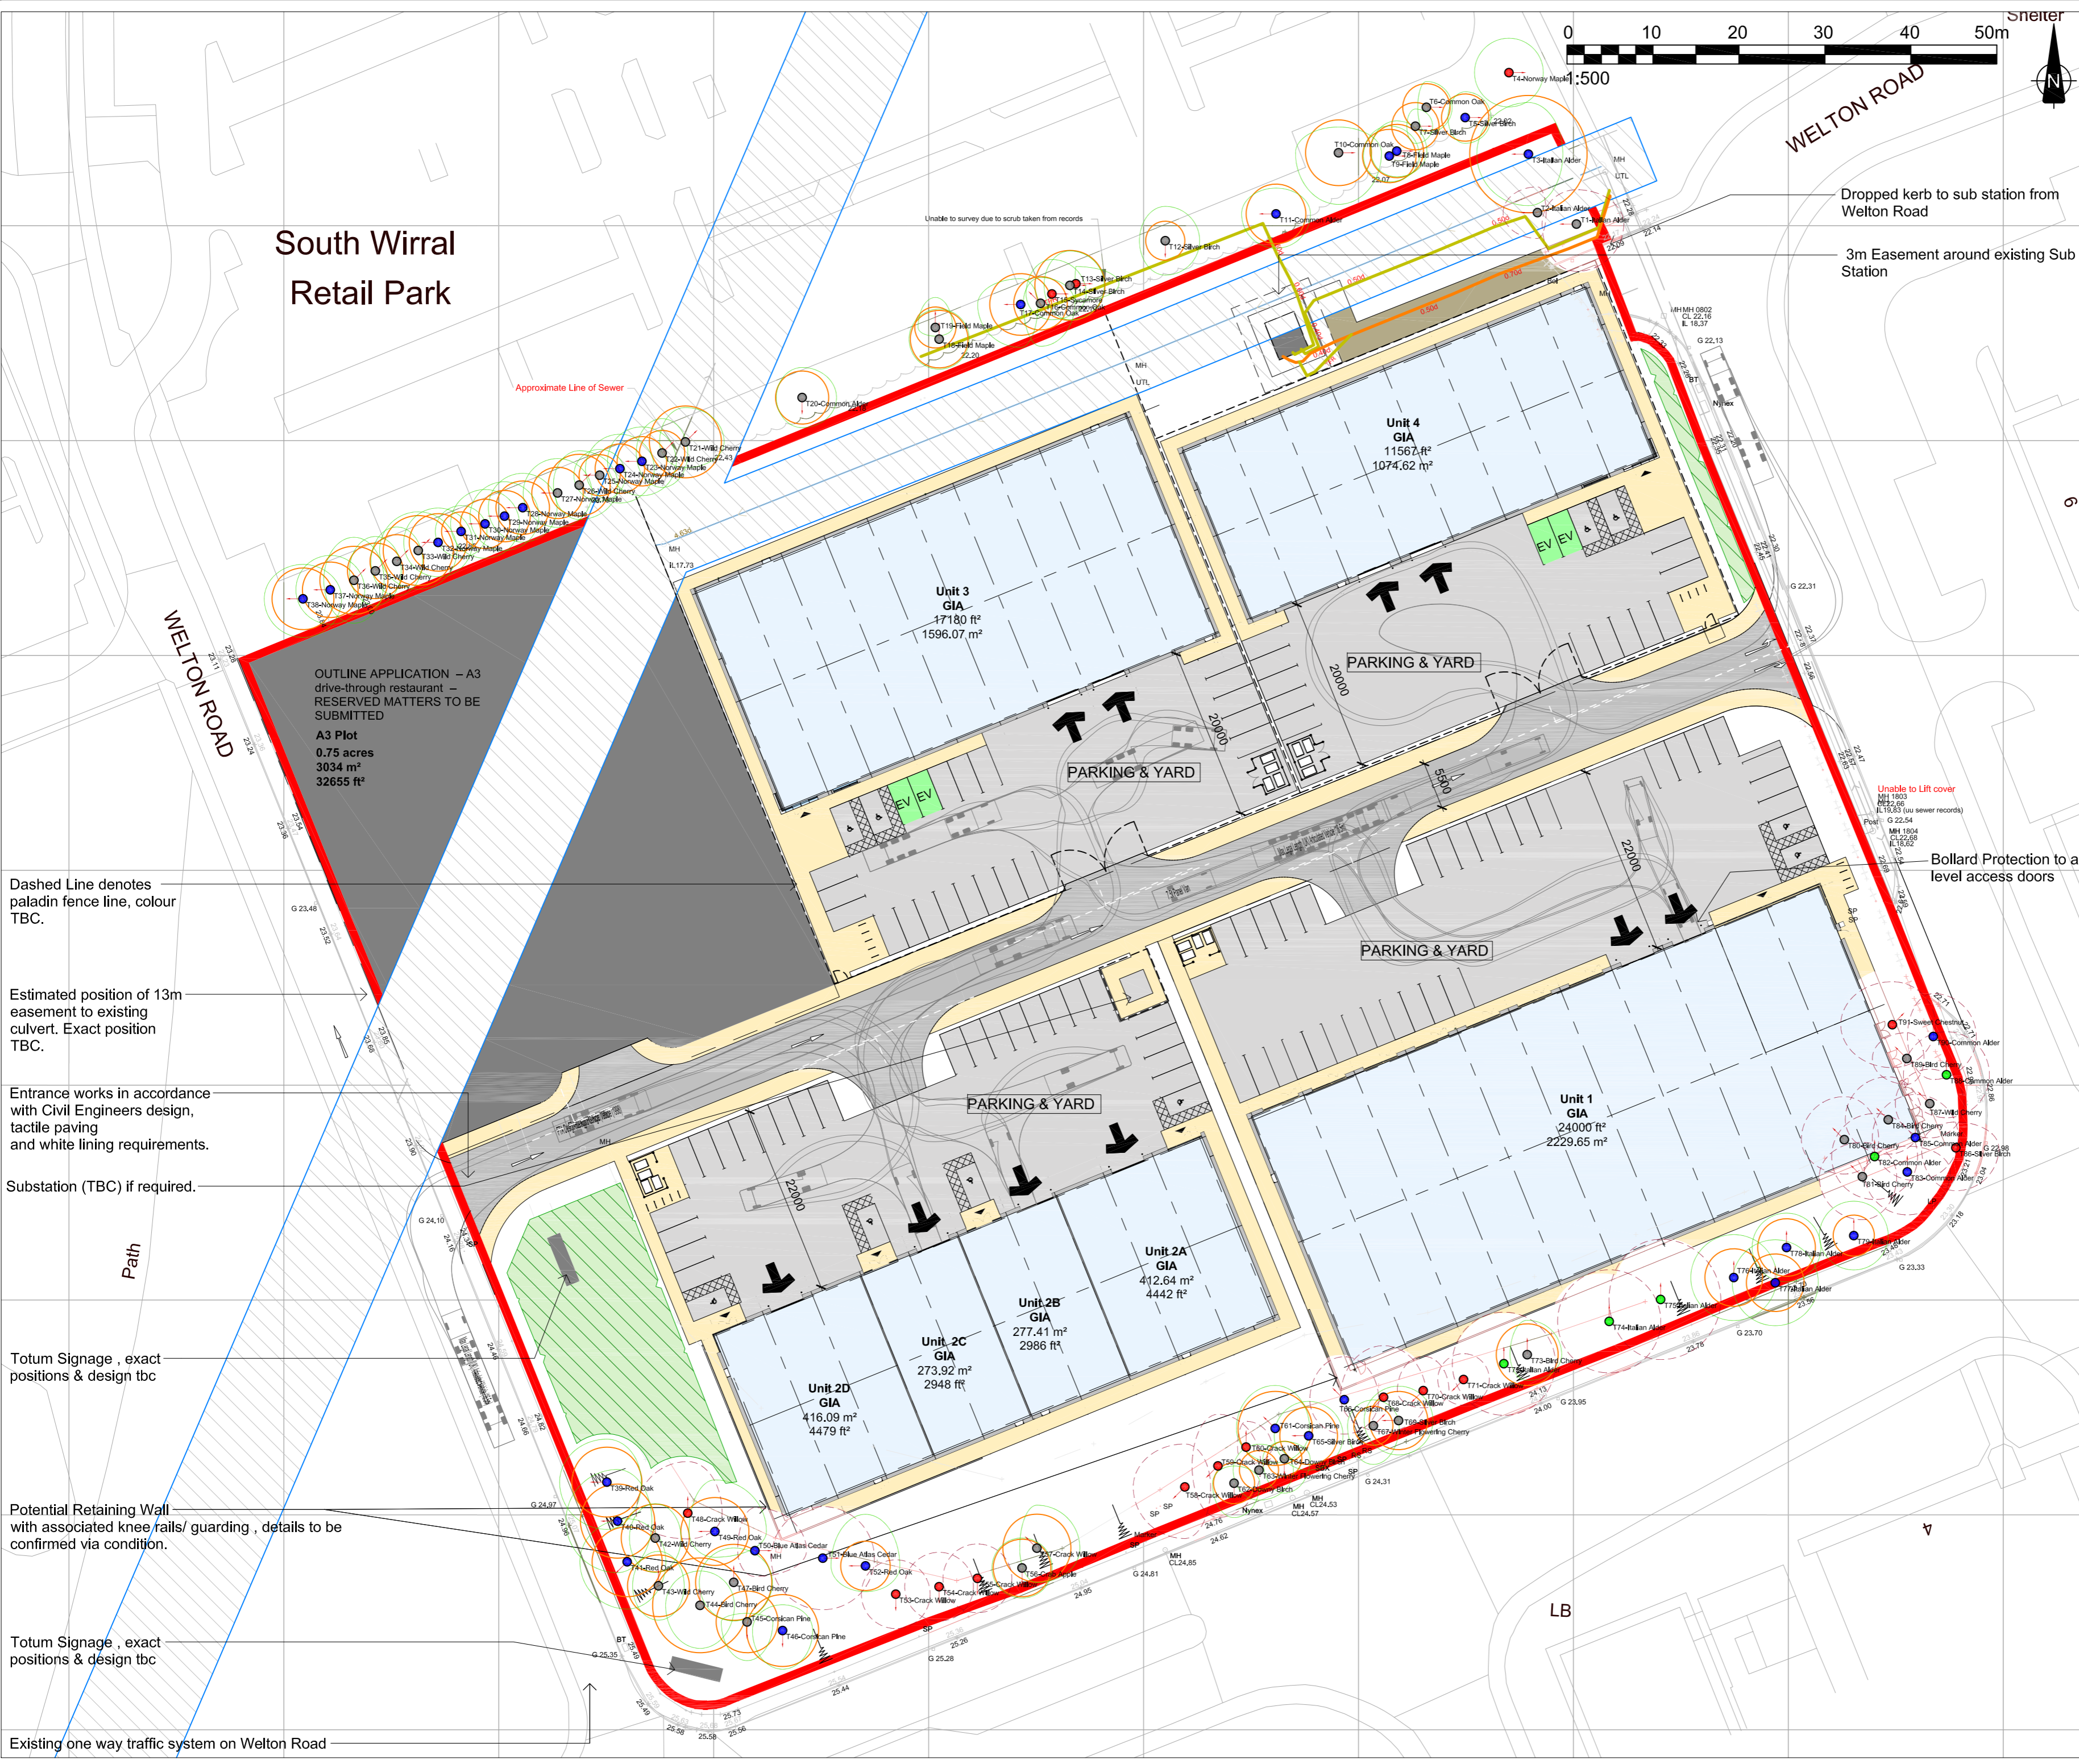
Drawing Title:
Arboricultural Impact Assessment

- 2.1 The proposed development is shown on plan THL-0710-6 attached to this report. The development consists of the constructions of several industrial units and associated parking and infrastructure.

- 2.2 Along the north boundary of the site, all trees will be retained and protected throughout the development.
- 2.3 Adjacent to Welton Road, T1 and T2 will be removed to allow for the construction of unit 4 as shown on the attached plan. Both trees are category C, and their removal will not only allow space for the development but will also give T3 more space to grow into. T3 is a category B Alder.

- 2.4 On the corner of Welton Road and Caldbeck Road is a group of 10 trees that will all require removal to allow space for the development. This group consists of 5 category C trees, 3 category B trees, and 2 category A trees. In addition to this 2 category U trees will be removed on the grounds of safety.

- 2.5 Along the site boundary with Caldbeck Road, 6 trees will require removal to allow for the development. This includes 3 category B trees and 3 category C trees. In addition to this, 10 category U trees will be removed on the grounds of safety.

- 2.7 It is recommended that a planting scheme is produced as part of the development. There are many Willow species on site which are generally not suitable for planting in this type of location, and it is recommended that more suitable species are chosen as replacements.
