HERITAGE STATEMENT

This Heritage Statement accompanies a Planning and Listed Building Application for a new roof dormer, repositioned door and conservation rooflight.

6 Church Street
Windsor
SL4 1PE

Date: 09th Nov 2021

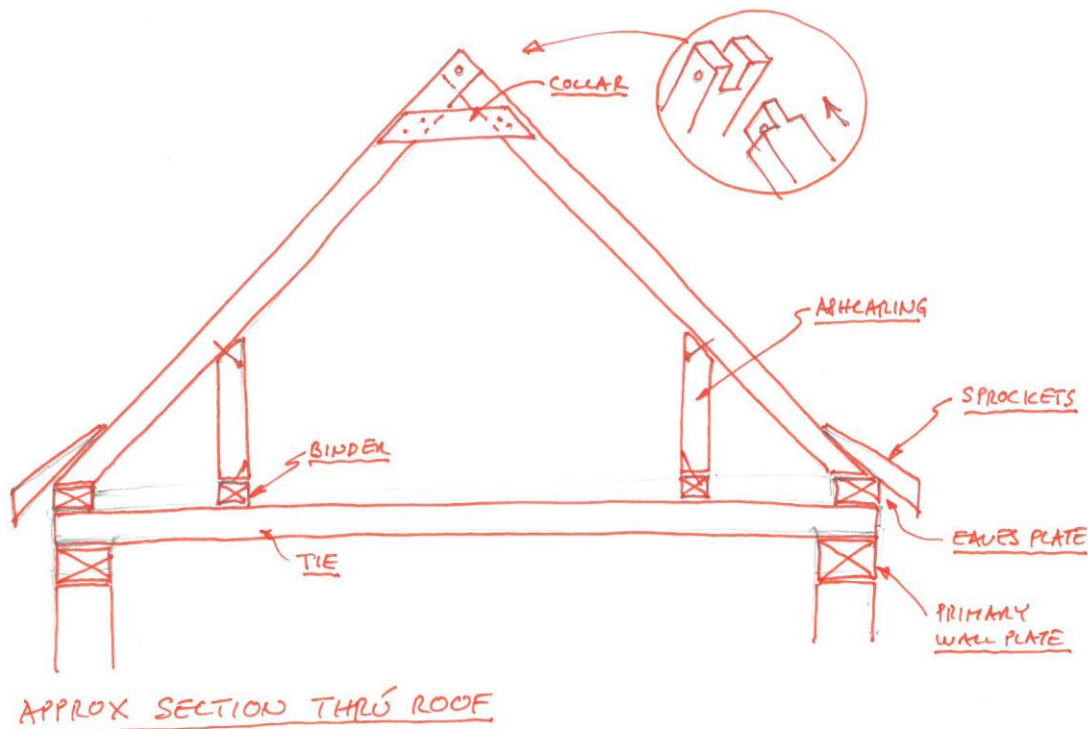
In the position of the unauthorised large dormer a number of the rafters have been removed. Some completely up to the mortice and tenon joint. Some partly, having been sawn off 6 inches down from the mortice and tenon joint.

All of the collars have been removed and a ridge timber of doubled up 4x2's inserted to the entire length of the ridge and propped at each end.

The sawn out rafters and collars have fortunately not been removed from site and are in the ground floor kitchen area.

As can be seen the collars and the ashlar studs brace the corners of each triangular roof frame.

The repair works are to reinstate the missing rafters and reinstate the collars at the apex. As the rafters have been removed in two different ways they will have to be reinstated in two different ways.

Where the entire rafter has been removed it can be reinstated and the pegged mortice and tenon joint at the head reinstated.

Where the rafters have been sawn off the recovered rafters will need to be offered up and a new section of rafter secured to each side to create a scarfed on extension to the rafters. In the same manner as the repairs to the roof rafters over the former chimney location.

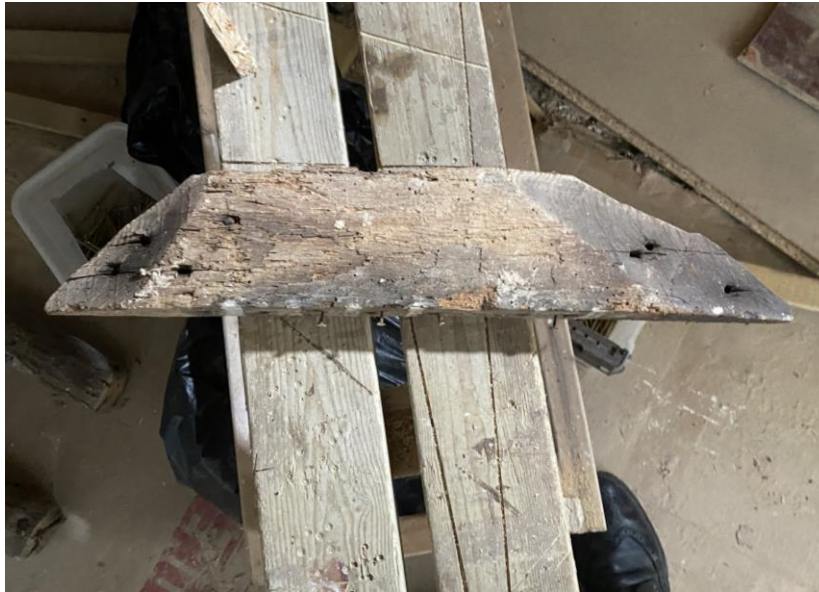
An example of one of the collars that has been removed. Which would appear to have been tosh nailed in place.

If some of the collars are missing from site or are too decayed new collars to be formed to the sizes of the existing examples.

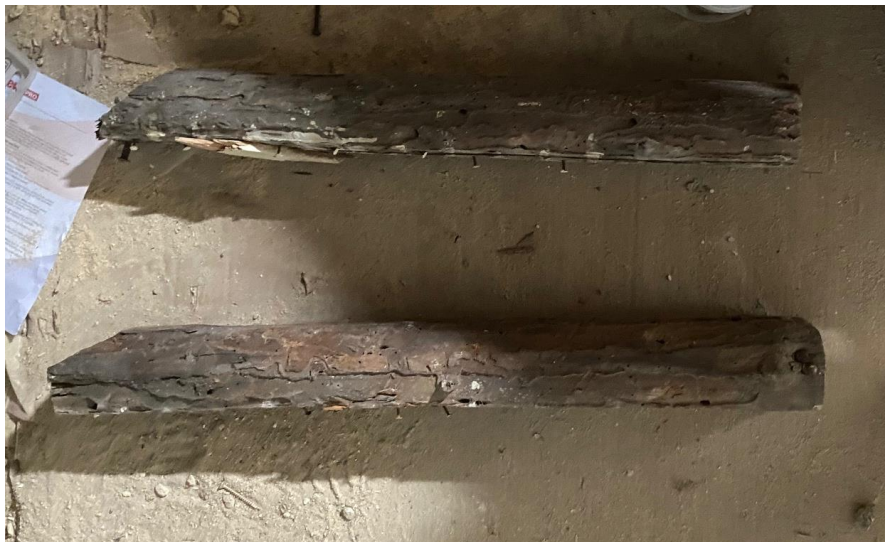
Original ashlar studs found on site that will be reused when reinstating the rafters.

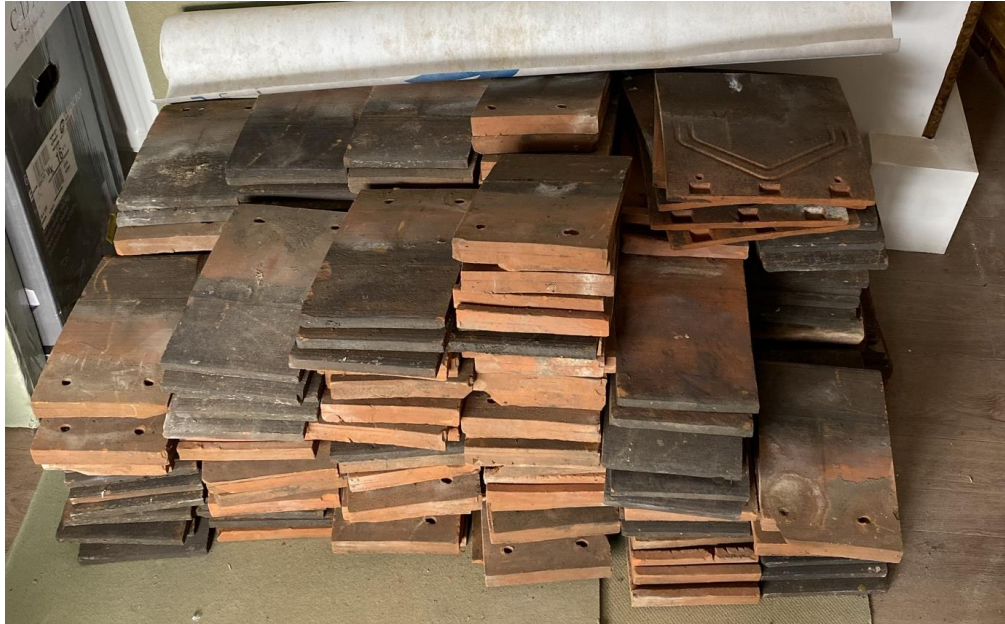
Fortunately the removed roof tiles have been retained on site. They are not original hand made tiles to this rear pitch but a combination of pugmill extruded tiles and machine pressed tiles.

They are weathered in and will match the roof that they have come off.

The roof covering will be a breathable sarking felt laid with a drape, tiling battens and reinstated tiling to match the existing roof works.

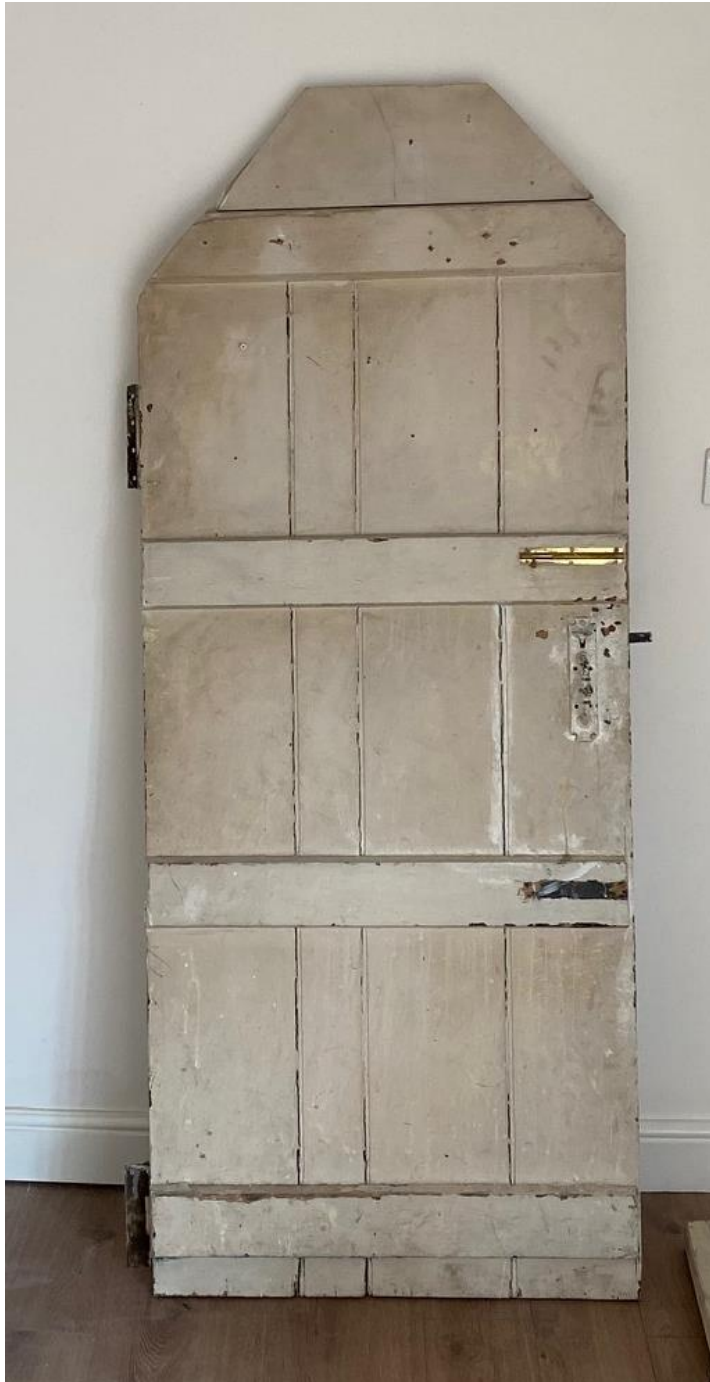
The original door was shaped to suit the apex of the roof space of the room.
The original door has been retained on site.
See photograph below.

It is a 4 ledged door of random width double Bead and Butt boards with early strap hinges. It appears likely that the two doors upon the second floor may be reused doors that have been altered and adapted for the building. The frames and architraves are more refined than would be expected for these doors.

The historic door should be reinstated if at all possible.

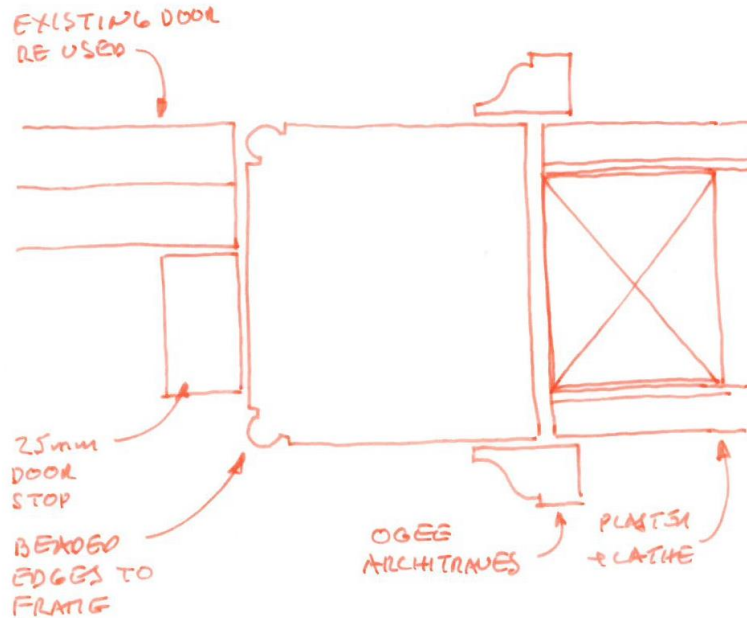
Arrangement of proposed new door frame and reused door.

It is not thought that the remains of the door frame that has been removed are still on site. Therefore a new door frame will be reproduced replicating the existing door frame and architrave to the doorway opposite.

nb The existing strap door hinges to be carefully removed from the fair face of the door and to be fitted to the door braces to allow the inward opening of the door to the room.

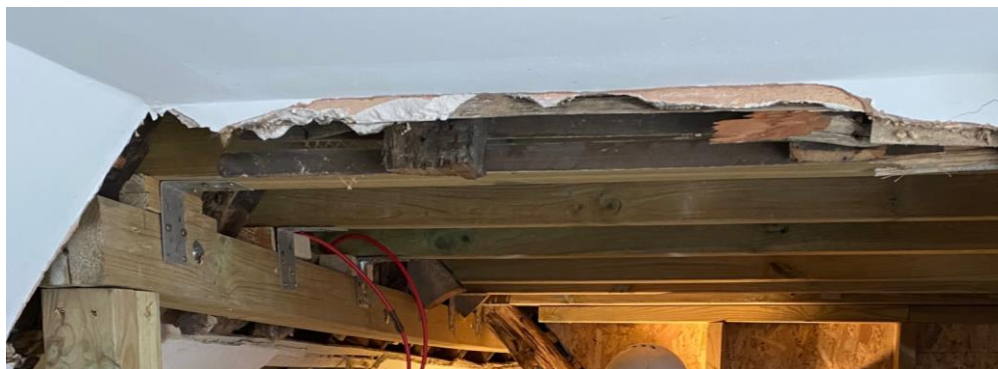
Cut out original studs

Two of the original vertical studs have been removed. If these are found amongst the materials currently on the ground floor they will be used in the reinstatement of the stud partition.

The make up stud partition to be finished in lath and plaster to match the lath and plaster adjacent. The plaster to be a lime plaster.

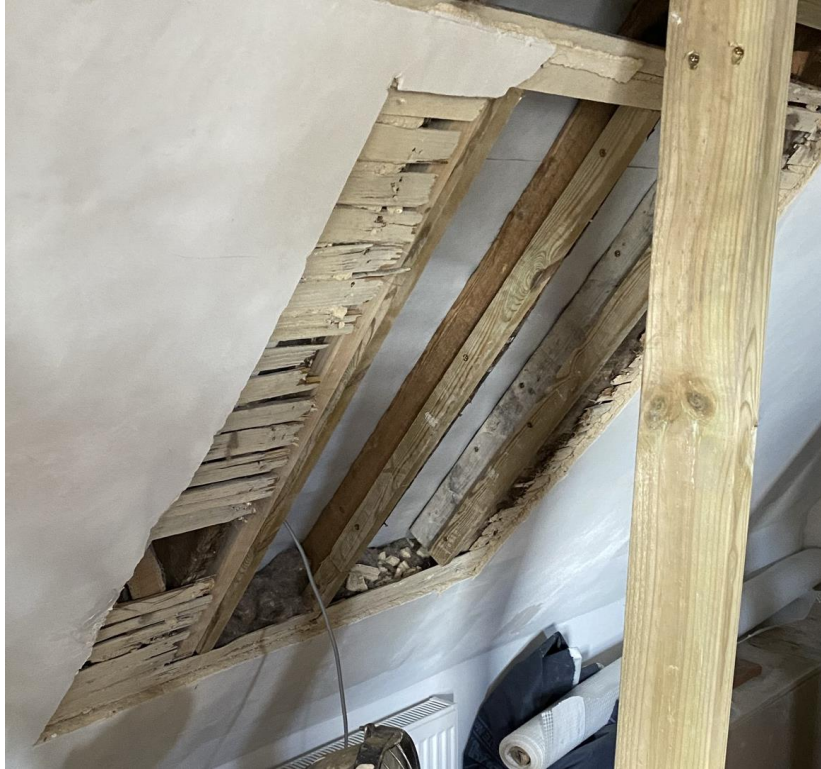
As part of the unauthorised work the ceiling finishes have been removed to part of the roof space.

It is in this position that a conservation rooflight is proposed.

This will necessitate the part removal of one of the rafters and introduction of a trimmer top and bottom.

The proposed rooflight to be sized to fit between the existing adjacent rafters.

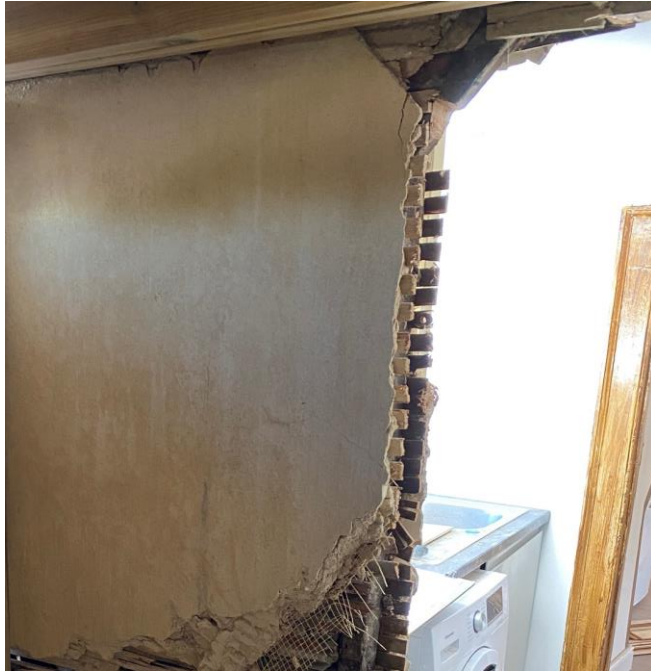
Side of existing dormer showing the lath and render to outside face and lath and plaster to inside face. Doorway in background to front attic room.

In the past a UPVC window has been fitted. This would be have been an unauthorised replacement of an existing window.

Additionally this existing dormer has been reroofed in mineral felt. Similarly this would have been an unauthorised reroofing. The age of the dormer would suggest that it would have originally had a lead roof.

It is therefore proposed to replace this window with a joinery casement window to the same detailing as that proposed to the new dormer adjacent.

It is therefore proposed to replace the mineral felt with code 5 lead and introduce lead rolls where necessary.
