DESIGN, ACCESS & HERITAGE STATEMENT

(INCORPORATING RAPID APPRAISAL)

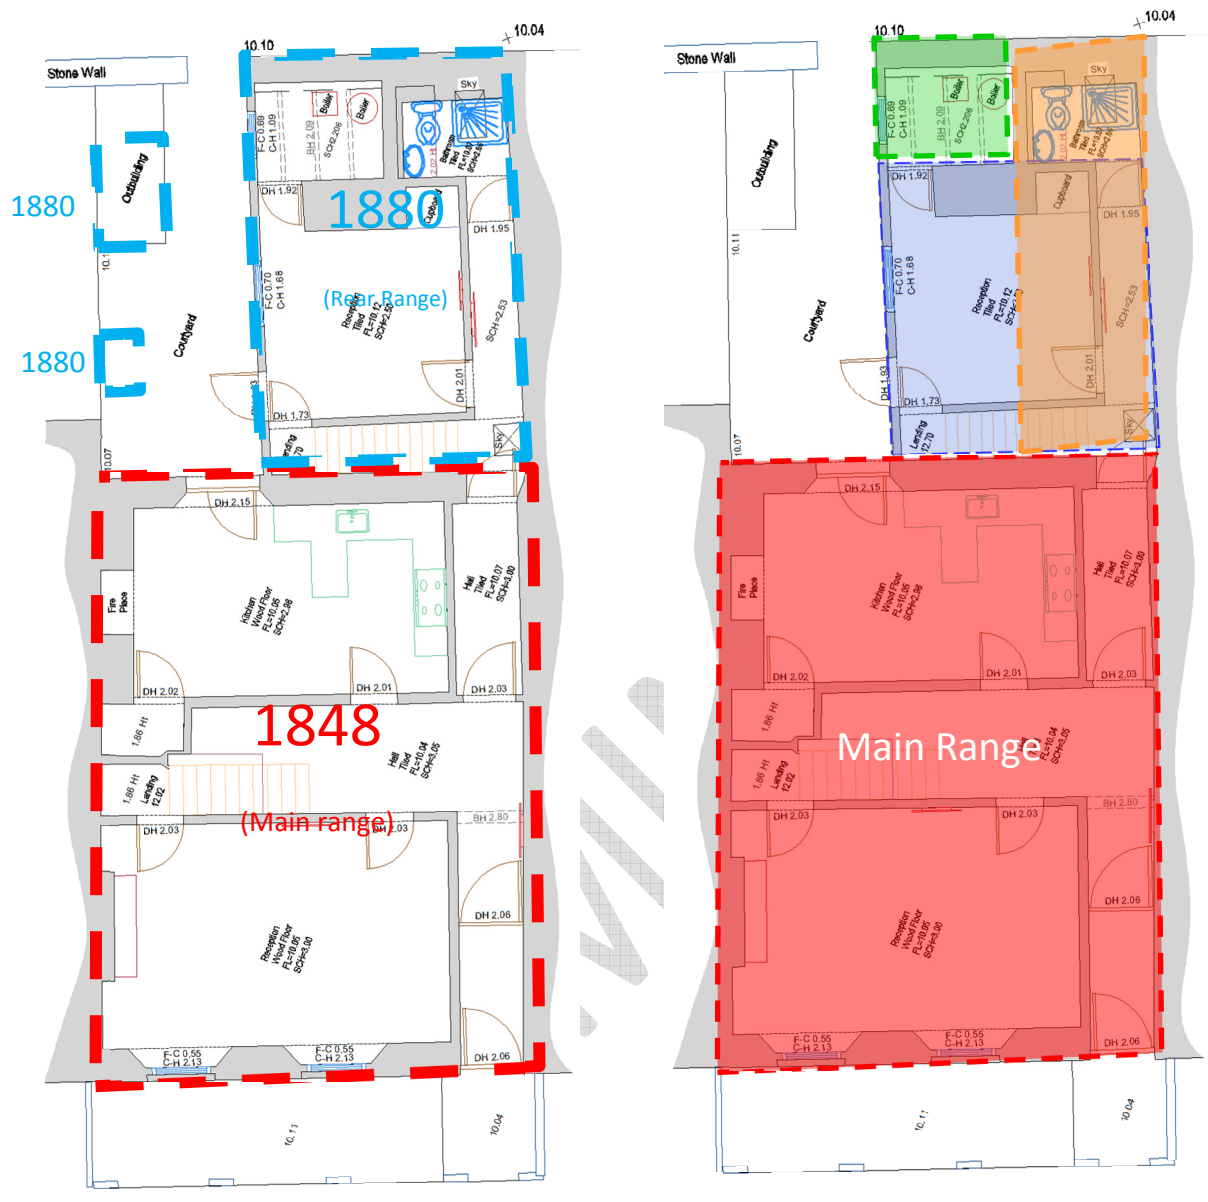
Fig 3 (left): 'Existing' survey drawing illustrating ranges by historic mapping

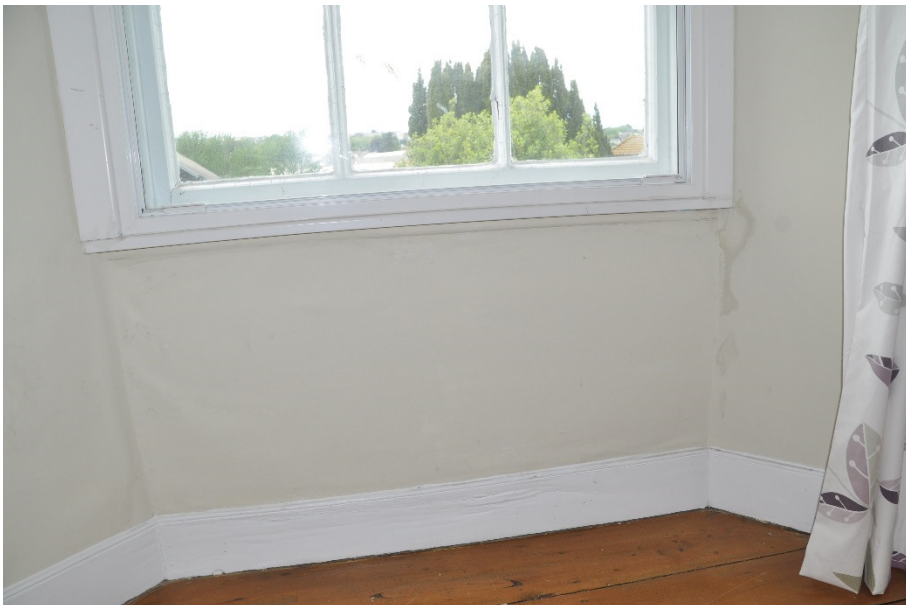
Fig 10: Existing main bedroom window. Window propped, secondary glazing installed and moisture ingress noted. Timber decay evident in skirting.

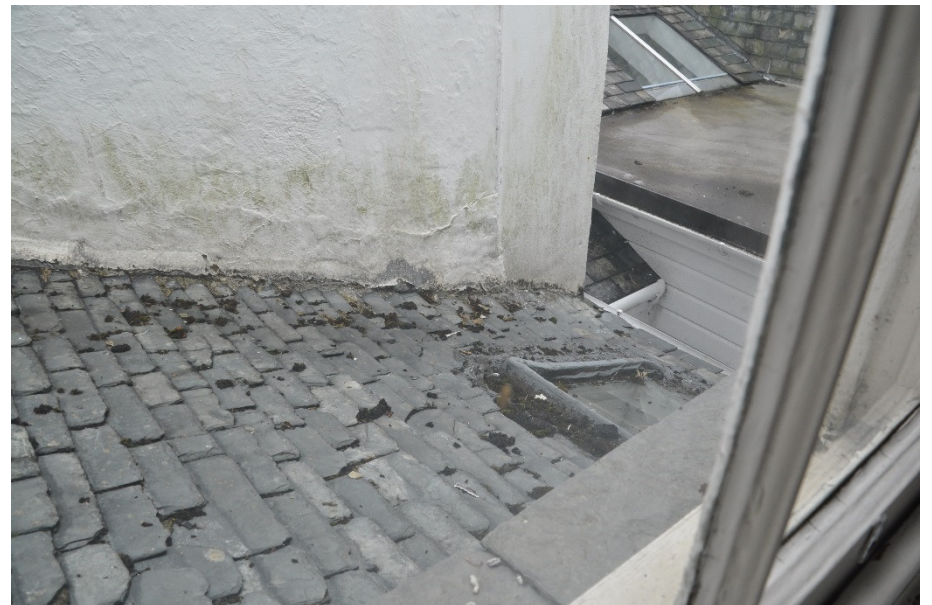
Fig 11: Existing roof over stair and roof window in rear range. Issues to flashings around window noted.

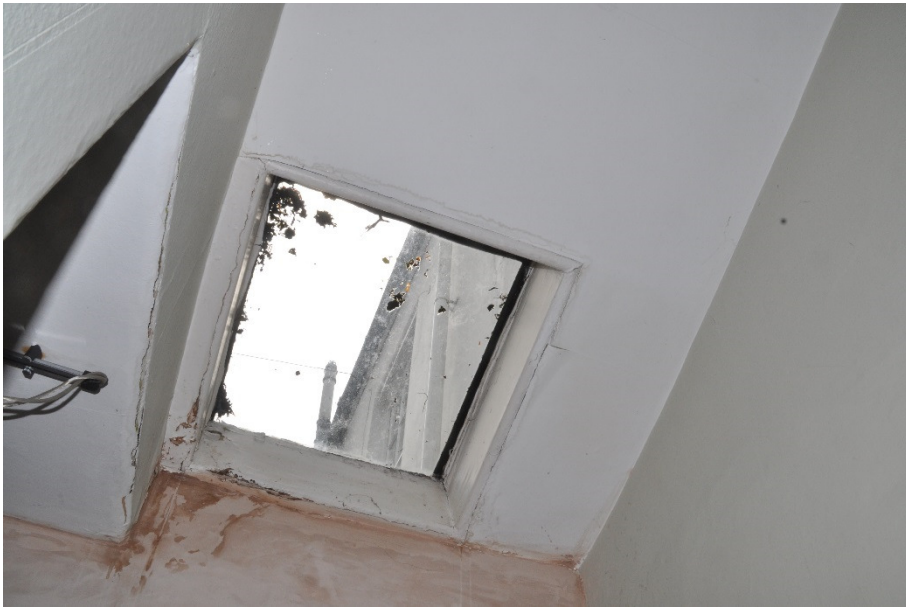
Fig 12: Existing roof window over stair- water ingress noted.

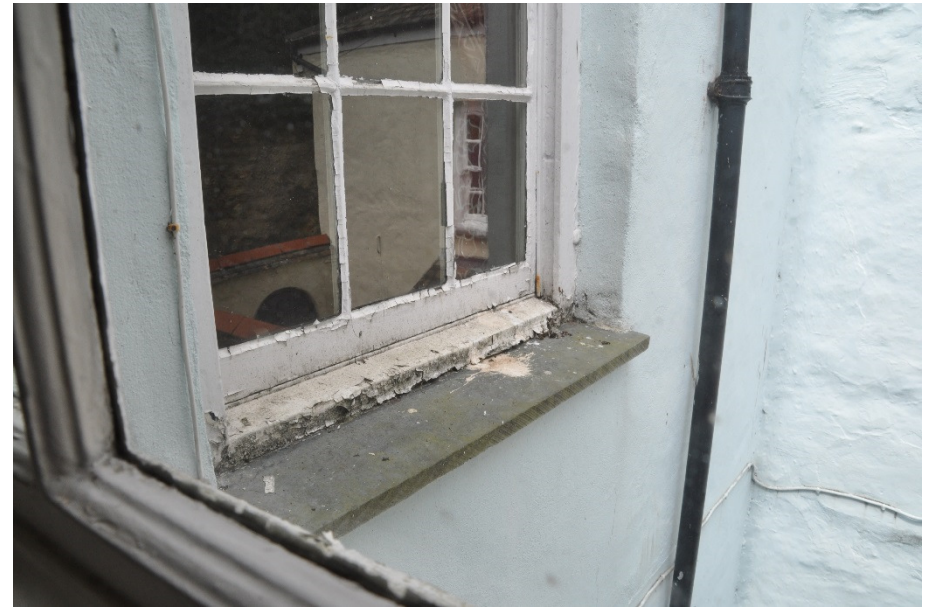
Fig 13: Significant deterioration to existing joinery noted.

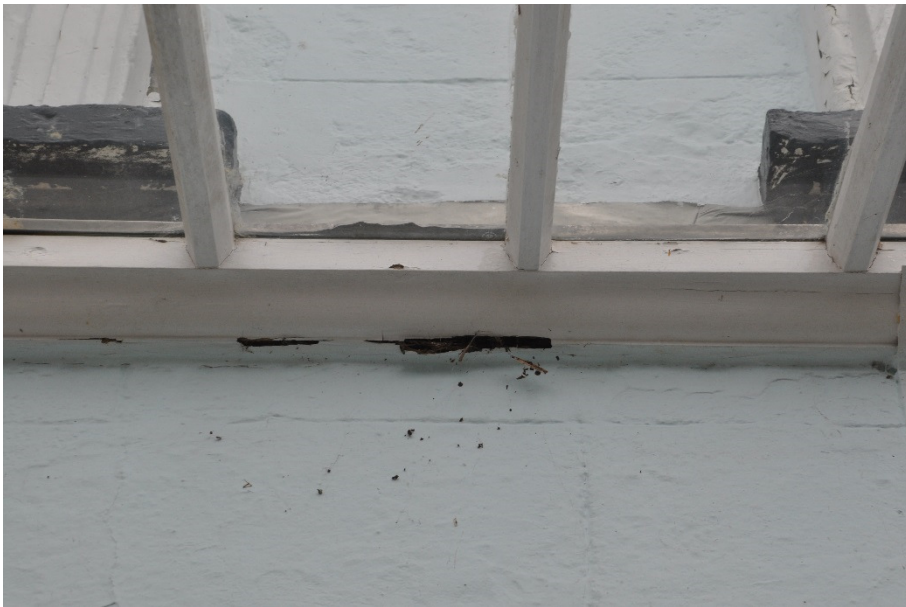
Fig 14: Modern veranda support timbers against existing wall significantly rotten. Abutment to wall covered by ad-hoc flashband repair.

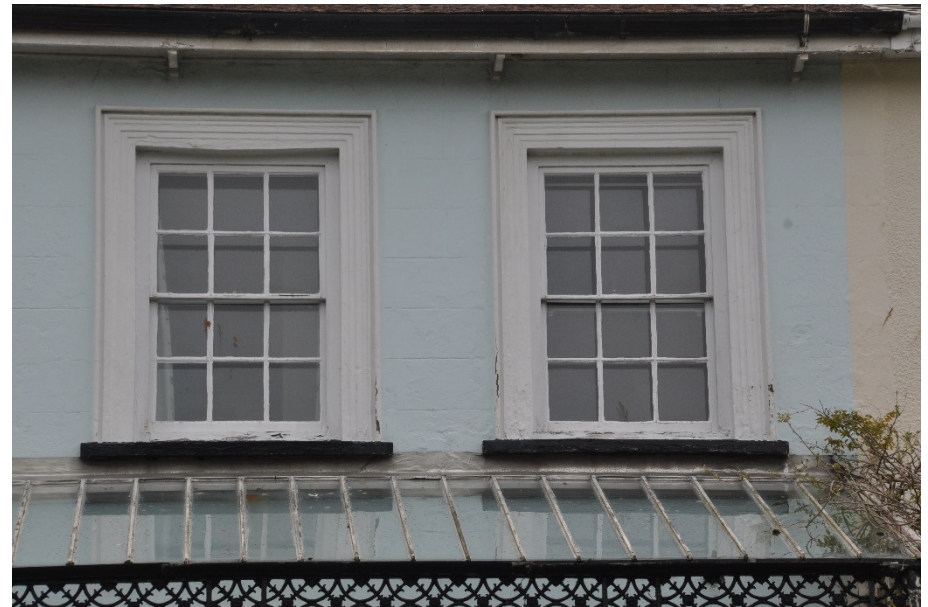
Fig 15: Modern veranda glazing bars in poor condition. Render mouldings around windows cracked and windows in poor condition.

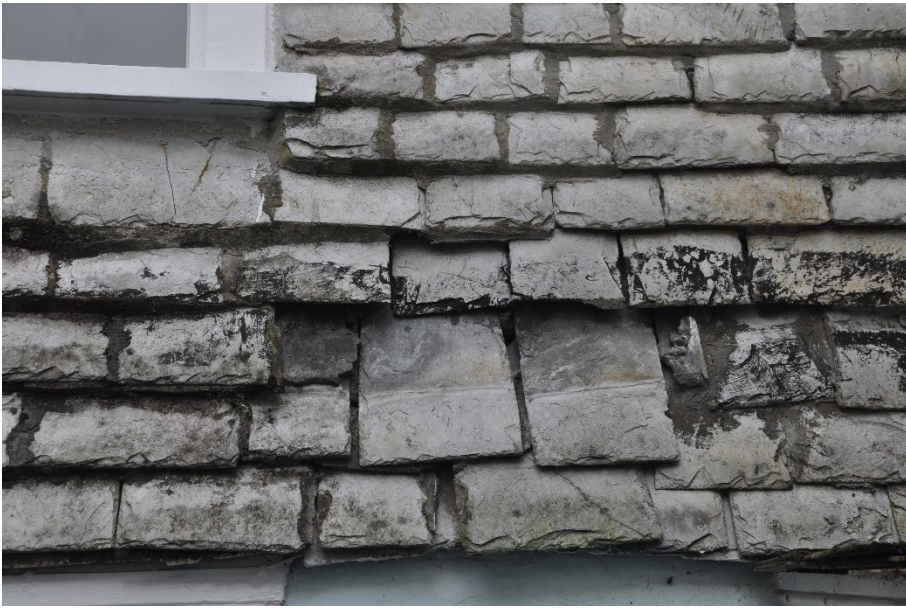
Fig 16: Significant defects and missing slates to rear range wall cladding.

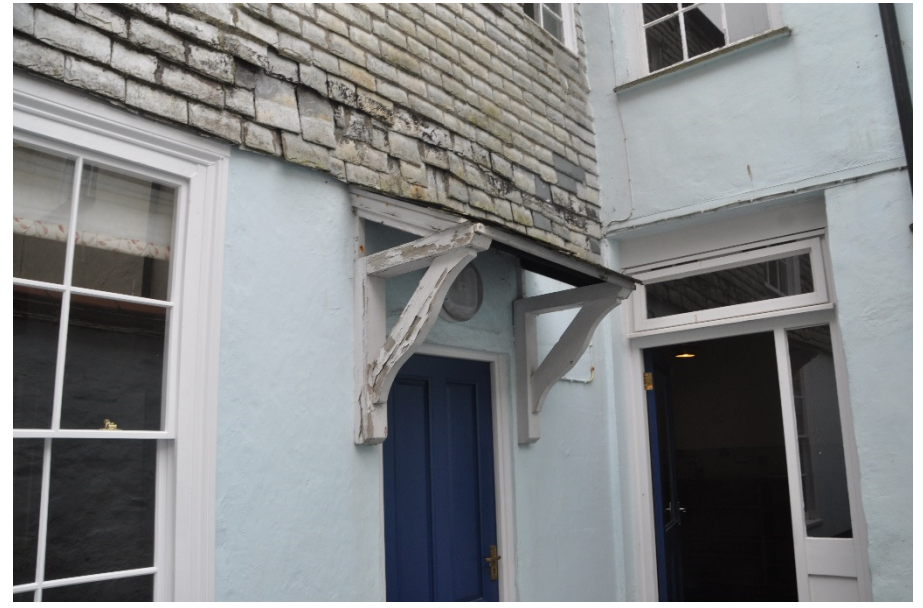
Fig 17: Defective slate cladding & defective modern porch canopy fitted with cement fibre roof slates.

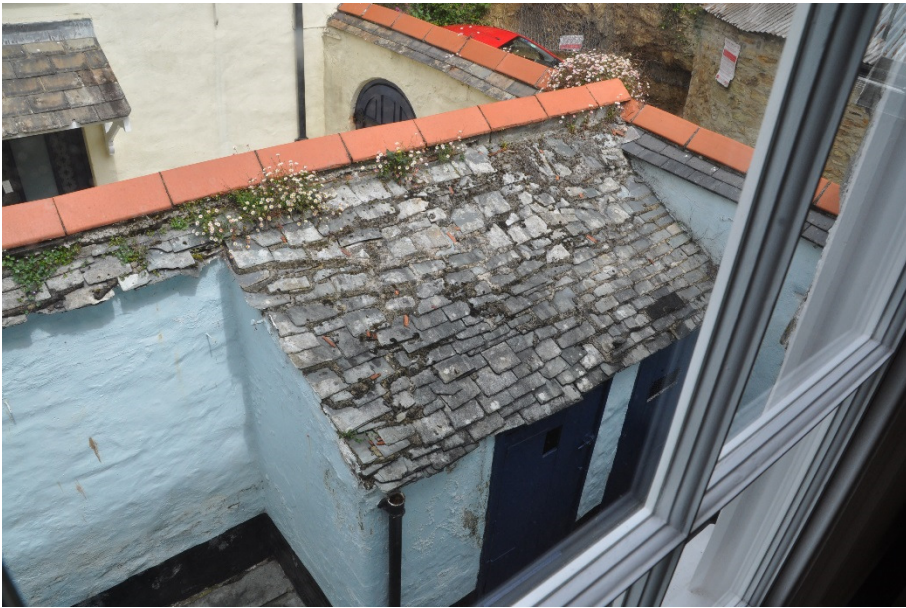
Fig 18: Significant defects to existing outbuildings.

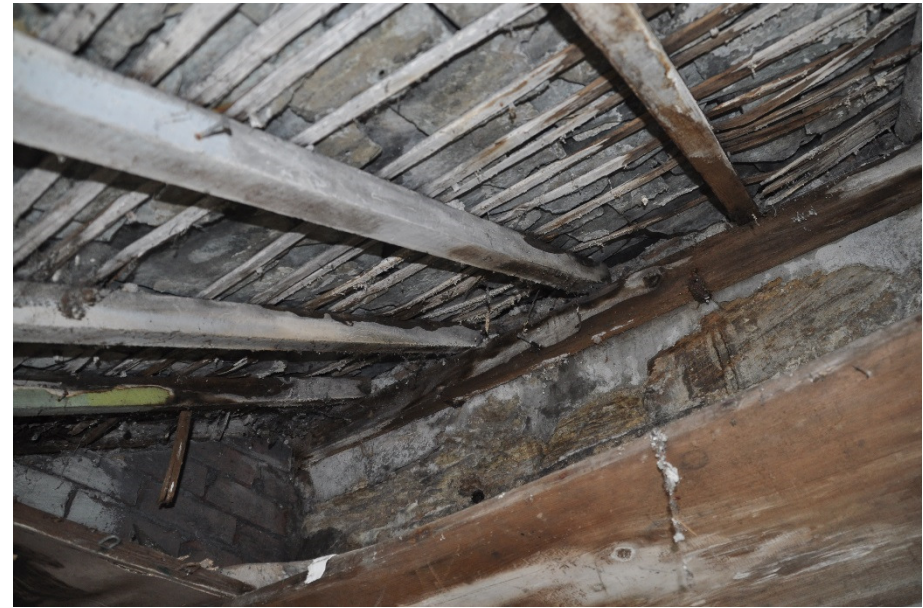
Fig 19: Significant moisture ingress to outbuilding and deteriorated roof.

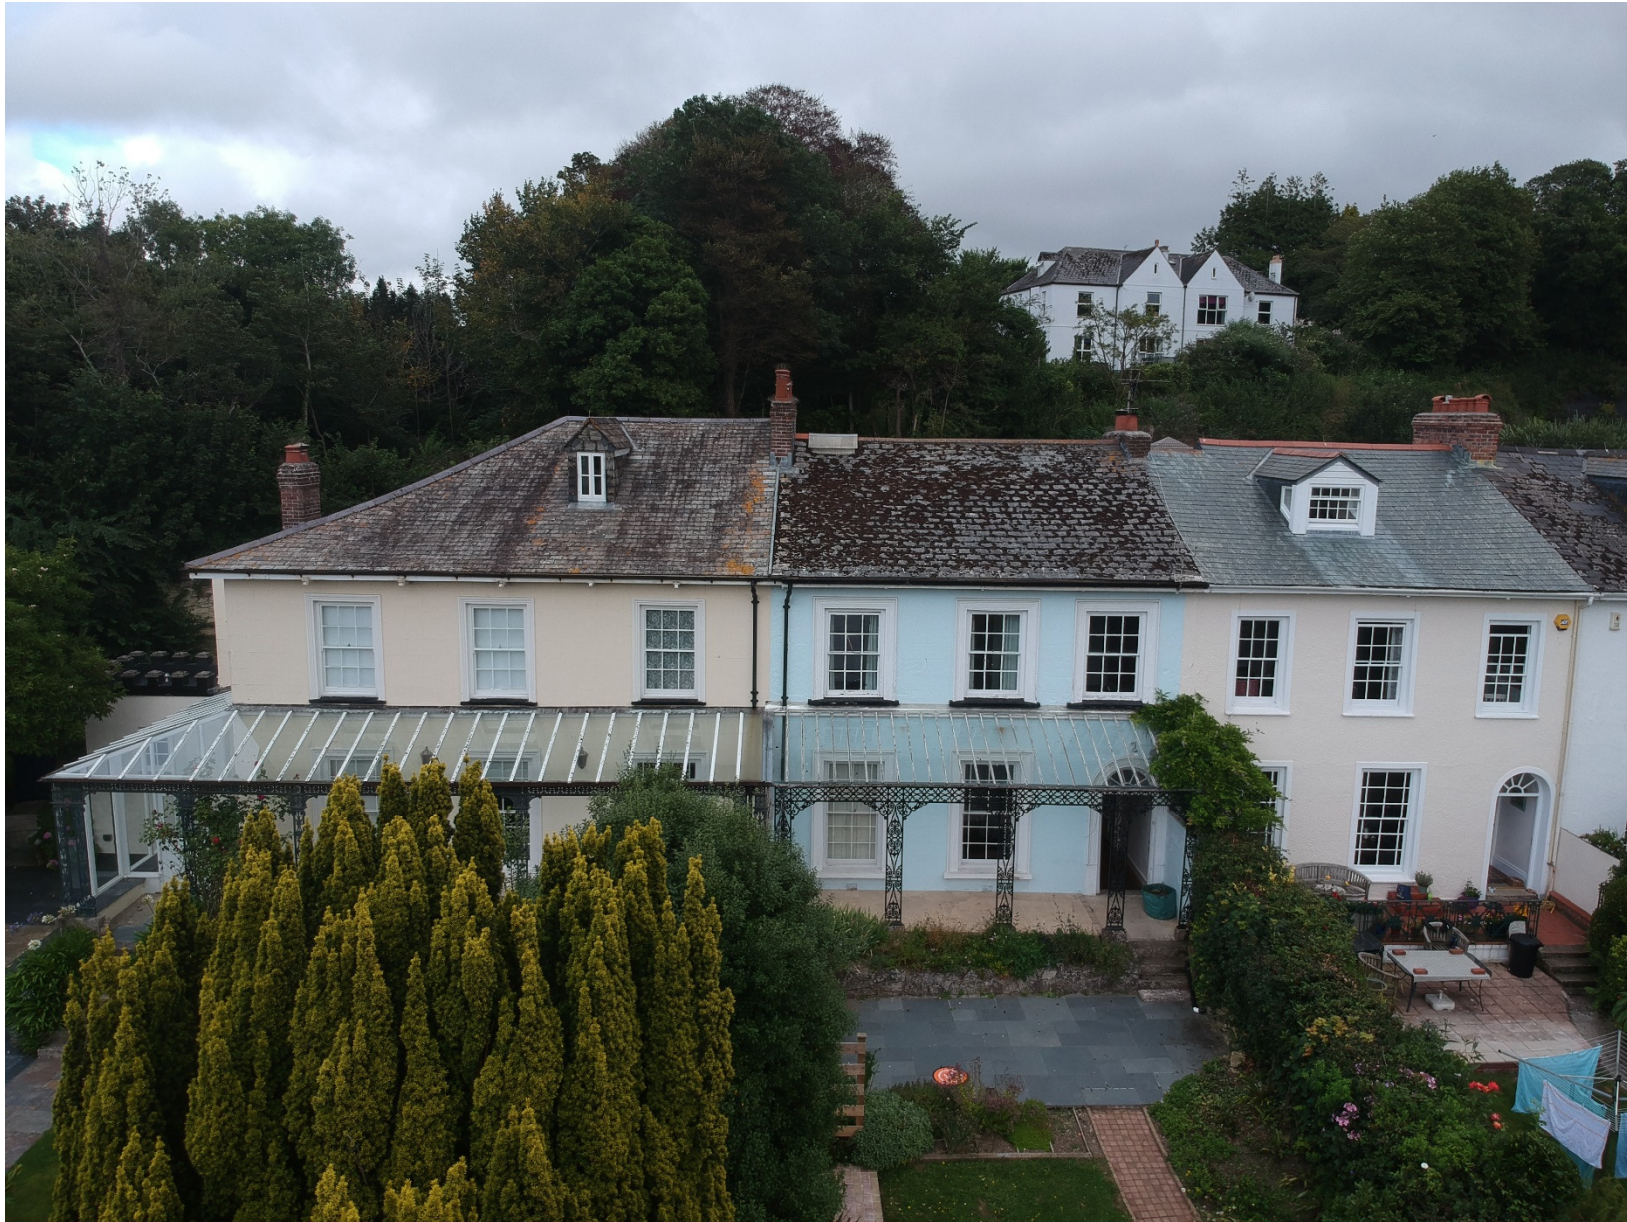
Fig 20: Drone imagery from front of site.
