**Arboricultural Impact Assessment:  
Fir Lodge, Stakenbridge Lane, Hagley, Worcestershire, DY9 0JE**

**Prepared for:**  
Michelle Feeney  
c/o BB Partnership Ltd Chartered Architects  
Studios 33–34  
10 Hornsey Street  
London  
N7 8EL

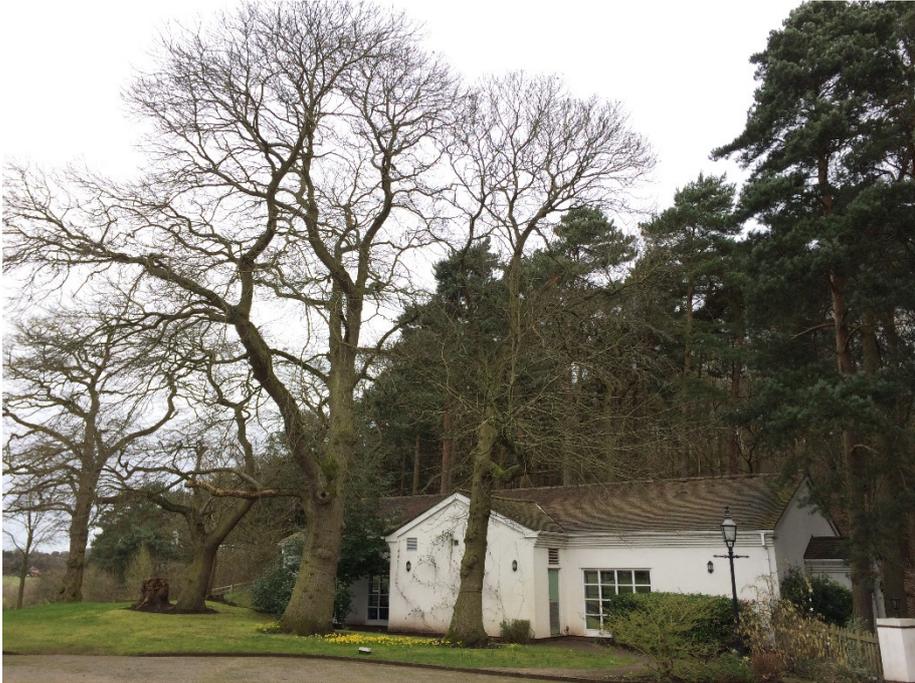
Photograph 1: The existing pool house viewed from the south. Mature sweet chestnut and false acacia in the foreground with the predominantly Scots pine plantation wrapping around the northern and eastern sides.

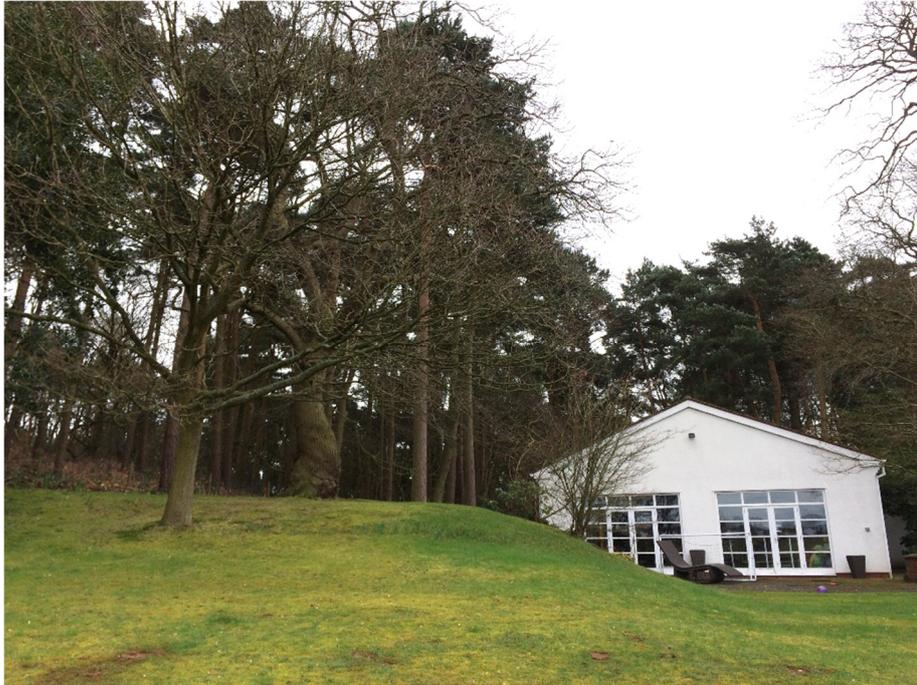
Photograph 2: The pool house with external terrace viewed from the western side. Note edge of pine plantation on raised ground, the pool house having originally been cut into the sloping ground levels.

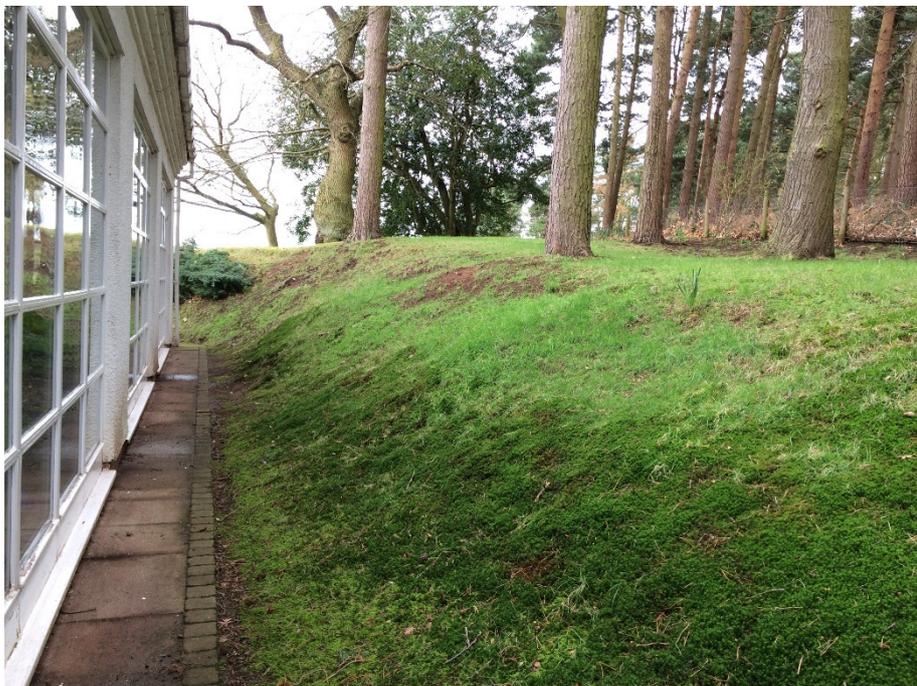
Photograph 3: View along the northern edge of the existing pool house looking north west and showing trees on an embankment.

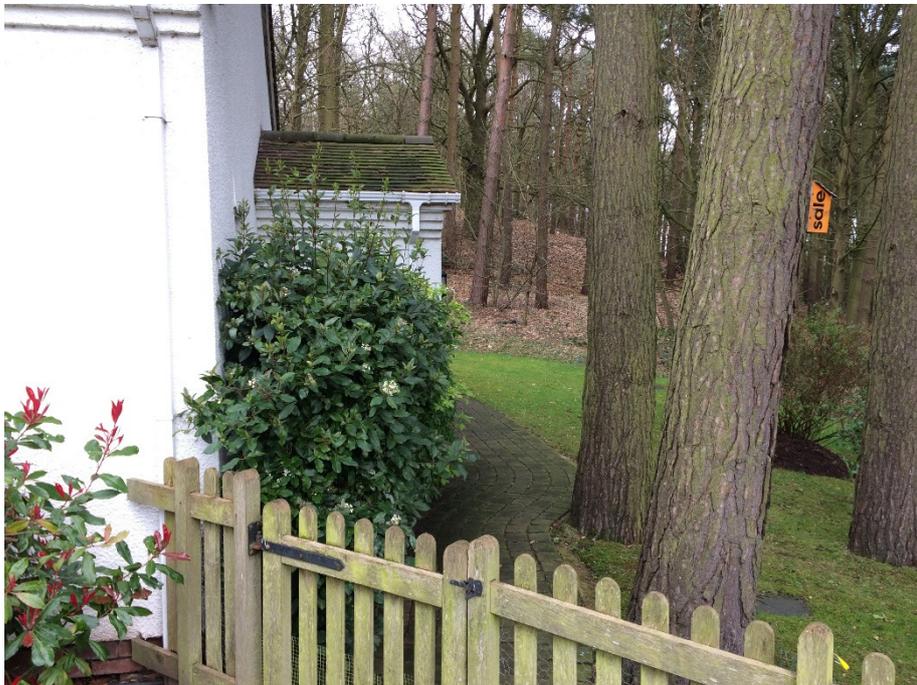
Photograph 4: Scots pine trees 8, 9, 10 and 11 standing off the south eastern corner of the pool house with trees 10 and 11 being closest. Of these trees, only pine tree 11 has any significant branch overhang to the current roof line.

Tree reference number	Species	Works required
8	Scots pine	Remove deadwood from lower crown. Shorten pendulous growth over drive to provide 4.5m clearance, cutting back to point of strong side growth.
9	Scots pine	Remove deadwood from trunk and crown.
10	Scots pine	Target prune lowest branch on drive side attached to trunk at around 4.5m above ground level and 70mm in diameter at collar. Remove deadwood from crown.
11	Scots pine	Shorten lowest branch over pool house roof, shortening it in length by around 2.5m and cutting to point of strong remaining side growth. Post-pruning, there is to be a minimum of 3.5m clearance off existing roof line.
12	Sweet chestnut	Remove epicormic growth from lower trunk to give clean trunk height of around 4.2m. Truncated primary branch extending towards drive that has previously been reduced is to have horizontal and drooping growth removed to give working headspace of at least 4m on lamp column side. From remainder of crown, remove dead and defective branches, selectively shortening branch in centre of crown that has recently shed secondary branch on drive side. At around 4.5m on pool house side, prune back two epicormic branches not exceeding 70mm in diameter at point of swelled branch collar. Shorten remaining epicormic growth on pool side so that post-pruning there is a crown clearance over the pool house roof of around 8m.

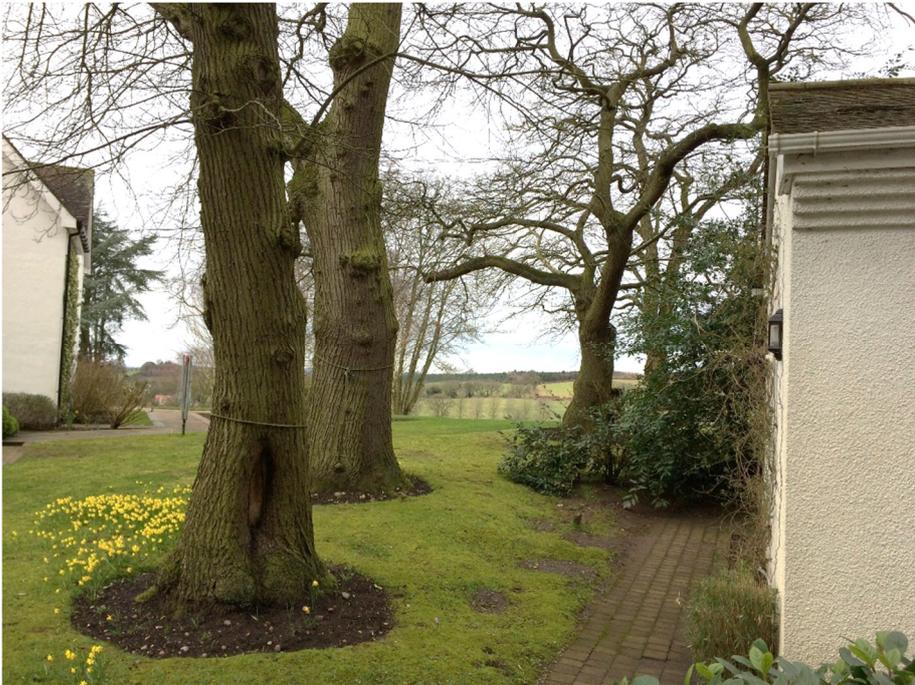
Photograph 5: Looking west towards sweet chestnuts 12, 13 and 14 with false acacia tree 15 in the far distance. Ground levels between the existing dwelling and the pool house are relatively level. The projecting element of the structure shown is the pool house plant room.

- 4.7 In arboricultural terms, the outstanding features are trees 12 to 15 to the southern side of the pool house, which collectively make a strong contribution to the setting of the site. Trees 12 to 14 inclusive feature part of their crowns on the northern side overhanging the existing swimming pool building roof. These trees were pruned back many years ago to provide clearance to the roof line and have typically produced replacement, small diameter branches of epicormic origin that have grown back into this space. Albeit they provide adequate clearance to the existing roof, further minor remedial pruning will be necessary to both safeguard the trees and provide room for the proposed pool house with appropriate clearance. Upon assessment, such pruning can be carried out in accordance with best practice and will not be to the long term detriment of the trees in either physiological or amenity terms.

- 5.9 In relation to the trunks of trees 10, 11, 12, 13, 14, 15 and 16, physical protection to the lower trunk structure is to be ensured by the construction of bespoke wooden board protection hoarding, effectively creating secure boxes around the trunks to avoid impact damage, with the remainder of their root protection areas receiving ground protection measures.

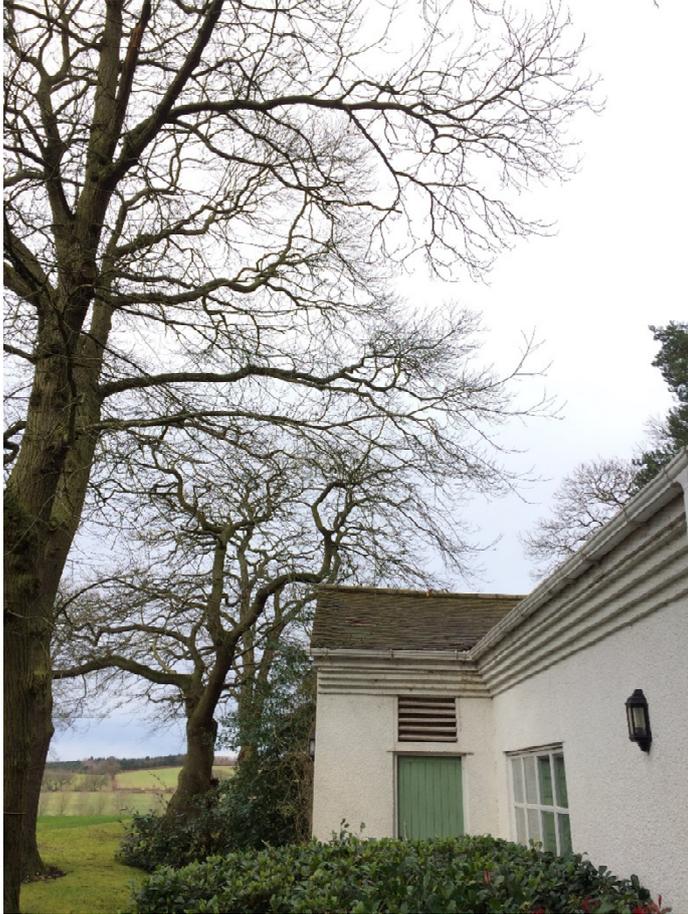
Photograph 6: Showing the northern parts of the crowns of sweet chestnut trees 13 and 14 in relation to the existing pool house roof line.

Tree reference number	Species	Works required
13	Sweet chestnut	Remove epicormic growth from main trunk/primary branches to a height of 8m above ground level where less than 50mm in diameter. Remove dead and defective branches from crown of tree. For lowest branch extending over pool house roof at a height of around 7m, shorten in length, removing outermost circa 3.5m, cutting back to points of side growth resulting in pruning wounds no greater than two thirds of the diameter of the remaining branch. For the section of crown overhanging existing vehicular hardstanding off the corner of the house (nearest tree 43), selectively shorten pendulous growth so that post-pruning there is at least 4.5m clearance. Lowest primary branch extending towards the corner of group G27 is to have outer growth shortened, removing around 2–3m of outer branches so as to allow machinery access beneath.
14	Sweet chestnut	Branch extending over pool house roof is to be pruned to the outer point of the horizontal section of branch radiating out at around 1.3m from point of branch failure many years ago. This will result in a somewhat truncated pruning wound of around 150mm in diameter, which will produce new adventitious branches that will require cyclical pruning. Remaining secondary growth extending towards the pool house side is to be pruned back to give around 2.5m clearance from building line.
