# Extension and Refurbishment to 8 Addington Square London, SE5 7JZ

Design, Access and Heritage Statement

Ref: 281

September 2021

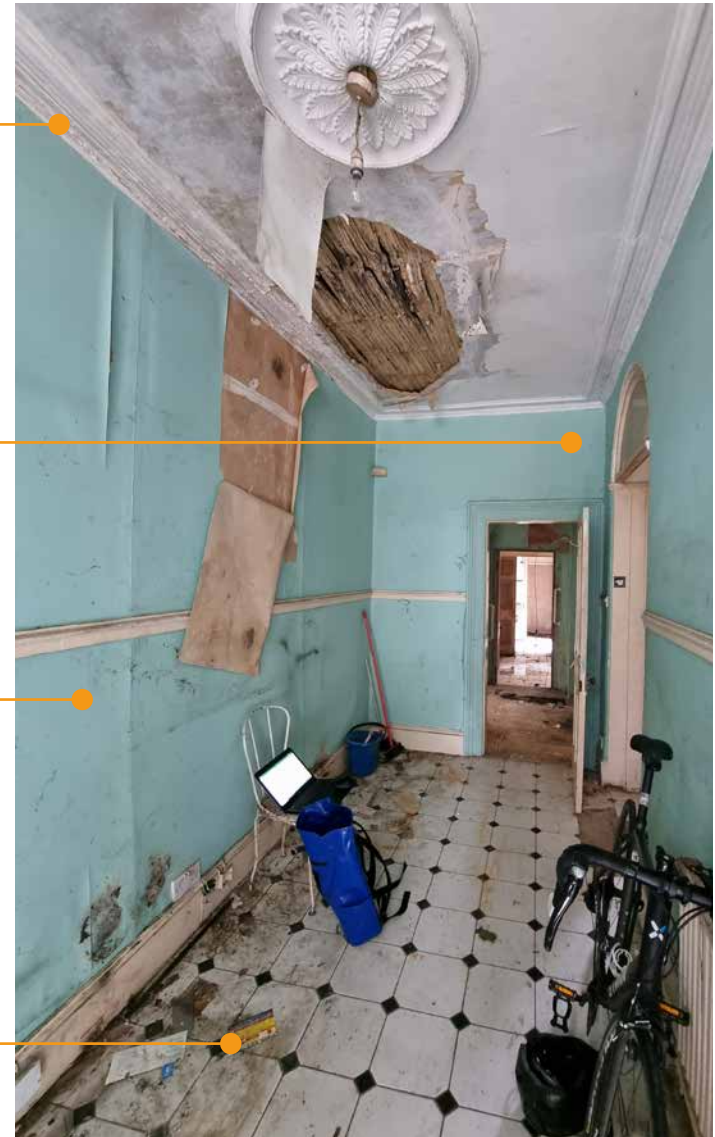
# 1.1 Entrance Hall - Photographs

Item	Description	Condition	Proposal
1	Ceilings	water damaged loss of approx 40% of plaster	Rebuild ground floor flat roof and parapet.
2	Wall	painted and papered	remove paper and assess plaster repair damaged areas with lime plaster and paint.
3	External Wall	poor and saturated	Rebuild failing east and south walls of entrance hall. South wall to be rebuilt for entire width of ground floor flatroof, up to 2 storey first floor bathroom.
4	Floor Tiles	damaged and dirty	remove tiles assess structure below and replace with new ones
5	Electrics/Fuse Board	out dated	replace with new compliant system relocate electricity meter to utility room.
6	Radiator	rusted	replace with new column radiator

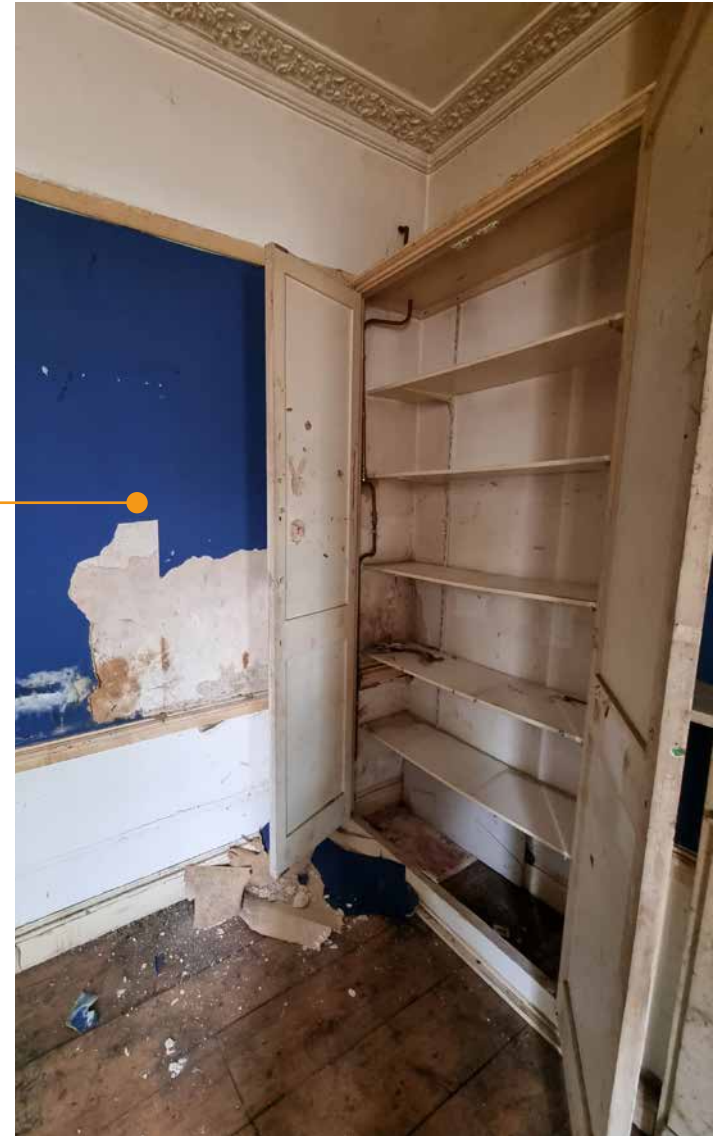
## 2.1 Reception Room - Photographs

Item	Description	Condition	Proposal
1	Ceilings	peeling paper	remove damaged plaster and repair with lime plaster
2	Walls	papered	remove paper and assess plaster repair damaged areas with lime plaster and paint
3	Shutter	poor	remove and refurbish and reinstate
4	Floors	timber boards	sand and treat
5	Wooden panelling	badly refurbished	remove chipboard and reinstate new timber paint
6	Door	poor	remove damaged plaster and repair with lime plaster

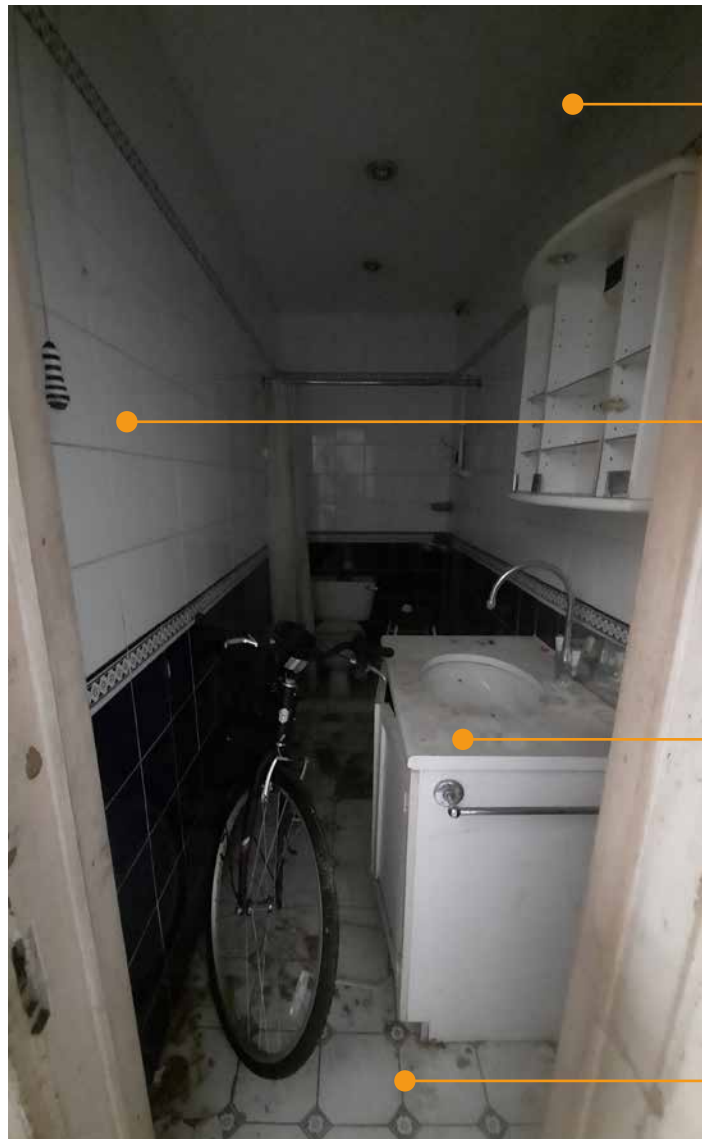
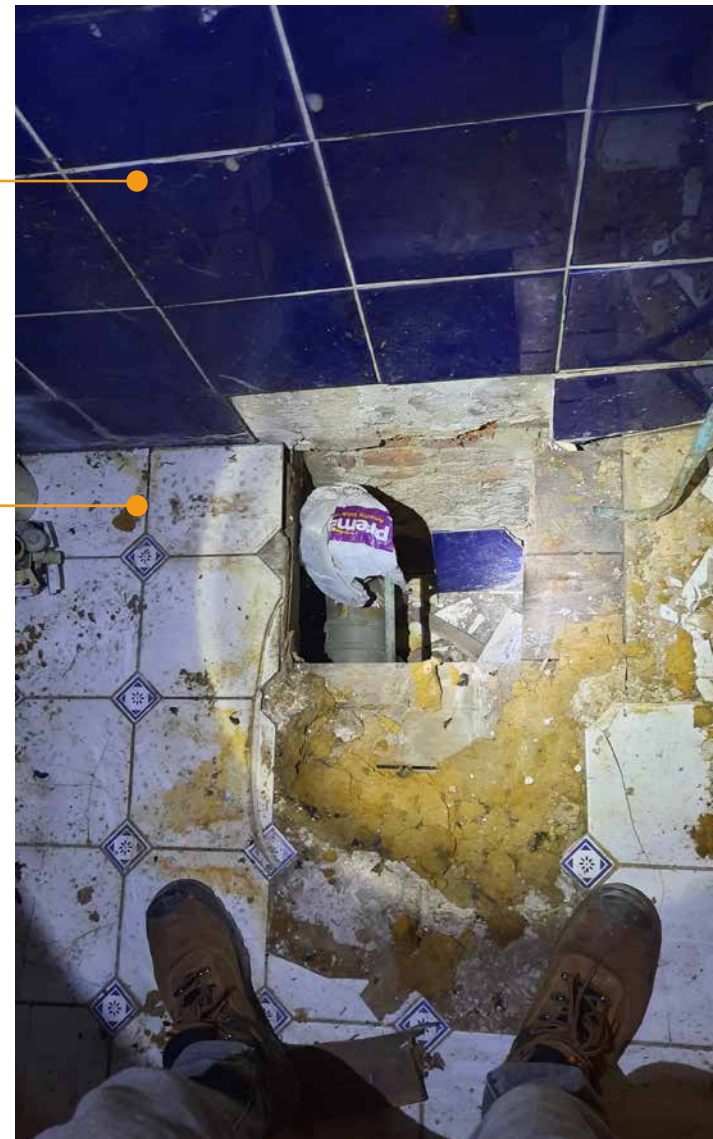
# 3.1 Shower - Photographs

Item	Description	Condition	Proposal
1	Ceiling	tiled and needs repair	remove tiles and re-plaster and paint
2	Floors	tiled and needs repair	Remove tiles, replace 3 decayed floor joists and new tiles over.
3	Ceiling	overboarded with plasterboard and spotlights	Remove tiles and re-plaster and paint. No existing coving, add egg-dart coving style as study
4	Furniture	poor condition	remove and replace with new layout

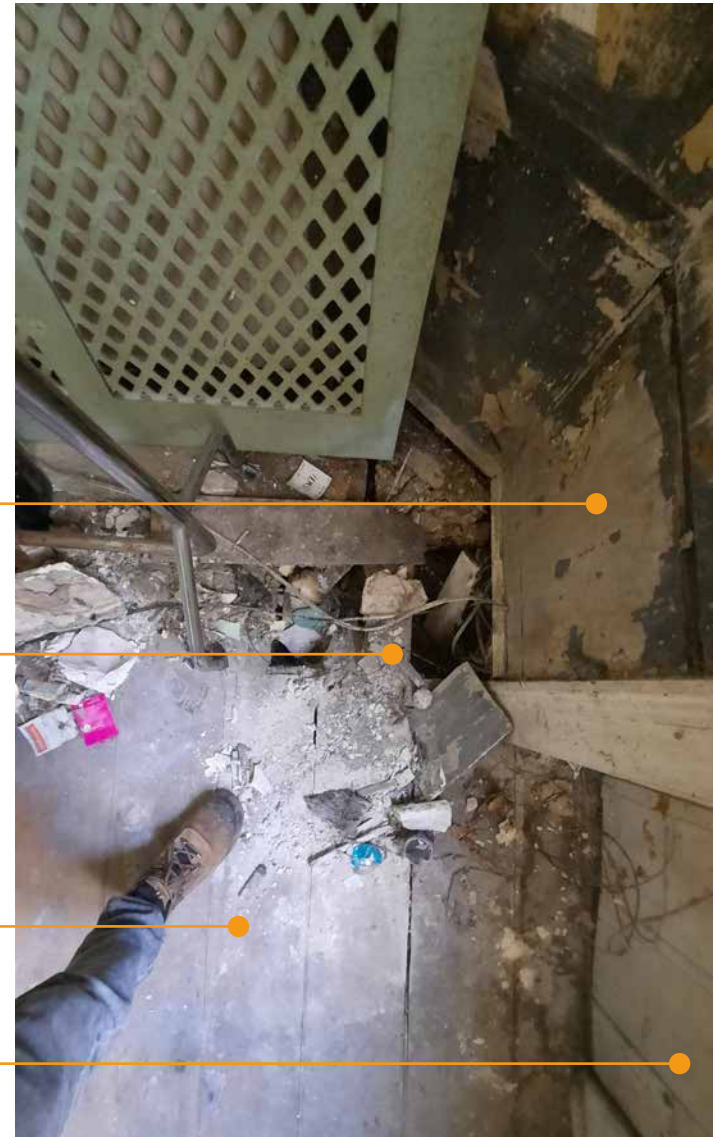
# 4.1 Study - Photographs

Item	Description	Condition	Proposal
1	Ceiling	tiled and needs repair	remove paint, patch, replace decayed non-original coving with new egg-dart coving style and repaint
2	Hole in ceiling	tiled and needs repair	remove damaged plasterboard, apply new one and skin and paint
3	Walls	overboarded with plasterboard and spotlights	remove paper and assess plaster repair damaged areas with lime plaster and paint
4	Water damaged wall	poor condition	remove and replace rotten timber, new traditional plaster walls
5	Floors	fair condition	sand repair and new coating
6	Hole in Floor	poor condition and rotten timbers	remove rotten timbers and replace floorboards to match
7	Radiator	rusty modern radiator	replace with column radiator
8	Double doors	rotten throughout	replace with new doors to match

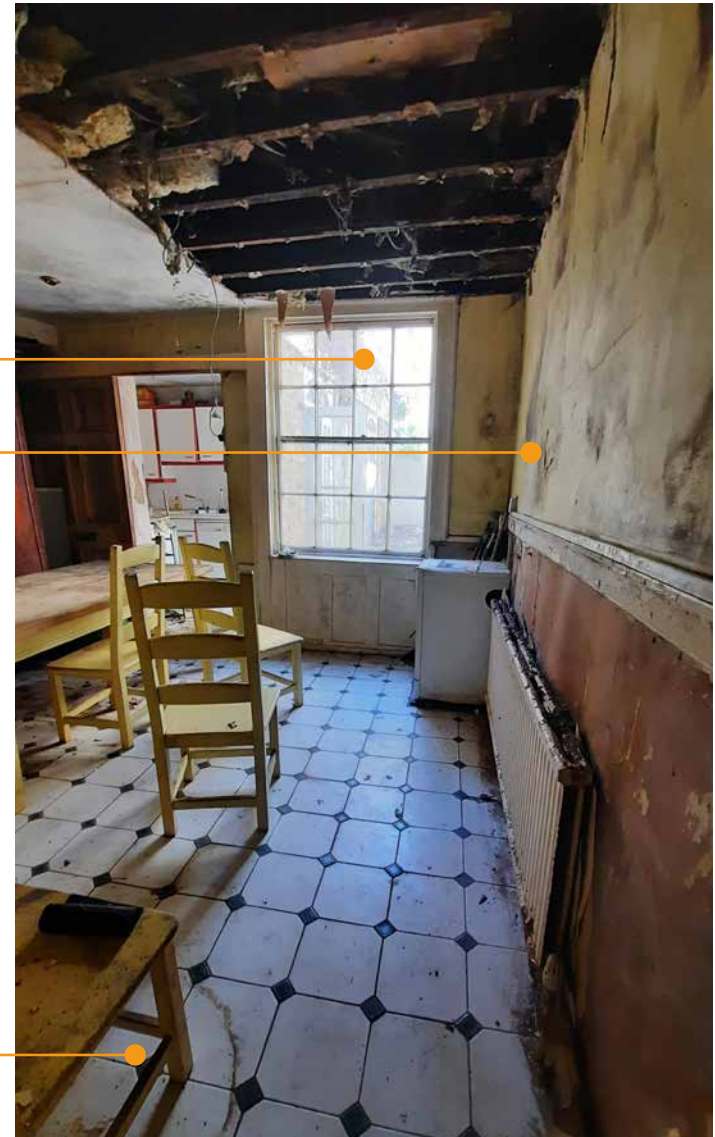
# 5.1 Dining - Photographs

Item	Description	Condition	Proposal
1	Floor	tiled and poor condition	remove and assess floor below, new installation substrate under floor heating and tiles
2	Walls	generally in poor conditio, part saturated	retain and repair where possible within new scheme, skimmed and painted
3	Roof / Ceiling	damaged and rotten	remove and replace with new timbers, insulation and flat roof system
4	Window Rooflight	rotten	decayed element to be replaced like for like Create opening and installation of lantern roof light above island

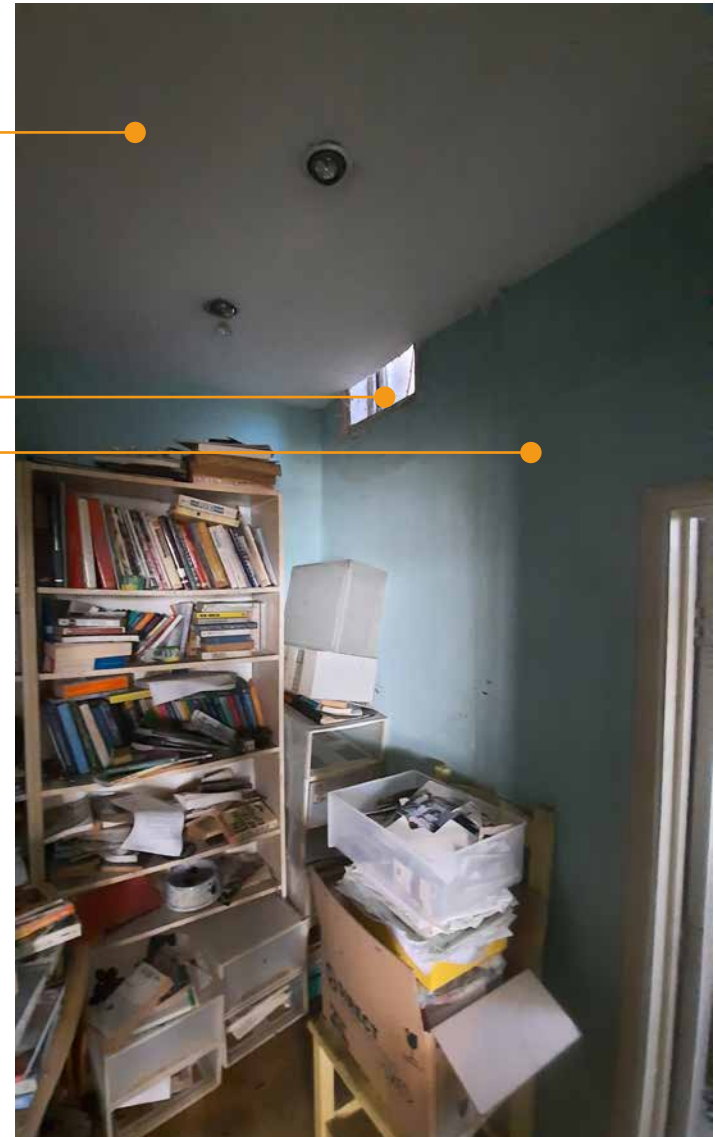
# 6.1 Office - Photographs

Item	Description	Condition	Proposal
1	Ceilings	new plasterboard dropped ceiling with spots	remove and replace with new plasterboard and light fittings
2	Walls	papered and painted, damp issues	strip paper, allow to dry repair plaster and paint
3	Floors	boarded over with new joists and chipboard	remove new structure and assess existing
4	Doors	poor condition	fit new door to dining, enlarge opening to new extension
5	Window	poor condition - half in ceiling	remove
6	Door to Entrance Hall		Remove and make good

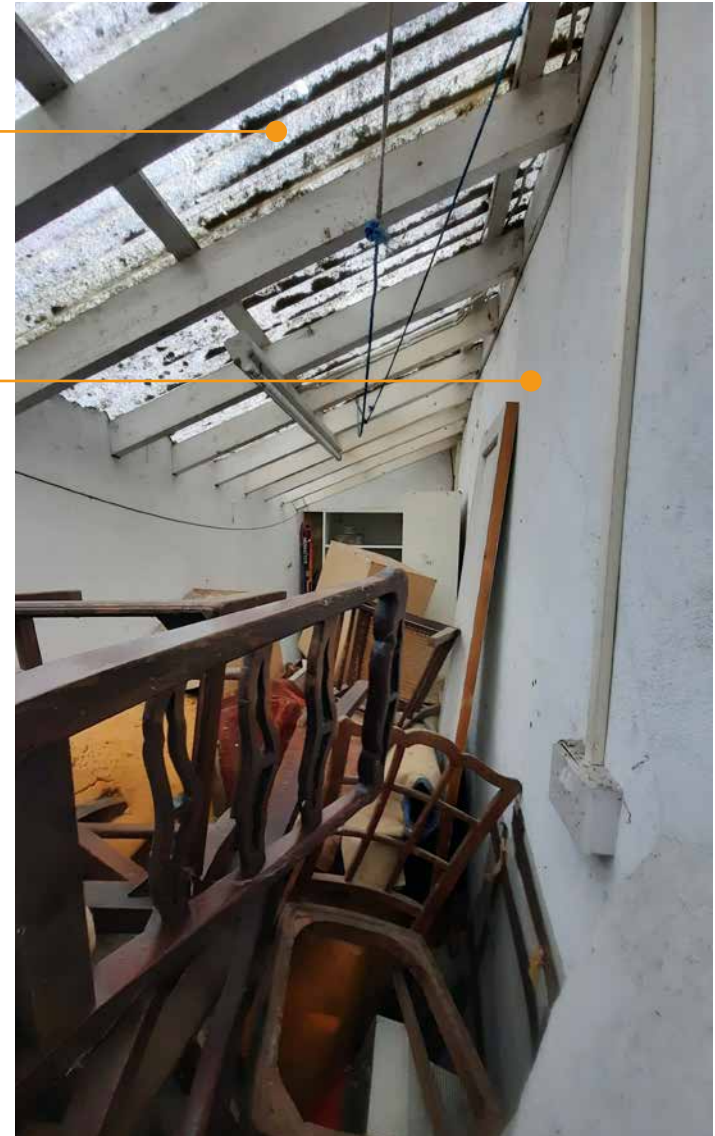
## 7.1 Store - Photographs

Item	Description	Condition	Proposal
1	Plastic roof	in need of clean and repair	remove and replace with new flat roof
2	Boundary wall	leaning and bowing	demolish and replace with new brick wall

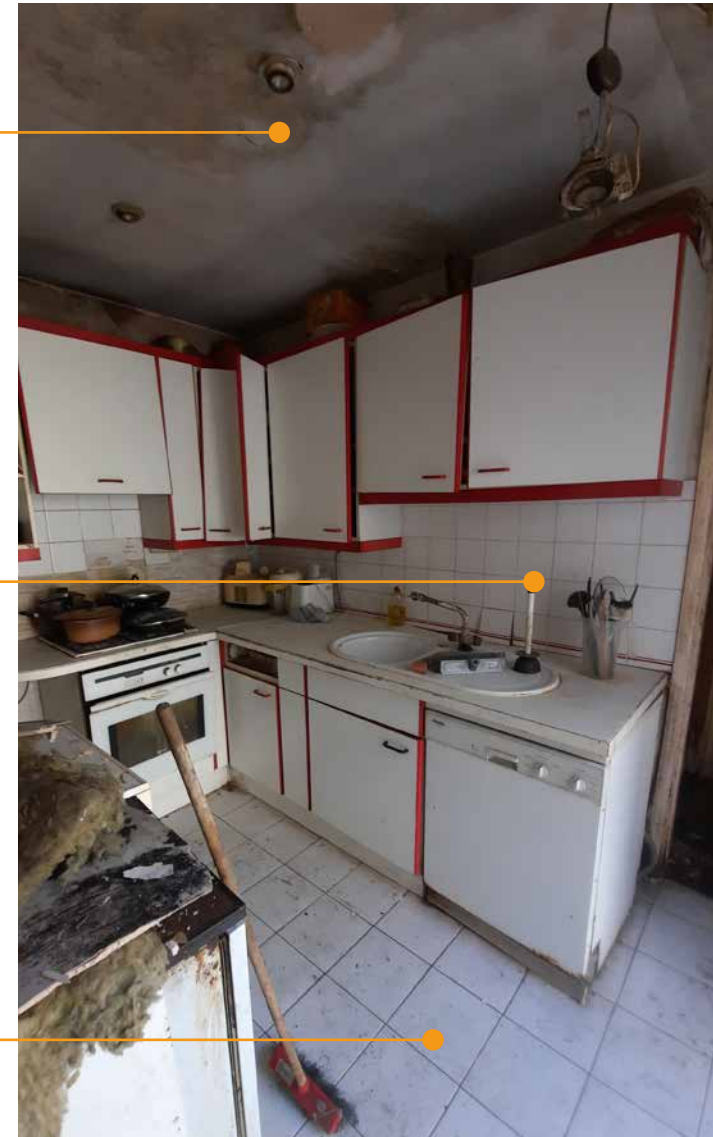
# 8.1 Kitchen & Utility - Photographs

Item	Description	Condition	Proposal
1	Floor	tiled and poor condition	remove and assess floor below, new installation substrate wood flooring
2	Walls	generally in poor condition, part saturated	retain and repair where possible within new scheme, skimmed and painted
3	Roof / Ceiling	damaged and rotten	remove and replace with new timbers, insulation and flat roof system
4	Doors	rotten	remove and replace wall with crittal style glazing

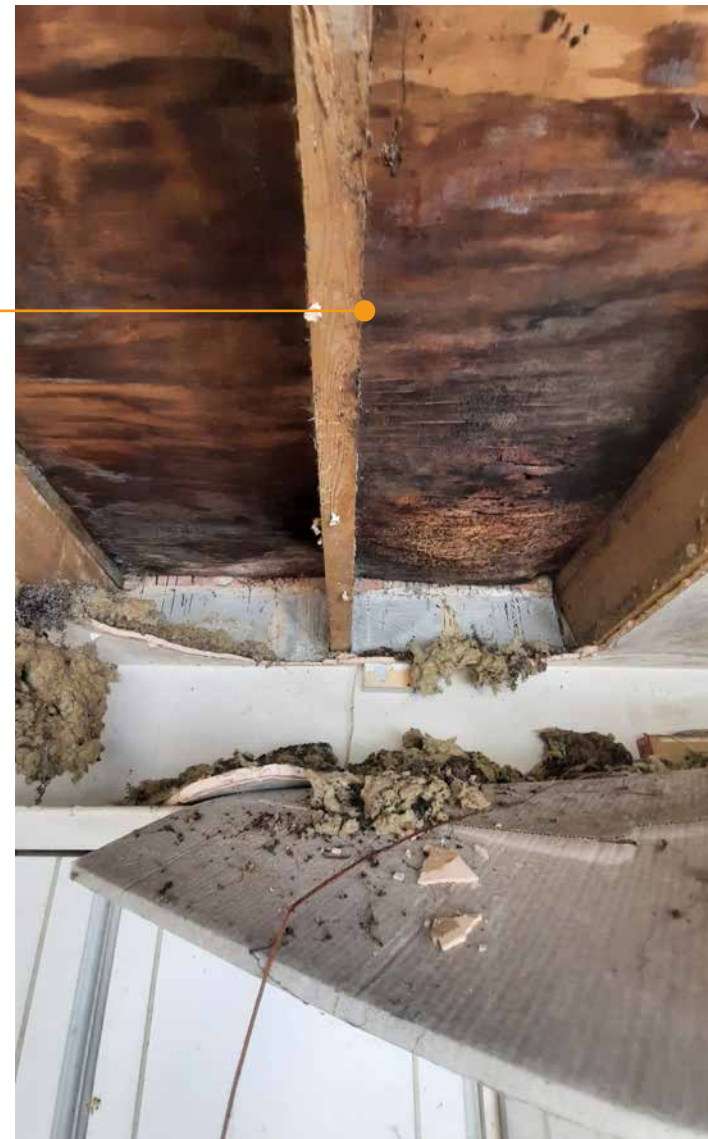
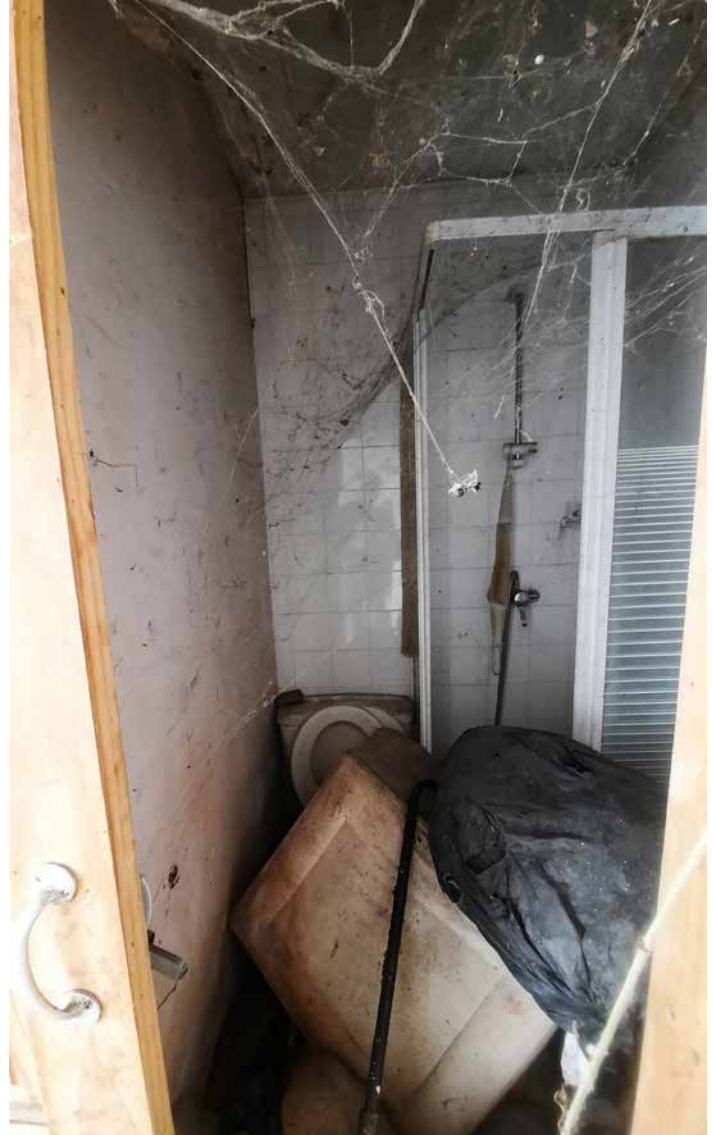
# 9.1 Bedroom 05 & Shower - Photographs

Item	Description	Condition	Proposal
1	Floor	tiled and poor condition	remove and assess floor below, new installation substrate new wooden floor
2	Walls	generally in poor conditio, part saturated	retain and repair where possible within new scheme, skimmed and painted
3	Roof / Ceiling	damaged and rotten	remove and replace with new timbers, insulation and flat roof system
4	Doors	rotten	remove and replace wall with crittal style glazing

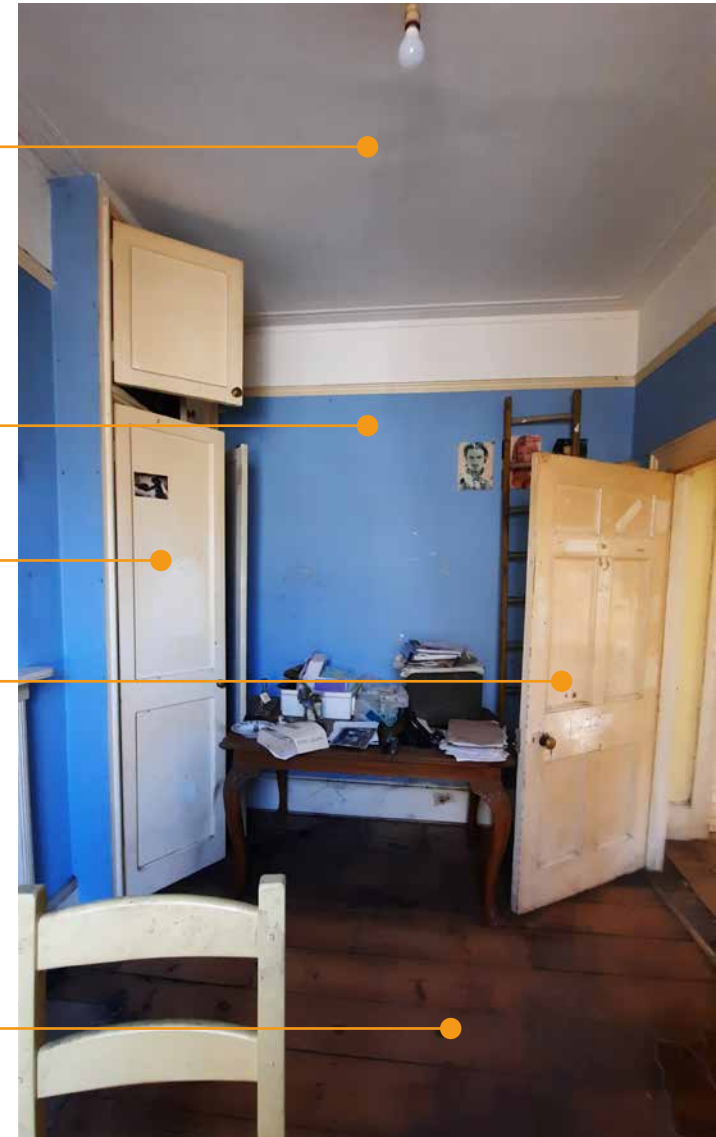
# 11.1 Bedroom 02 - Photographs

Item	Description	Condition	Proposal
1	Ceilings	peeling paper	remove damaged plaster and repair with lime plaster
2	Walls	papered	remove paper and assess plaster repair damaged areas with lime plaster and paint
3	Shutter	poor	remove and refurbish and reinstate
4	Floors	timber boards	sand and treat
5	Wooden panelling	badly refurbished	remove chipboard and reinstate new timber paint
6	Door	poor	remove damaged plaster and repair with lime plaster
7	Radiator	rusted modern radiator	replace with column radiator

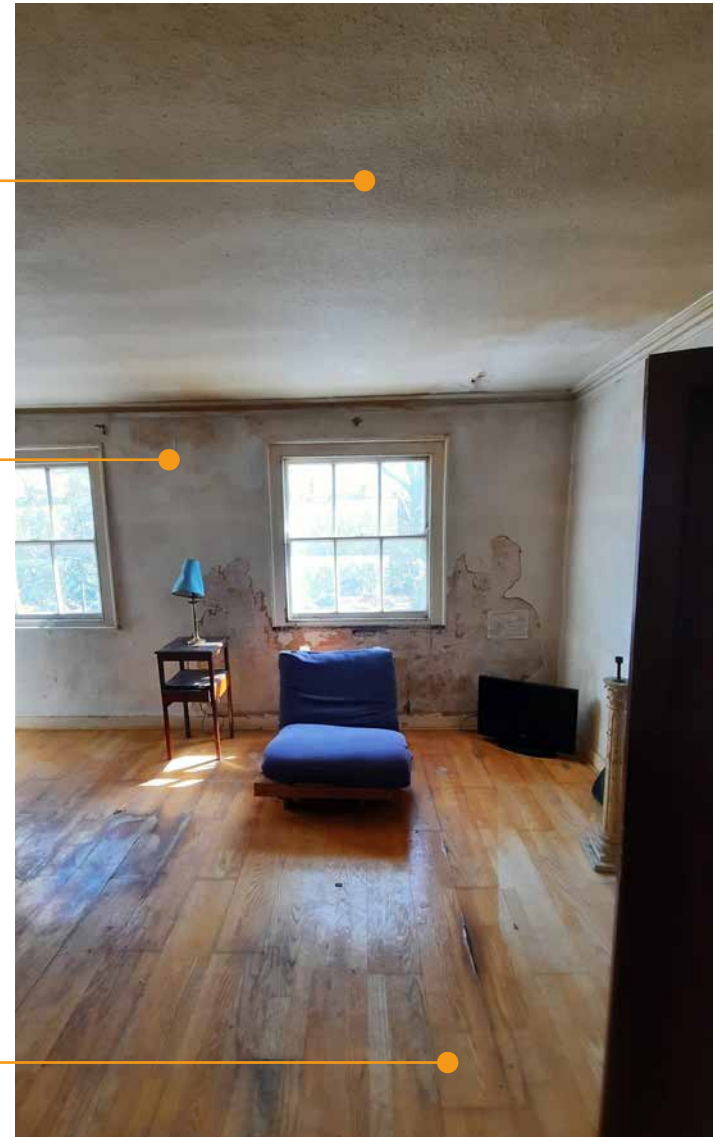
# 13.1 Bedroom 03 - Photographs

Item	Description	Condition	Proposal
1	Ceilings	peeling paper	Remove plasterboard and replace with new plasterboard and skim. Modern unoriginal coving to be replaced with egg dart style coving
2	Walls	papered	Remove plaster/plasterboard and replace with new plasterboard and skim
3	Floors	timber boards	Repair cracked boards, to be covered with underlay and carpet
4	Door	poor	Retain original door and architrave, repair and fill any cracks and paint white. Move internal door location to accommodate 2nd floor shower room
5	Radiator	rusted modern radiator	replace with 2 new column radiators under windows

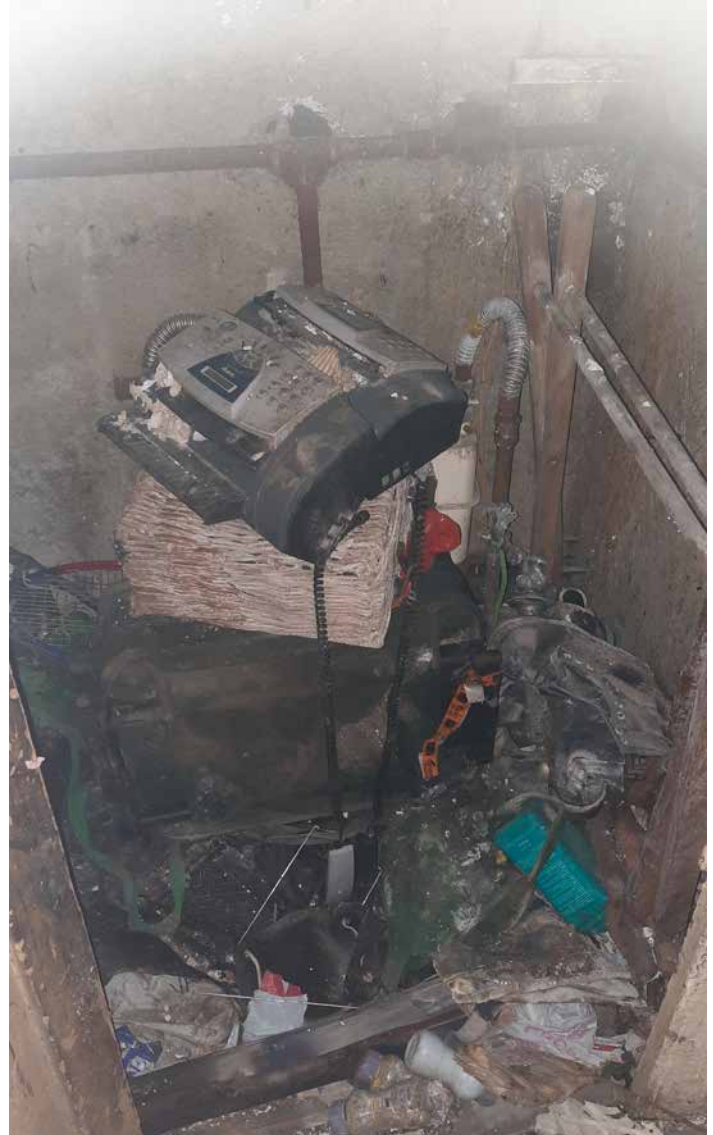
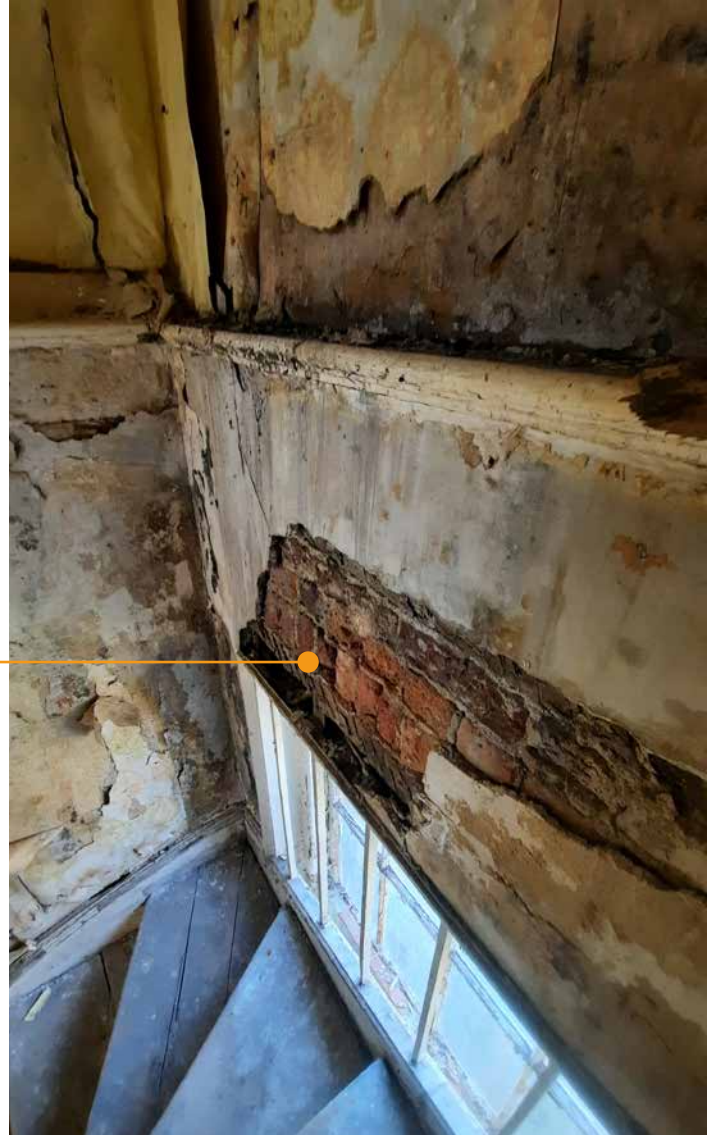
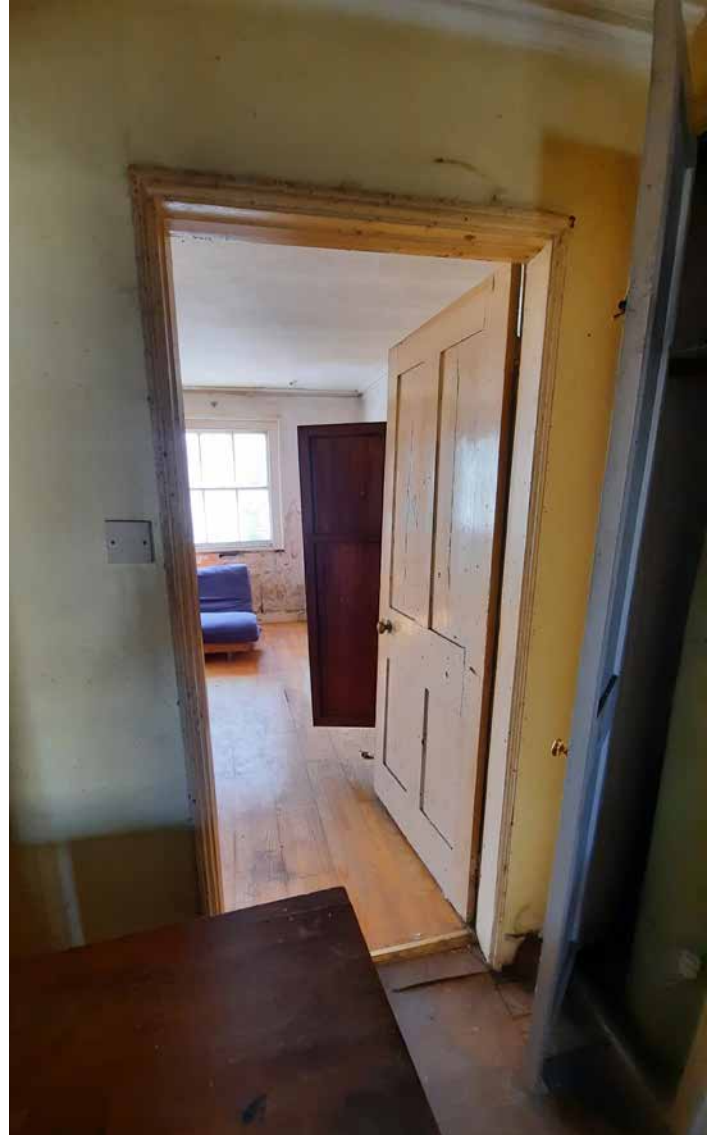
# 15.1 Stairwell - Photographs

Item	Description	Condition	Proposal
1	Walls	water damage and blown plaster throughout	remove all damaged plaster to allow structure to dry and new lime plaster, painted with breathable paint, remove paper and repair, repaint elsewhere
2	Ground Floor	tiled over chipboard	remove tiles and repair/replace substrate where required, new tiles over
3	First Floor	timber sheets over original floor boards	remove sheets, repair, replace floor boards
4	Stair Soffit	blown, damaged and damp plaster	remove damaged plaster for structural inspection
5	Staircase	coming away from wall	Retain Staircase and make structural repairs to decayed elements
6	Ceiling	damaged plaster	remove damaged plaster and repair with lime plaster

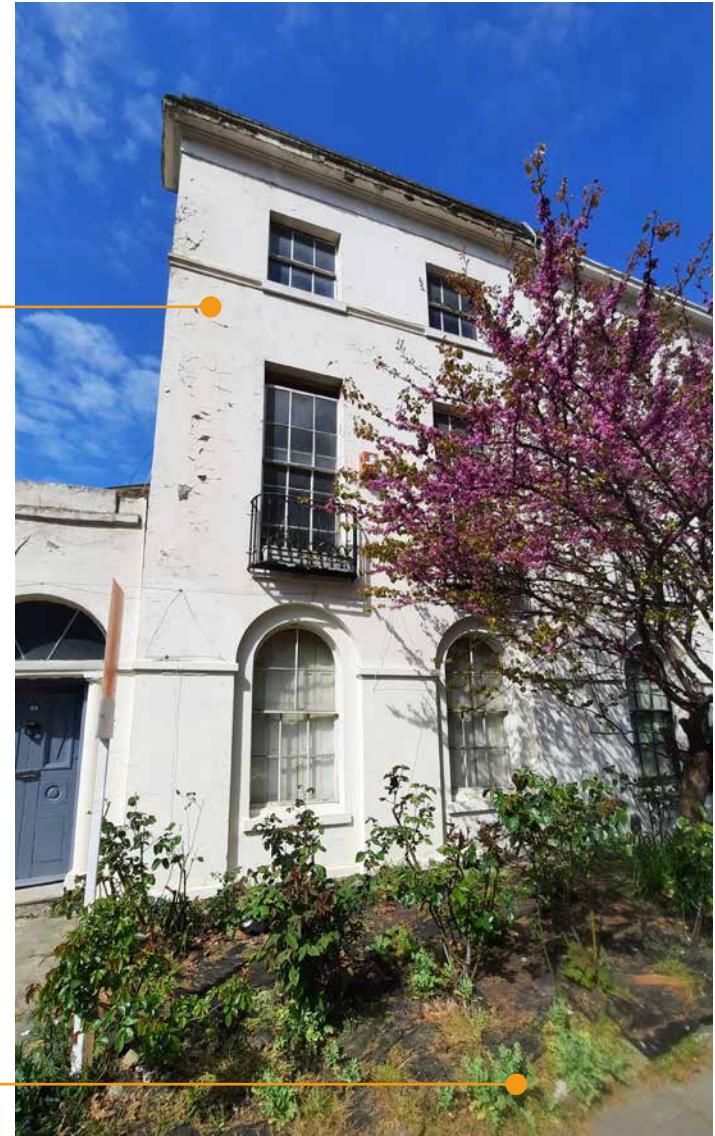
# 16.1 External Works - Front - Photographs

Item	Description	Condition	Proposal
1	Paintwork	peeling off	remove and repair render, repaint with breathable paint
2	Railings	removed	reinstate railing to match adjacent
3	Structural Damage to Porch	water damage	South and East walls of porch to be rebuilt on guidance from structural engineer
4	Brickwork	degraded	remove any cement mortar, clean and re-point with lime mortar
5	Waste / Soil piper	various stages of degradation	remove and replace with black metal, scheme to be designed

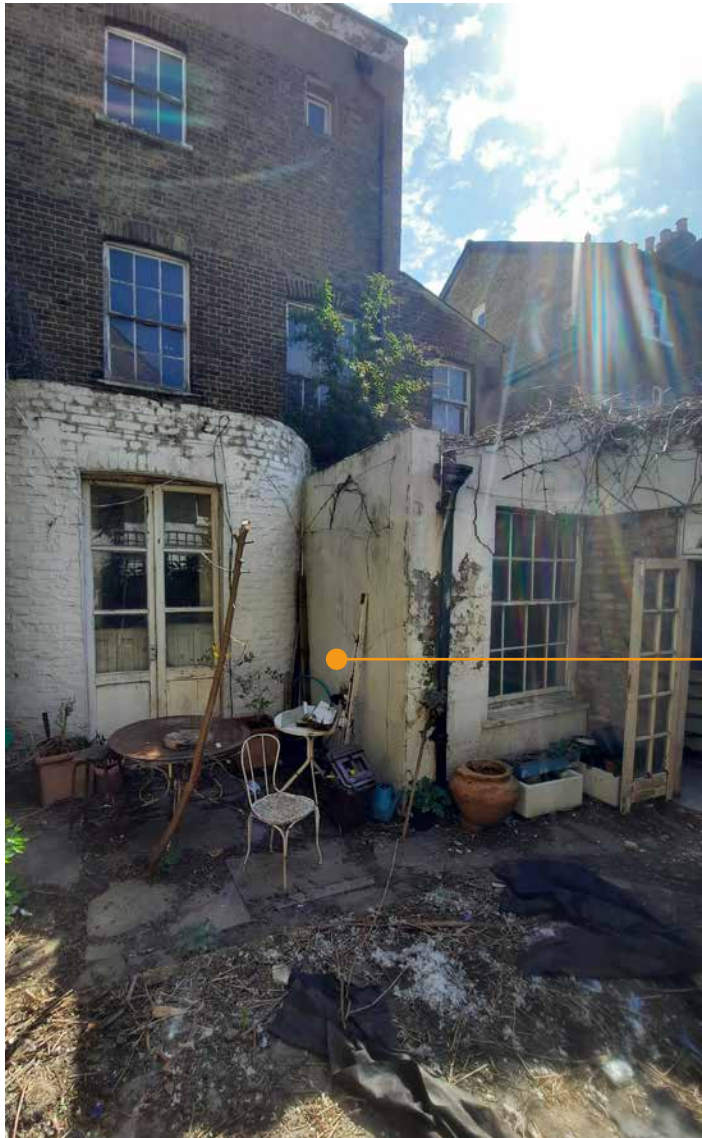
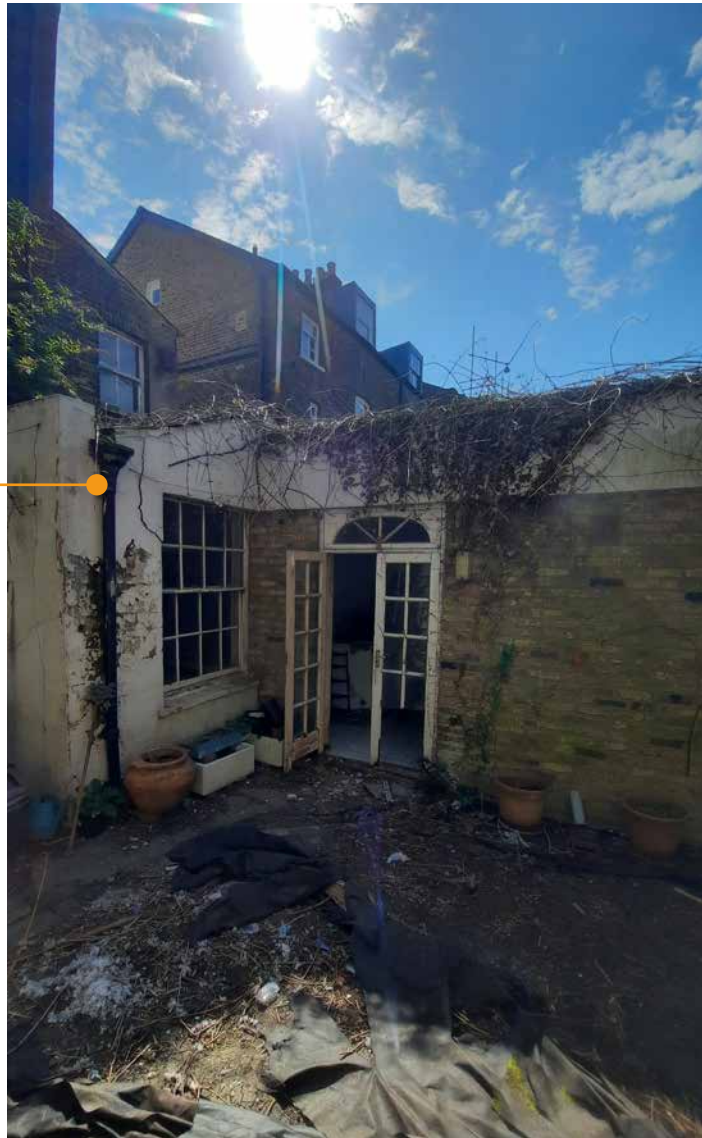
# 18.1 Courtyard - Photographs

Item	Description	Condition	Proposal
1	Courtyard	Full of debris and over grown plants	remove debris and plants in anticipation of new scheme
2	Brickwork main dwelling	Water damaged	remove loose mortar and re-point with lime mortar
3	Rain water pipe	Blocked	clear and repair
4	Painted Brickwork	poor condition	remove all loose paint and repaint with breathable paint

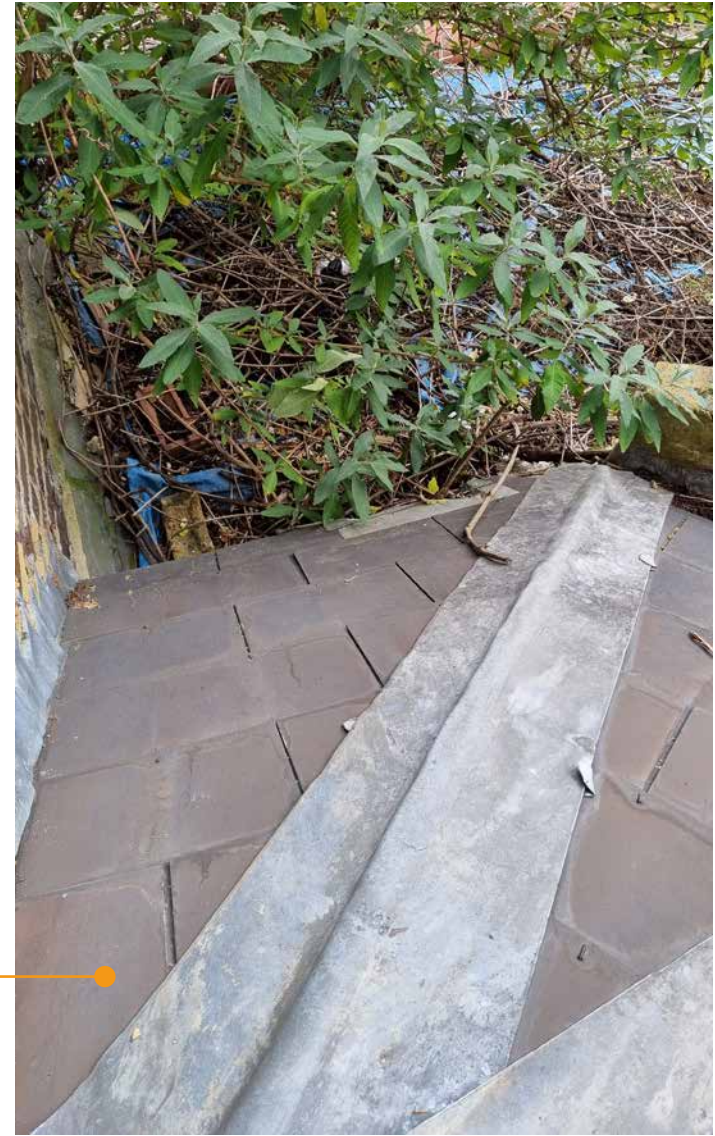
# 20.1 Roofs - Study - Photographs

Item	Description	Condition	Proposal
1	Slates	Fair condition	retain if possible remove debris and vegetation

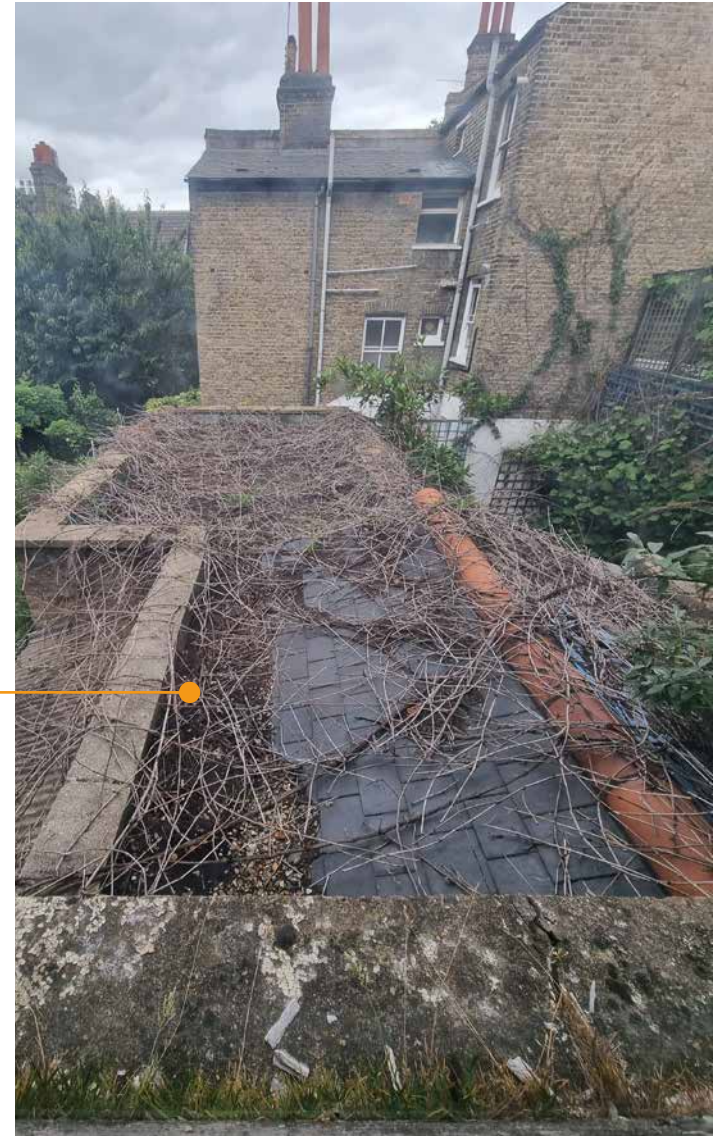
# 21.1 Roofs - Rear Extensions - Photographs

Item	Description	Condition	Proposal
1	Roof covering and structure	Generally poor condition - rotten structure in places	remove coverings and remaining structure, build new flat roof with insulation

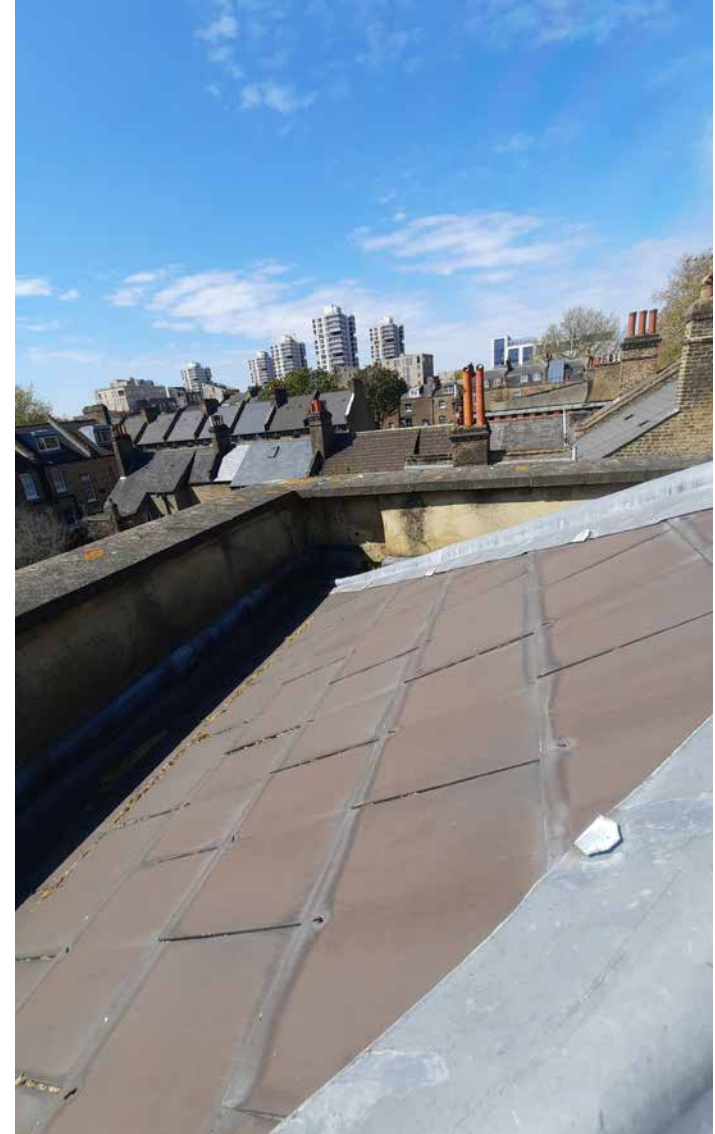
## 22.1 Roofs - Main Roof - Photographs

Item	Description	Condition	Proposal
1	Roof Covering	Generally good condition, signs of water damage in below	retain and repair
2	Parapets	Concrete coping	remove and replace with painted render system
