Project: 20_5837_09_44
Site: 58 Leicester Road, Narborough, Leicester, LE19 2DG
Client: Jay Badiani

Document Title:	Arboricultural Implications Assessment
Document Author:	Ffion Maguire
Project Manager:	Matt Harmsworth
Project Title:	58 Leicester Road, Narborough, Leicester, LE19 2DG

Arboricultural implications assessment to BS 5837 2012 of trees at: 58 Leicester Road, Narborough, Leicester, LE19 2DG.

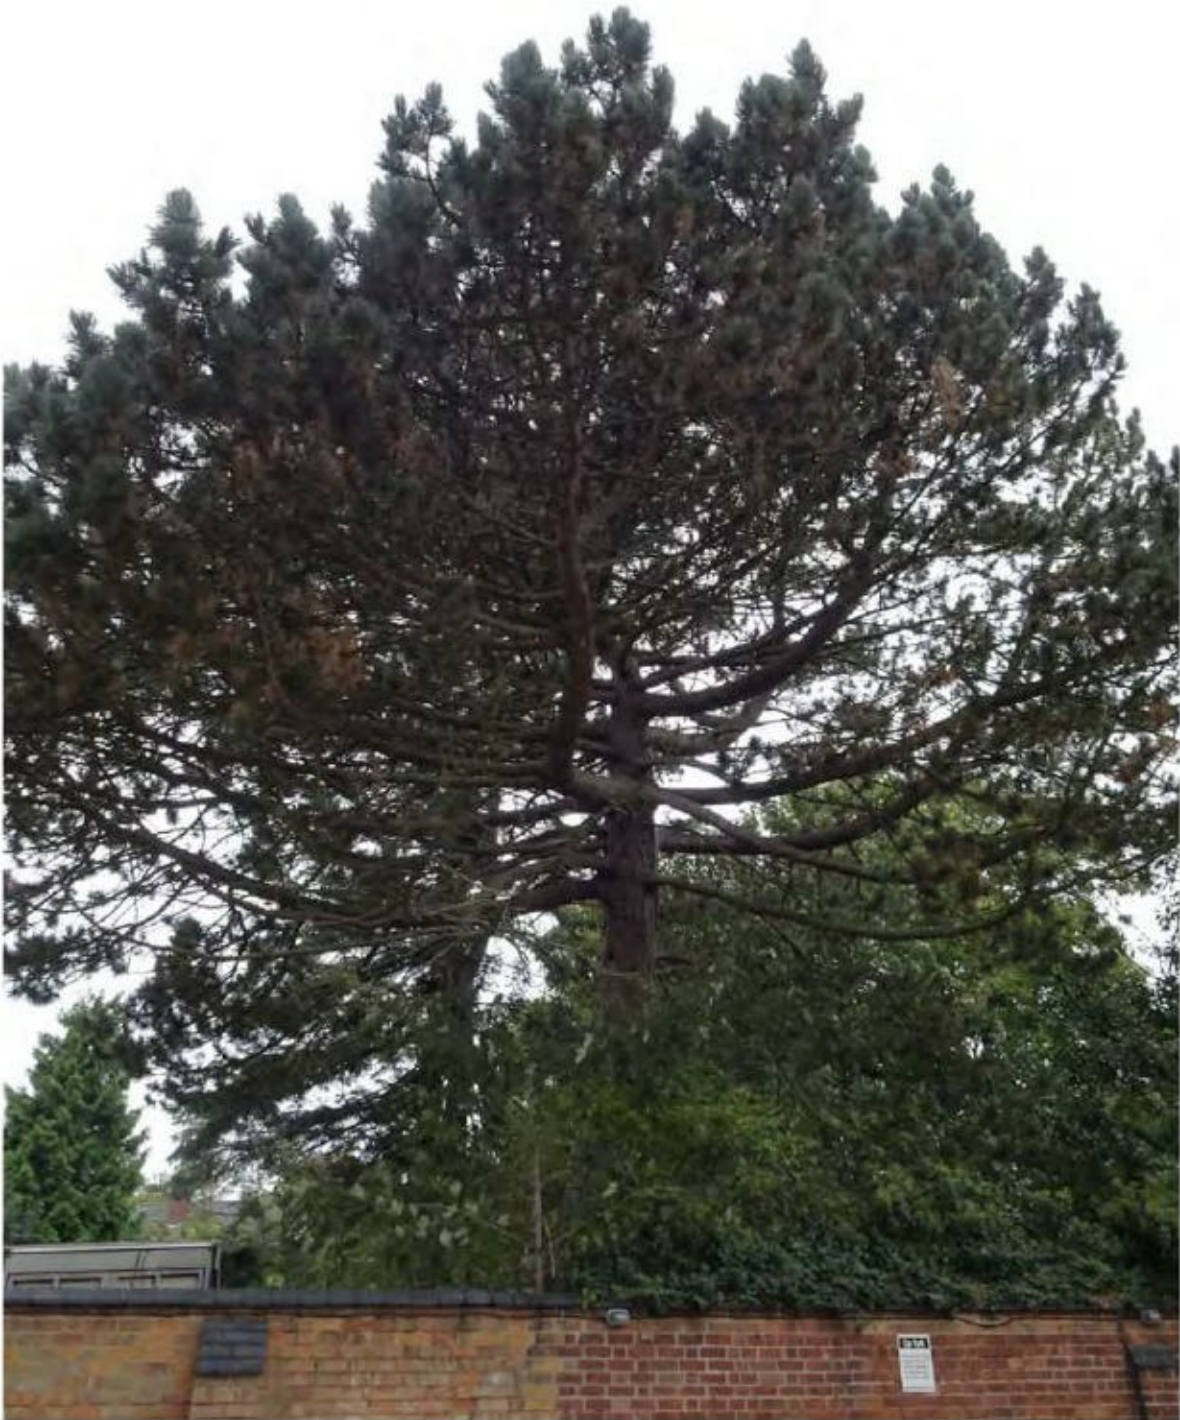
Photographic plate showing tree T1, a mature Corsican Pine located on the site's boundary.

- 4.8 Tree T1 is a mature Corsican Pine located offsite, on the site's north-west boundary. The base is located within a hard surface area of paving and 50% of the RPA lies beneath the car park and adjacent wall. The roots may be impacting the wall, causing structural damage. The tree has good structure, form and vitality, however, has a significant overhang. A crown lift to clear the adjacent wall is recommended.

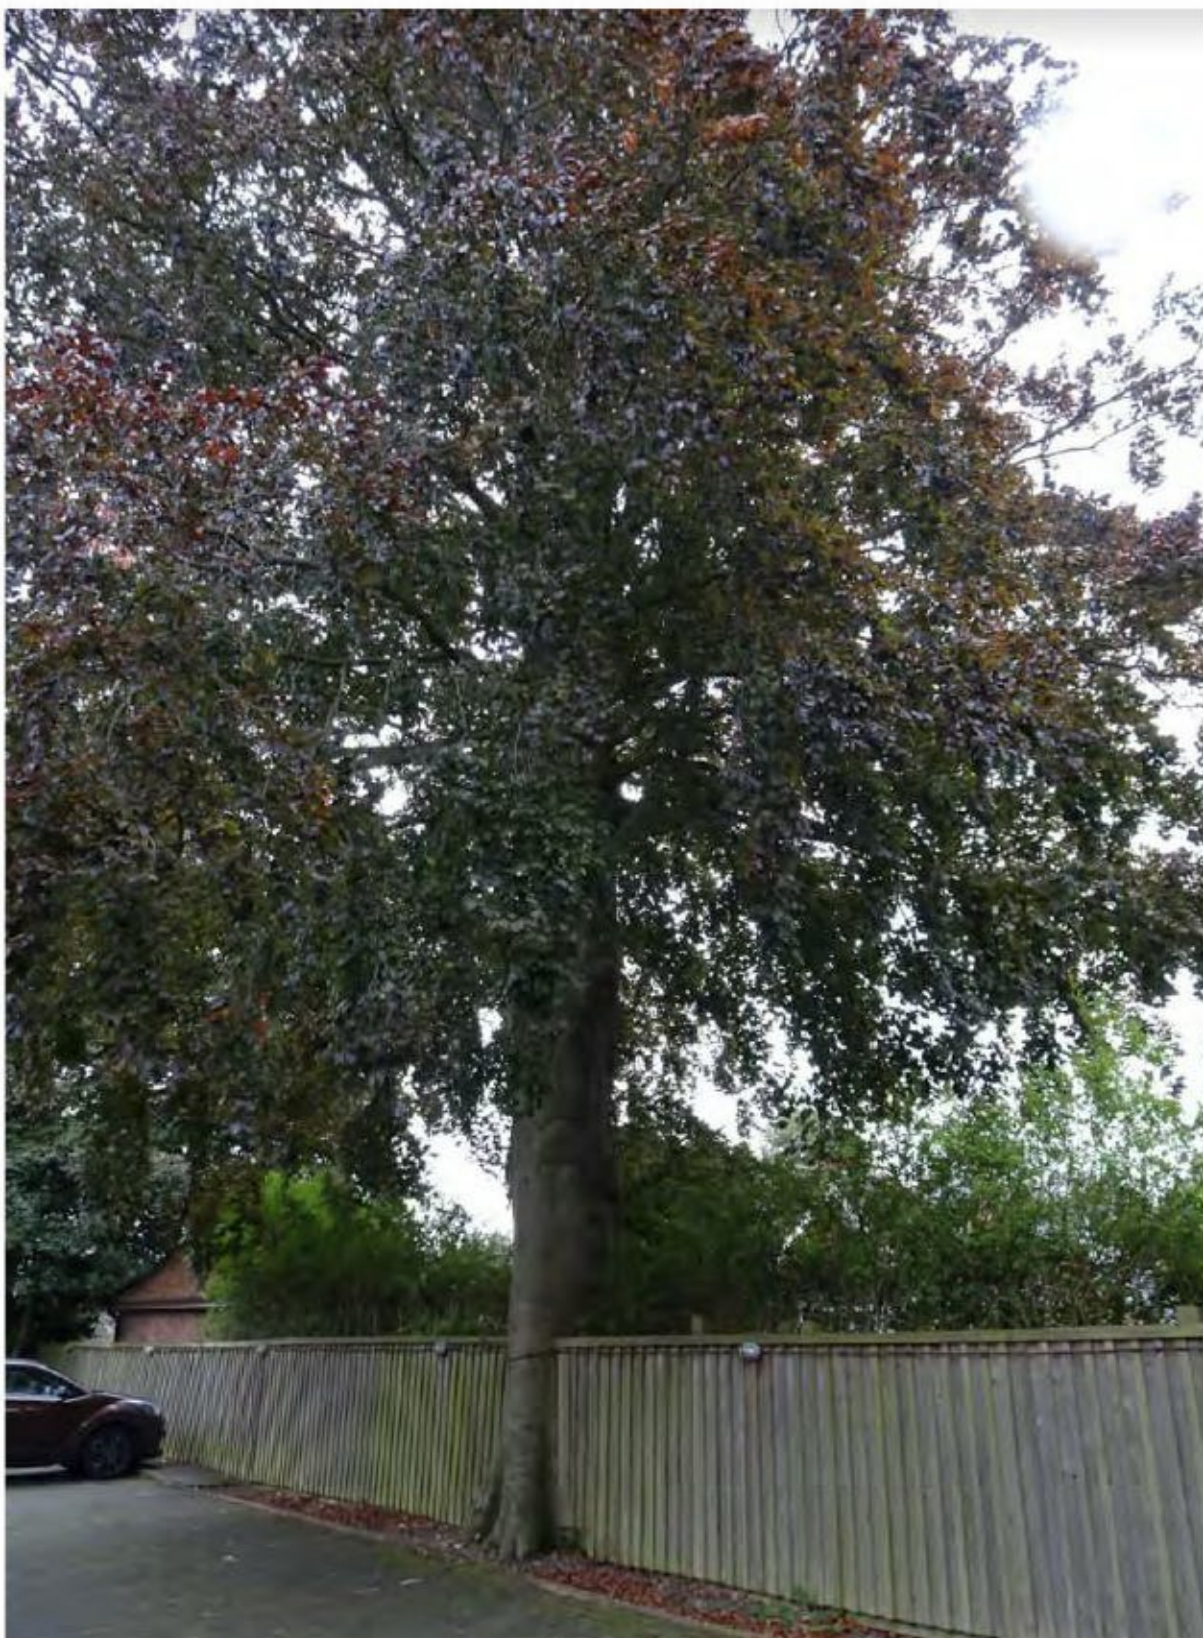
Photographic plate showing tree T2, a mature Copper Beech located on the site's boundary.

- 4.9 Tree T2 is a mature Copper Beech located on the site's south-west boundary. The base is located within a hard surface area of paving, which is being damaged by the tree's root system. The tree's stem is bordered by boundary fencing. The branches are encroaching upon the adjacent building. The tree is deemed to be in a good condition. Therefore, no managed work is required.

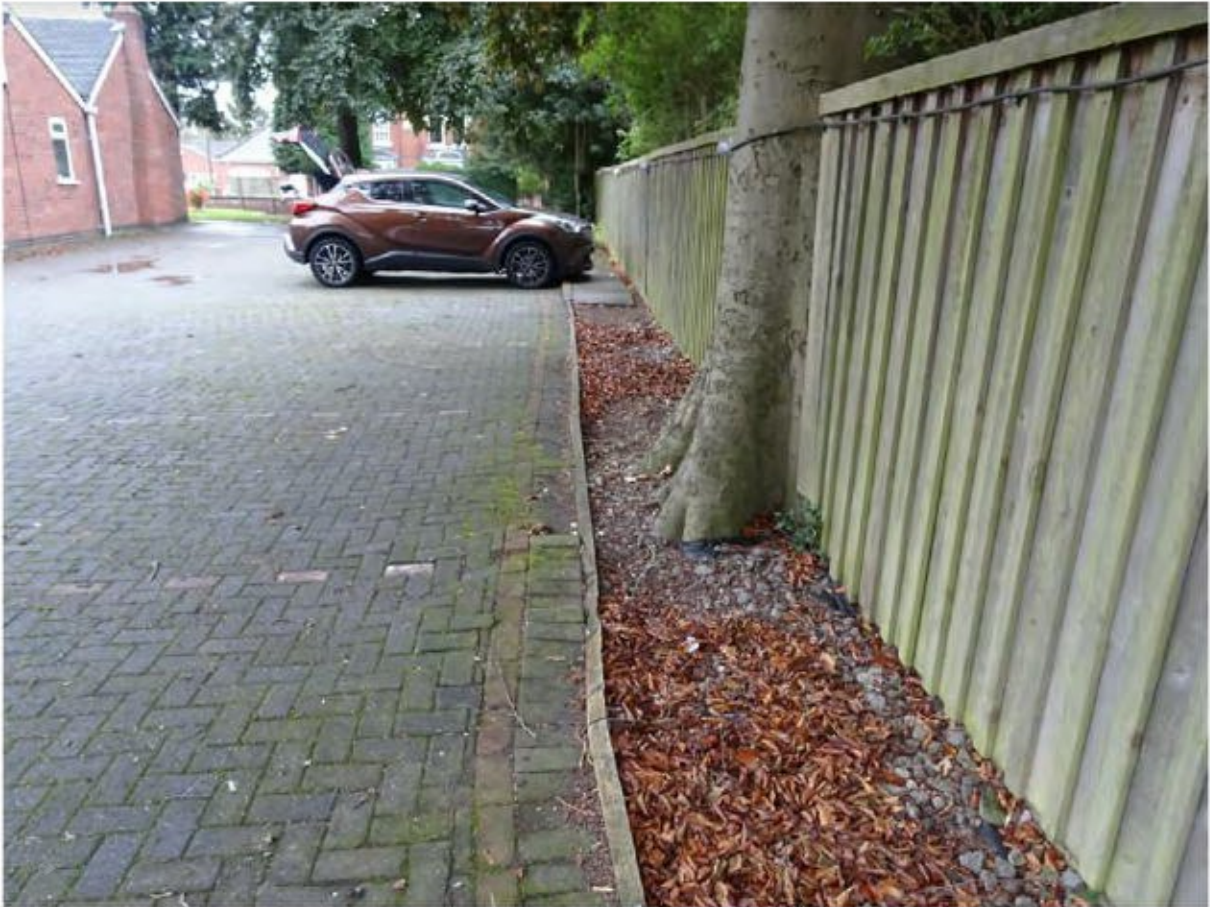
Photographic plate showing tree T2 growing within a hard surface area of paving.

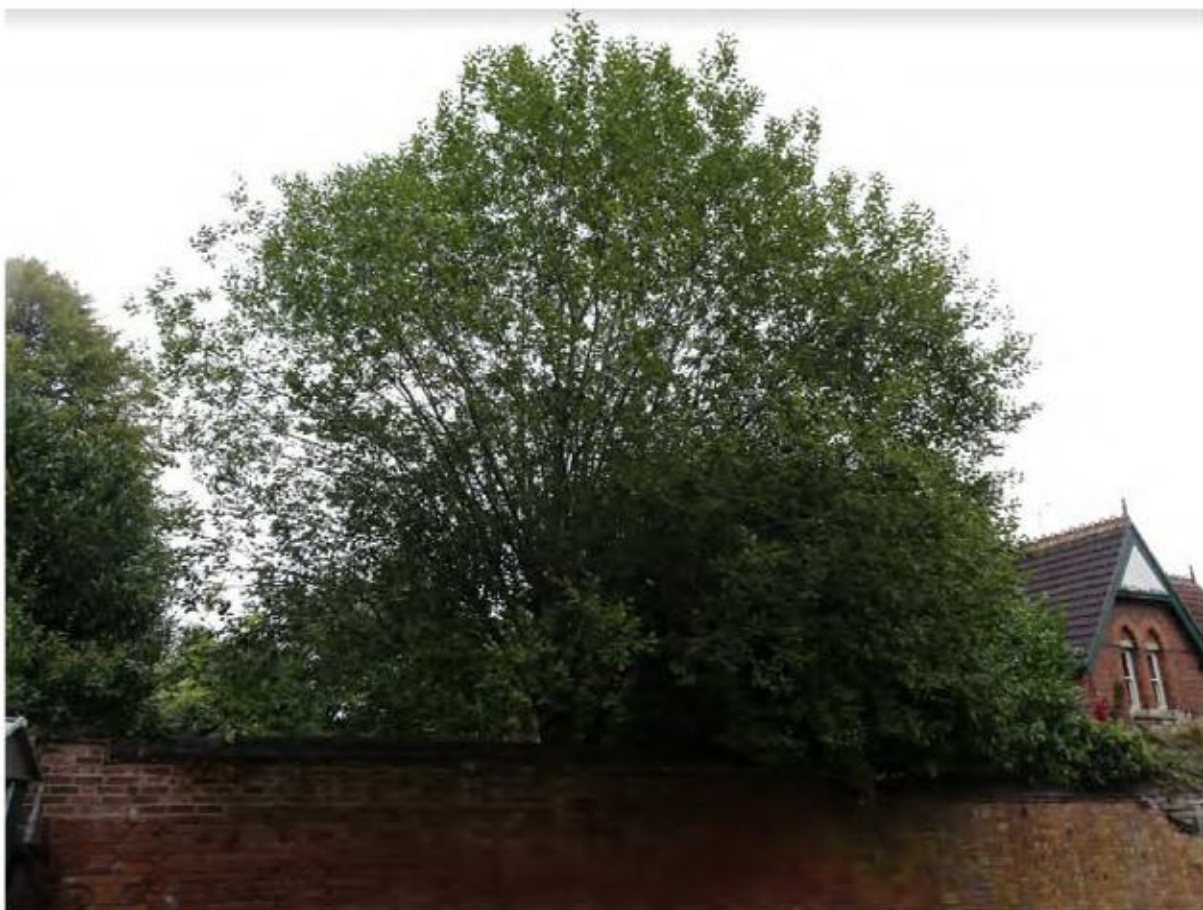
Photographic plate showing tree group G3, consisting of Cherry Laurel and Willow.

- 4.10 Tree group G3 consists of early-mature Cherry Laurel and Willow located offsite, on the site's north-west boundary. The stems are growing within a hard surface area of paving. The group is an outgrown boundary feature and the branches are encroaching upon the adjacent building.

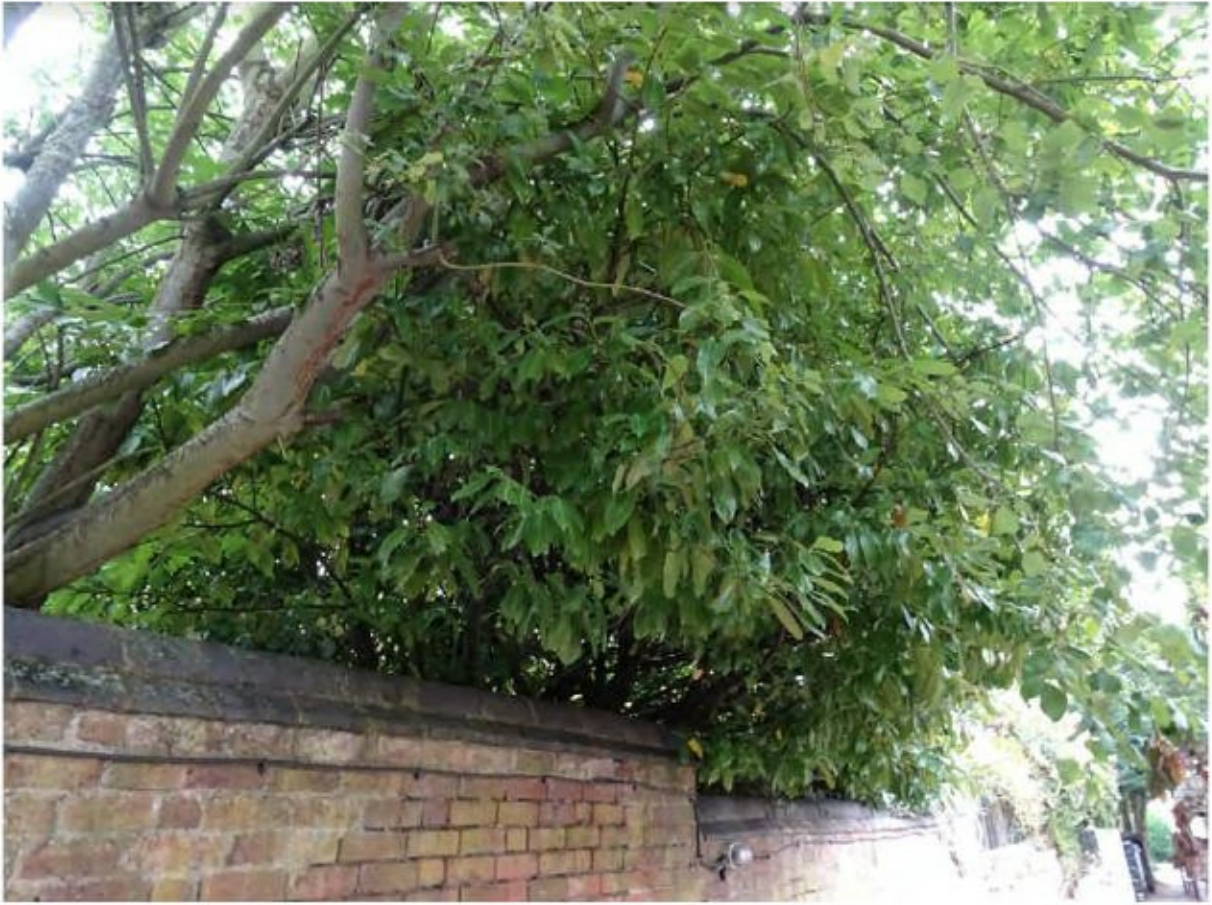
Photographic plate showing tree group G3, adjacent the north-east boundary wall.

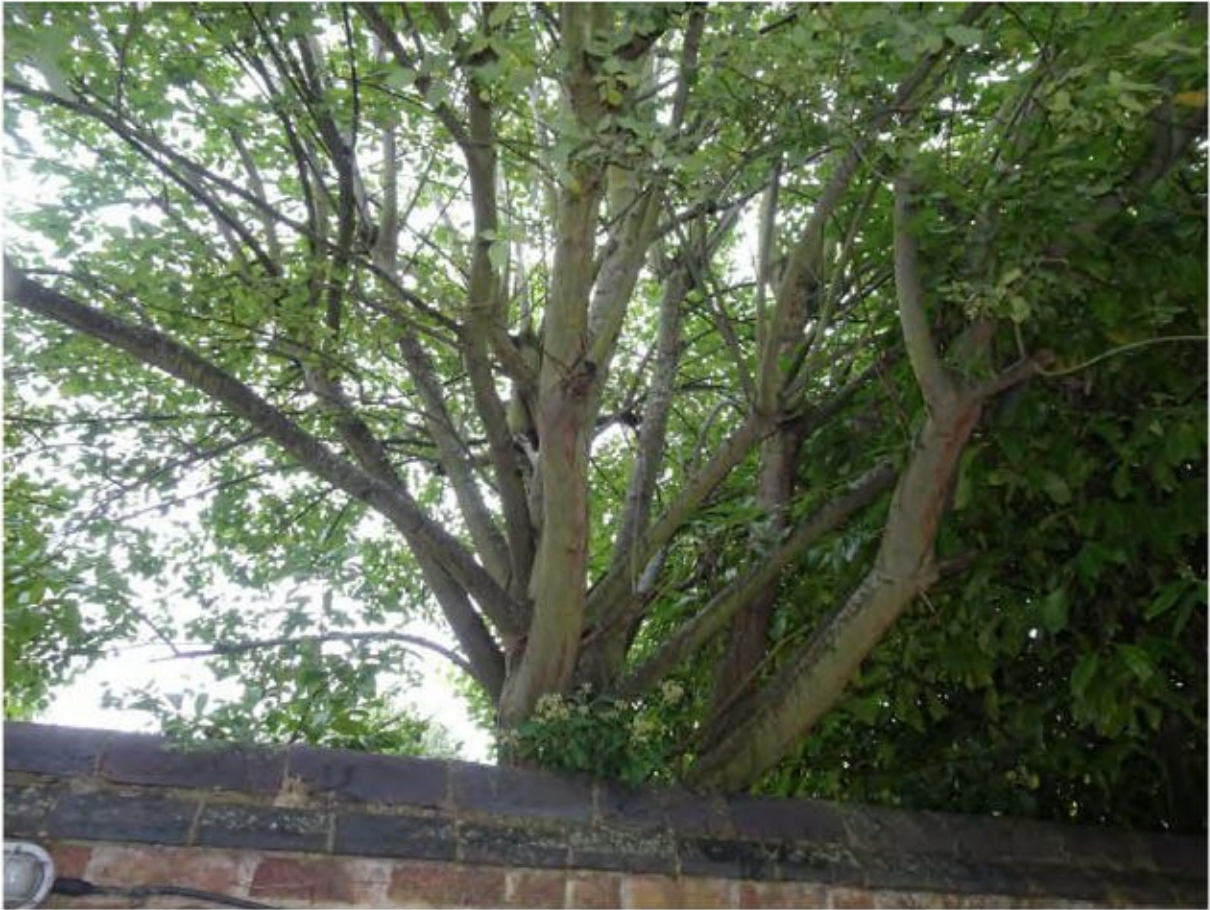
Photographic plate showing tree group G3, located on the site's north-eastern boundary.

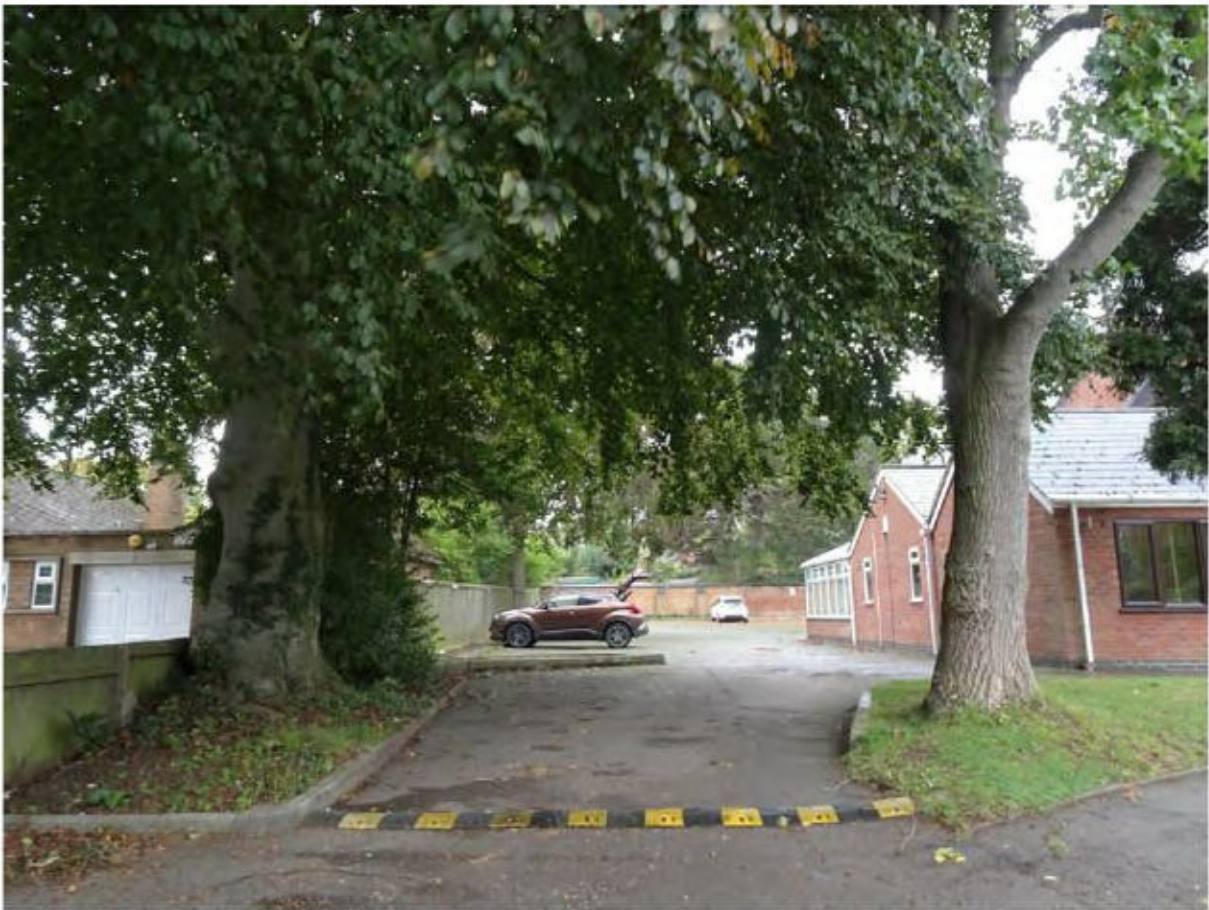
Photographic plate showing trees T4 and T5, growing within a hard surface area of concrete.

- 4.11 Tree T4 is a mature Copper Beech located on the site's south-west boundary. The tree is growing within a raised bed located in a hard surface area of paving. The branches hang low over the carpark and are encroaching upon the adjacent building. There is ivy on the tree which should be removed.

- 4.12 Tree T5 is a mature Sycamore located onsite, south of the existing property. The tree is growing within a raised bed located in a hard surface area of paving. The branches hang low over the carpark and are encroaching upon the adjacent building.

- 4.14 The trees should be inspected sooner if there is a noticeable decline in their condition, or following extreme weather events.
- 4.15 Trees T4 and T5 may require a crown reduction and crown raise in the future to prevent the branches from further encroaching upon the carpark and adjacent building.

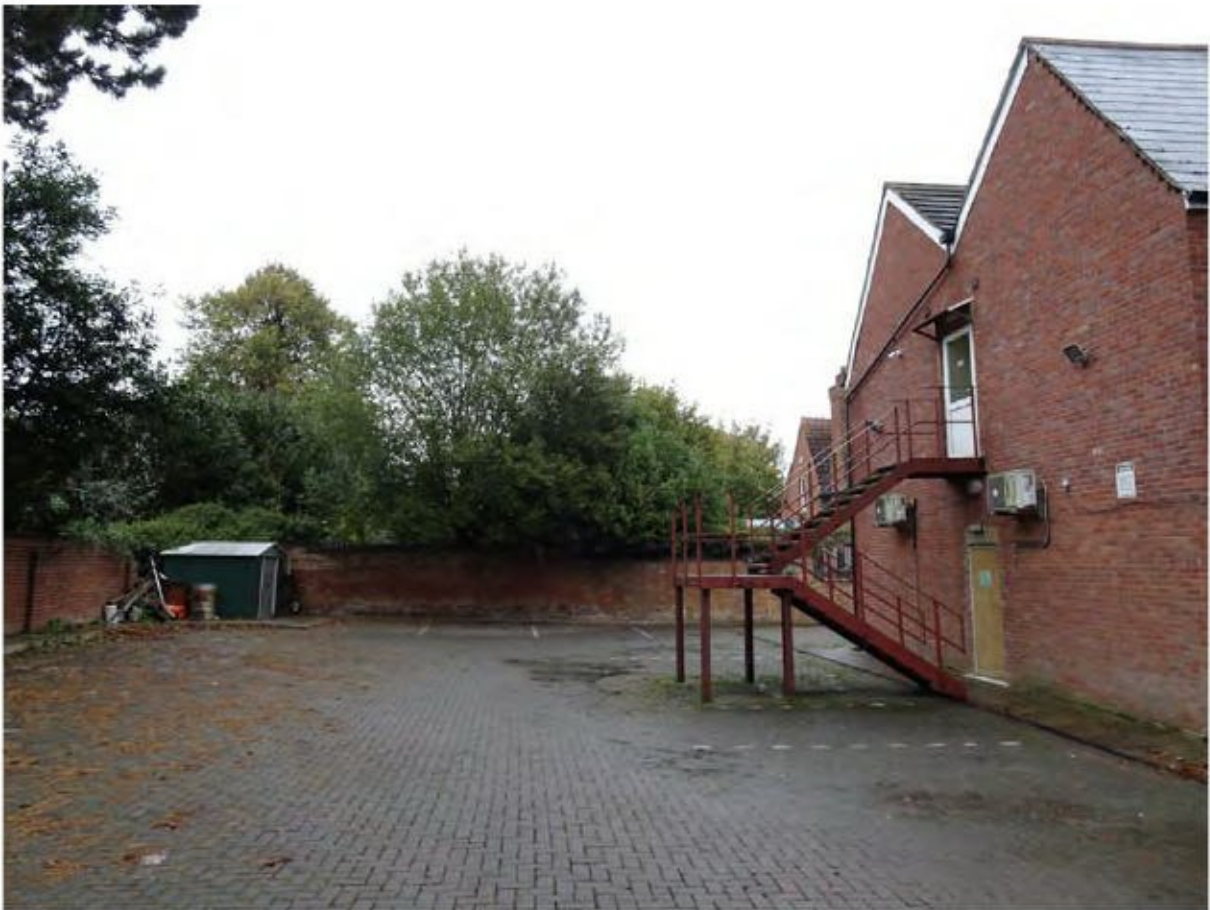
Photographic plate showing tree group G3 within the survey site.

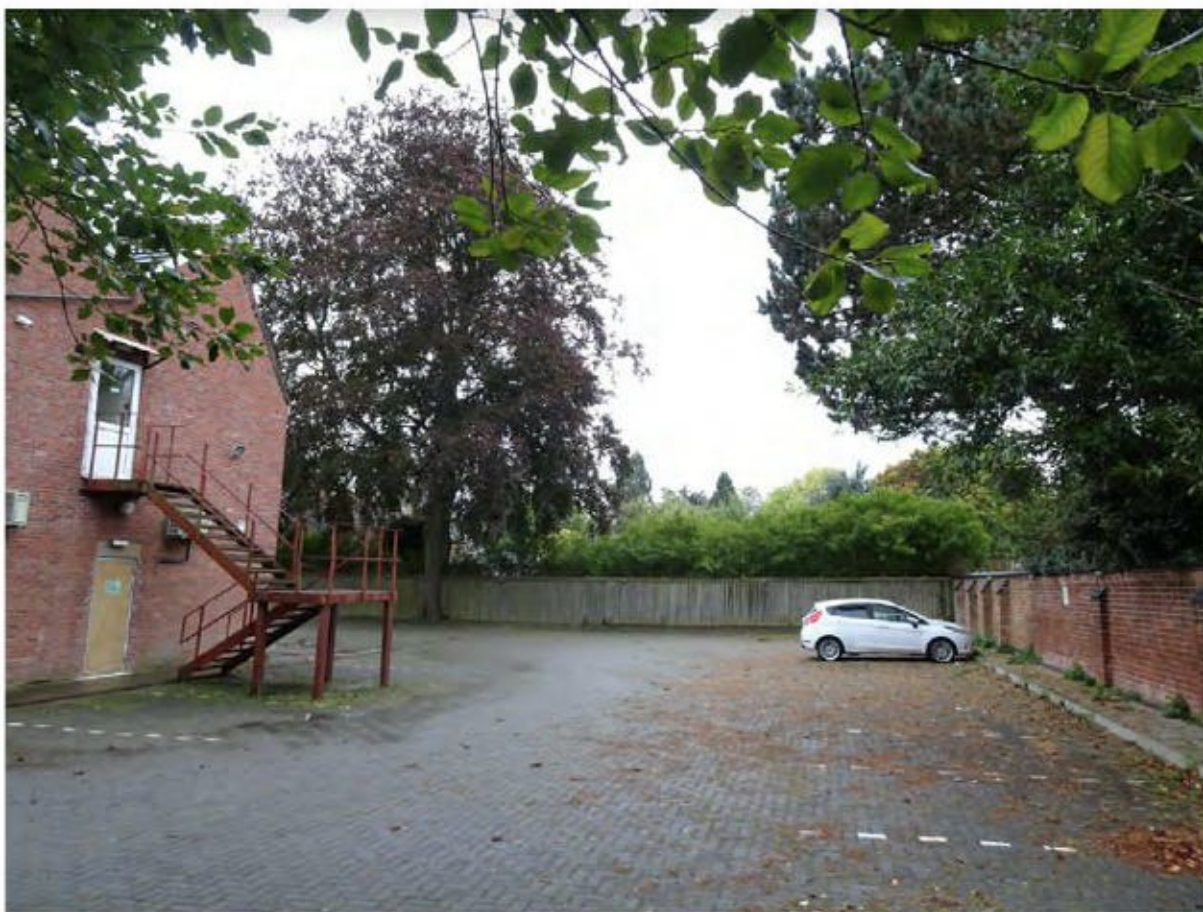
Photographic plate showing tree T2 within the survey site.

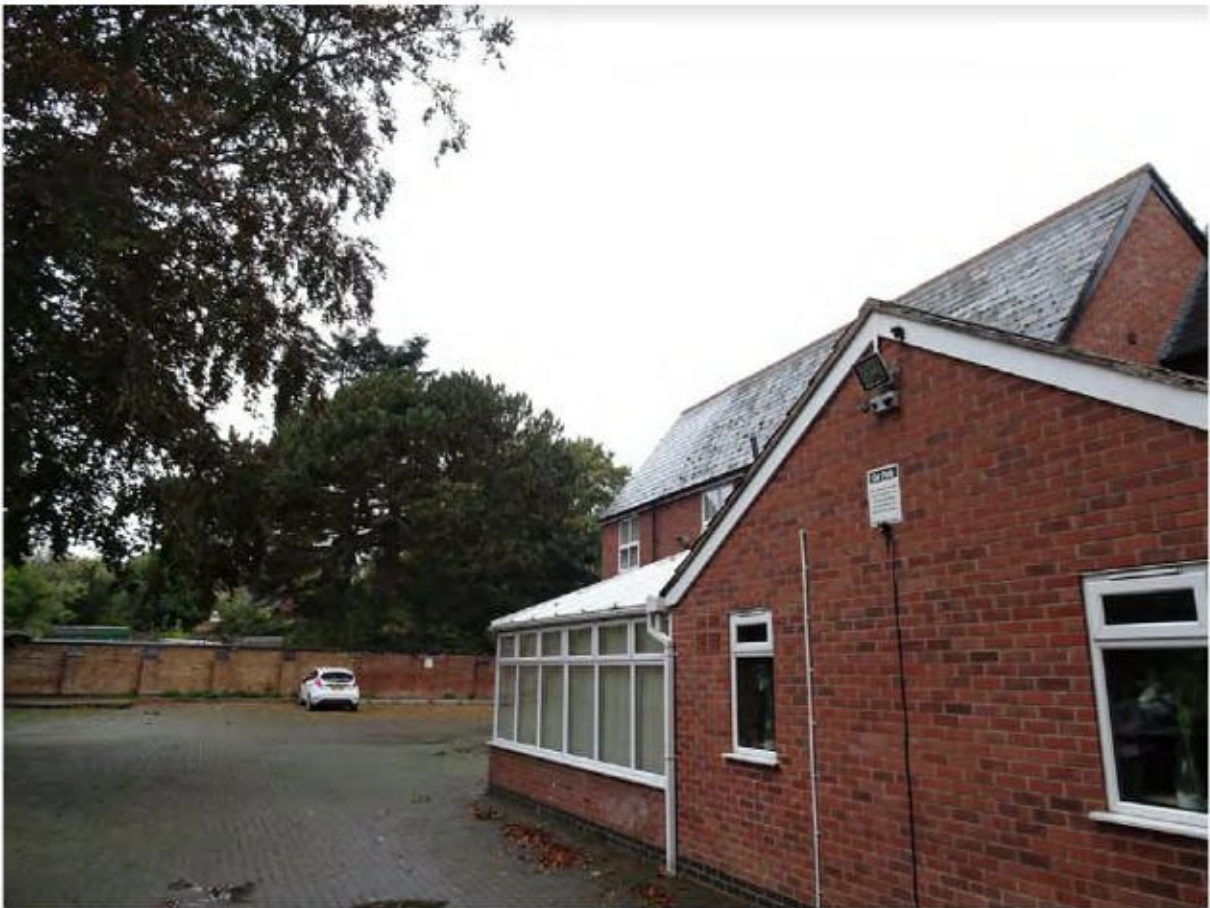
Photographic plate showing tree T2 within the survey site.
