Arboricultural Report

BS5837 Tree Survey

**New House
Maidstone Road
Nettlestead
ME18 5HE**

14th June 2021

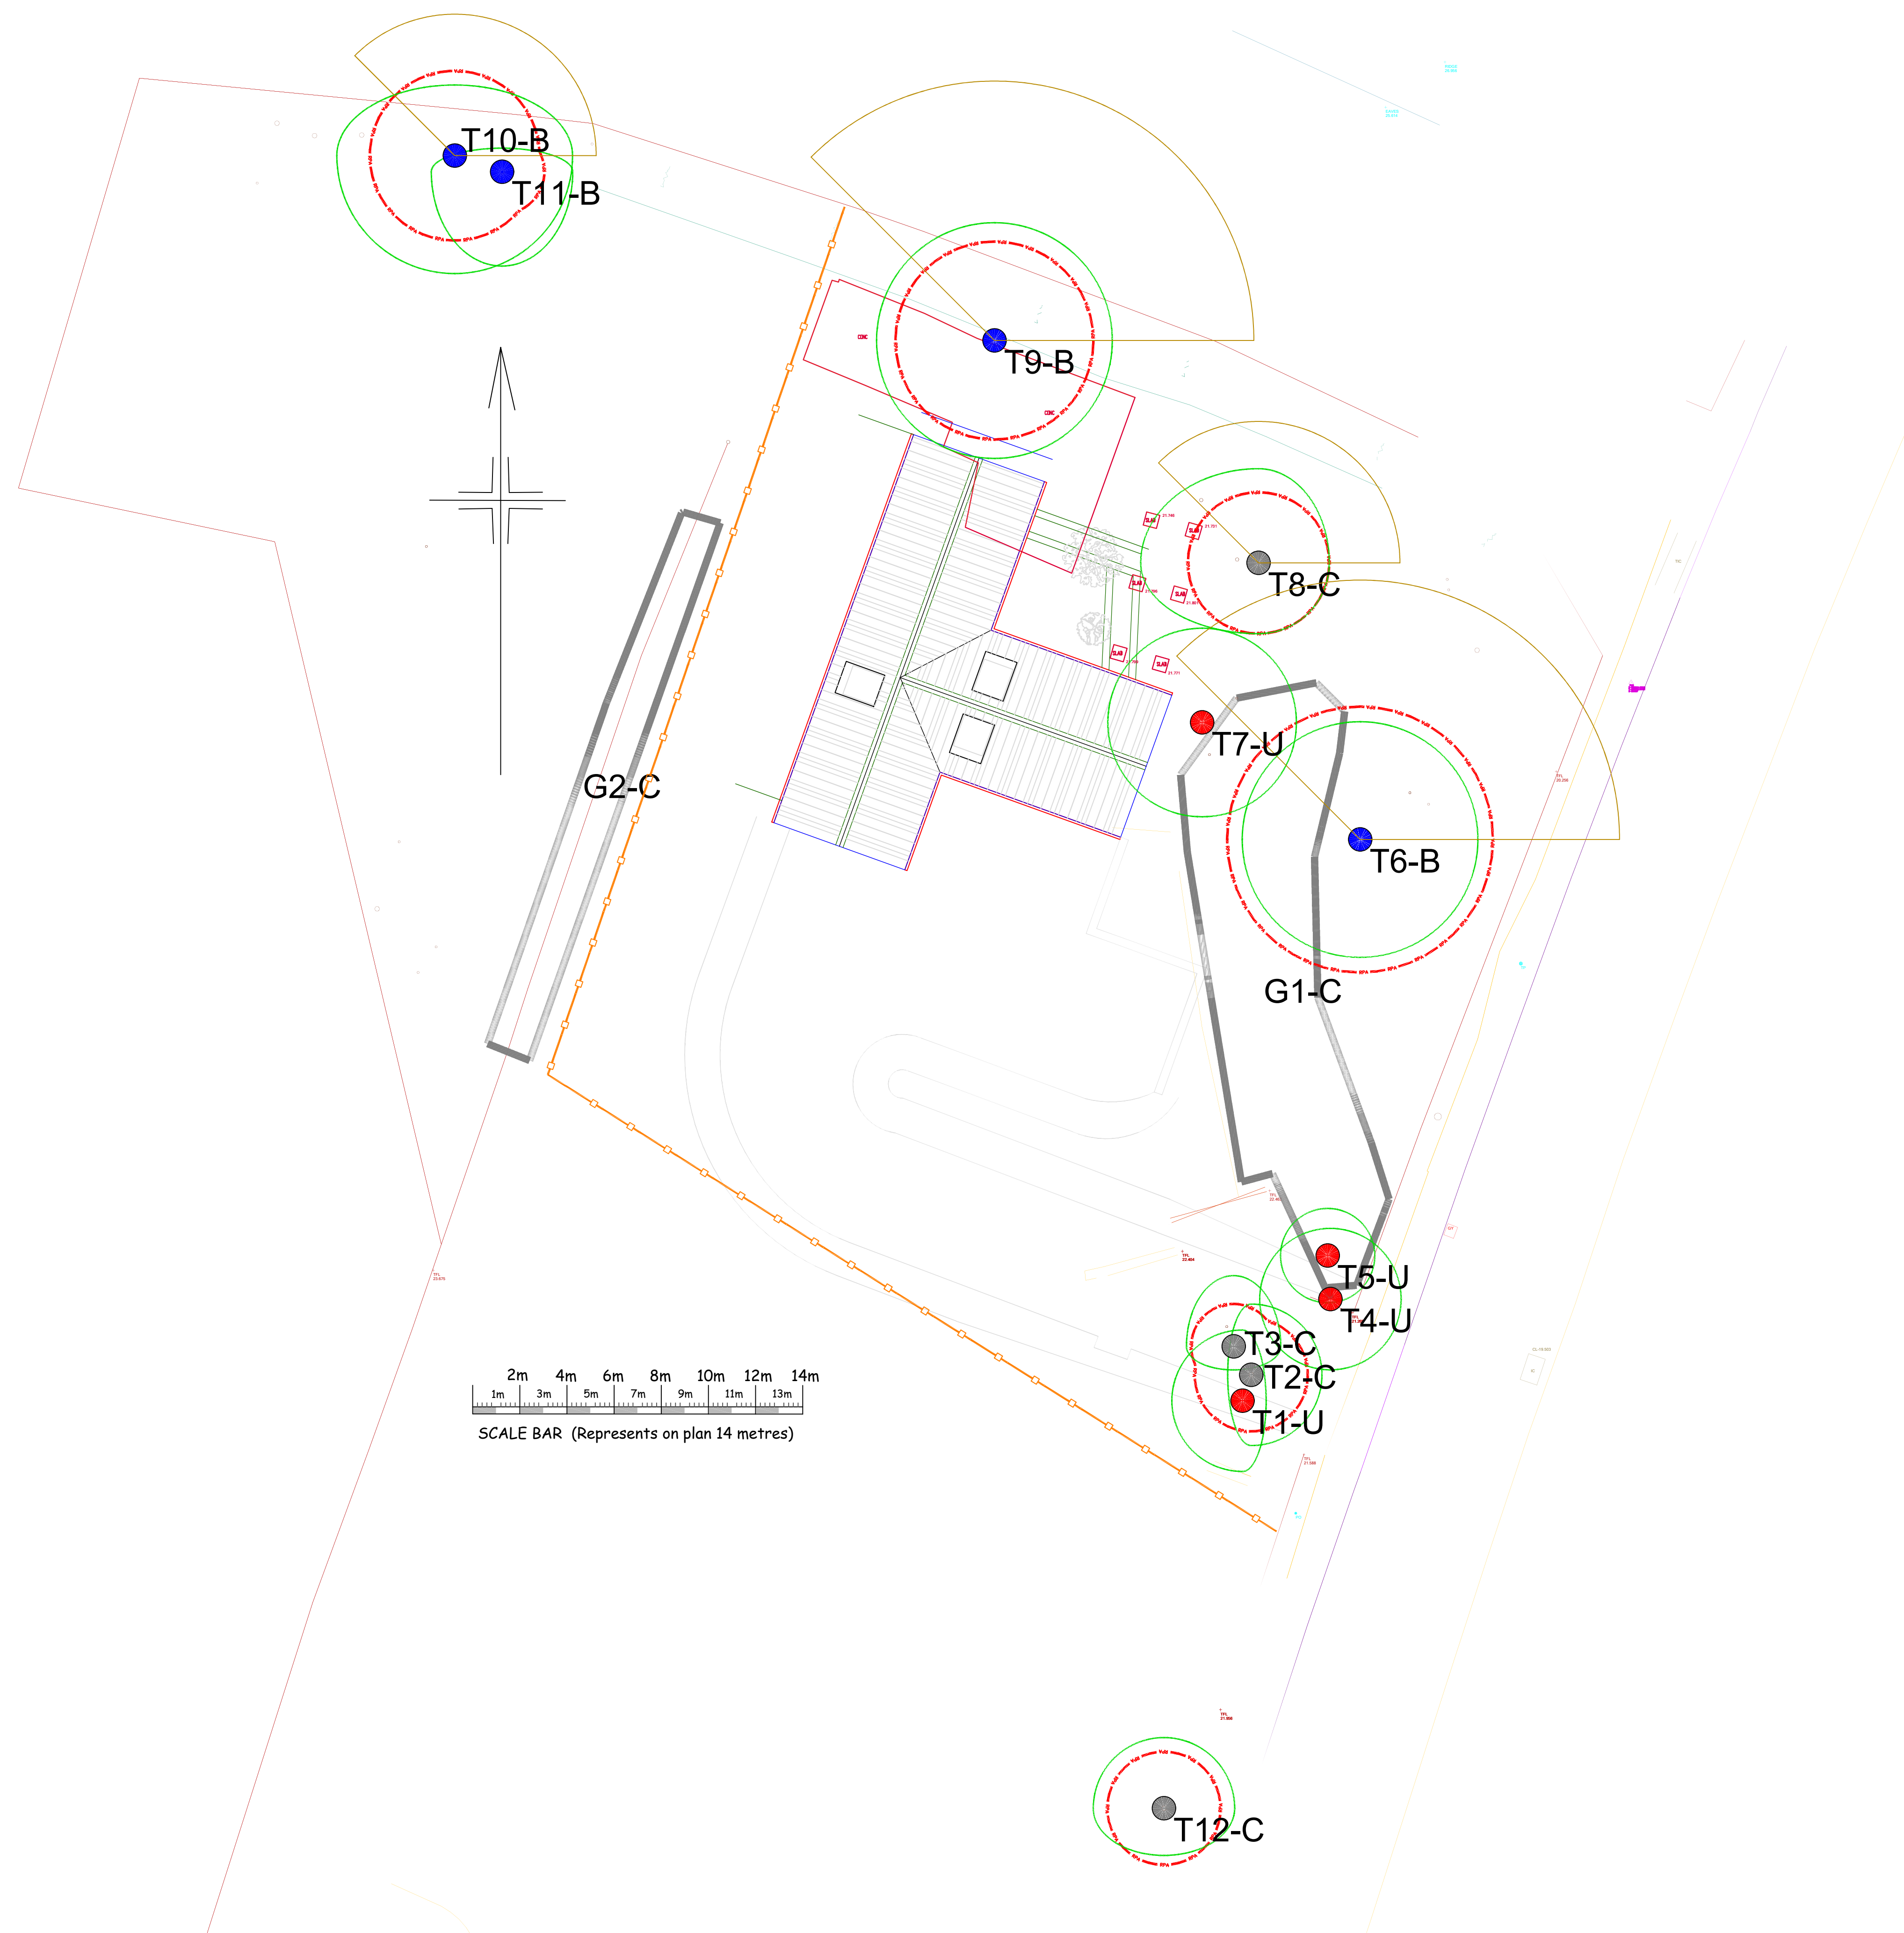
TREE SURVEY & CONSTRAINTS PLAN

- The soil level has remained the same throughout the area so the root flares on all the trees are exposed.
- There is no evidence of any recent root disturbance or radial trenching having recently taken place. A new access driveway has been installed close to trees T1-T5, however these are either young or in poor condition.

- The proposed development will result in an incursion of <3% into the root protection area of the Cherry (T9) which is negligible and therefore conventional construction methods can be used.

- I would recommend the removal of the Ash trees (T2 & T3) in order to incorporate the new design and allow for new hard landscaping and as young **Category C** trees they should not therefore be considered as a constraint to the development.
- The poor physiological and structural condition of the Ash (T5) and Elms (T1, T4 & T5) are such that their removal is recommended on purely arboricultural grounds regardless of whether the development is permitted or not. For the purposes of the survey, these trees have been recorded as **Category U** (BS5837: 2012, Table 1) being in a condition where they cannot be retained as living trees for longer than 10 years. These trees are extremely poor specimens with any remedial works considered unlikely to produce trees with any degree of longevity.
