# Aston Hall: Investigation of structural timber elements – South range barns

Site note 1 for March 2021, job no. 153.32

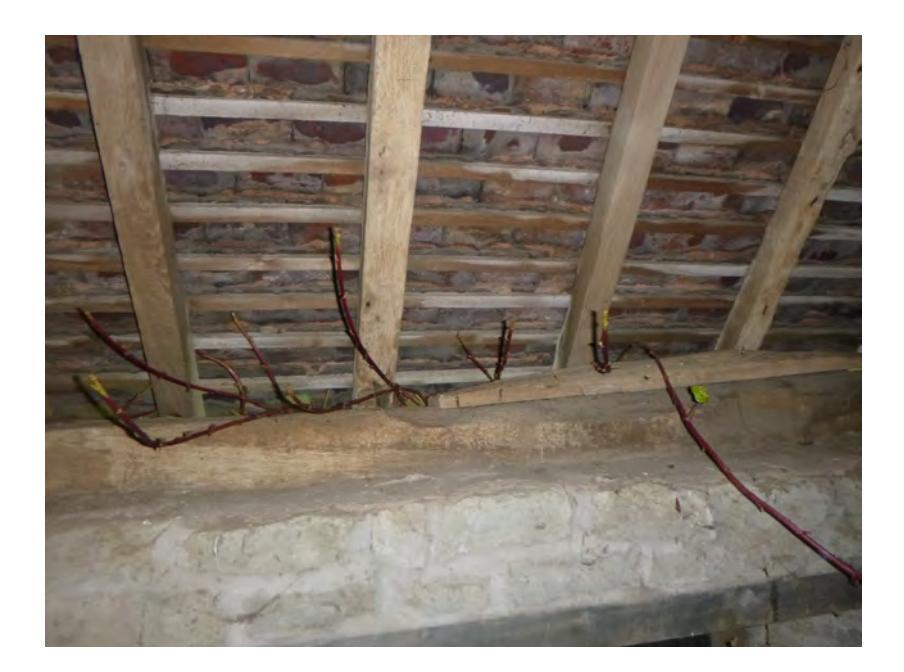
### Fig 9:

Bays 1 and 2; showing significant and well-established plant growth emanating from between the structure and the external cladding, and penetrating the roof structure. This was not considered detrimental at the time of survey, but should be eliminated to prevent detachment of external boarding in the future

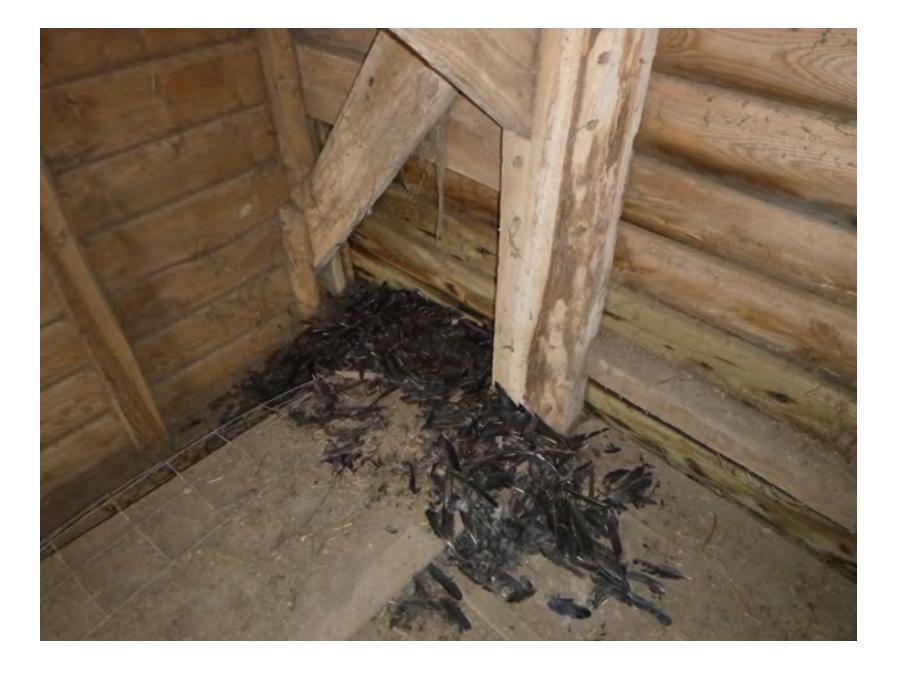
Bay 3; showing further small piles of frass consistent with Common furniture beetle, and although no structurally significant timber decay was detected, these localised areas will almost certainly extend if left unchecked

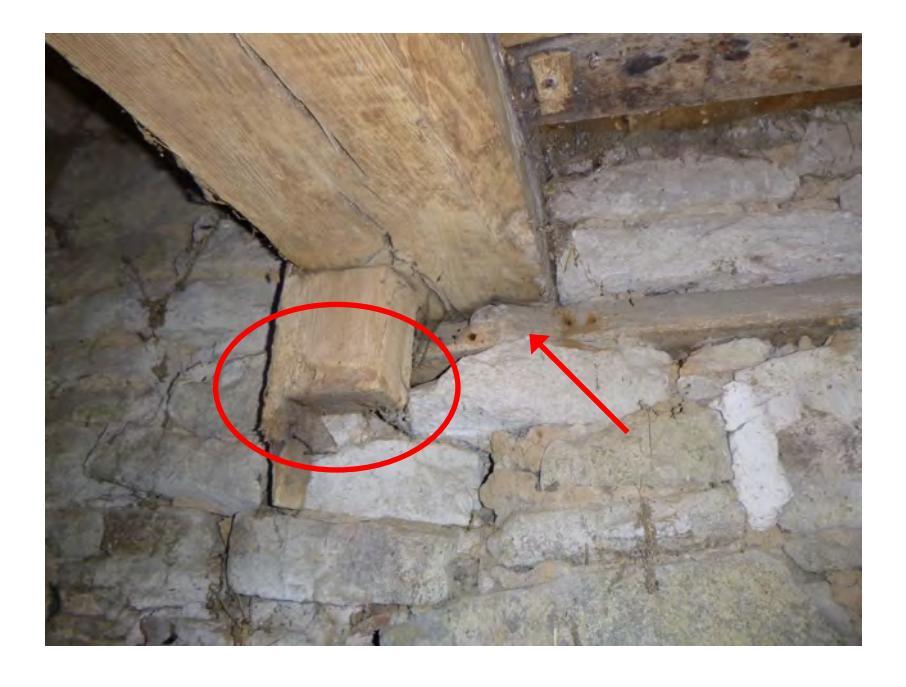
Also showing surface decay and water and salt staining to the face of the floor beam, caused by moisture tracking from damp masonry at the bearing ends of the beam

Floor beams were deemed suitable for retention at the discretion of the Structural Engineer. However, the cut out supporting post to the easternmost beam should be replaced. Consideration should be given to isolating the bearing ends of beams in contact with masonry using a suitable DPM

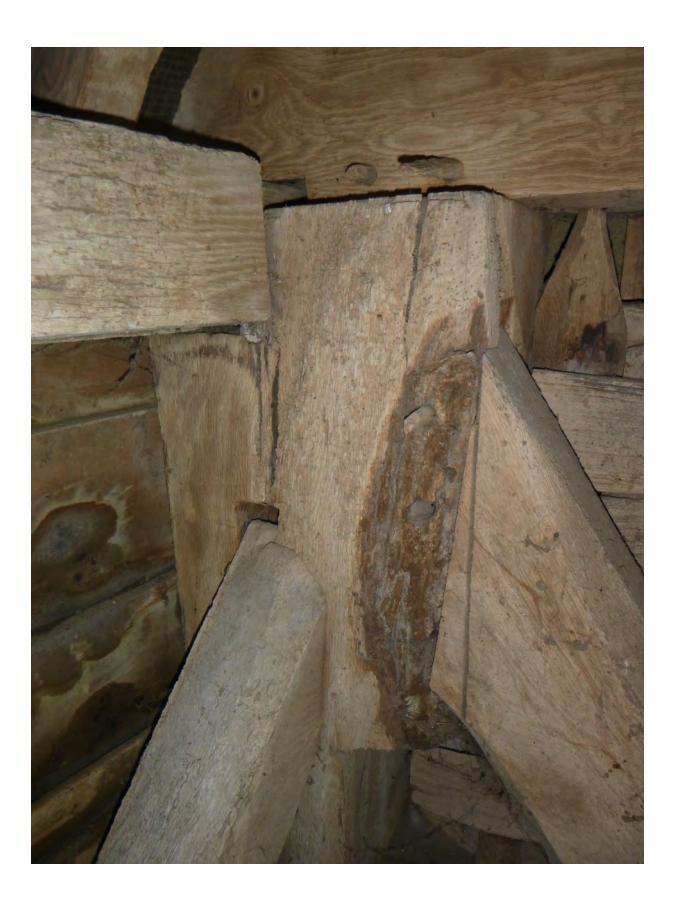
#### Fig 65:

Bay 7; showing the small fractures at the top of the main post for truss 7. These were not considered structurally significant but may require strengthening with steel to prevent further unwanted movement

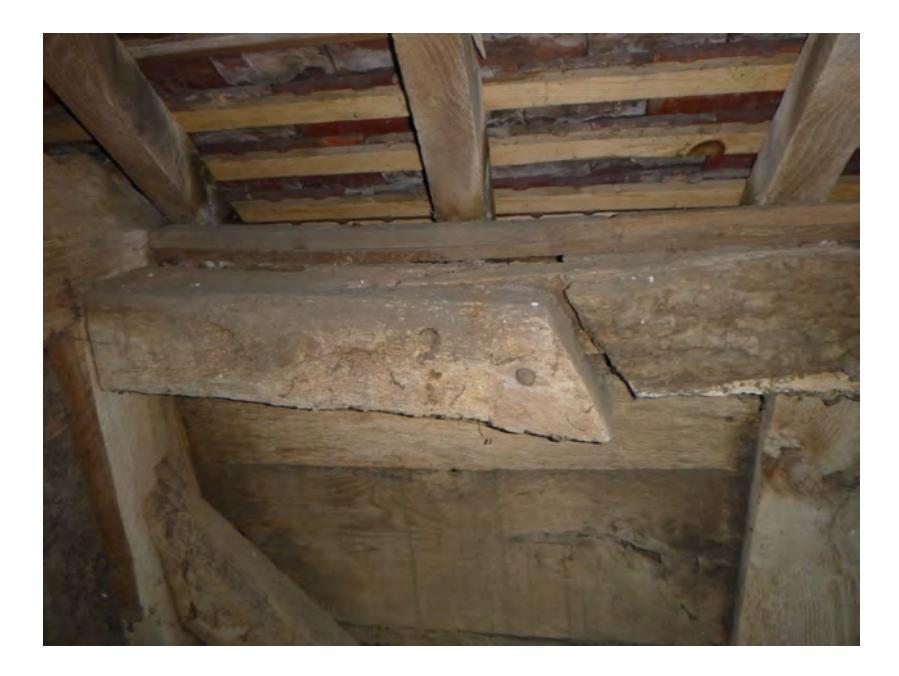
Bay 7; showing the large fracture in the tie-beam at the north bearing end of truss 6. This was considered most likely a result of failure of structural elements below, particularly in the main post and the supporting plate, primarily from persistent rain water penetration and subsequent decay. Note remediation in the recent past using steel angle bracket, threaded rods, and softwood bracing

No chemical treatment required. Structural Engineer to comment on suitability of previous repairs to tie-beam of truss 6 at north end. Significant strengthening works with steel required to repair head of post at south end of truss 6. Every effort should be made to re-direct water away from the building to prevent further structural decay affecting vulnerable timber elements. Allowance should be made for strengthening/repairing the failing wall plate joints to the east of truss 6 at both the north and south sides

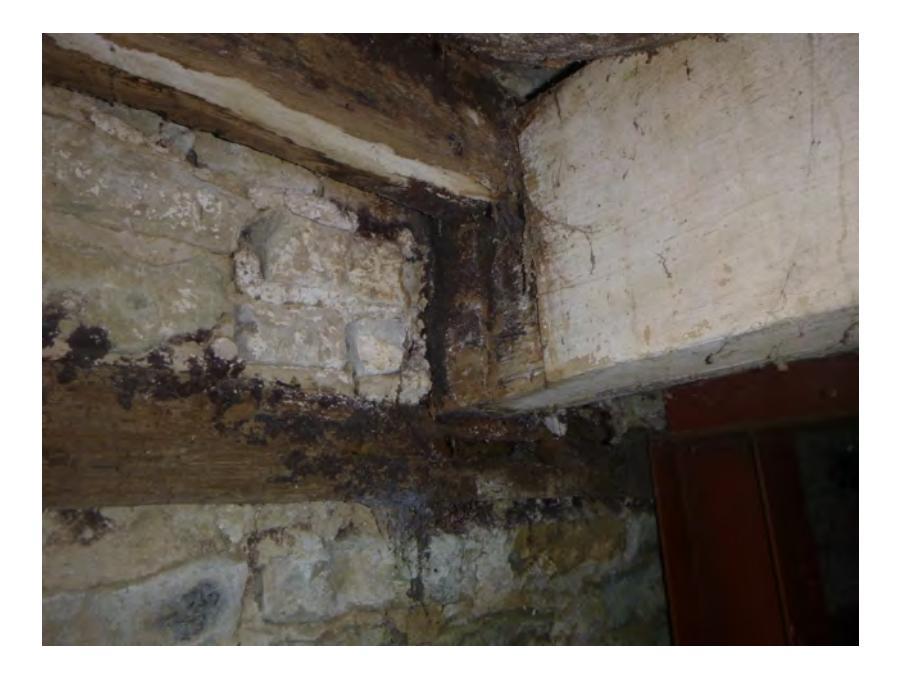
Ground floor; showing the bearing end of one of the primary beams. Note the water-staining and darkening of the timber suggesting ongoing issues with damp and decay. Moisture content readings taken from timbers on the west side were generally above the decay threshold

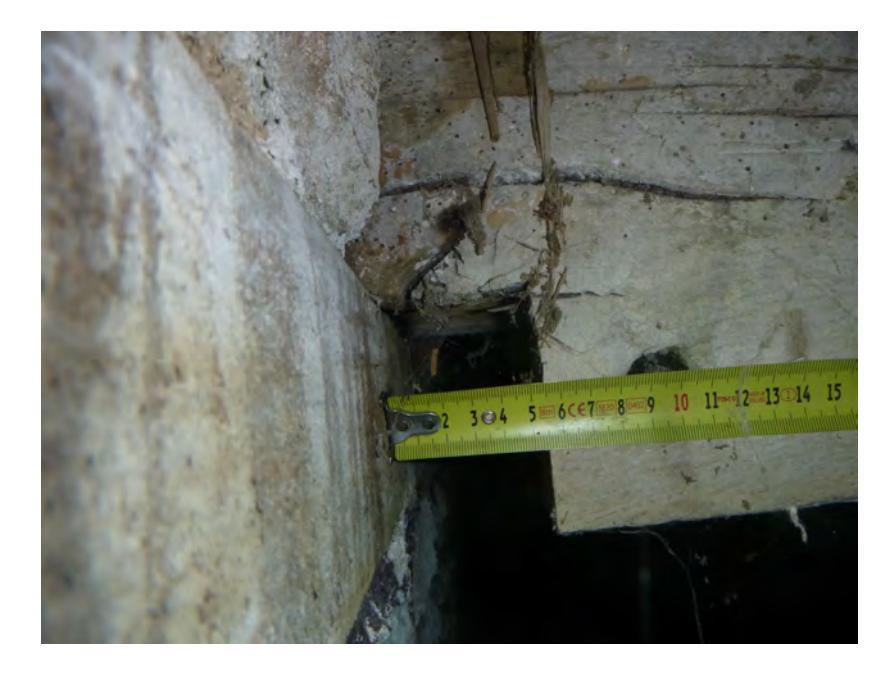
Ground floor; showing one of the decayed lintels on the west side. Note the two-part build-up and decay of the outermost element by wet rot and subsequent wood-boring beetle infestation

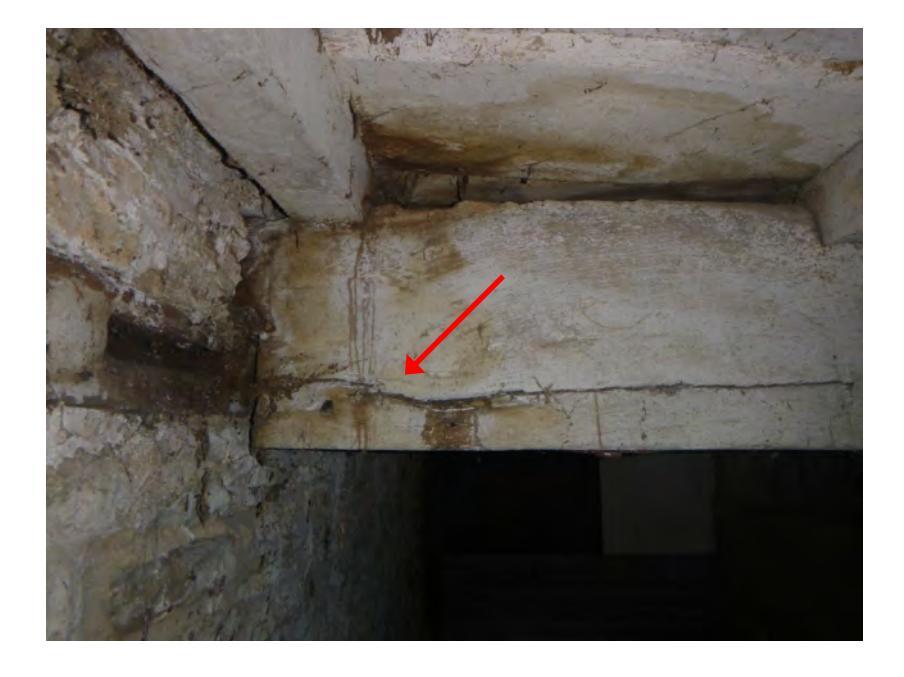
Ground floor; showing another of the decayed lintels on the west side. The innermost section was decayed by active wet rot and wood-boring beetle infestation

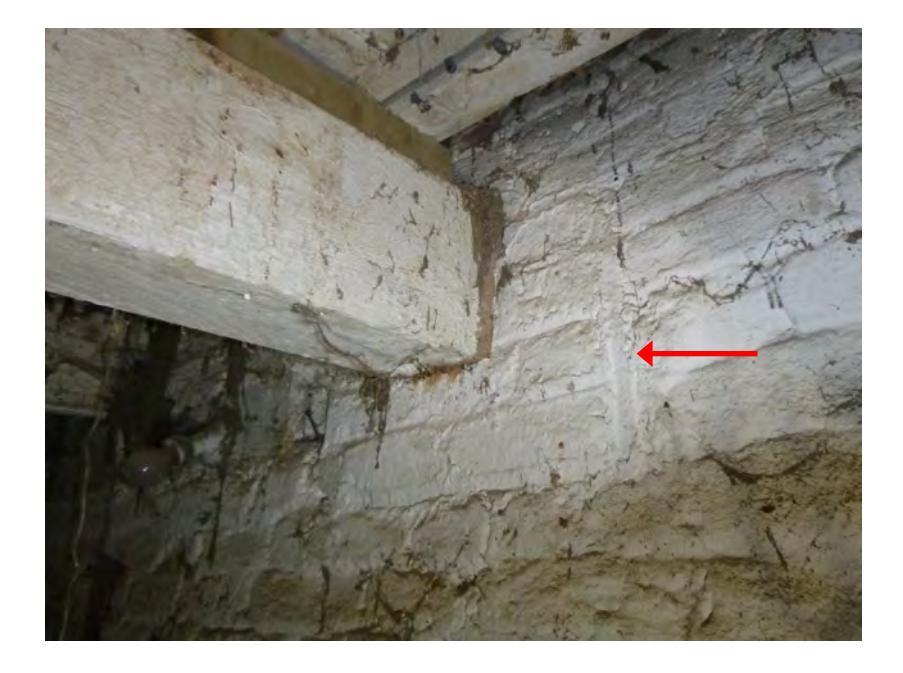
Floor structure; showing timber decay to the base of a supporting timber post of the primary beam in Fig50 above, affecting up to ~50 per cent of the cross section (arrowed)

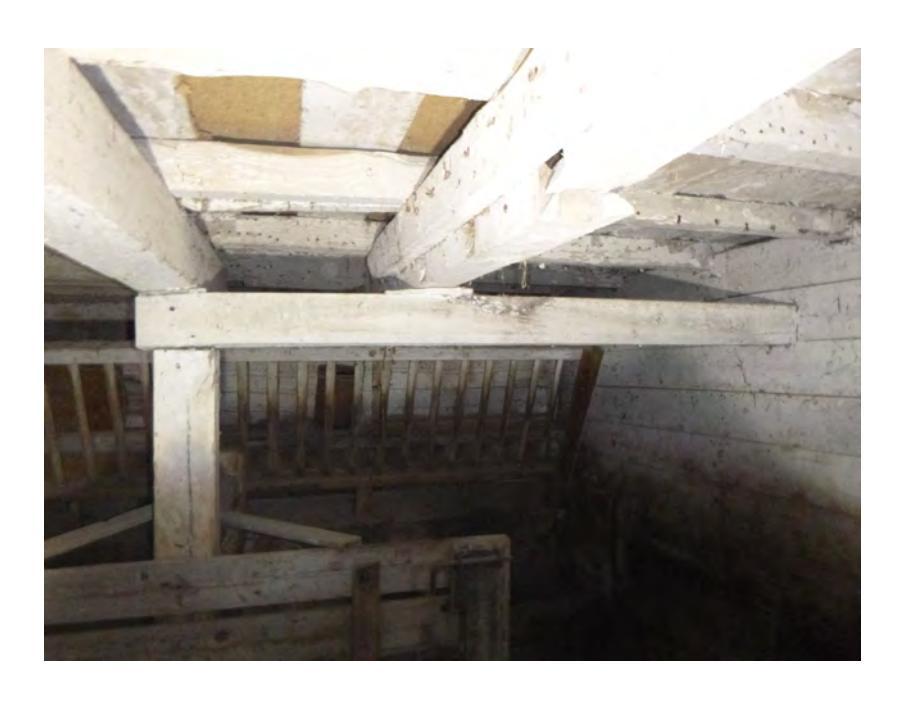
Note this fracture has occurred at an old mortice where the beam is weaker, and has been subject to remedial partner repairs along the face of the beam

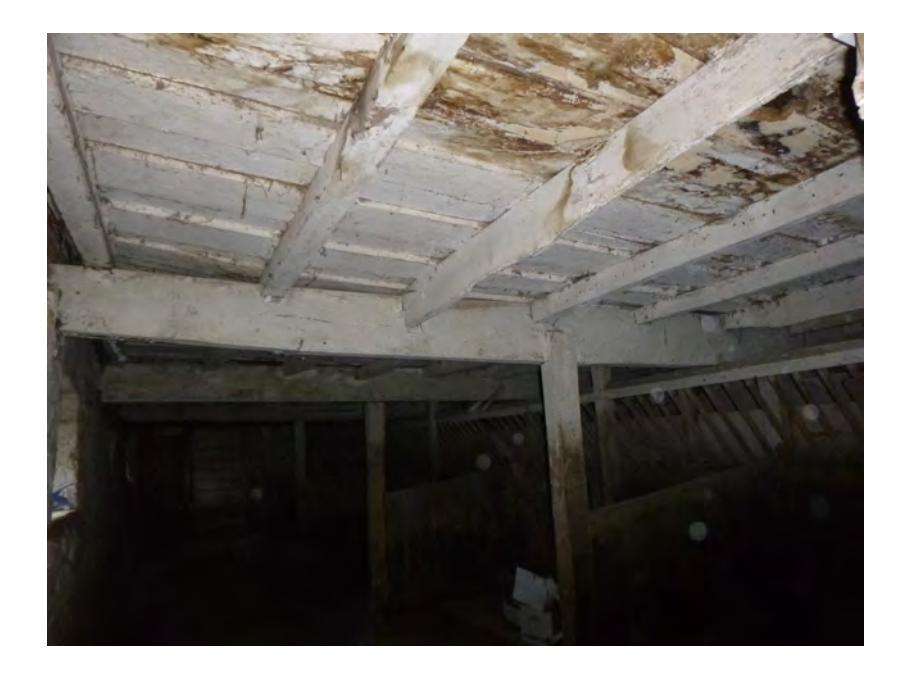
Note this arrangement, with the tenon at the top third of the joist and jointed near the top of the face of the beam, subjects the joist to high levels of compressive forces, which without a 'tusk', leaves only the thickness of the tenon to resist said forces, leading to shear fractures as seen here

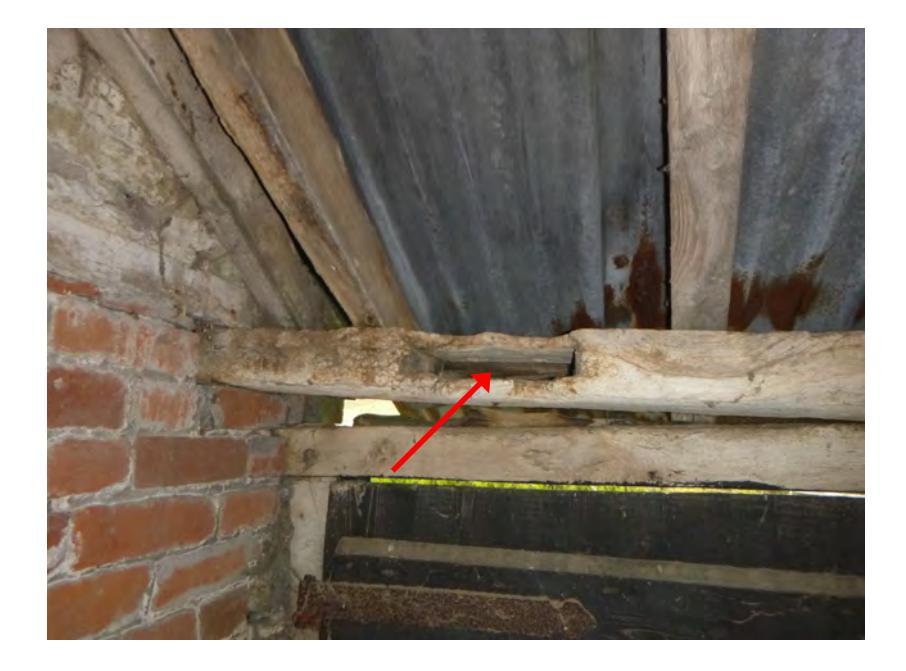
North stable block; showing structurally significant timber decay affecting bearing end of purlin on south pitch at west end. Also localised decay around wall plate embedded in west masonry wall

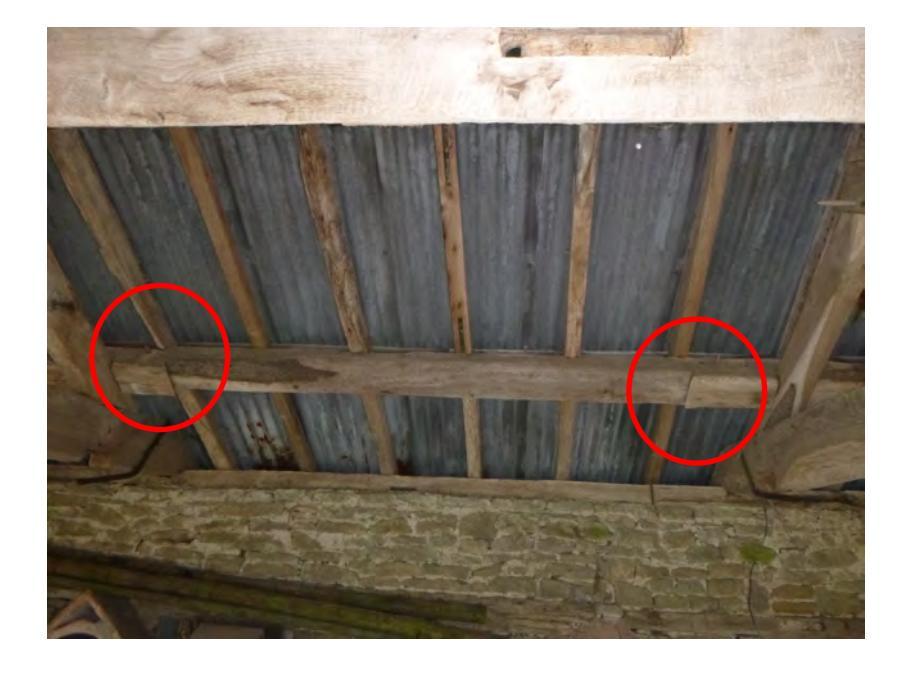
North stable block; showing structurally decayed common rafter on north pitch at east end
