ASTON HALL - SHROPSHIRE
Aston Munslow - Craven Arms

DESIGN AND ACCESS AND
HERITAGE STATEMENT

Submission to Local Authority

September 2021 - REV 0

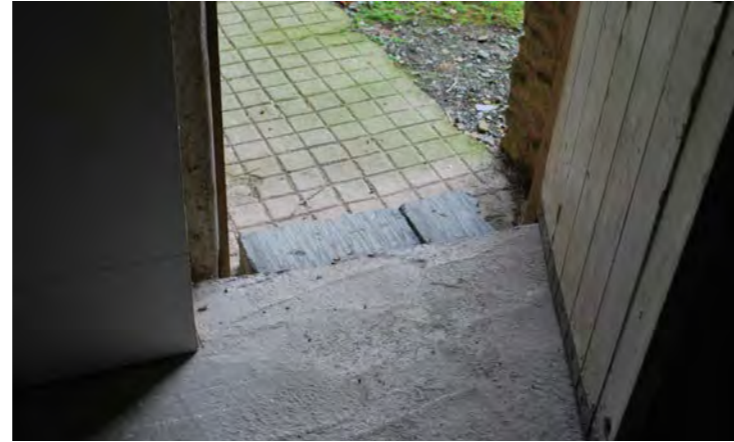
4. MODERN CONCRETE OR CEMENT SCREED

4. Concrete floor: This is a raised floor and it is likely that a cement screed has been applied over a traditional floor, this will need to be removed and replaced with a breathable floor.

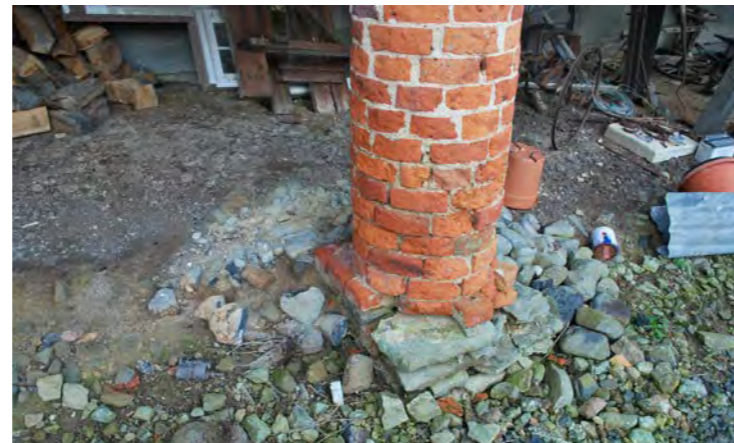
5. BRICK PIER BASES DAMAGED BY RISING DAMP

5. Brick piers: The oversite concrete has forced damp up the soft brickwork, which has delaminated due to subsequent frost action. It will need to be repaired and repointed in lime.

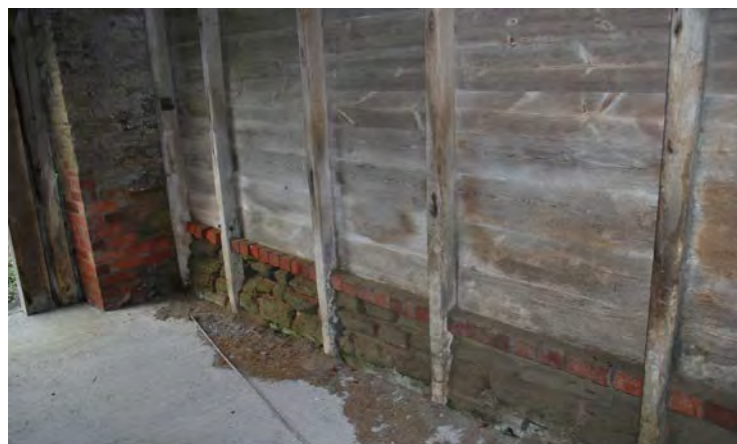
3. MODERN CONCRETE FLOOR AND DAMP IN DWARF RETAINING WALL

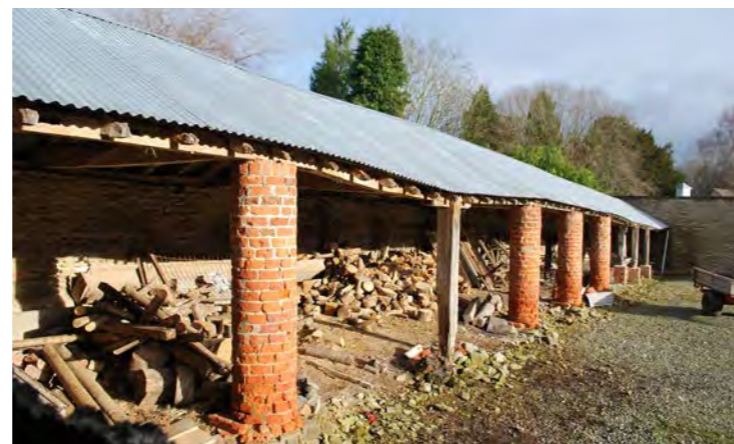
6. BRICK PIERS: MISSING PIERS TO BE REBUILT

6. Brick piers: Open barn: The brick decay to the bases has resulted in their total collapse in the past, and some are now missing. It is proposed that they should all be rebuilt.

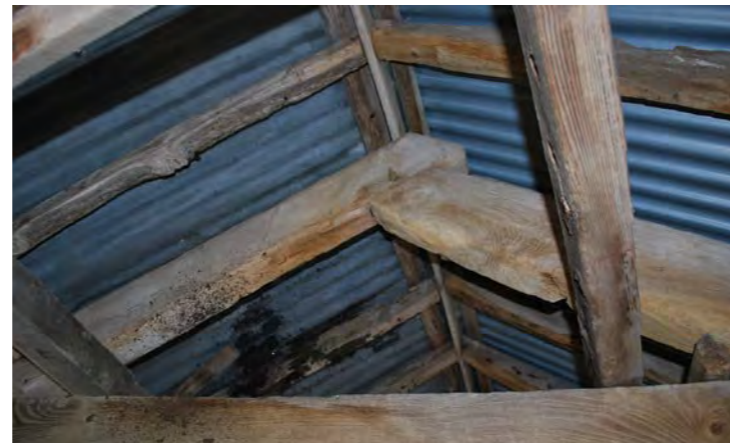
4. Simple triangular truss to the open barn roof: This range has been in very poor condition in the past. Many of the piers collapsed and the roof covering removed and replaced with corrugated iron. The remaining timbers, though crude, may still be serviceable as structure to support new timber-work.

4. SIMPLE TRUSS TO OPEN BARN ROOF

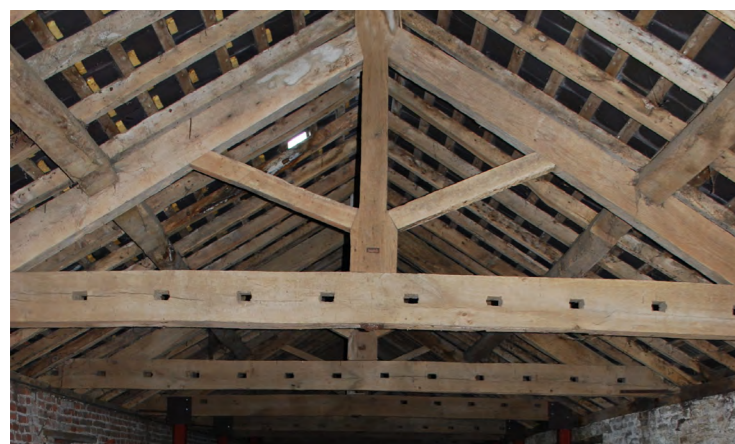
3. King post truss similar to photo 2. When the roof was reslated, the farmer economised by not replacing the roof battens and employed timber blocks instead. The roof cover-up is likely to fail because of the deficient fixings achieved.

3. KINGPOST TRUSS WITH TIMBER BLOCKS SUPPORTING THE SLATES

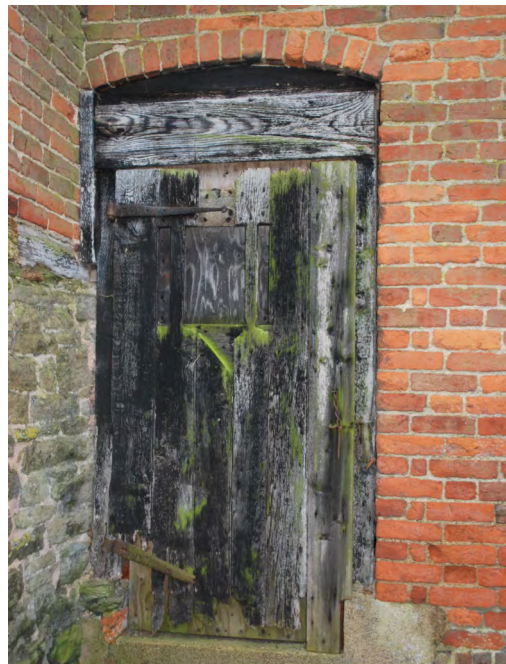
2. HISTORIC DOOR VERY BADLY ALTERED

2. Historic door: This door has been very badly strengthened with plywood and provided with a concrete threshold. The threshold will need to be replaced, the door lining scarfed in where missing, and the door properly repaired.

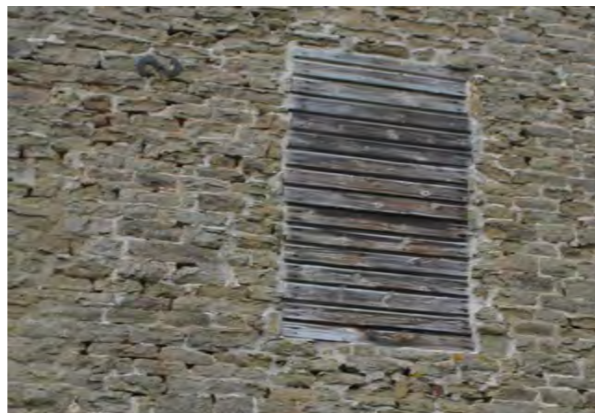
7. TIMBER SLATTED WINDOW OPENING

7. Timber slatted window opening: The original timber frame and window is likely to have rotted away and been replaced with this crude old boarding with open joints to allow ventilation.

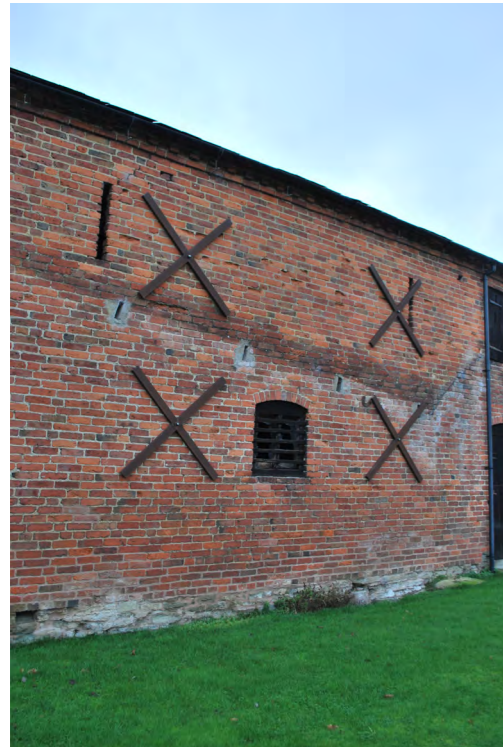
1. Steel wall ties: The South facing brick walls of the North range are leaning out dramatically, see photo 3. Significant structural strengthening has been constructed, which is exceptionally crude and ugly, but appears effective. The cause of the outward leaning wall is likely to be a rotation of the foundations, inadequate tying of the first floor joists to these walls to provide restraint and prevent the outward thrust of the roof.

1. STEEL WALL TIES

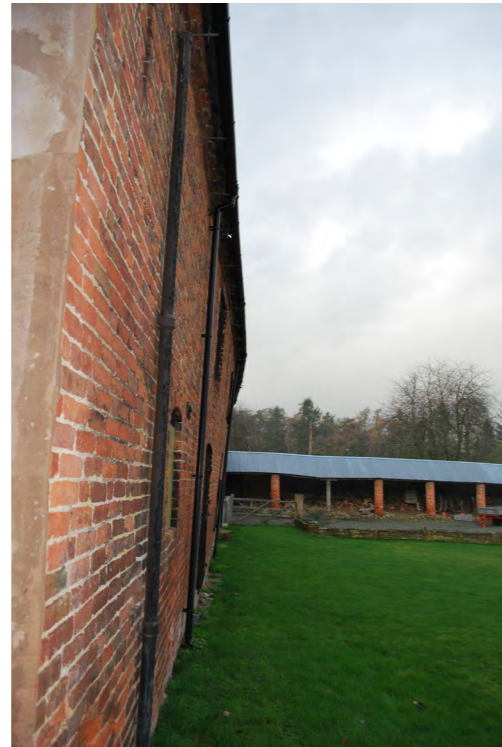
3. OUTWARD LEANING SOUTH WALL

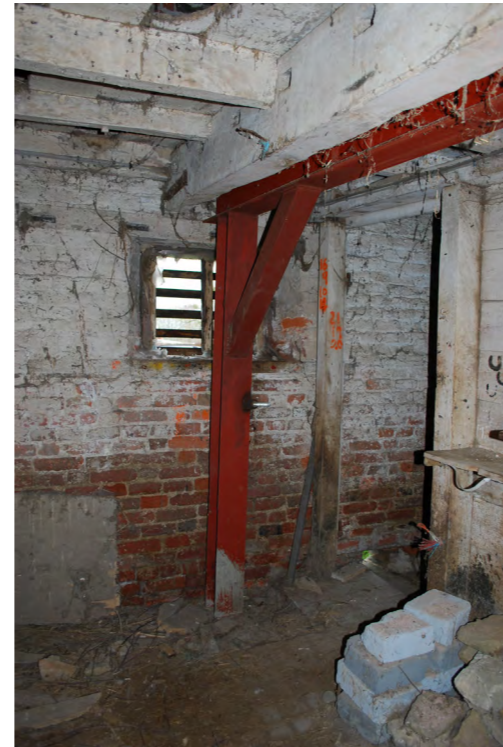
5. Internal Steel Frame (South Wall): This frame appears to support the structure at first-floor level, similar to Photo 2. It is proposed to replace it with a more sympathetic structure. The first-floor timbers have generally failed or are failing, and it will be necessary to repair and tie-in these floors to the walls on each side to provide additional restraint.

5. INTERNAL STEEL FRAME (EAST WALL)

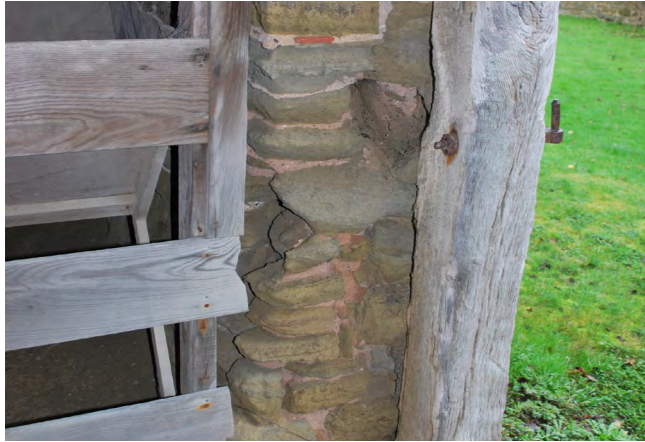
1. STONE PIER TO BE REBUILT

1. Stone pier needs to be rebuilt: The local stonework is very 'soft' and has deteriorated severely. It is structurally relatively weak and fails when overloaded. Stone repairs will be also required.

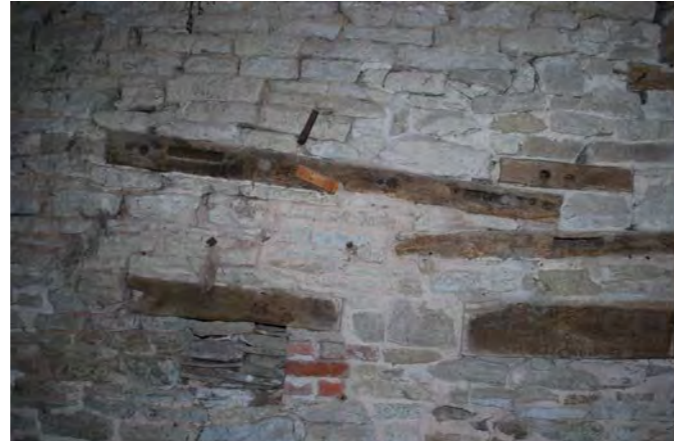
4. STRUCTURALLY FAILING STONE WALL
NEEDING TO BE TIED TOGETHER

4. The stone wall will need to be tied together: this wall, has been extensively repaired using 'bonding' timbers. However, there appear to be movement cracks that could still be 'live'.

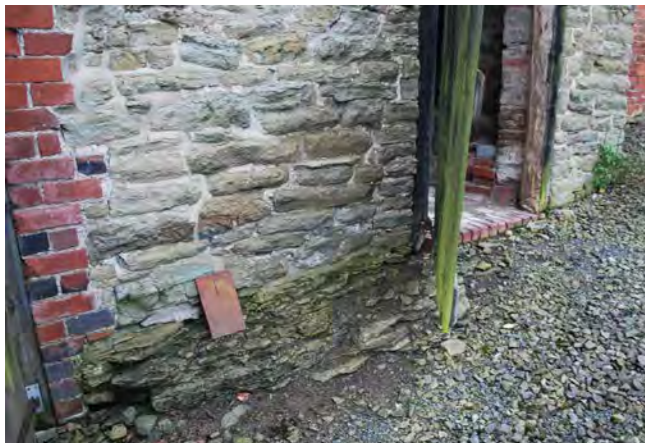
2. BRICK AND STONEWORK TO BE REPOINTED

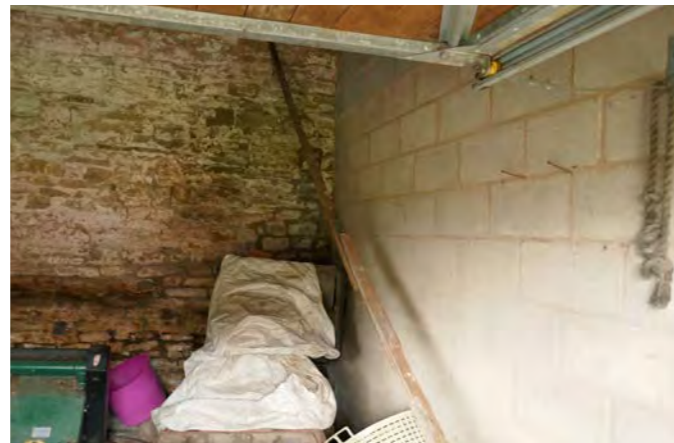
5. MODERN CONCRETE BLOCKWORK TO COACH
HOUSE TO BE REPLACED

5 & 6. The current proposals for the Coach House take into consideration the reconstruction of the modern concrete blockwork walls in order to take the proposed new double pitched roof.

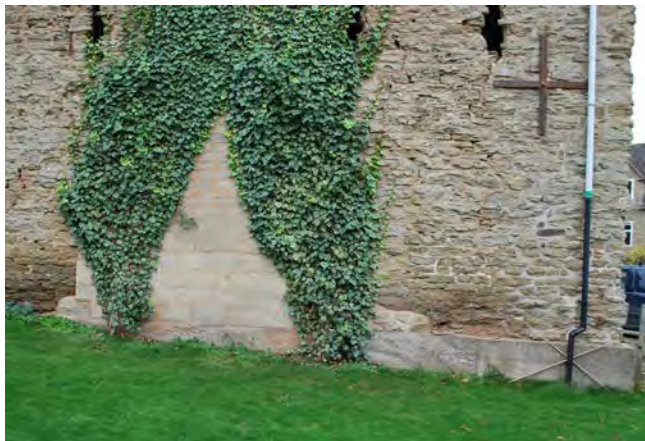
3. MODERN CONCRETE BLOCKS TO BE REPLACED

3. Modern concrete blockwork will need to be replaced: This section of wall would appear to have collapsed in the past and been rebuilt with a new concrete footing above and presumably below ground level.

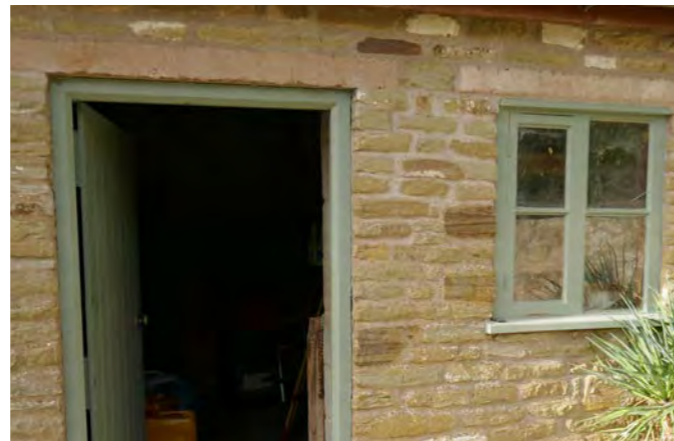
6. MODERN BLOCKWORK & STONE ELEVATION
WITH CONCRETE LINTELS TO BE REPLACED
