# **Arboriculture Impact Assessment**

Project:
Summerville,
Hargate Drive,
Hale WA15 ONL

Date: June 2021

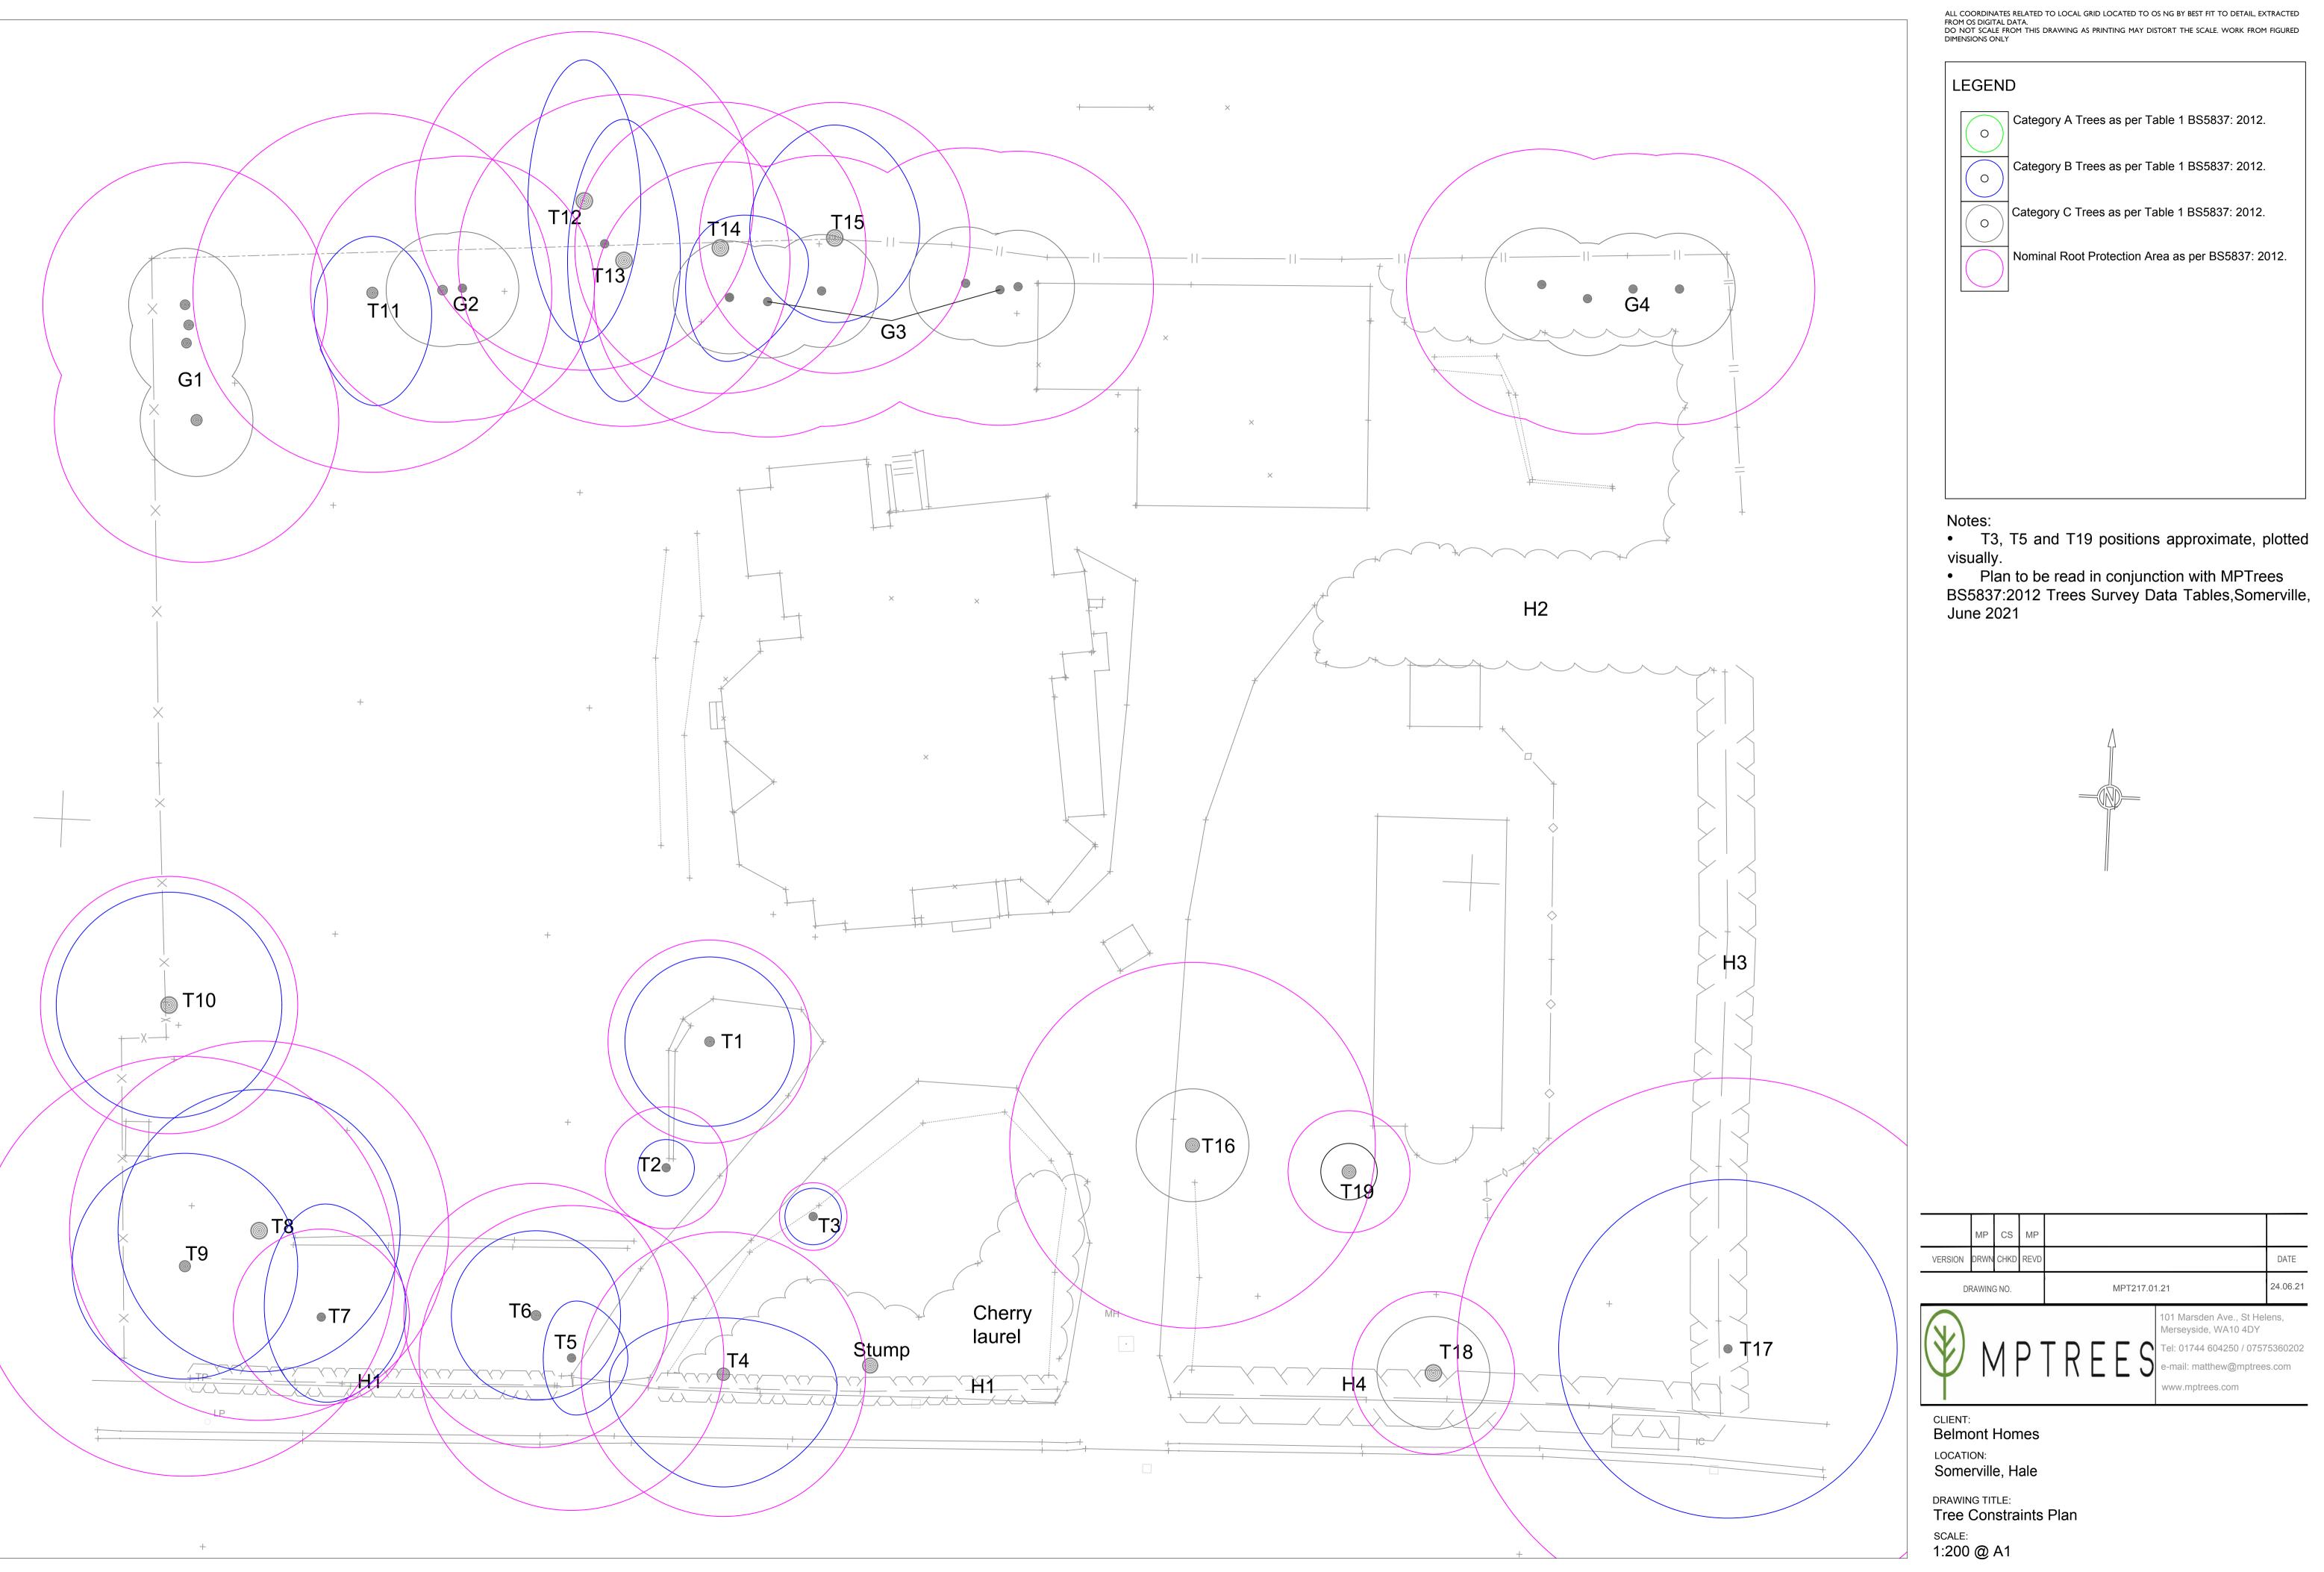
MP	CS	MP		
VERSION	DRWN	CHKD	REVD		DATE
DF	RAWING	G NO.		MPT217.01.21	24.06.21

2.1 The application site is in a residential setting and consists of a detached property set in formally landscaped grounds. There are a variety of both native and non-native trees on and adjacent site. The current site layout and the location of all trees surveyed for this assessment can be seen on plan MPT217.01.21 at appendix 1.

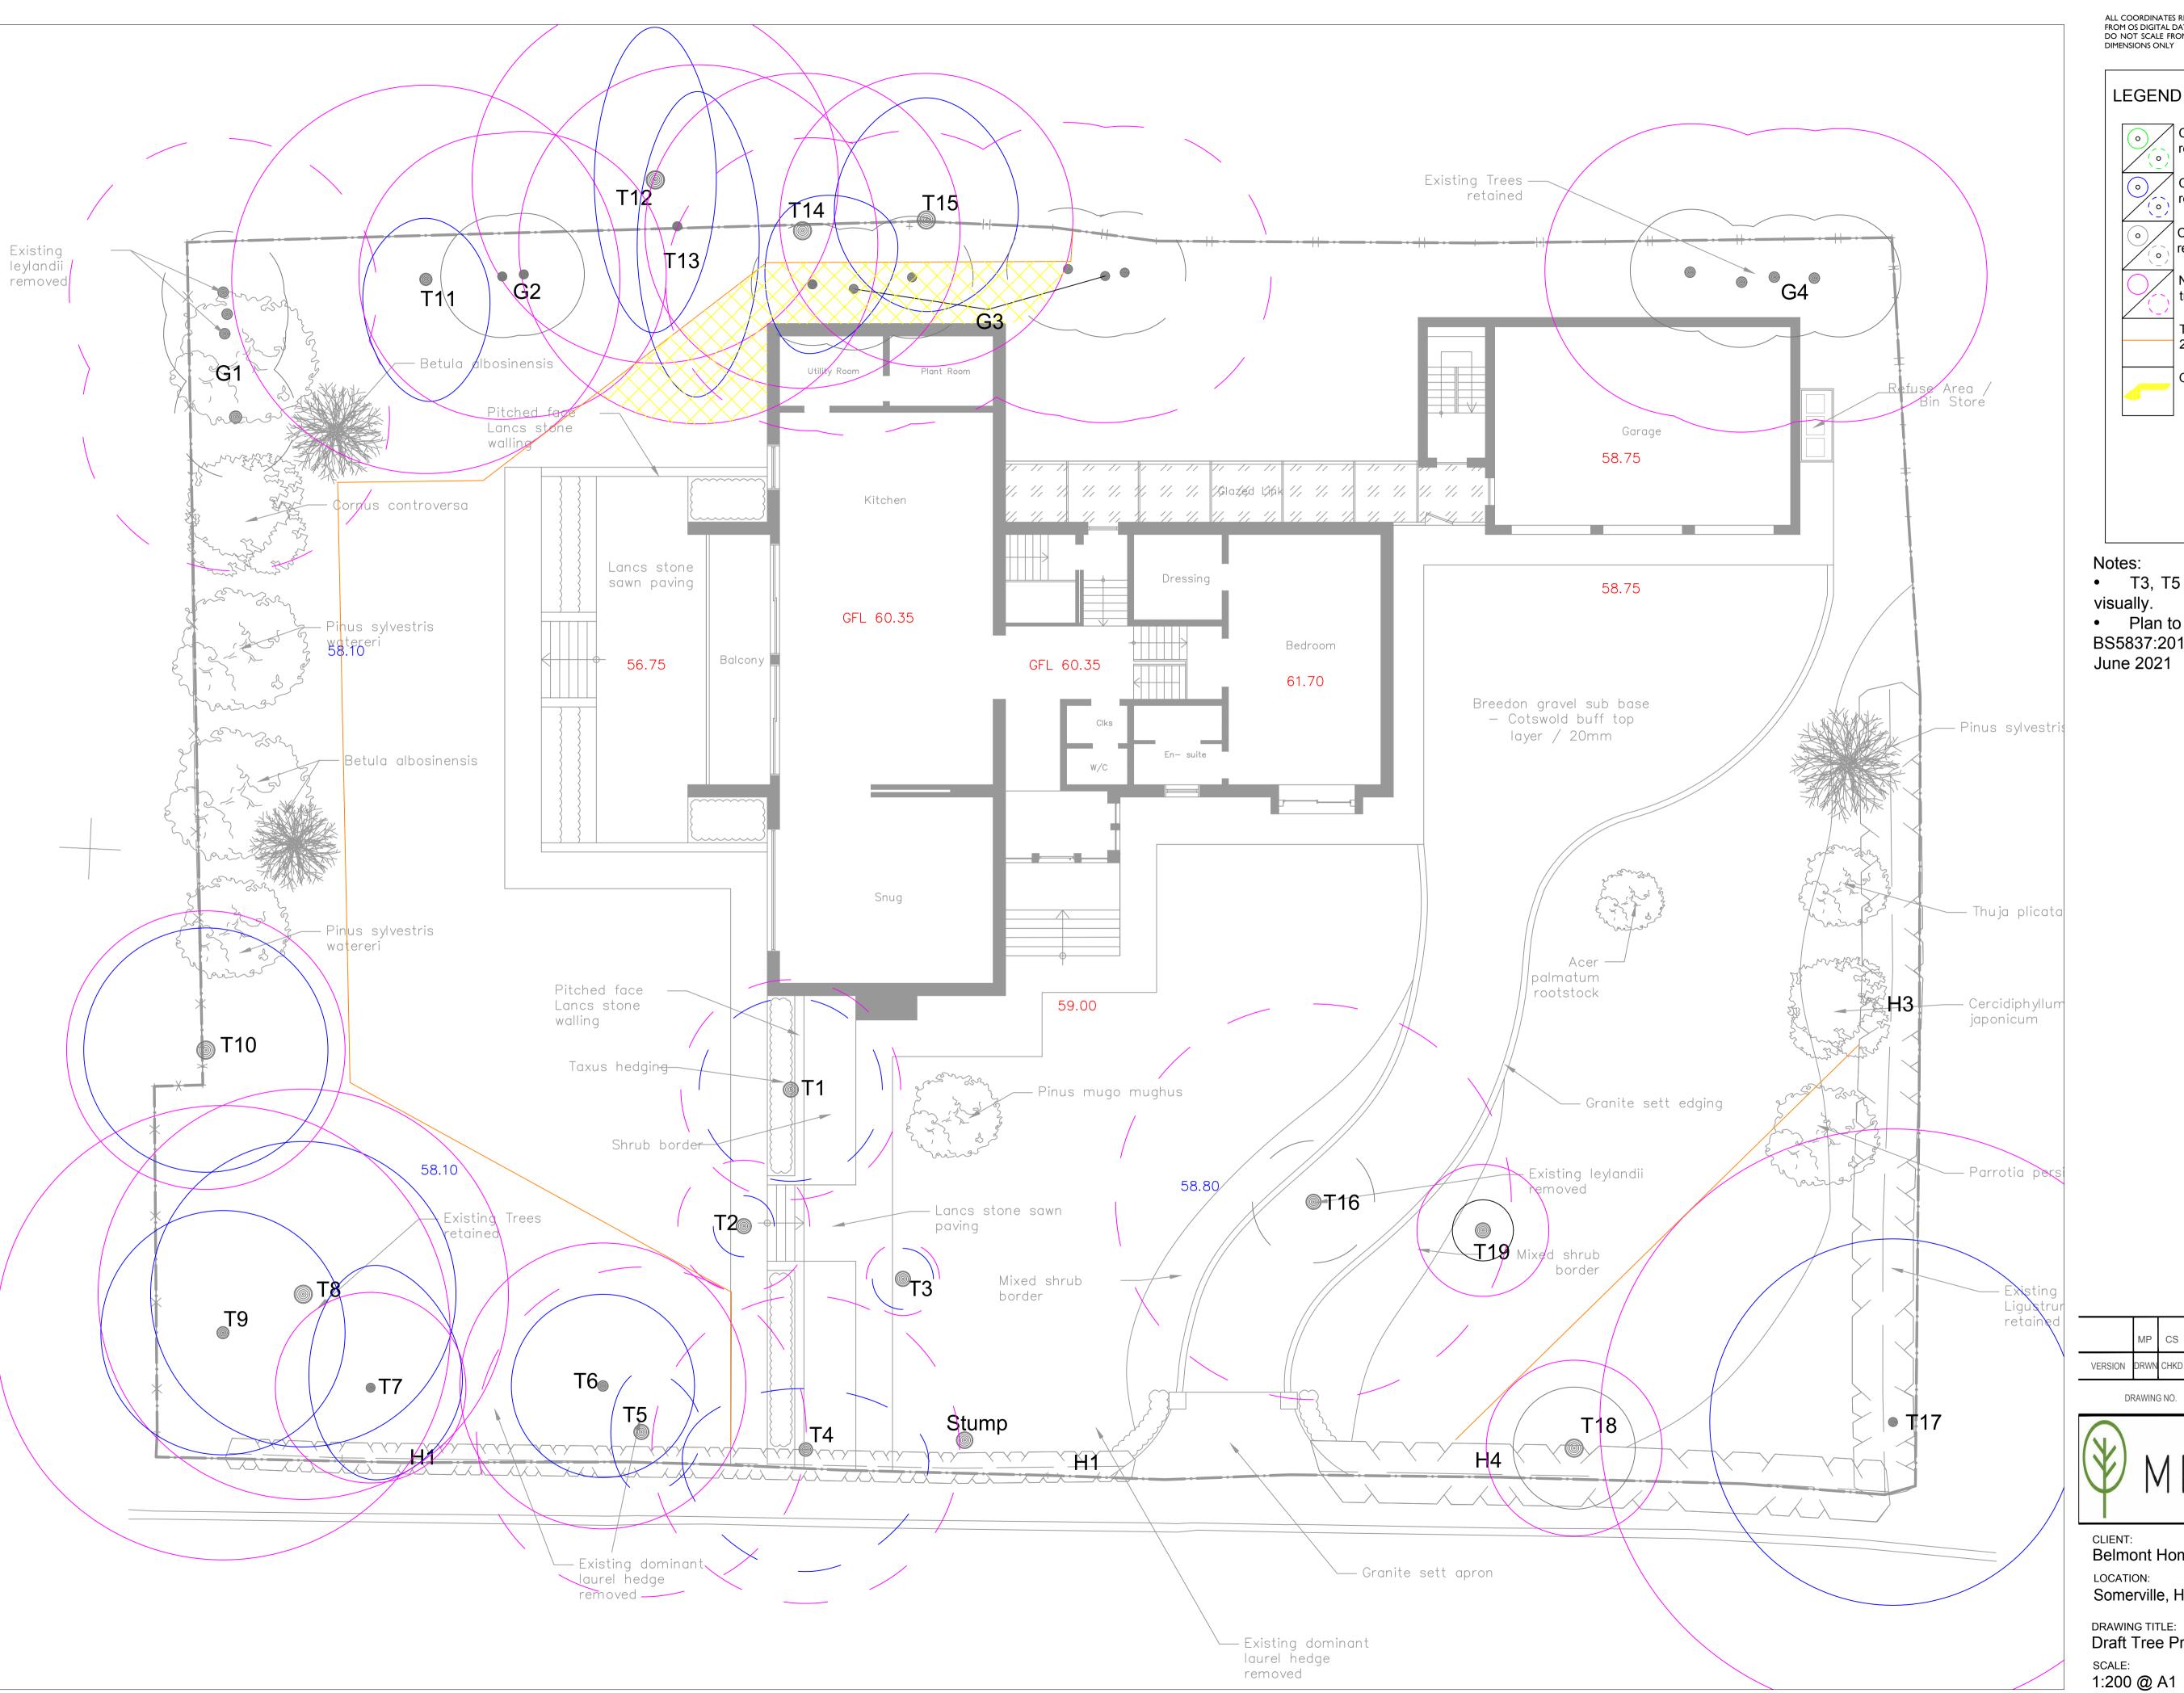
DRAWING TITLE: Draft Tree Protection Plan

4.1 As can be seen on drawing MPT217.02.21 at appendix 3, the application proposal will require the removal of; 5no. individual trees categorised as category B2 as per Table 1 of BS5837:2012, 1no. category C2 individual tree, and two groups of category C2 trees.

- 4.3 As can be seen on drawing MPT217.02.21 at appendix 3, the new dwelling and garage is proposed within the Root Protection Area of trees T13, T14, T15 and G4. The construction of new foundations will result in root damage to these trees. In addition, the erection of scaffolding and the passage of men and machines within the RPA will result in further root damage and loss through ground compaction. The root damage and loss to these trees will have a moderate to major negative impact on these trees and will lead to a decline in their condition and safe useful life expectancy.

- 4.4 To mitigate potential root loss, foundations for the new dwelling and garage within retained trees RPA must be constructed using mini plies and ground beams to remove the requirement for excavations.

- 4.5 To mitigate any further root damage and/or loss to retained trees, tree protection barriers conforming to section 6.2.2 of BS5837: 2012 must be installed before the start of demolition activities, and maintained for the duration of construction activities, in the locations recommended on the draft tree protection plan at appendix 3 of this report. Areas protected by fencing must be exclusion zones to all demolition and construction activities, including the storage of materials or the discharge of waste, unless otherwise agreed by Trafford Council.

- 4.6 In addition to tree protection barriers there will be a requirement to install ground protection, in accordance with section 6.2.3 of BS5837:2012, in those areas of RPA outside of tree protection fencing. Fencing will need to be set back from the proposed new build line to facilitate scaffolding and passage of men and machines and ground protection must be installed before the start of demolition activities, and maintained for the duration of construction activities, in the locations recommended on the draft tree protection plan at appendix 3 of this report.
