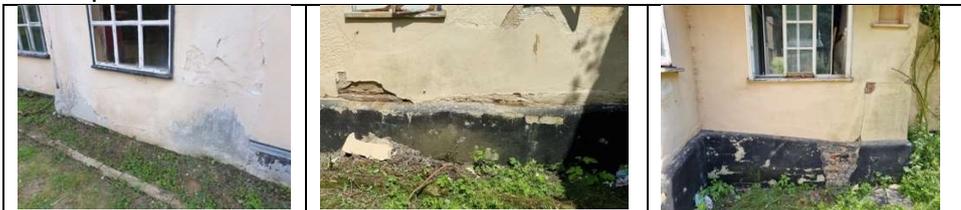
7. The areas of concrete that will be removed have no pargetting details on them so no new pargetting will be introduced. Photos attached showing existing concrete render with a plain finish.

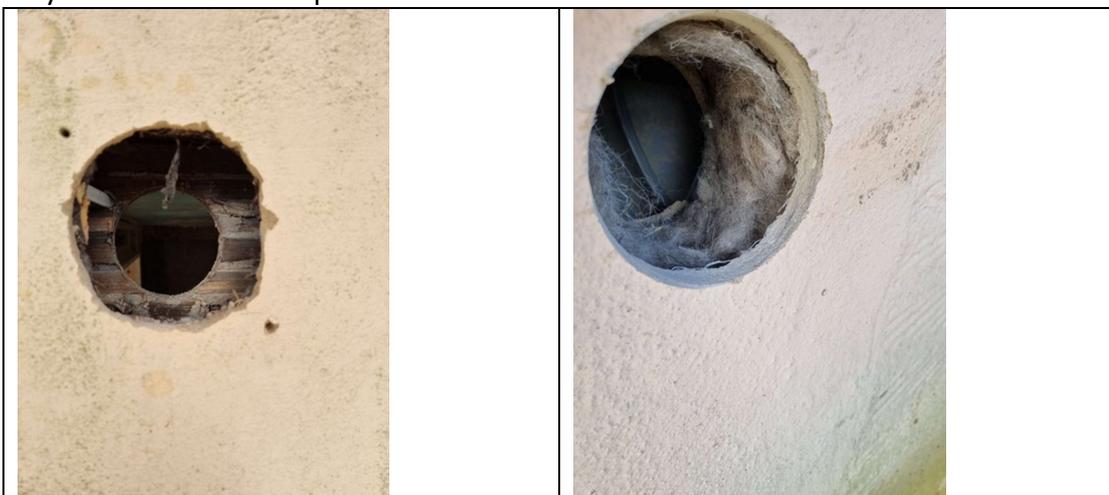
8. Photos attached showing extractor vent cutouts through the existing infill material only. Locations on Floorplan J and K.

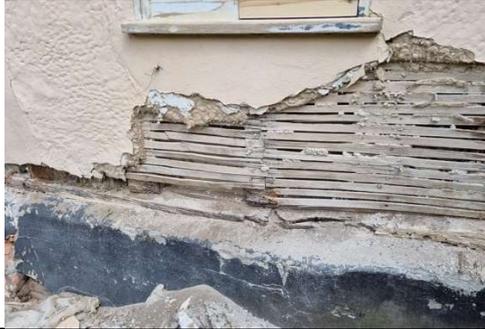
Existing

9. Location on Floorplan G,H and I. Many existing laths are in good condition as per photo and can be used for the new lime render. Proposed to replace any broken and rotten laths with Riven Chestnut Laths, details on web link below. These will be fixed with ring shank nails as per instructions to the existing timber which is in good condition.
