BS5837:2012 Tree Survey Report

Proposed Relocation of Wendover Cricket Club to Tring Road, Wendover Site

Tring Road, Wendover, Aylesbury HP22 5PN

Revision B 7th September 2021

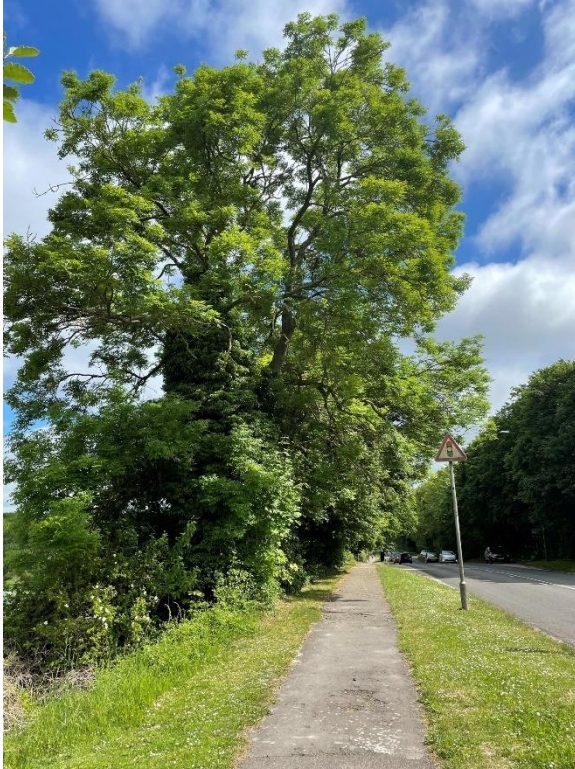
5.2 Of the 7 individual trees and 5 groups surveyed, 1 tree from G1 will require removal to facilitate construction of the development. The new access road is close to the trunks of the other trees in the group and will require protection using a “no-dig” cellular confinement system to protect the tree roots when constructing the new bellmouth access.

Photo 1 - View of G1 Ash, Pear and Plum trees adjacent to the footway on Tring Road where the new access is proposed

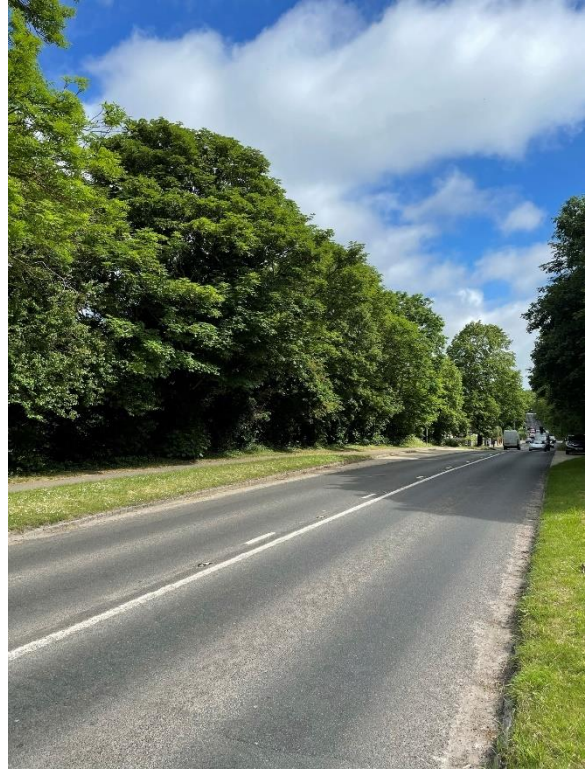
Photo 2 – View of G2 Hawthorn, Sycamore and Lime and G3 Sycamore adjacent to the footway on Tring Road

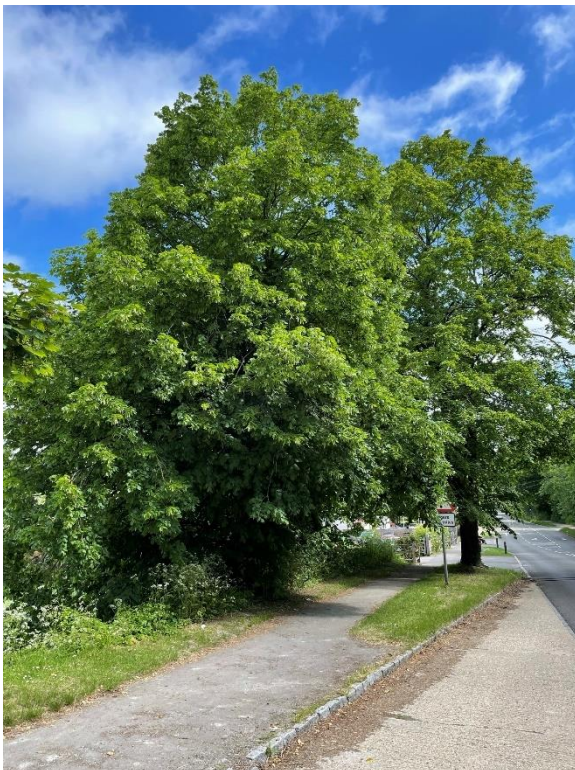
Photo 3 – View of T1 Lime, G4 Sycamore and T2 Large Leaved Lime adjacent to the existing access.

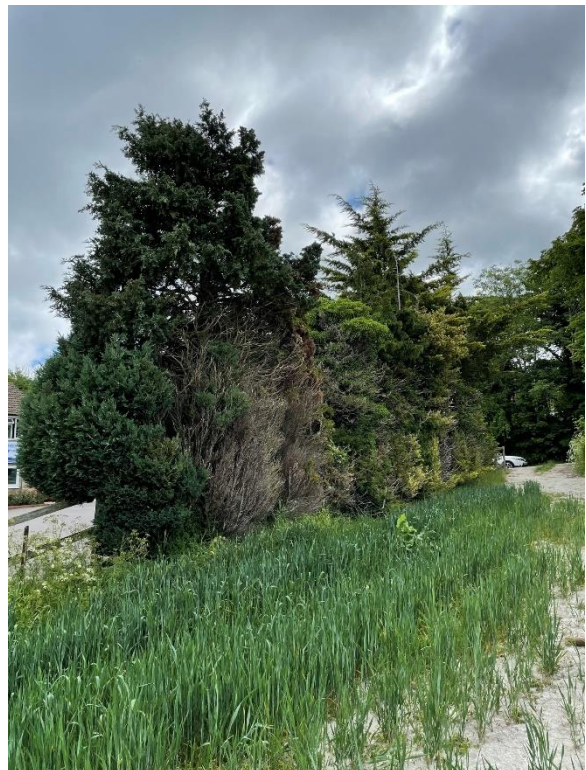
Photo 4 - View of the poor row of conifers (G5) within the site boundary

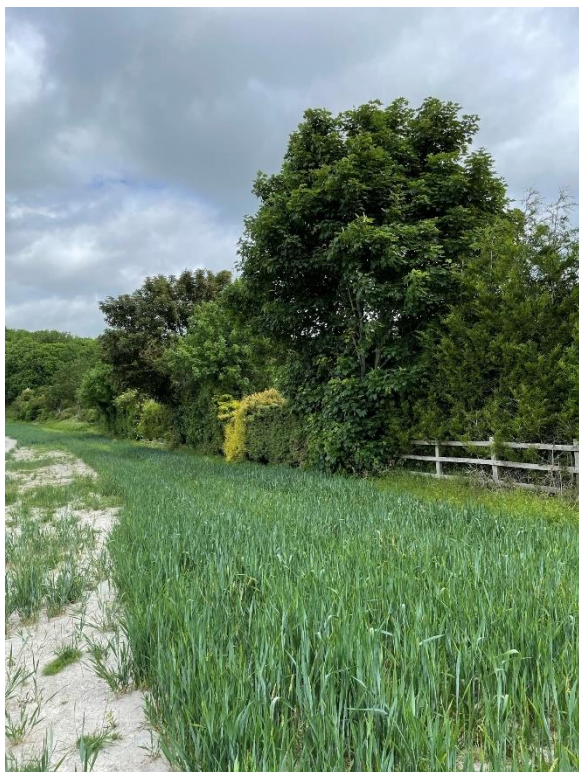
5.3 The layout of the car park on the whole does not encroach into the RPA of any of the trees to be retained, with the exception of T3 which has 2 car parking spaces encroaching approximately 2m into the root protection area which is detrimental to the survival of the tree. It is recommended that the layout is amended to move the spaces outside of the RPA. If not, then a “no-dig”

Photo 5 - View of T3 and T4 Sycamores located beyond the northern boundary

cellular confinement system should be used to protect the tree roots when constructing the car parking spaces.

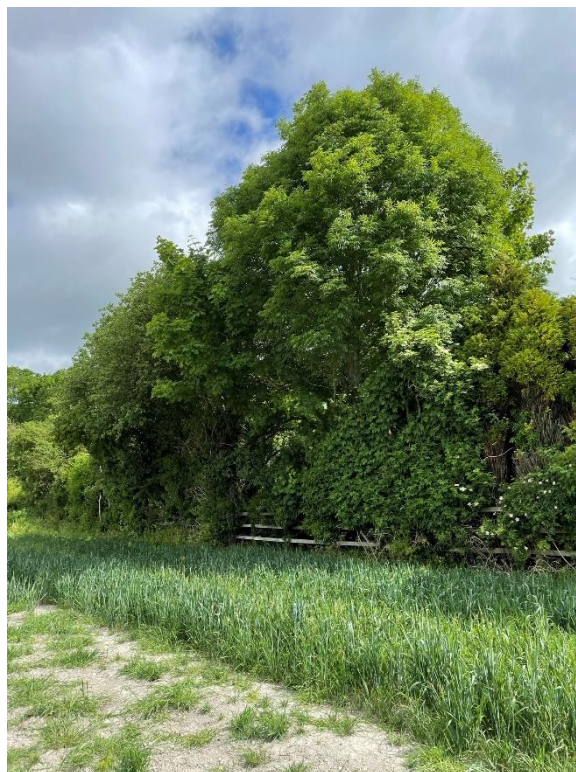
Photo 6 – View of T5 Sycamore, T6 Grey Willow and T7 Crab Apple located beyond northern boundary
