## Planning Application Reference: PP-10271975

Address: 18 Trevone Crescent, St Austell, Cornwall PL25 5ED

### Overview

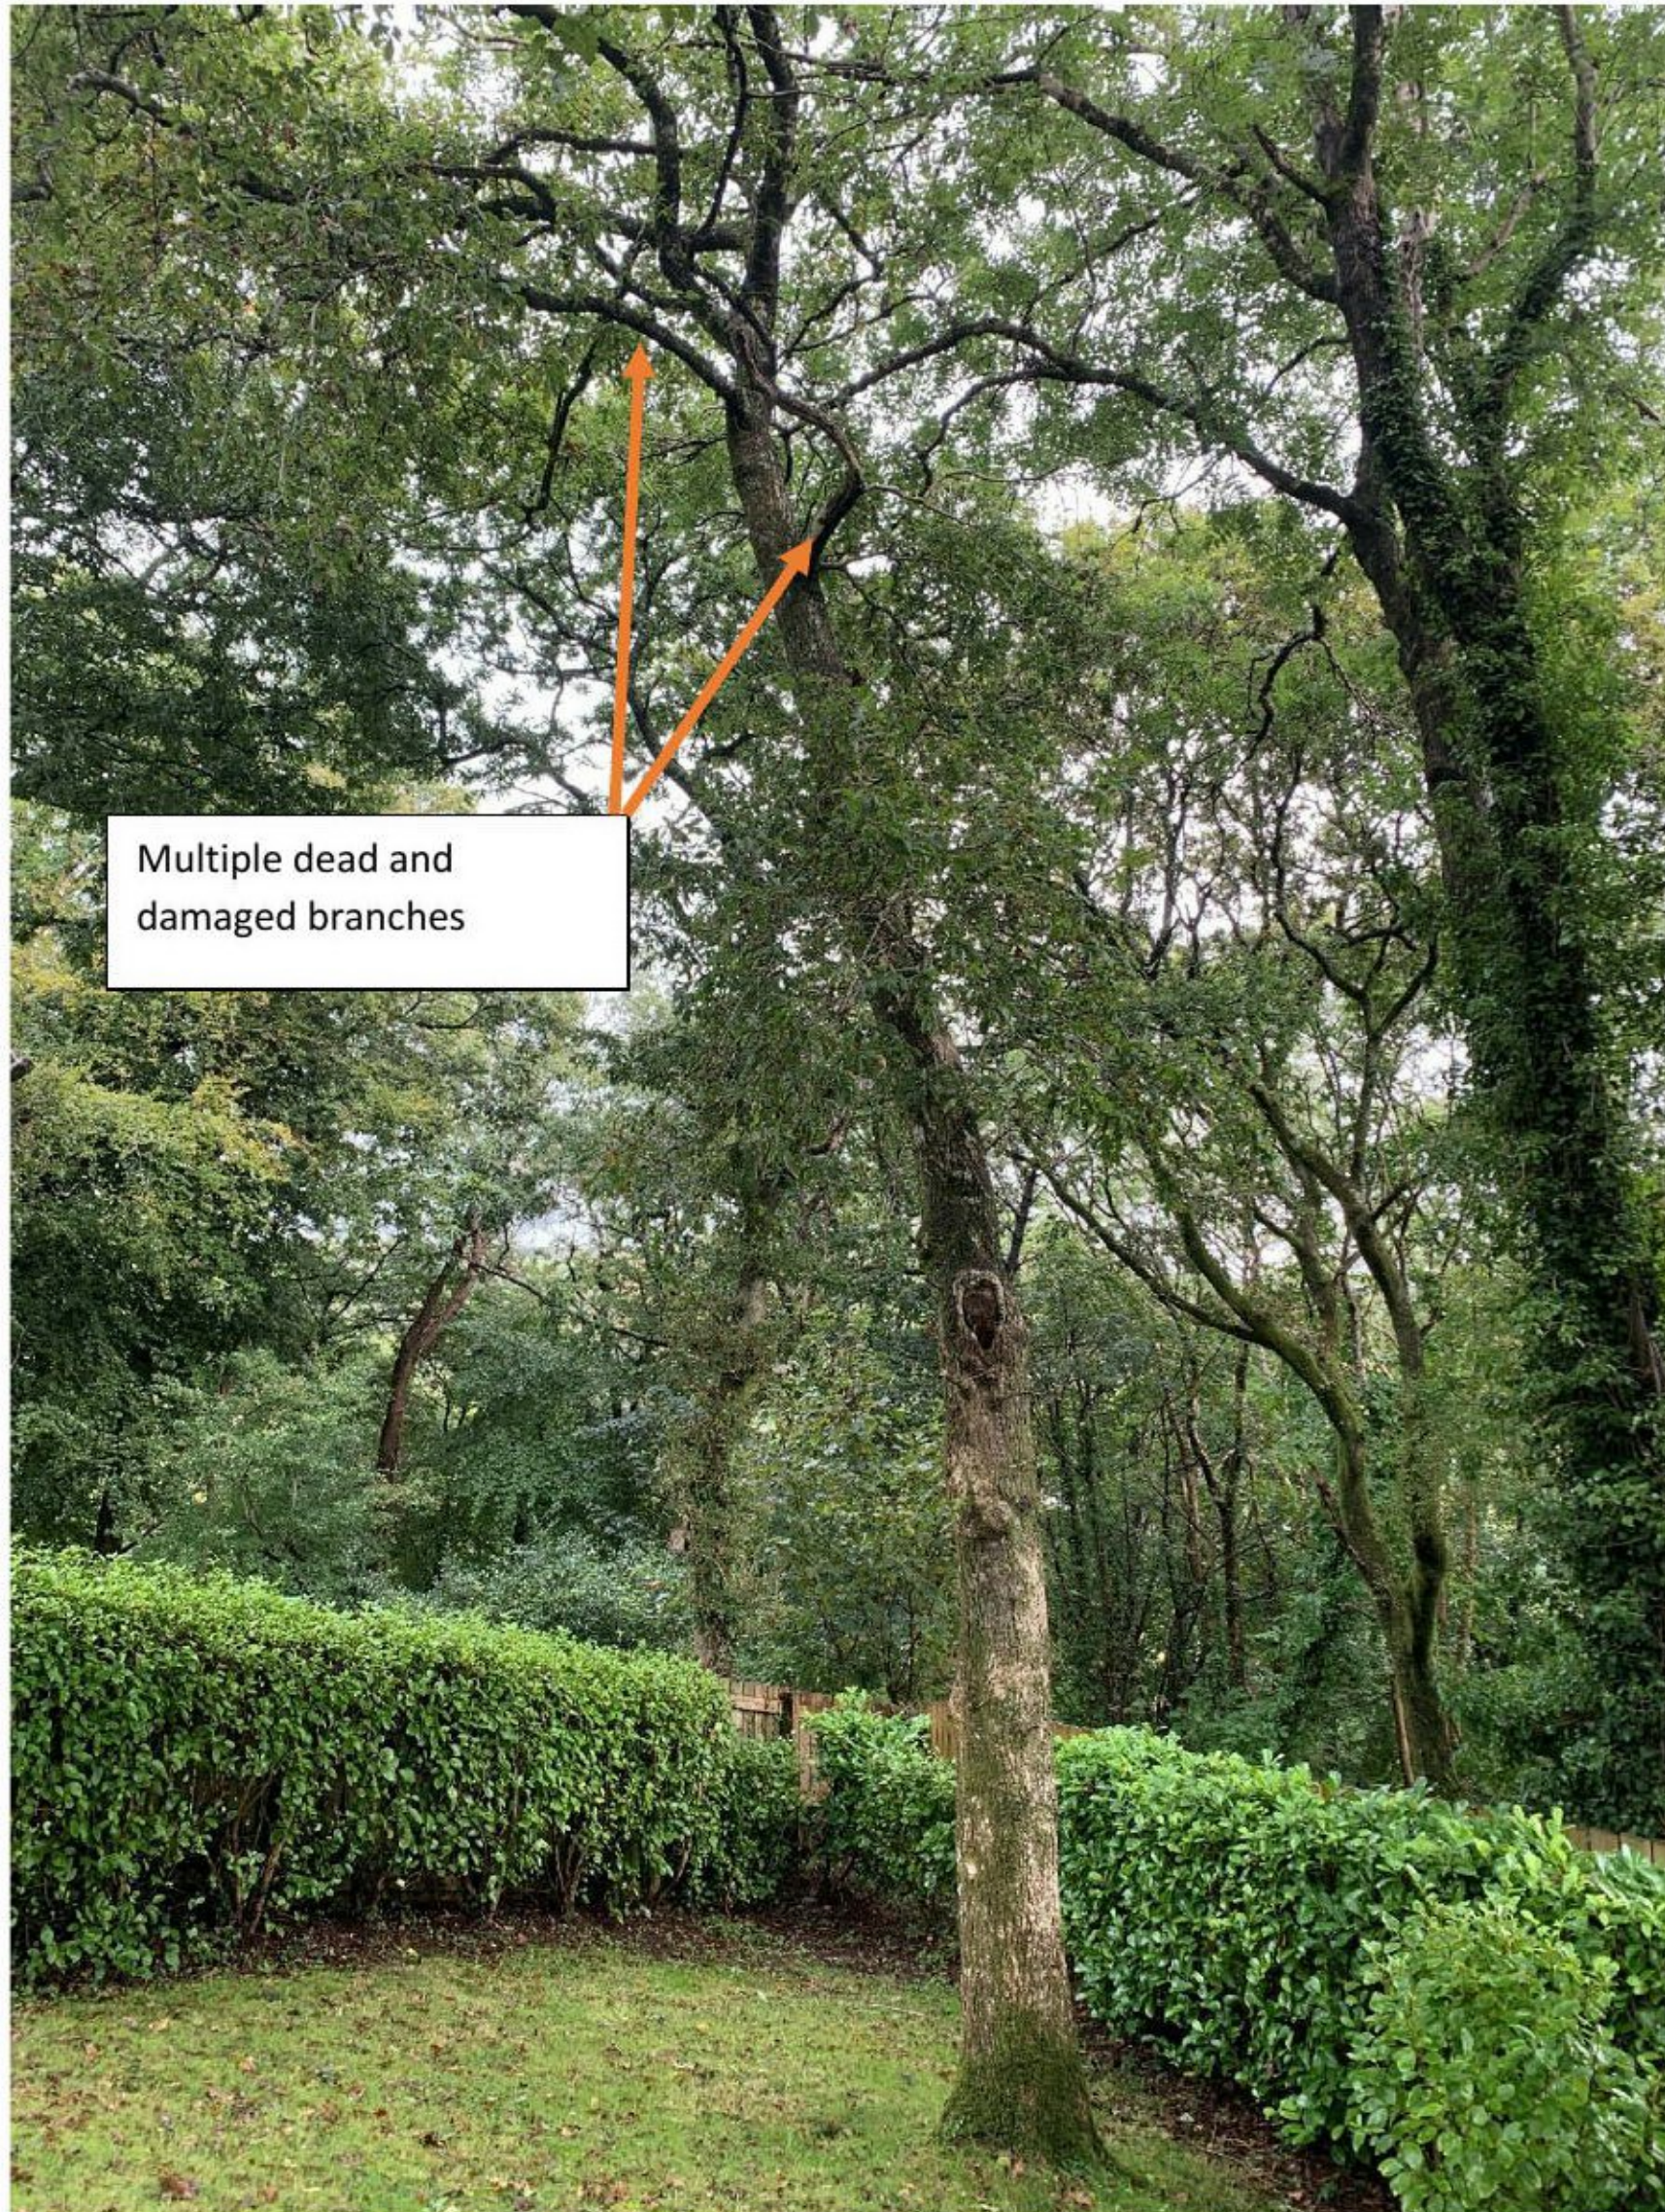
Tree 1: Oak

Limited work required, removal of dead branches which create a hazard to anyone walking under the tree.

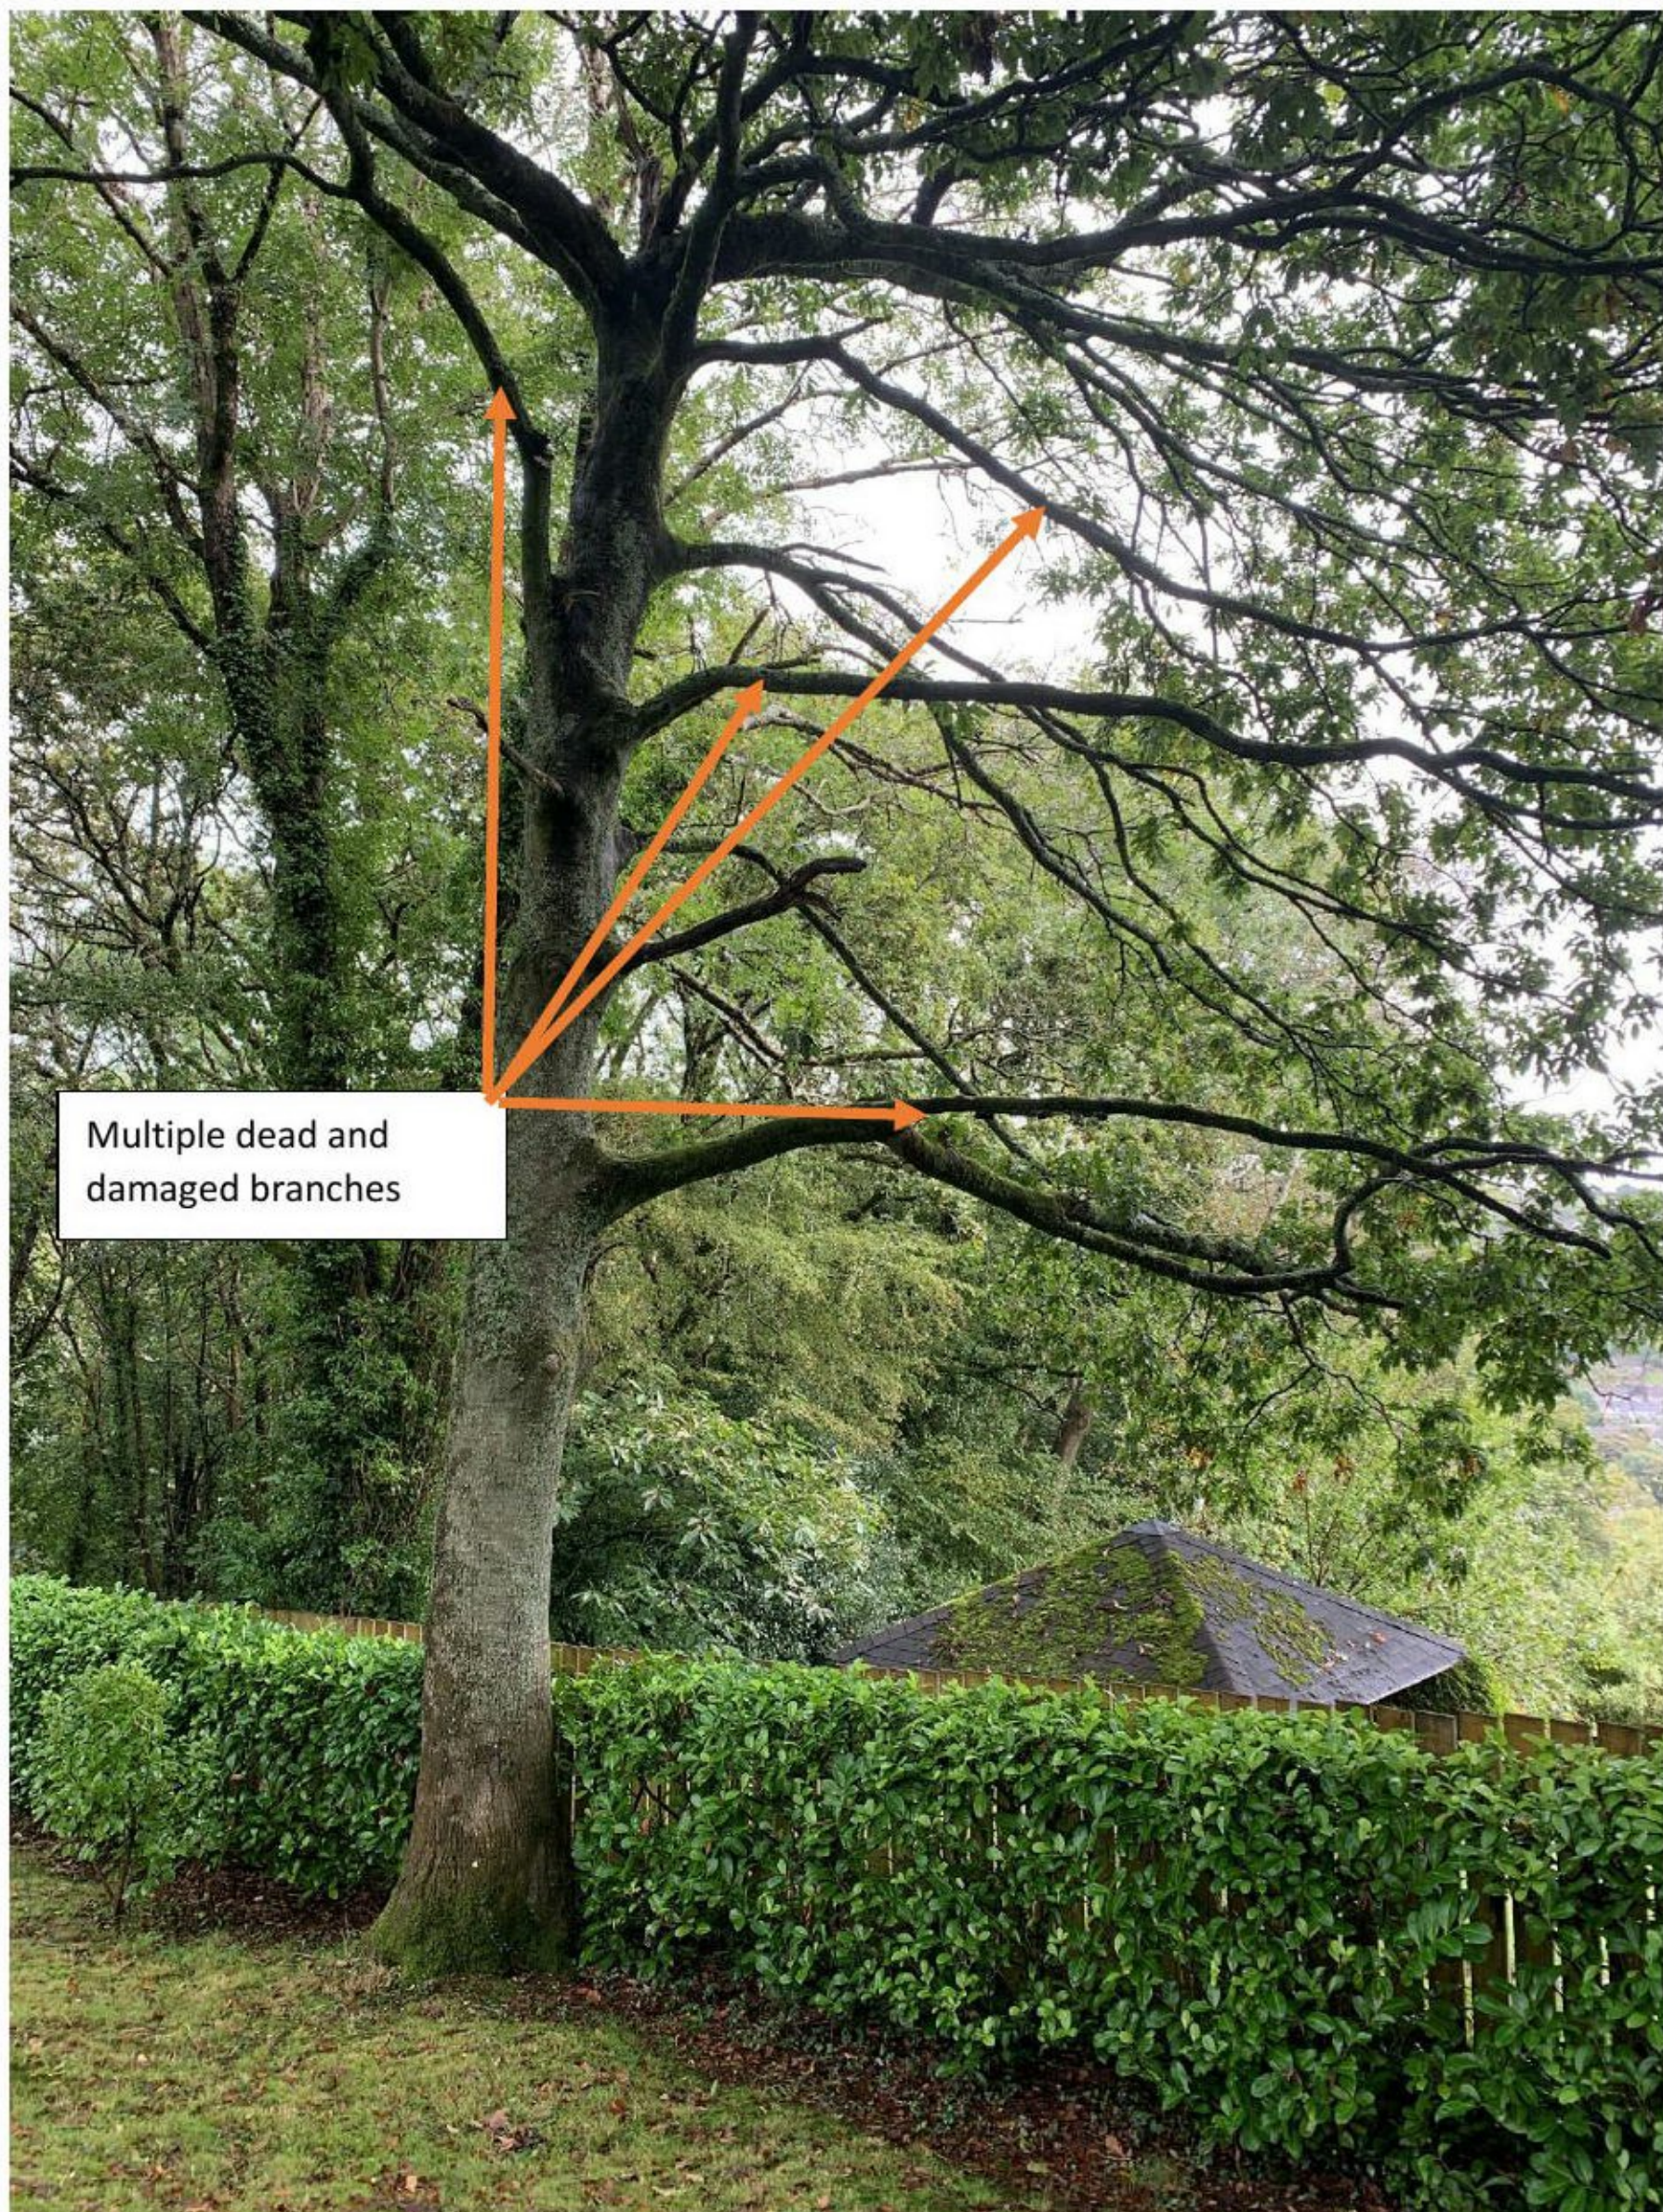
## Tree 2: Oak

Limited work required, removal of dead branches which create a hazard to anyone walking under the tree. Tree growth is biased towards the downhill side and overhangs neighbour's garden

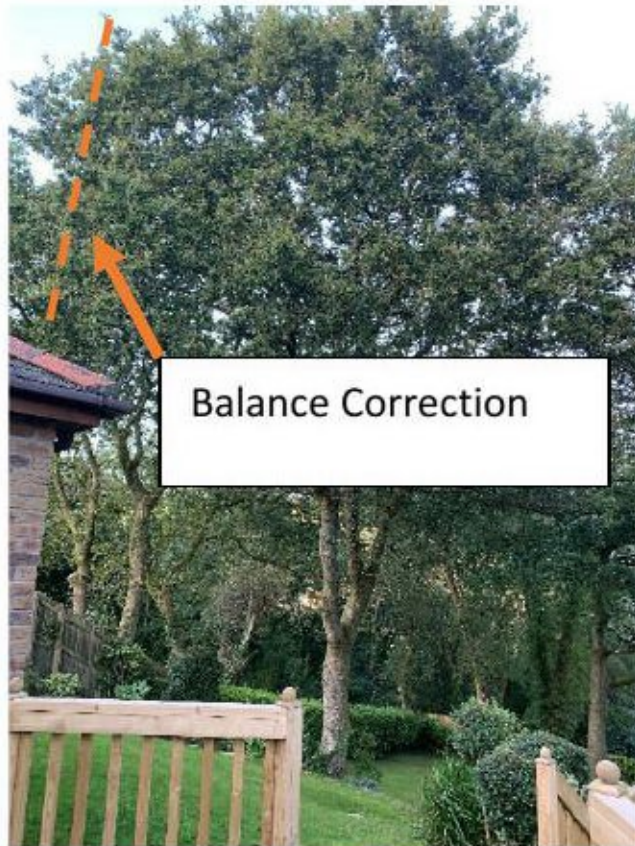
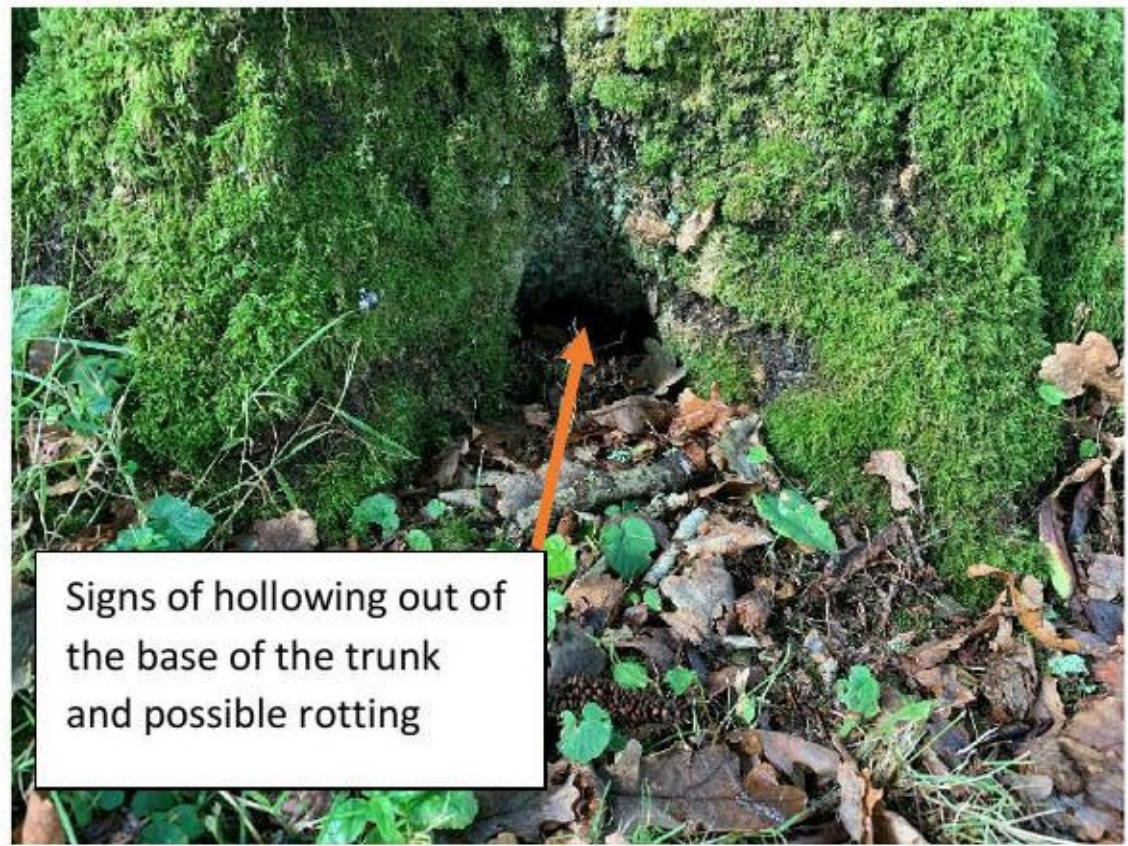
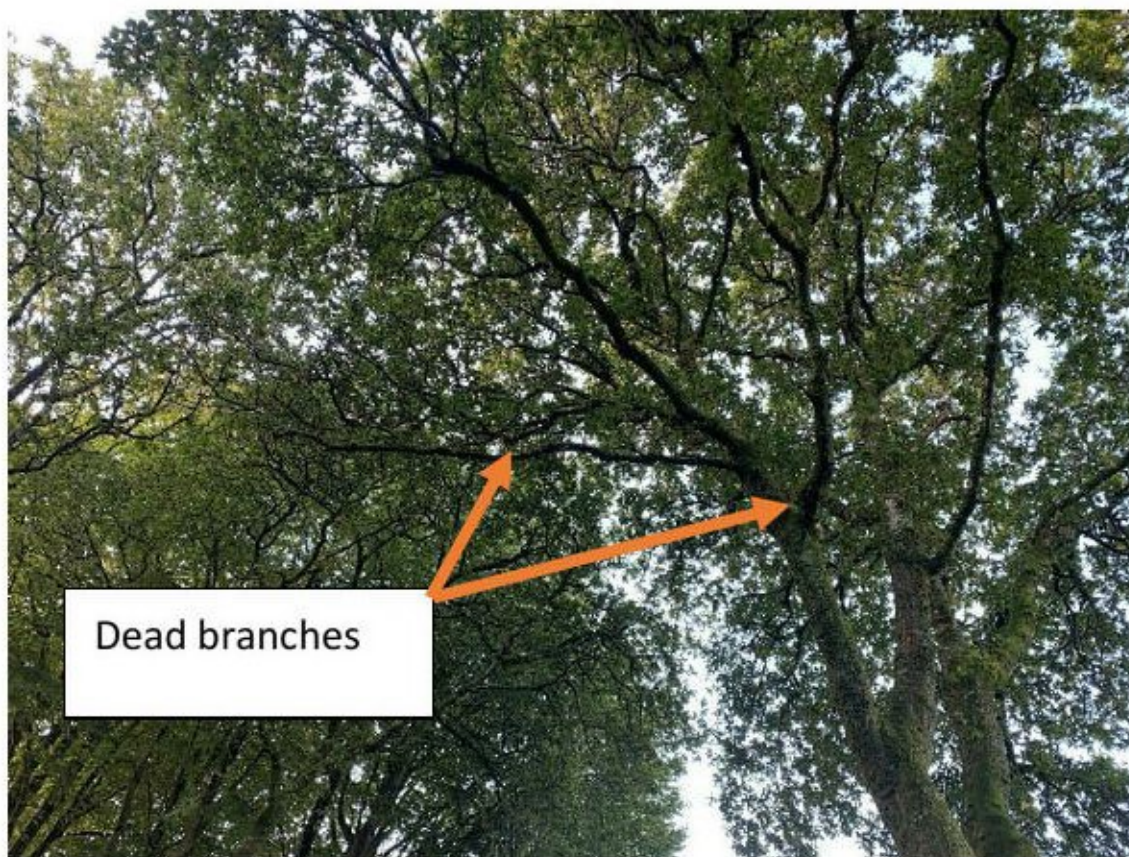
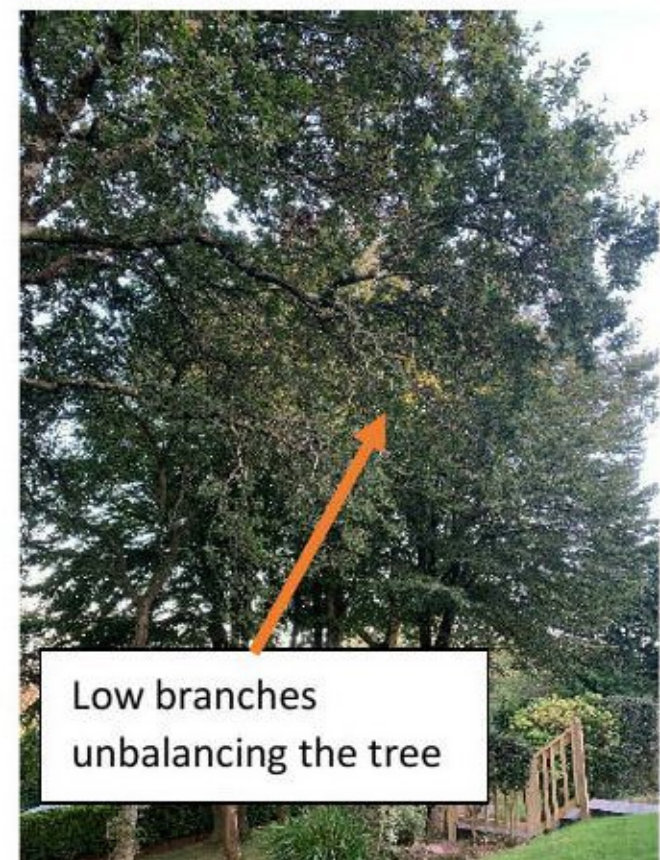
### Tree 3: Turkey Oak

Crown lift and balancing of limbs to remove the branches which are drooping close to the garage. The tree is show early signs of decay at the base of the trunk, whilst this is not currently causing concern management of the weight and balance of the tree is felt to be prudent.

We have consulted a couple of tree surgeons, and both raised the hollowing out of the trunk – whilst not extensive at this time the tree is weakened meaning that removal of lower branches and deadwood, and balancing the load on the trunk is advisable

#### Removal of dead branches

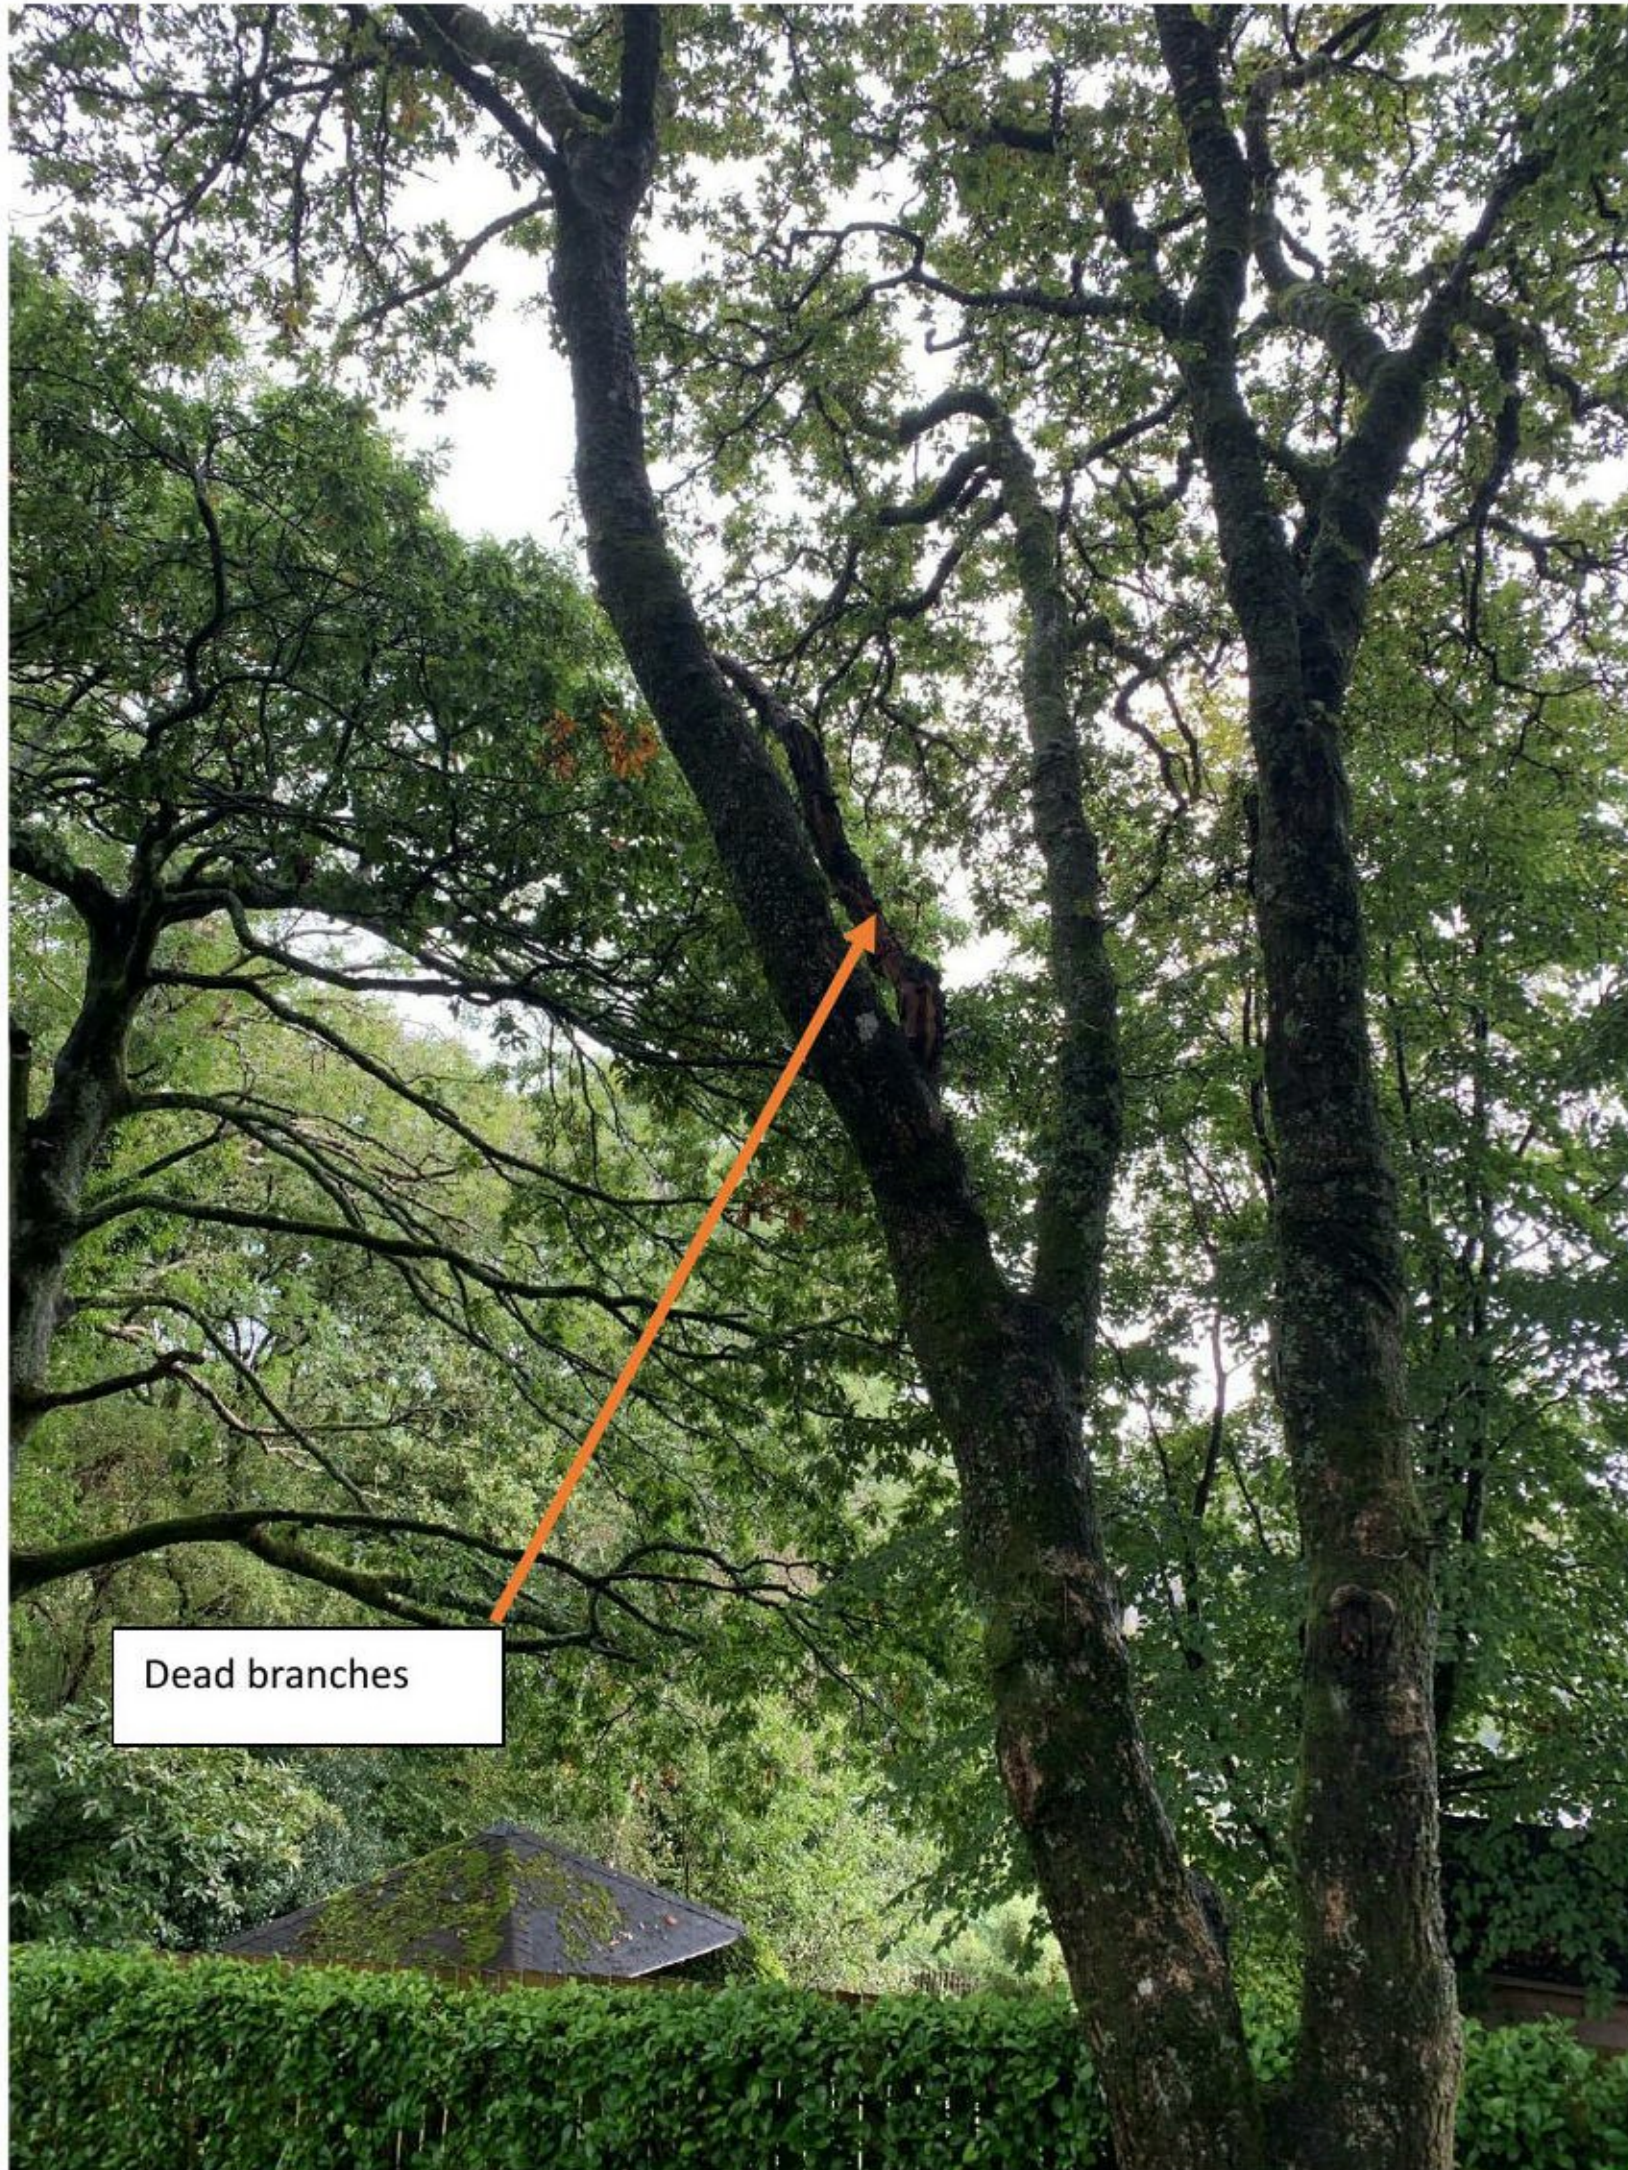
Tree 4: Beech

Tidying of fronds on trunk, removal of dead branches if any

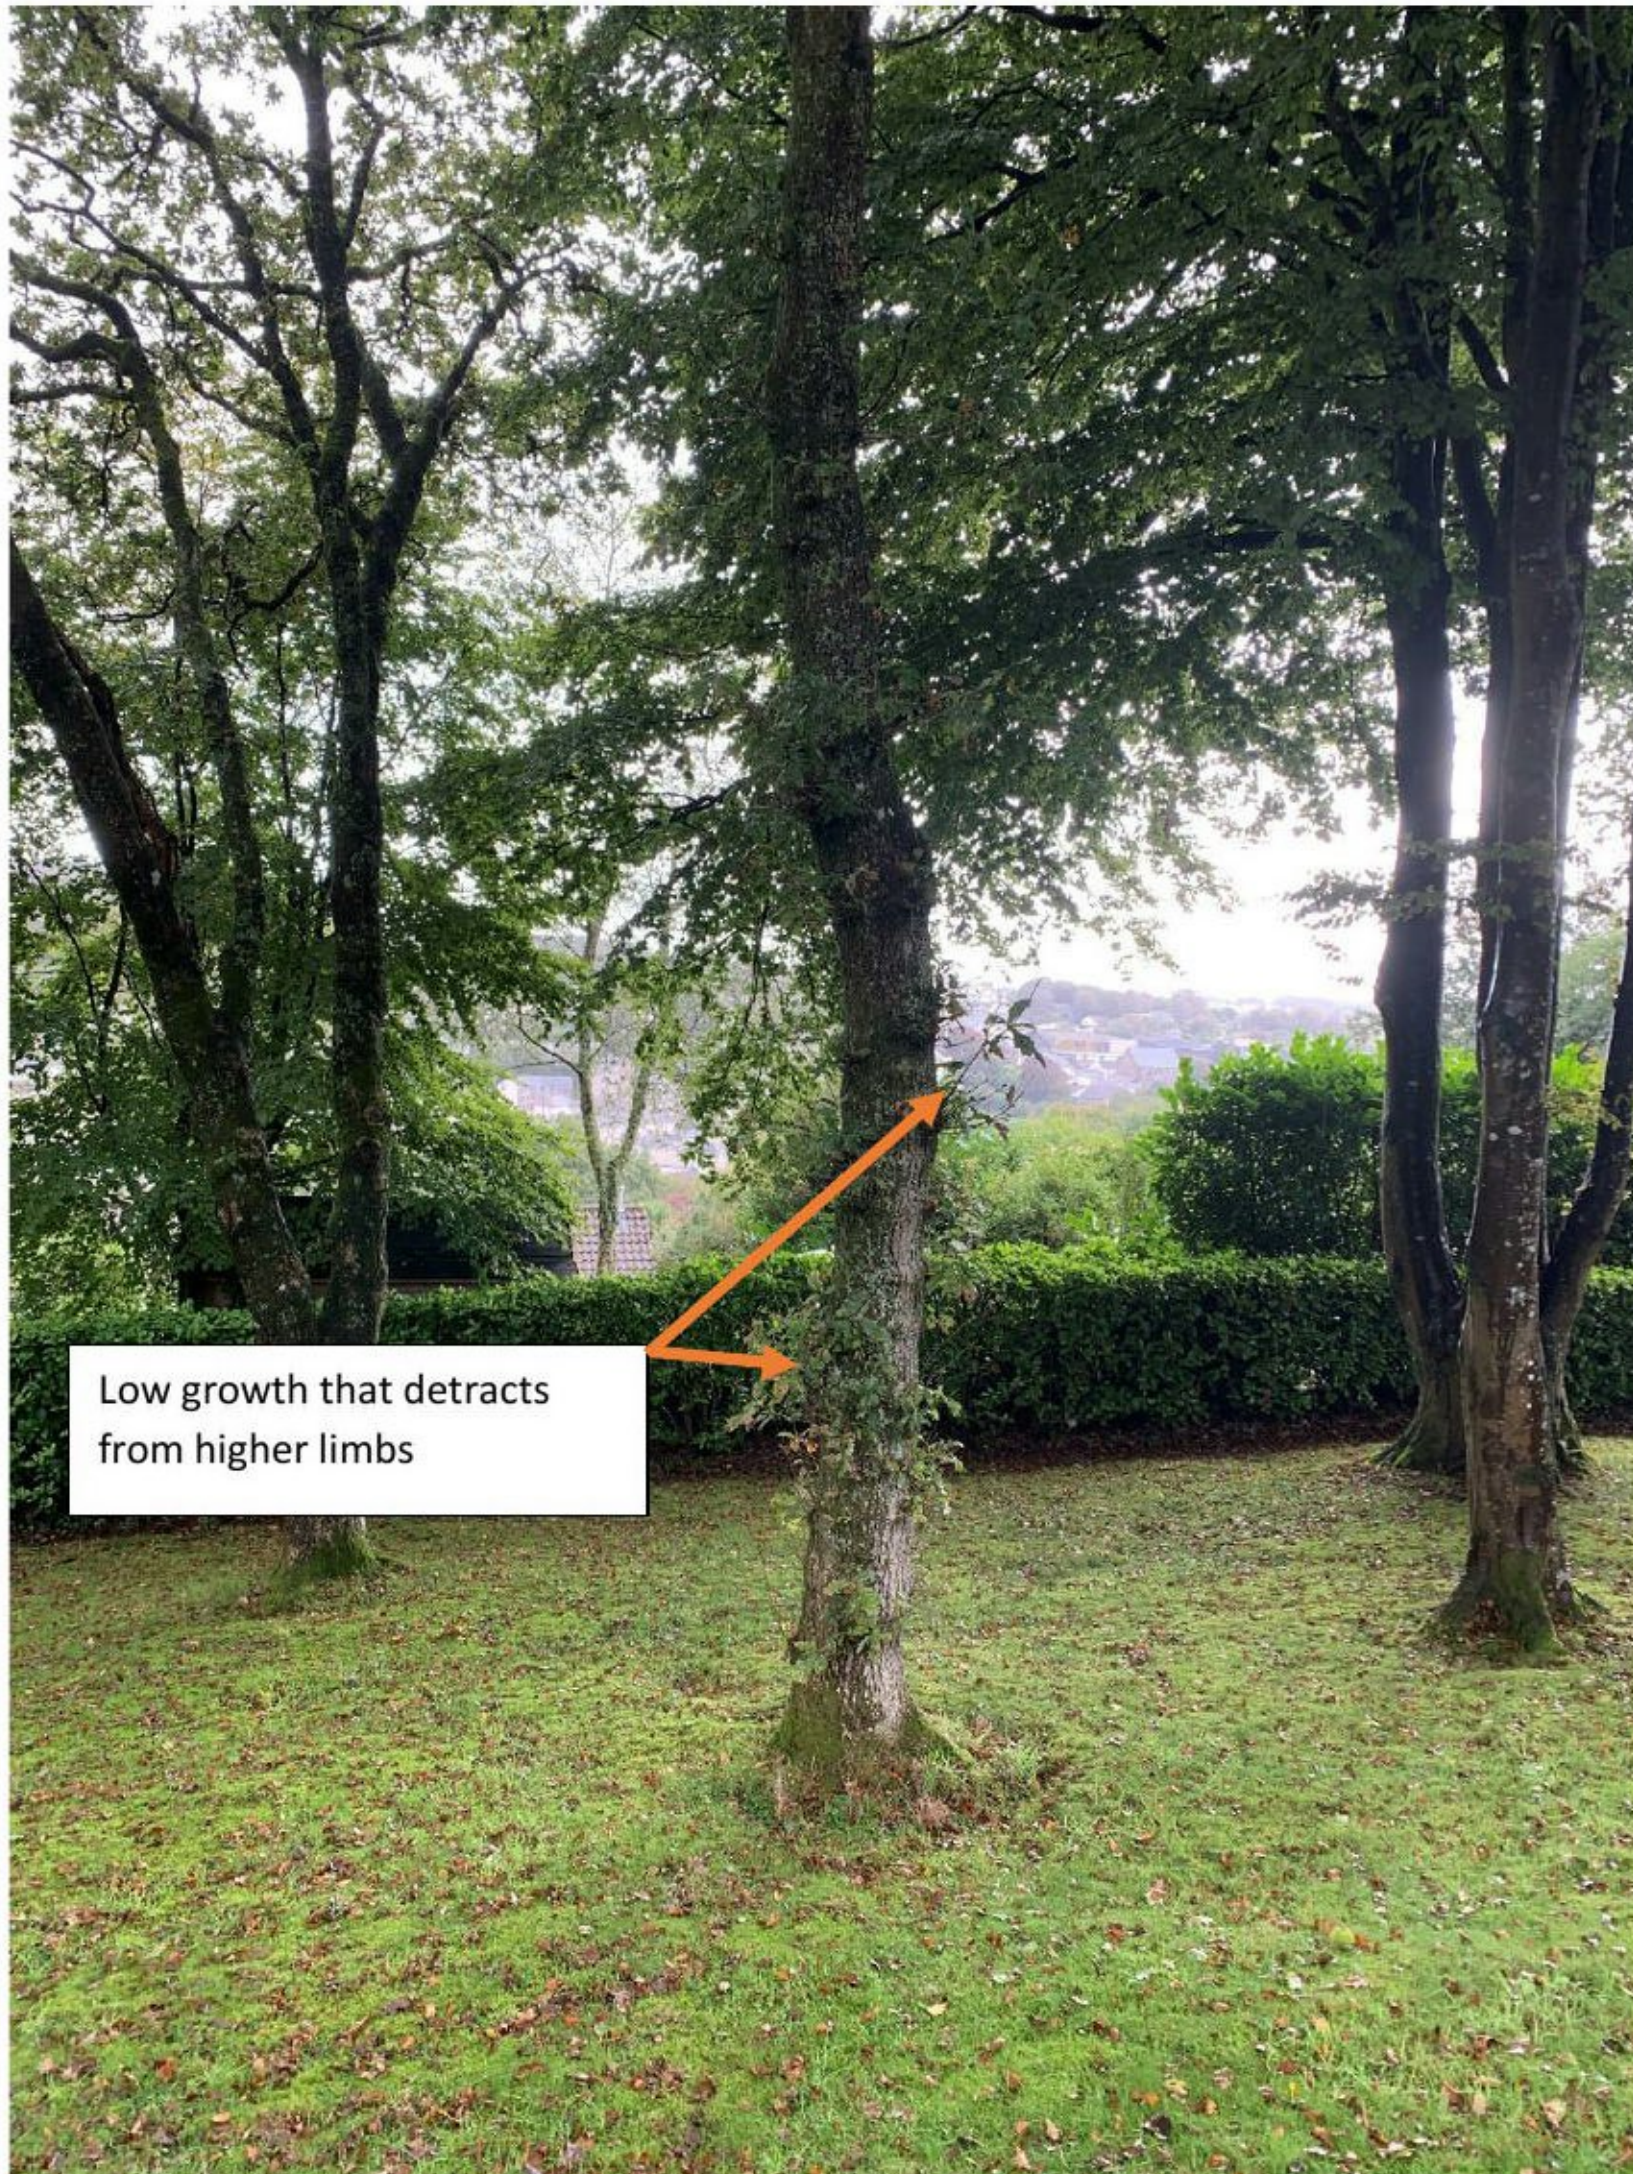
Tree 5: Beech

Minor maintenance and removal of dead branches if any

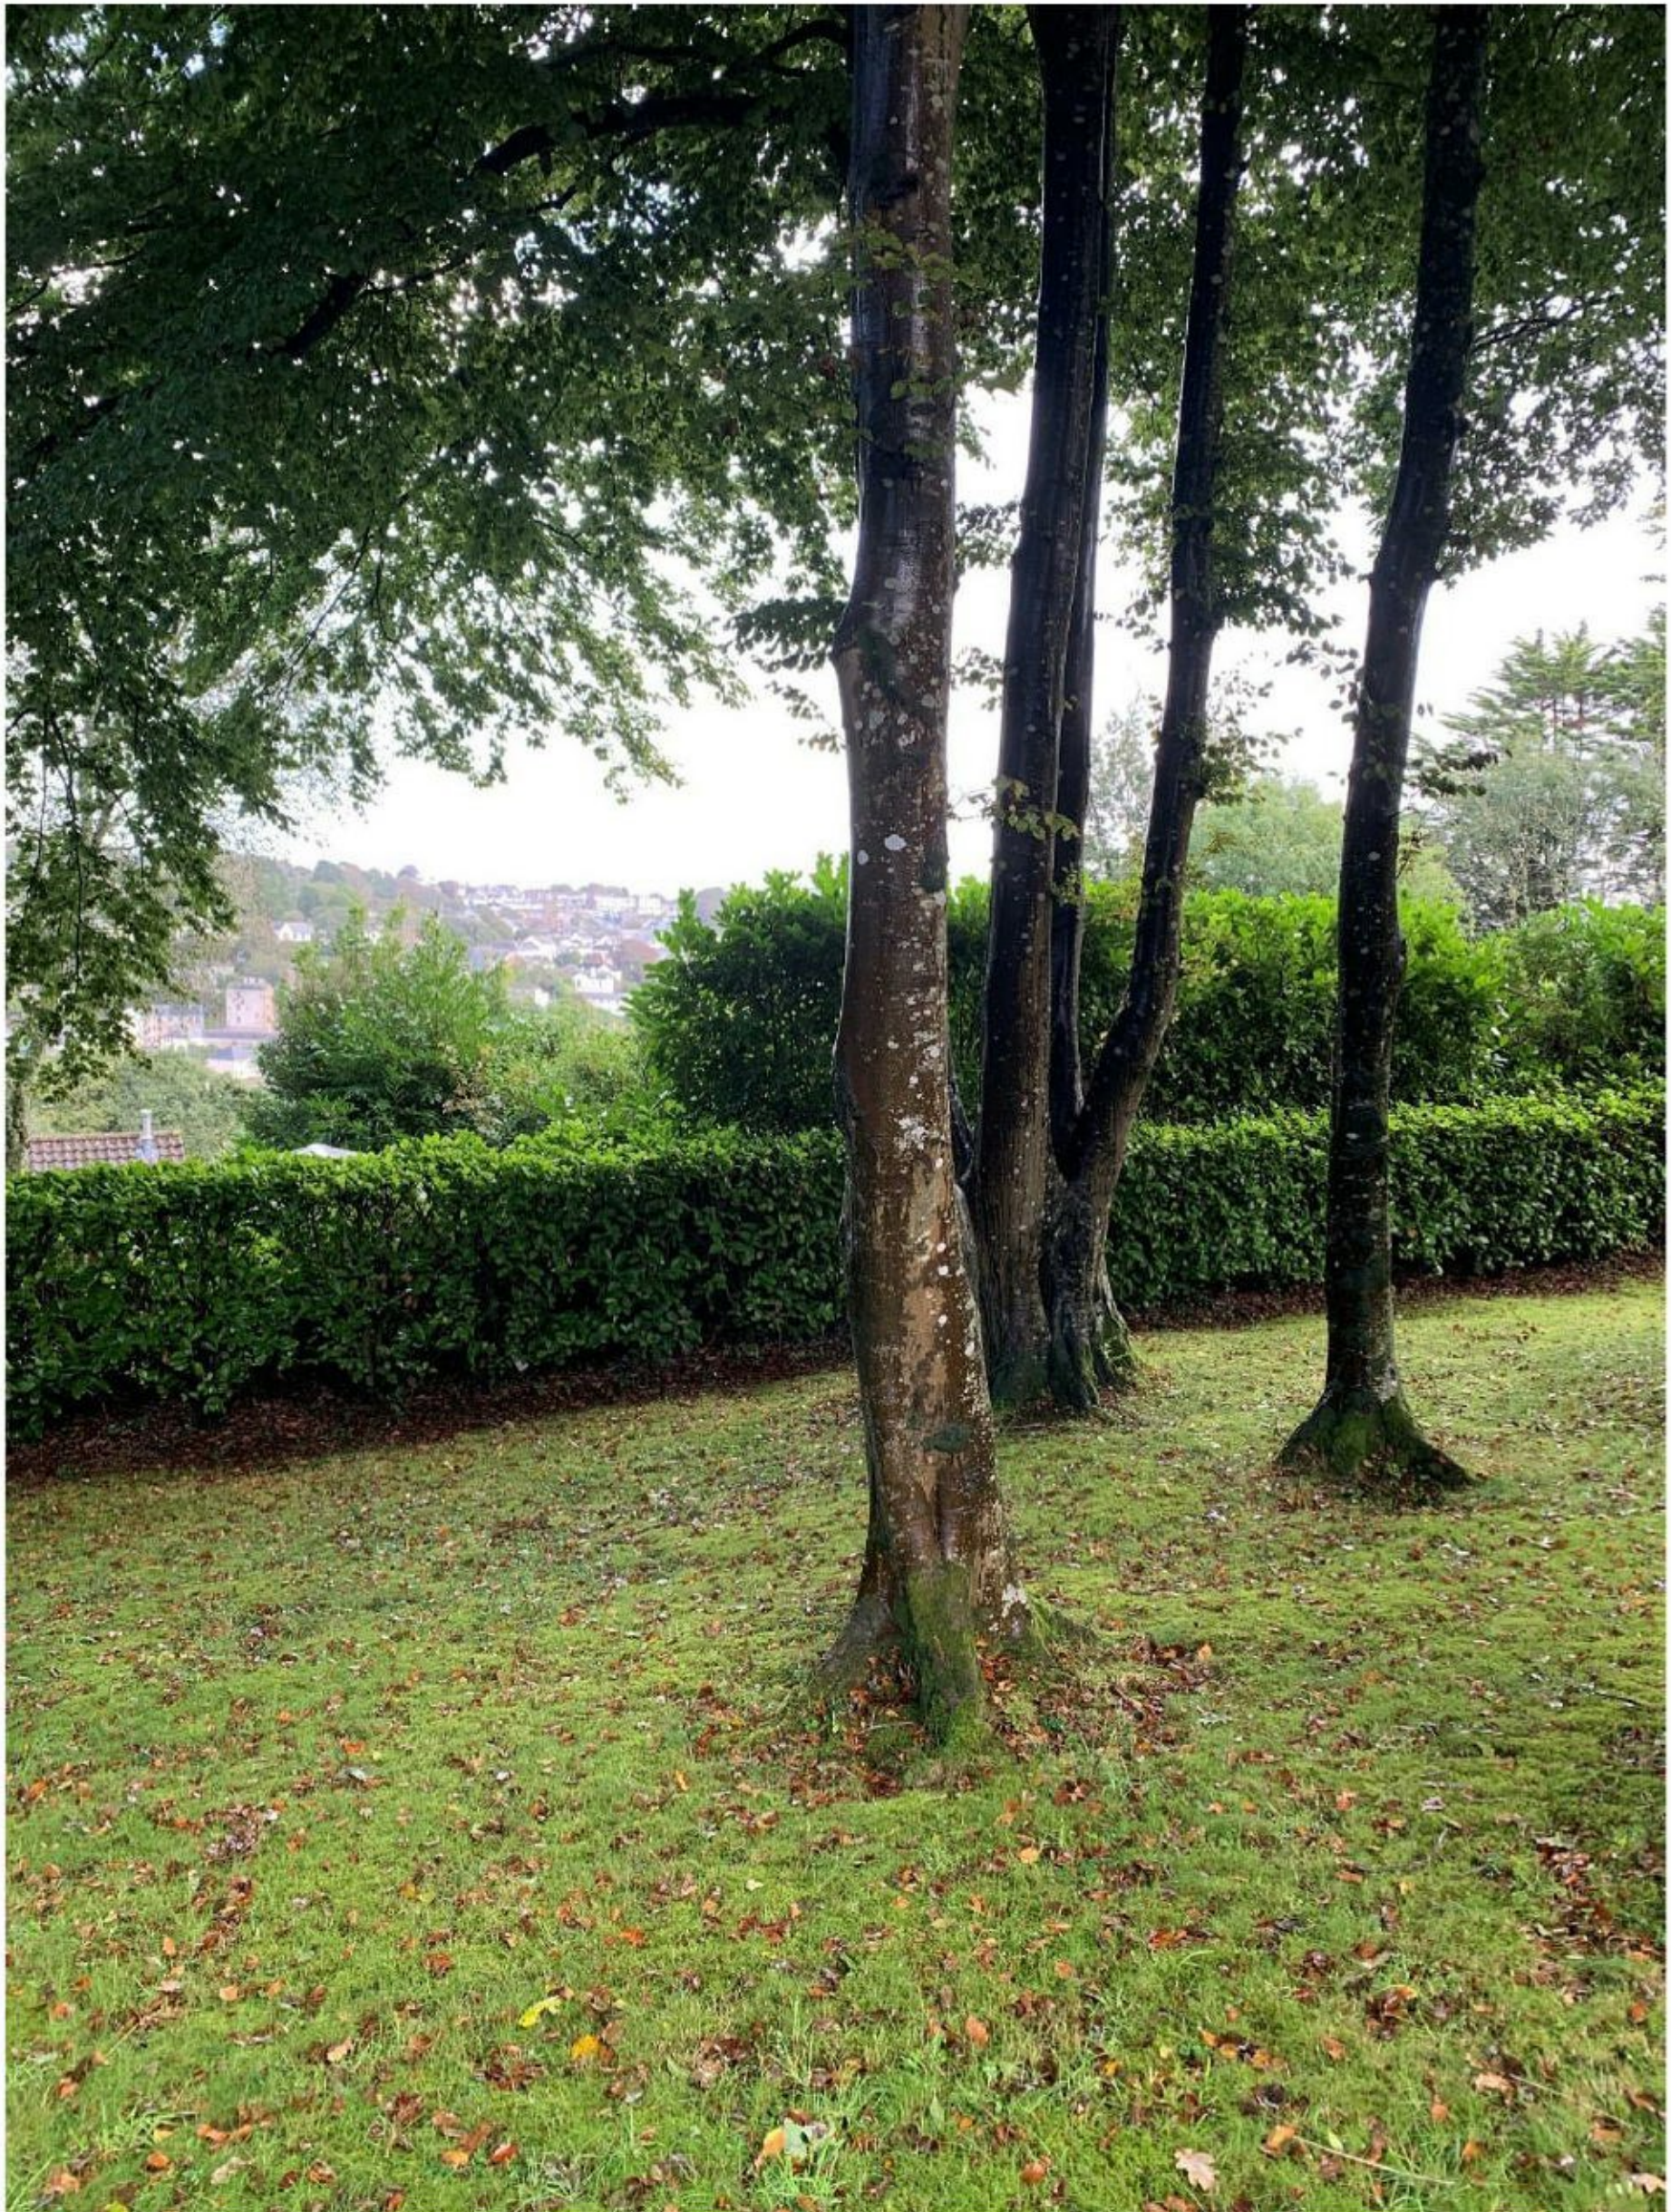
Tree 6: Beech

Tidying of fronds on trunk, removal of dead branches if any
