## Planning Application Reference: PP-10271975

Address: 18 Trevone Crescent, St Austell, Cornwall PL25 5ED

### Overview

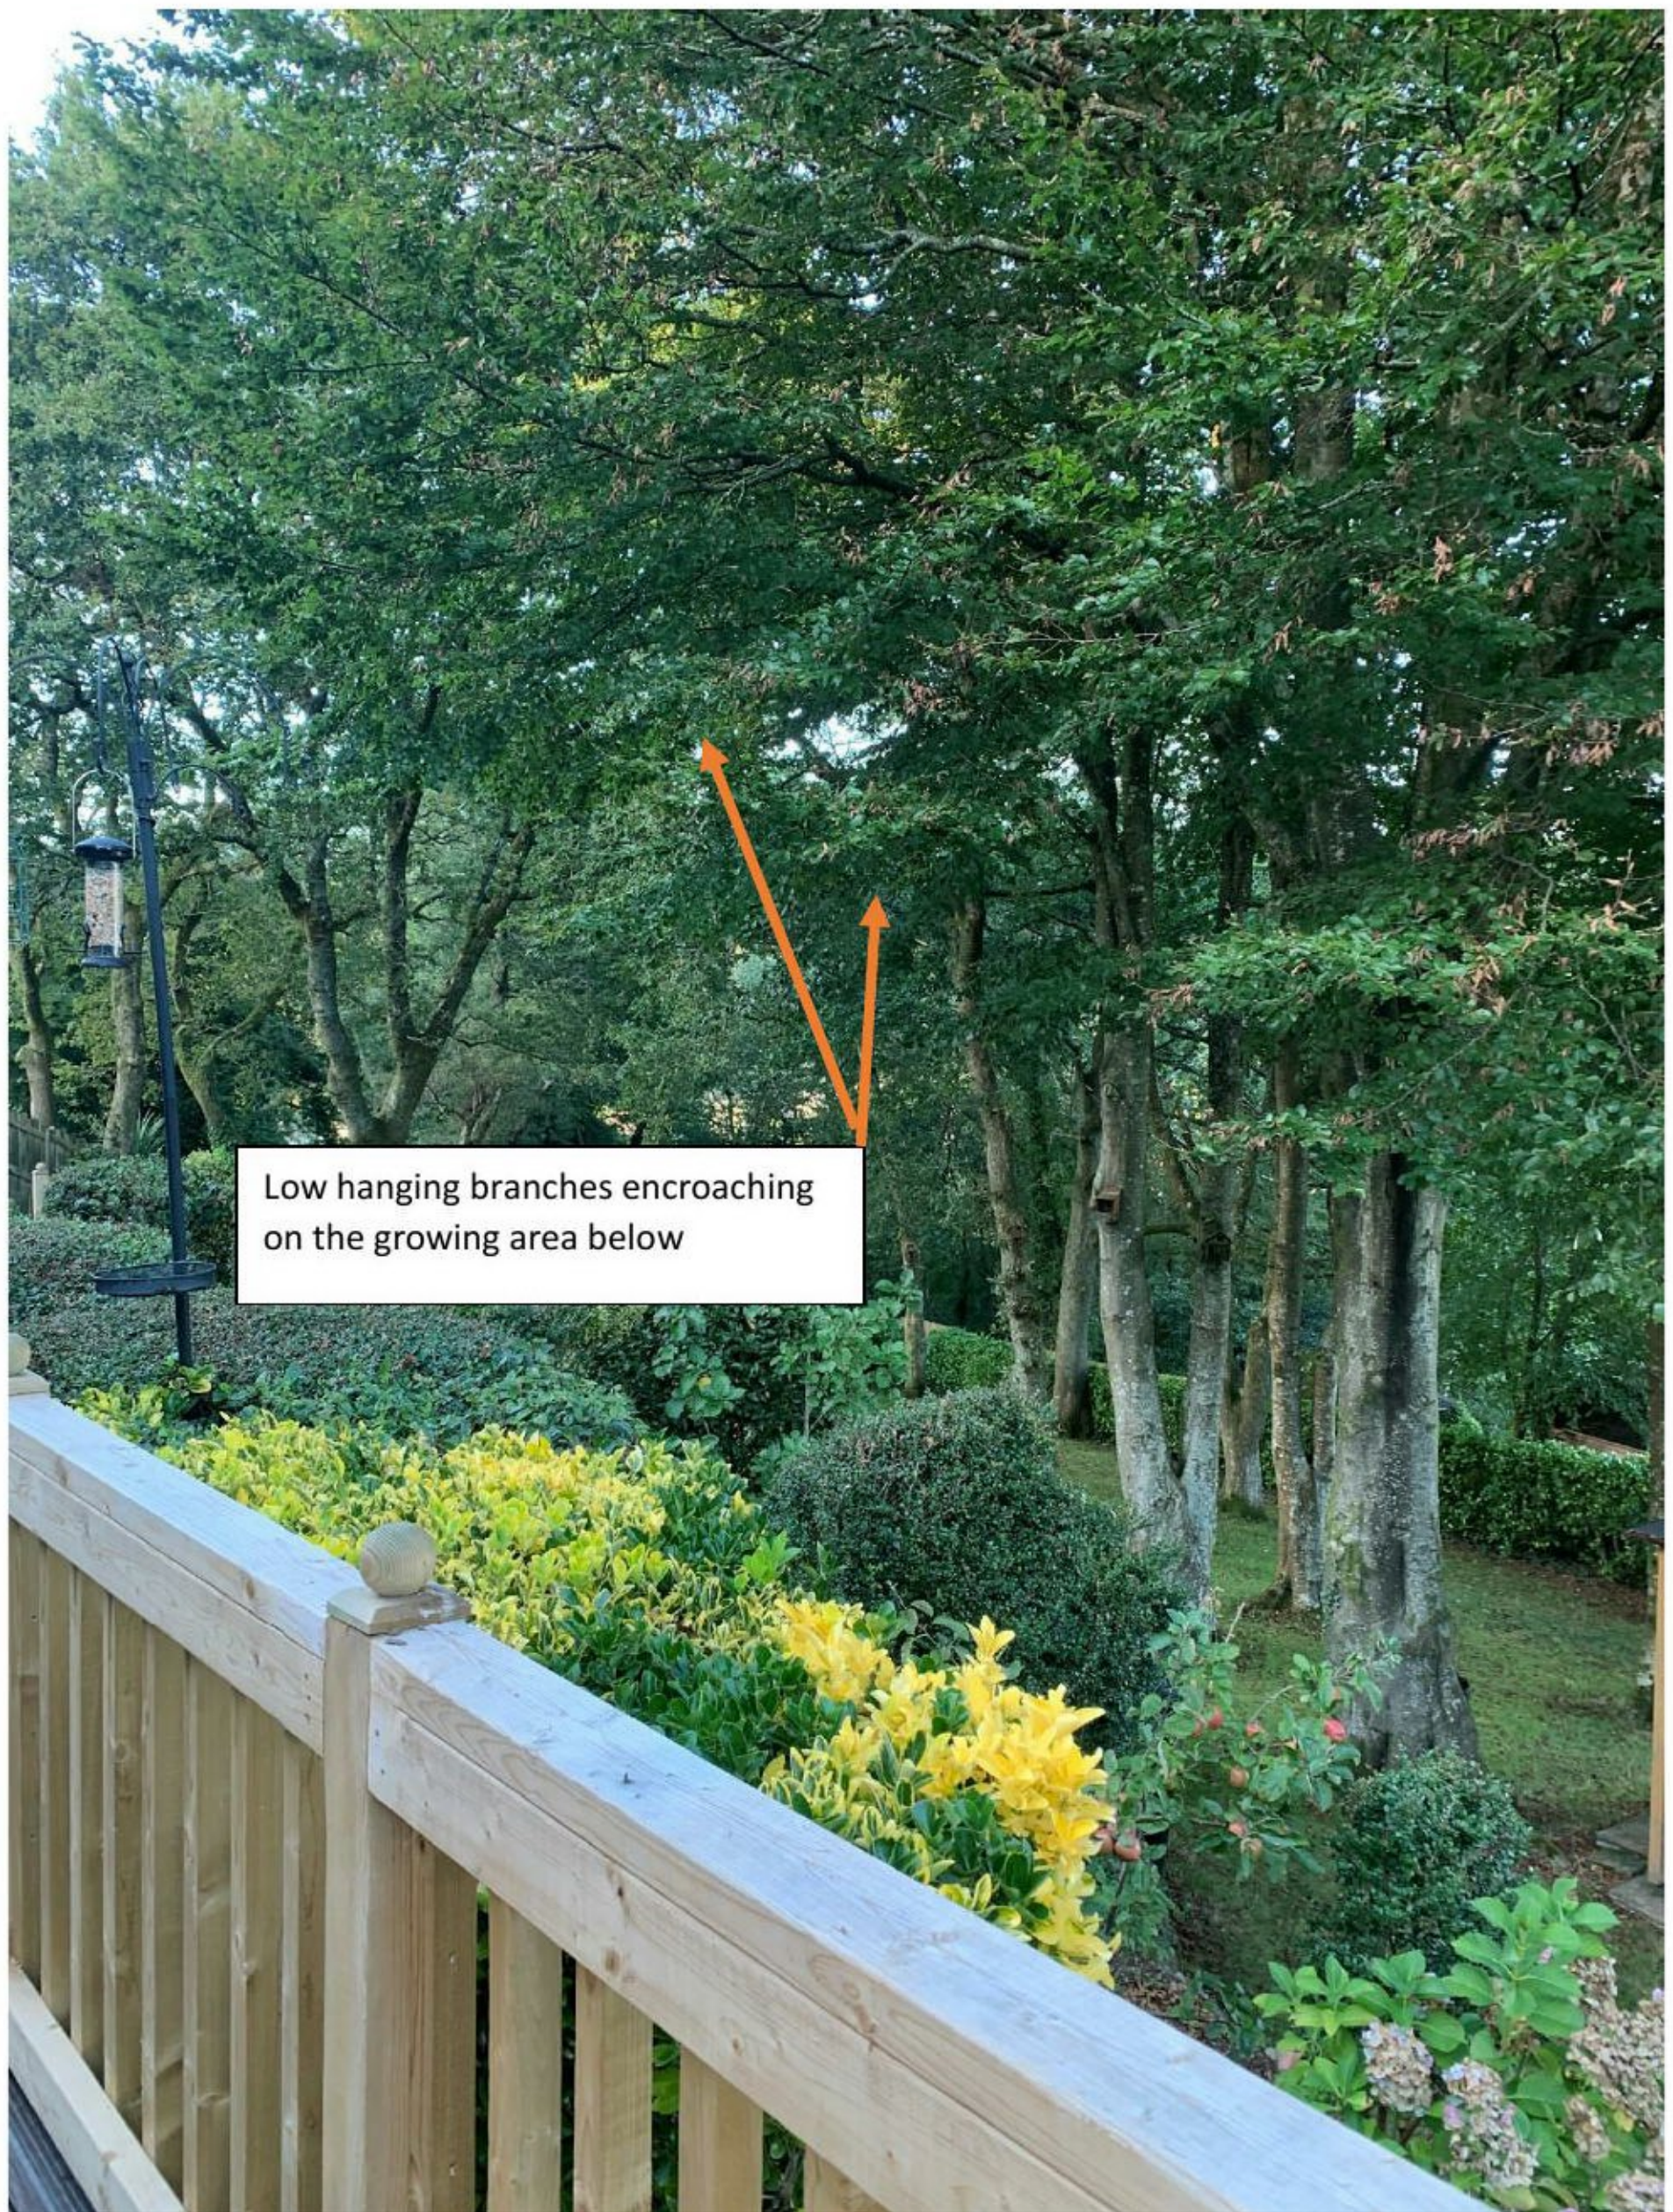
Tree 7: Beech

Crown lift and removal of dead branches. To include branches overhanging the garden towards the house

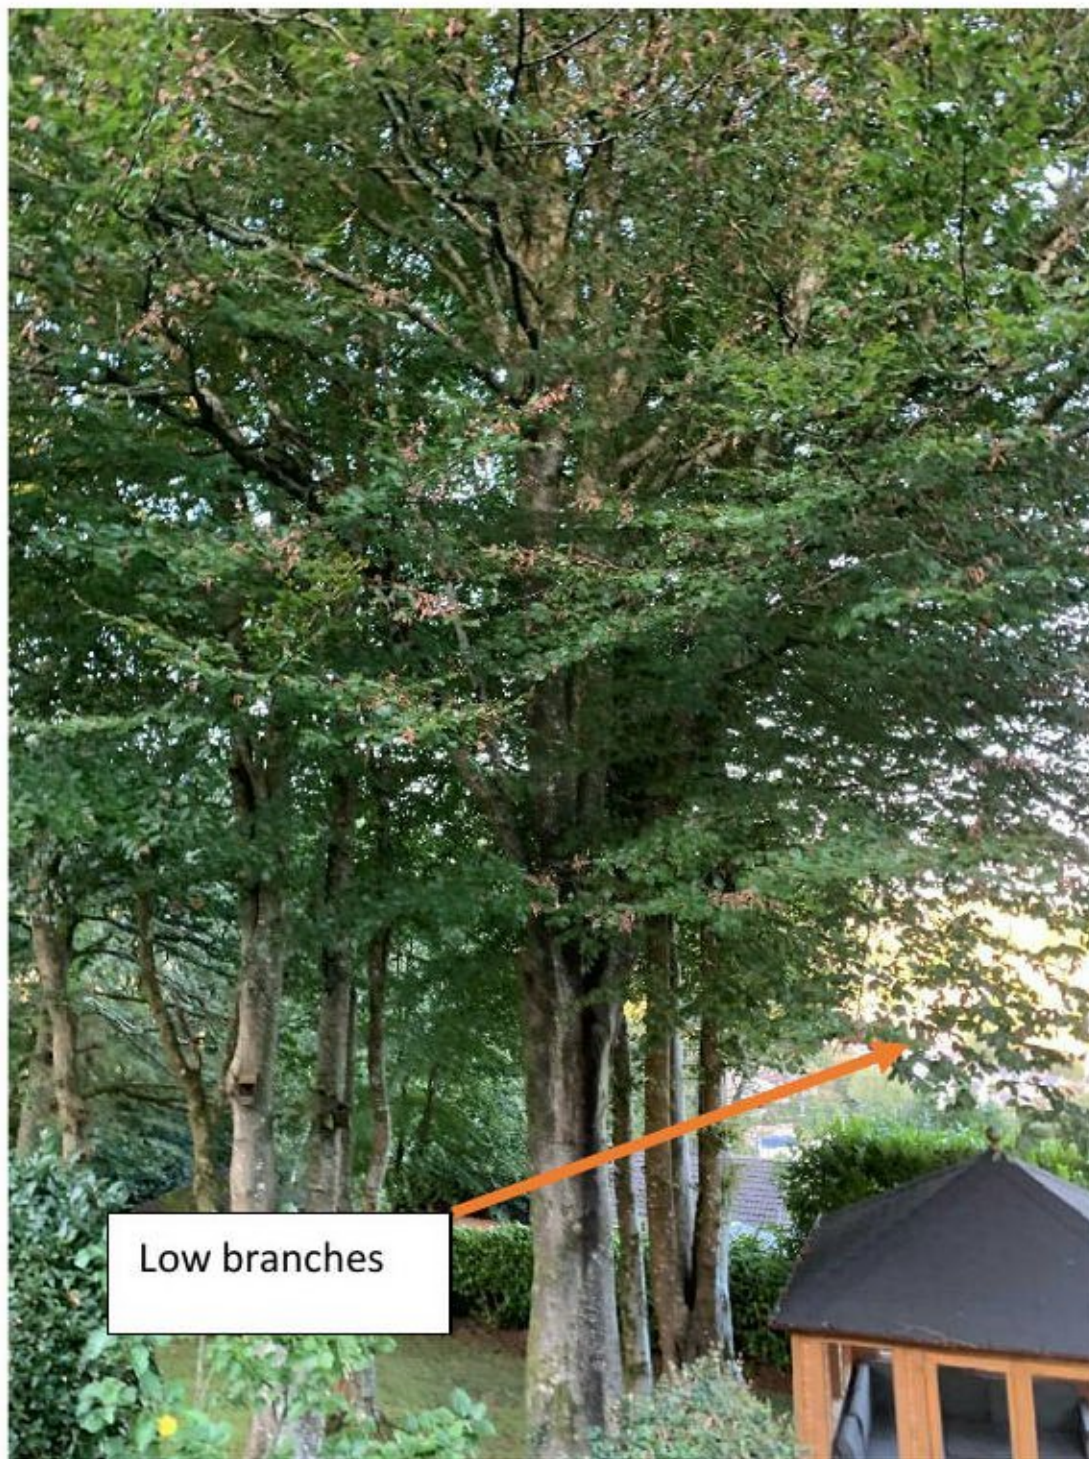
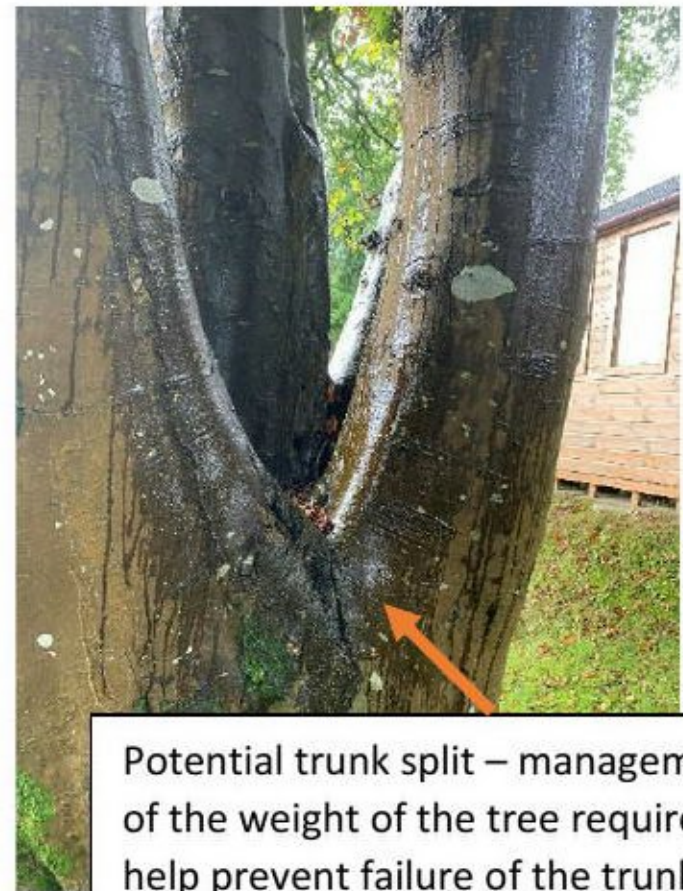
## Tree 8: Beech

Crown lift and removal of dead branches. To include branches overhanging the summer house

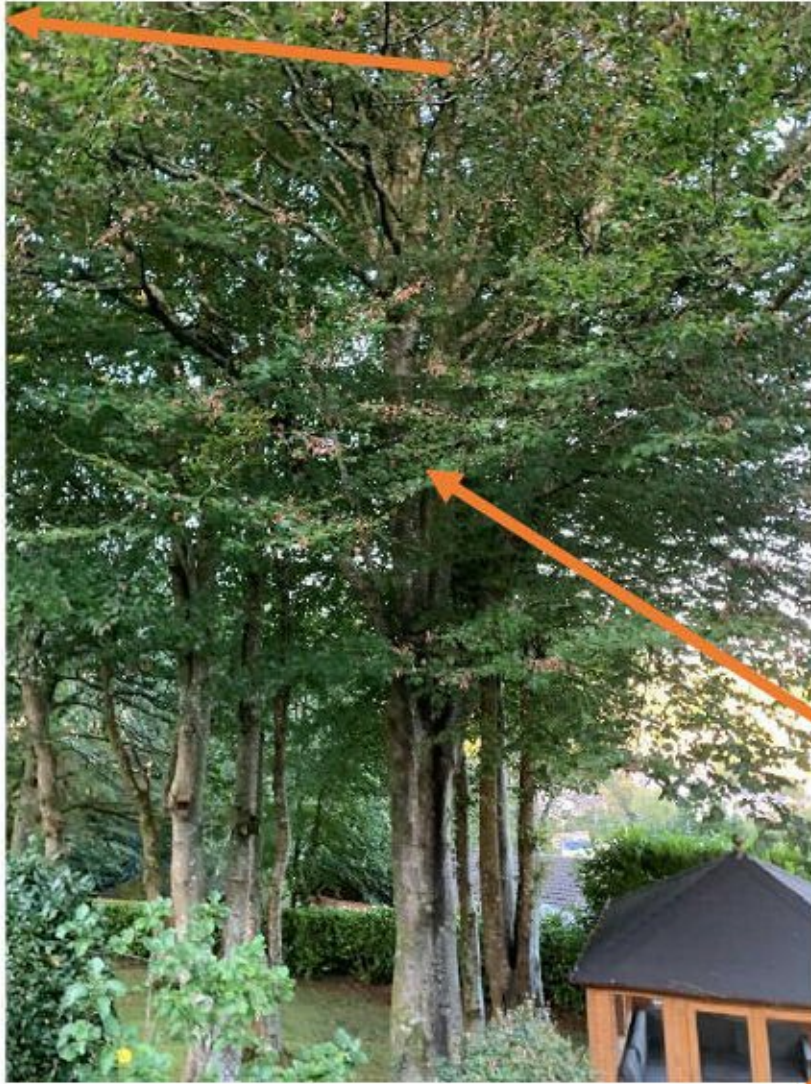
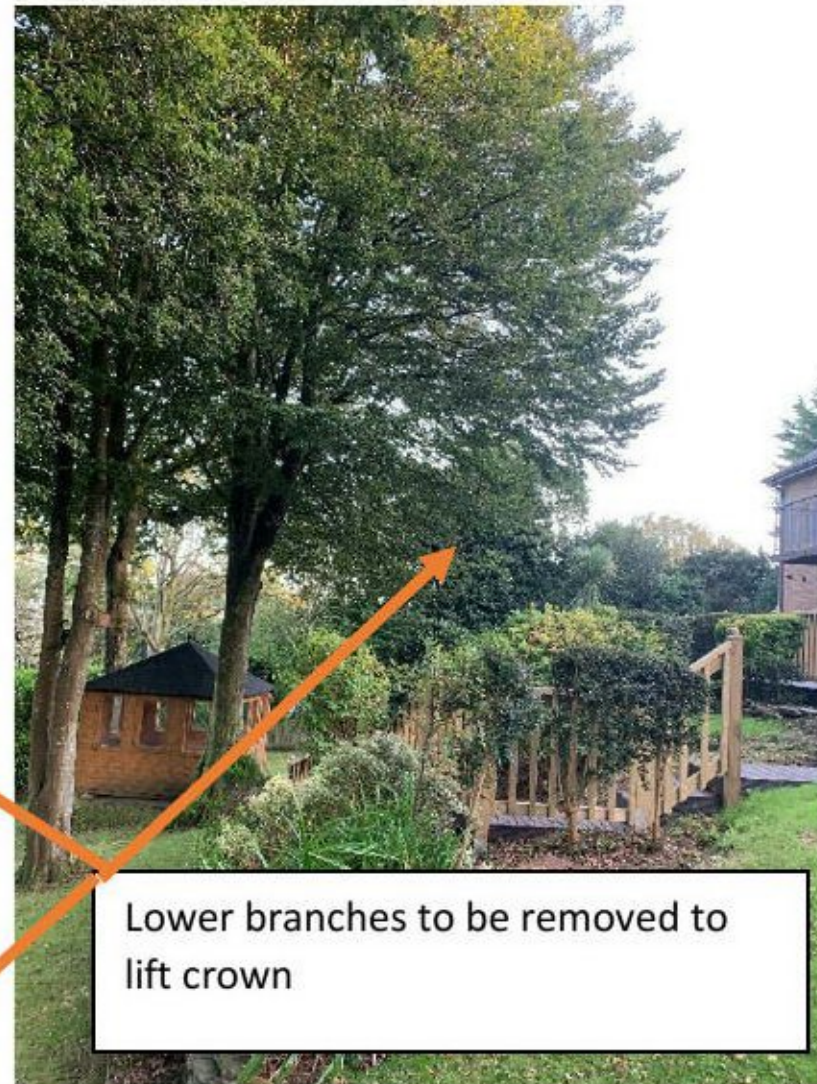
## Tree 9: Beech

Crown lift and reduction of the spread of the tree, and removal of dead branches. To include branches overhanging the garden towards the house, summer house and planting area underneath.

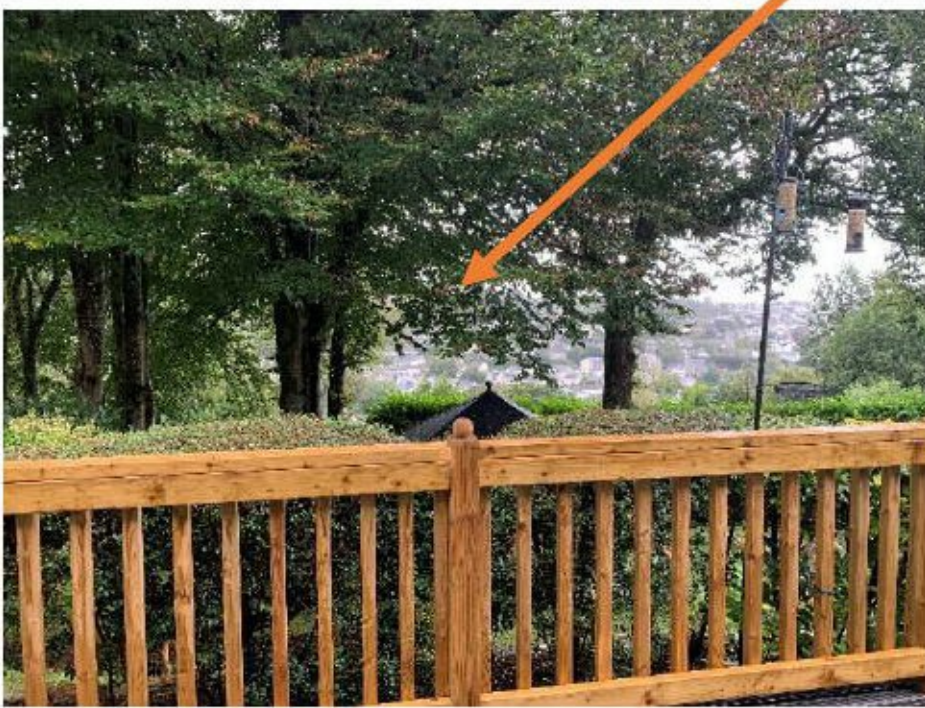
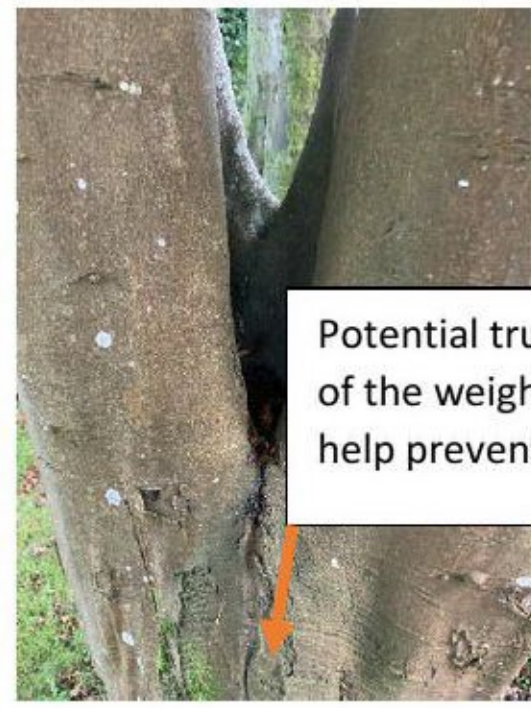
Lower branches to be removed to lift crown

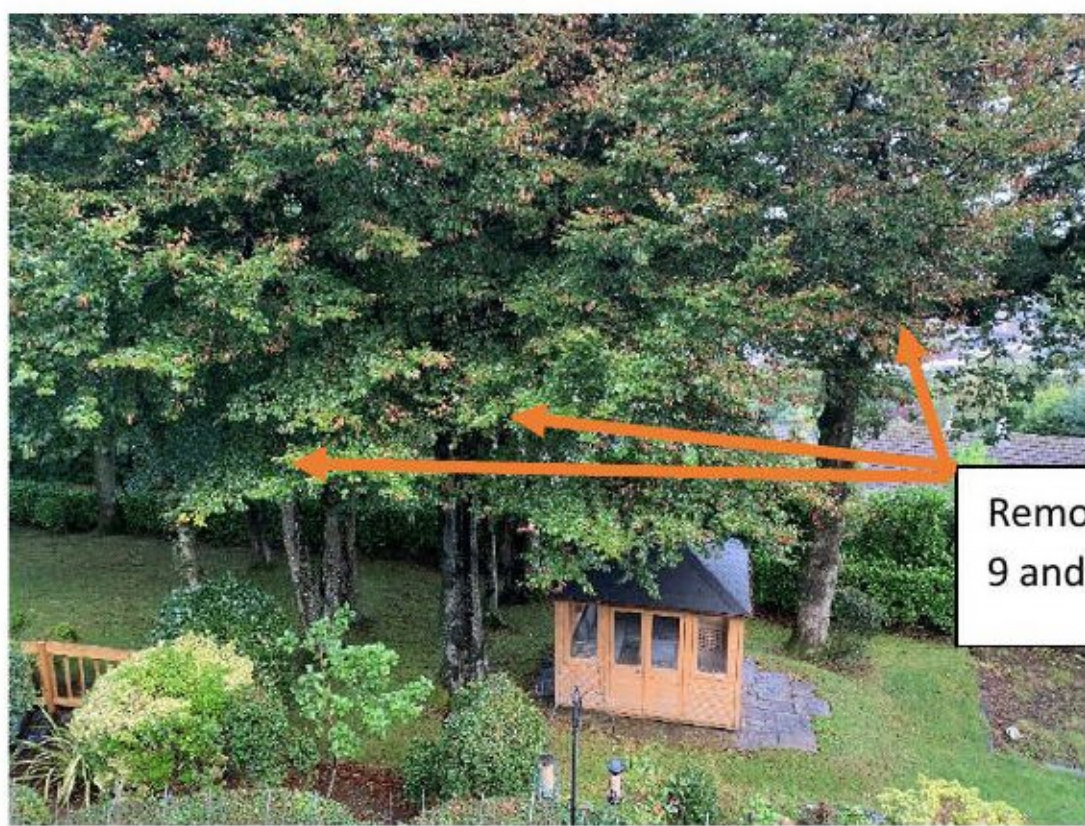
Potential trunk split – management of the weight of the tree required to help prevent failure of the trunk

Removal of lower limbs to aid Trees 9 and 10 to grow

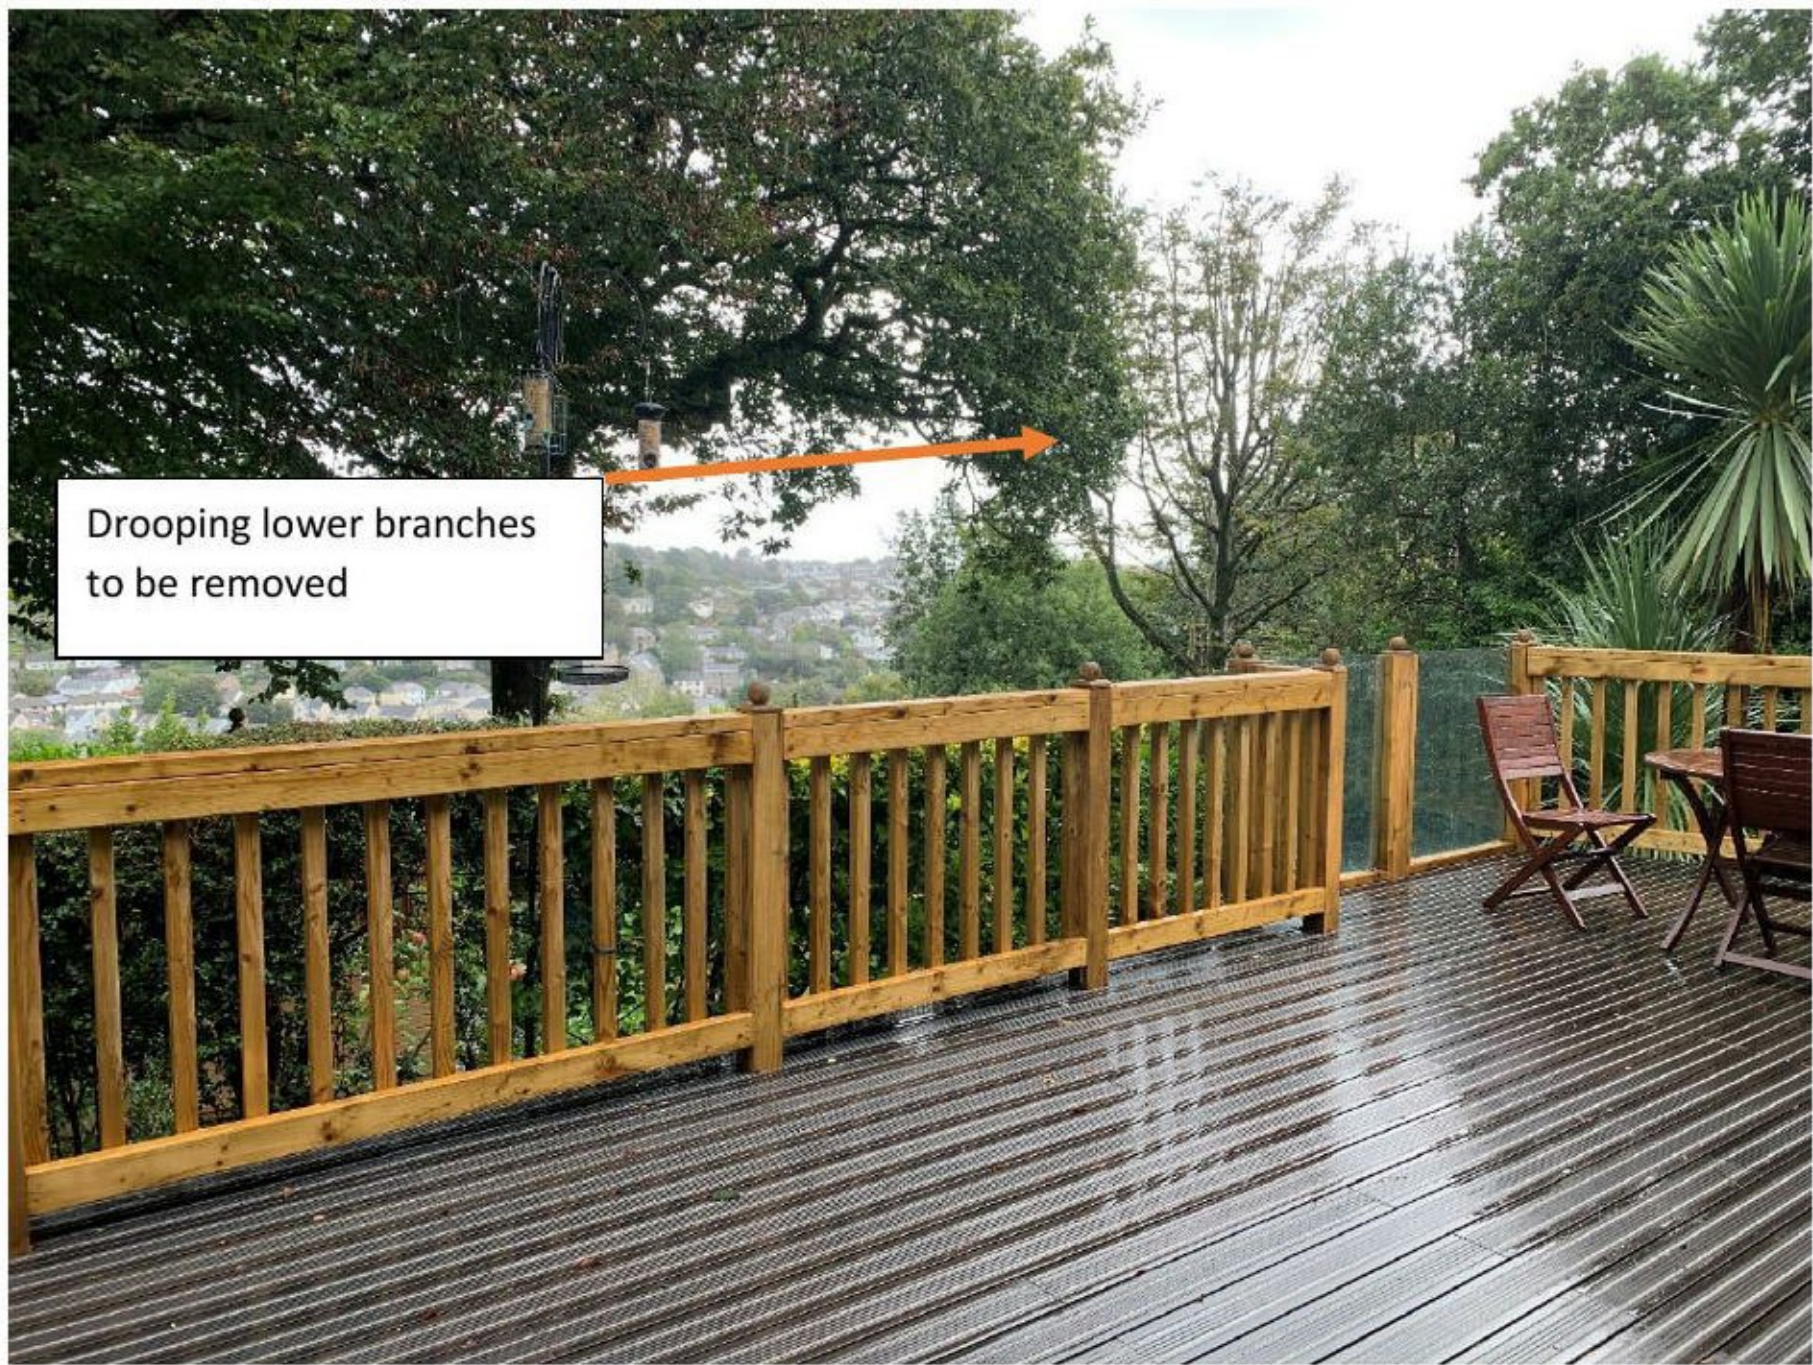
Tree 10: Oak

Crown lift and reduction of the spread of the tree. To include branches overhanging the summer house

Drooping lower branches  
to be removed

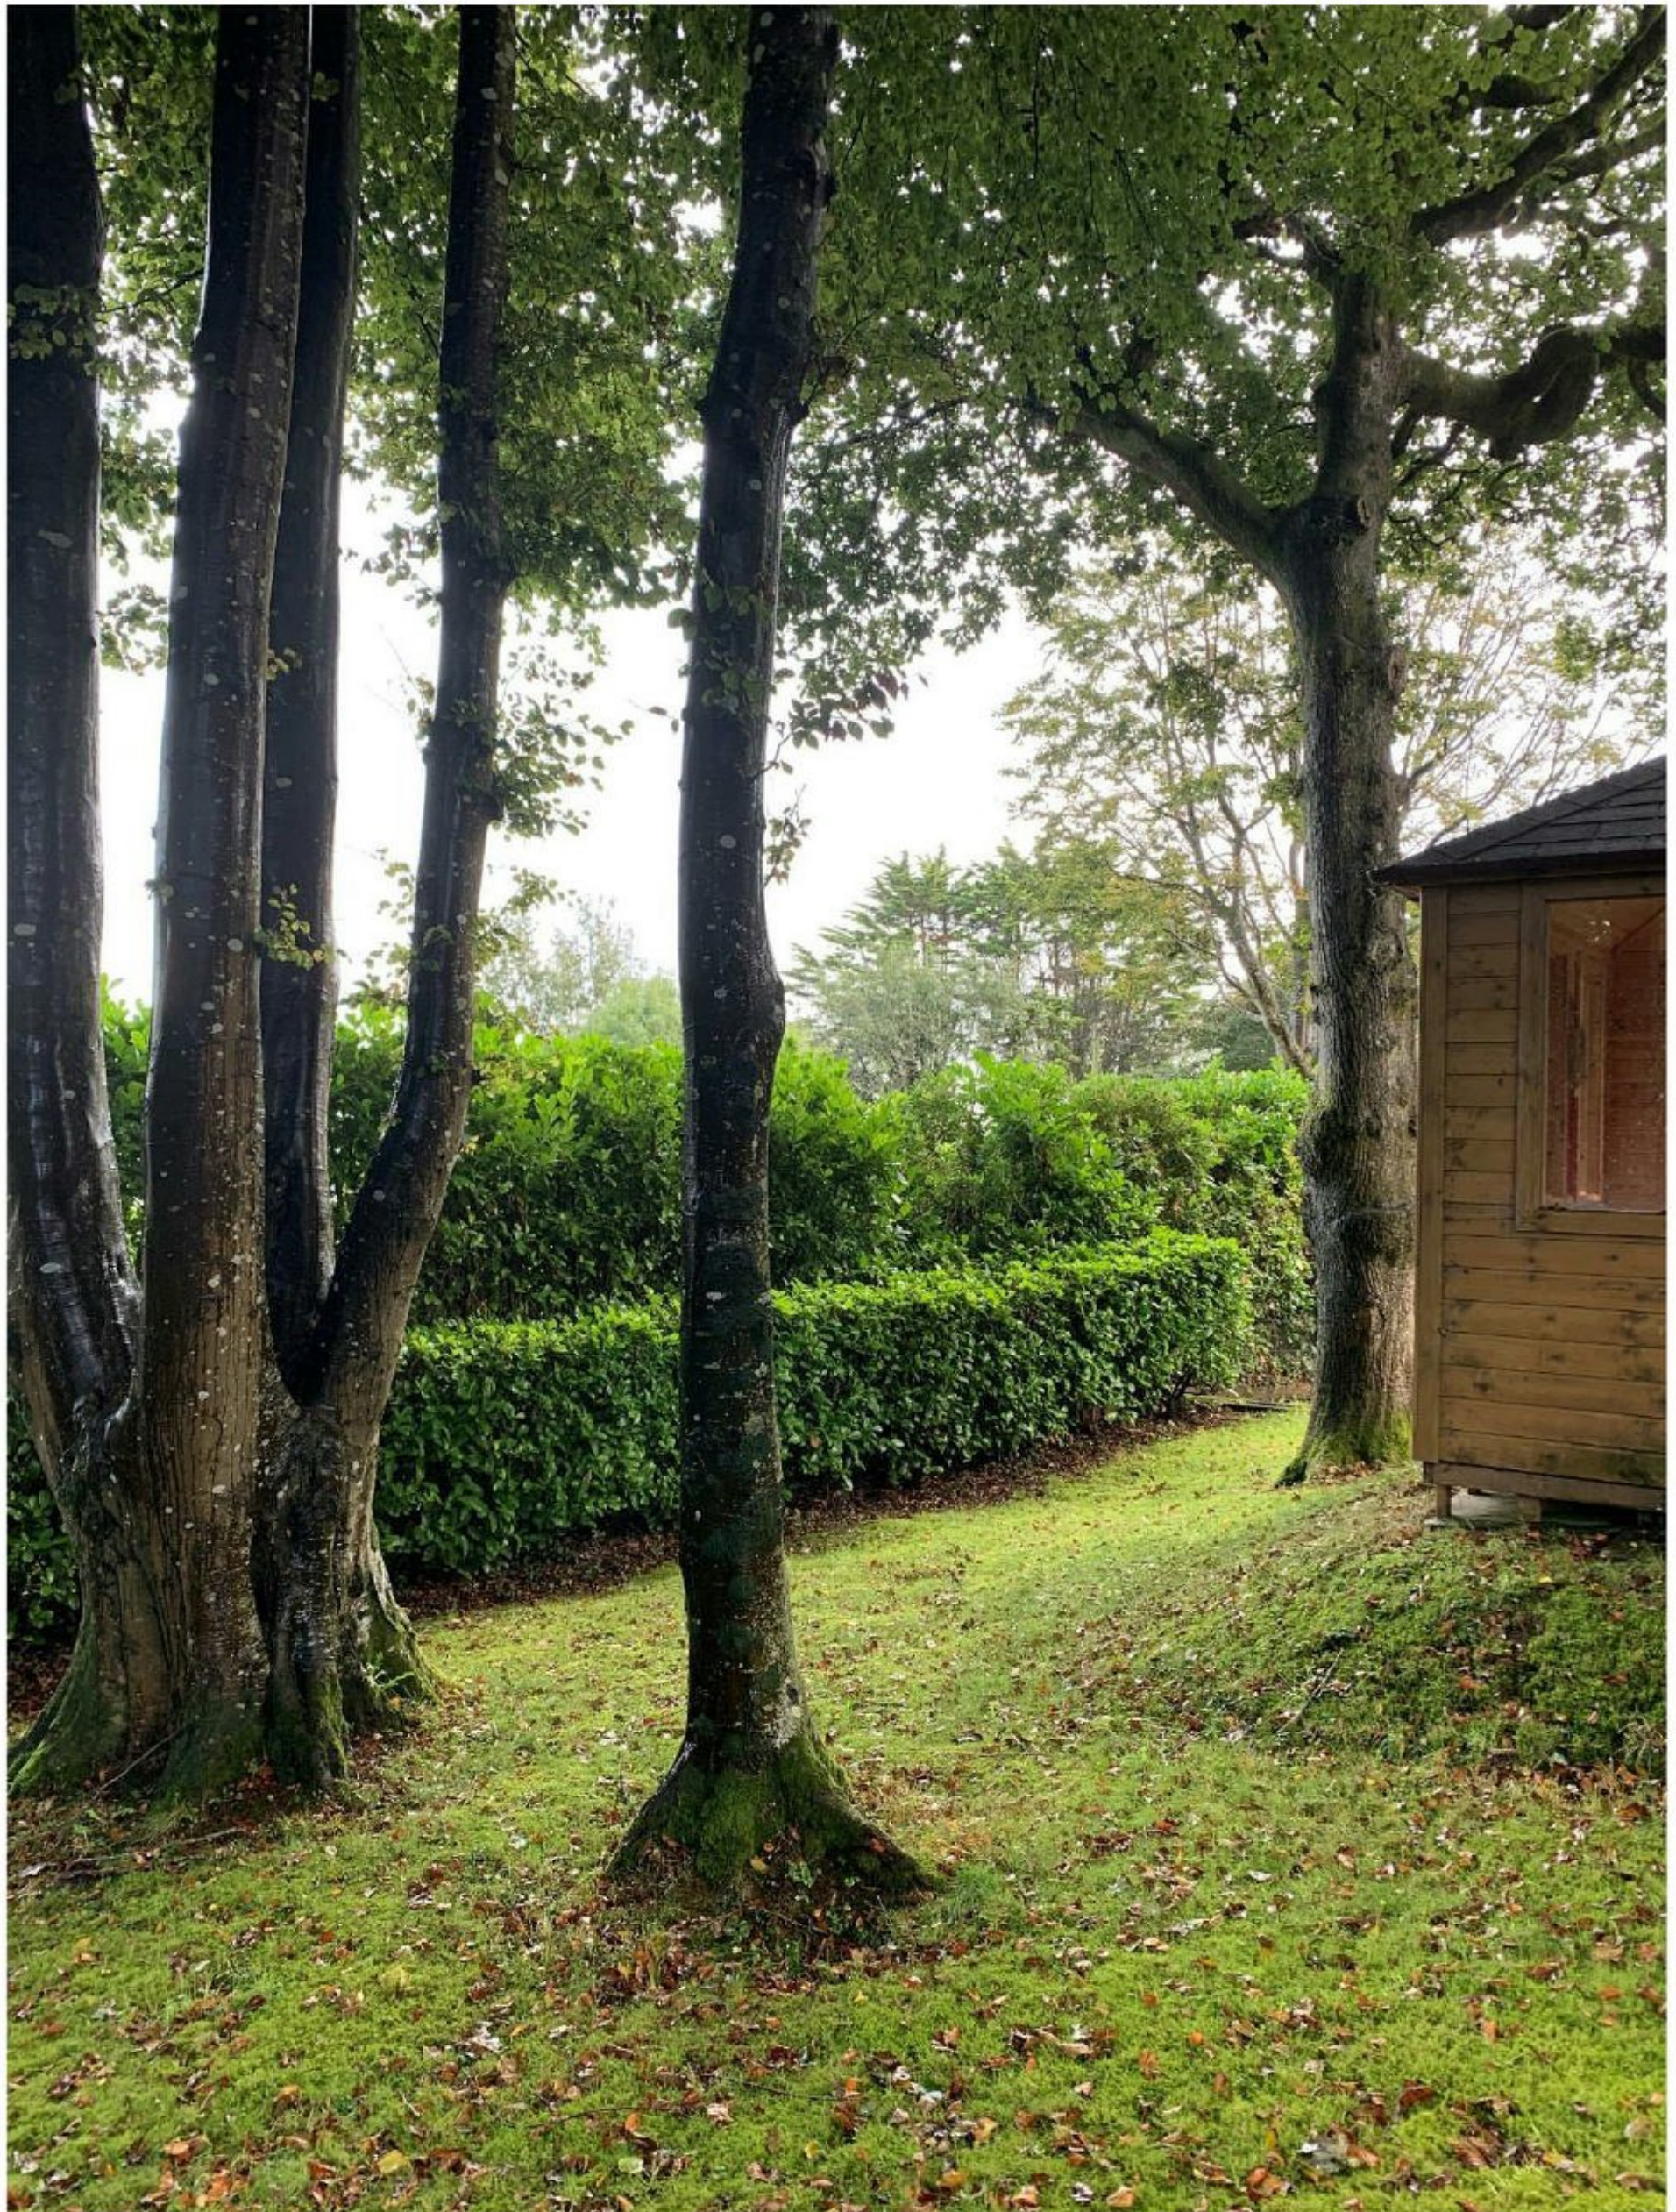
Tree 11: Beech

Tidying of fronds on trunk, removal of dead branches if any
