Arboricultural Assessment

**4 Bay Willow Drive
Redland
Bristol BS6 6TU**

TITLE
**Tree Constraints Plan
4 Bay Willow Drive**

TITLE
**Tree Protection Plan
4 Bay Willow Drive**

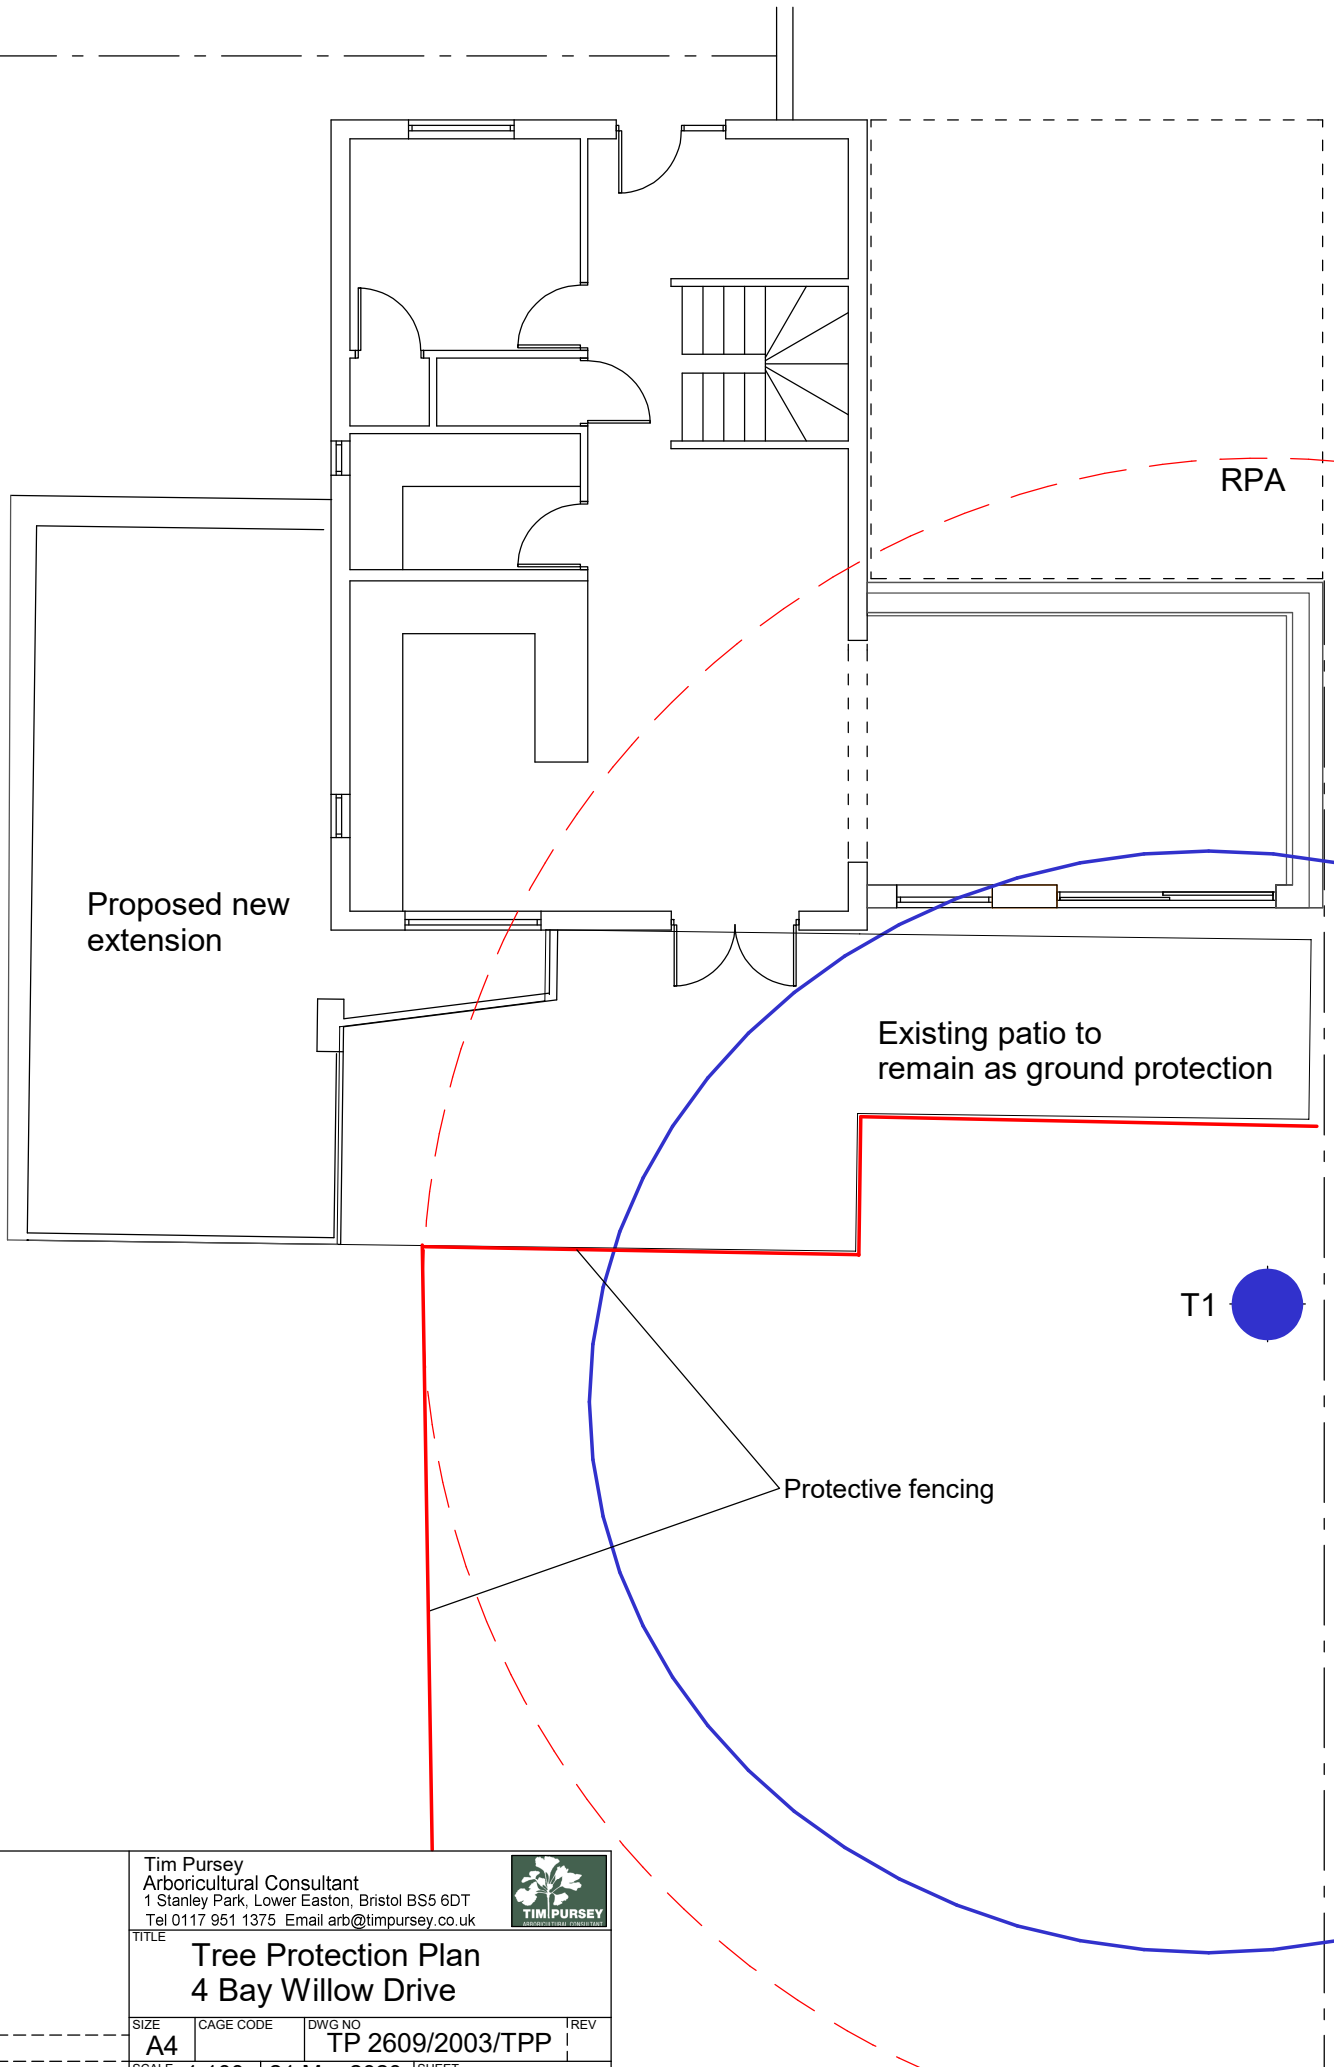
SIZE A4	CAGE CODE	DWG NO TP 2609/2003/TCP	REV
SCALE 1:100	21 Mar 2020	SHEET

- 7.1 The rooting system of Poplar T1 occupies part of the subject garden as well as part of an adjacent garden.
- 7.2 The proposals to construct an extension will involve works which will occupy some 2m² of the total root protection area. This is insignificant and the tree will be unaffected by the proposal.
- 7.3 It is important, however, that the remainder of the RPA is adequately protected to avoid root damage. This is fairly easily achieved through the use of protective fencing and the retained patio acting as ground protection. The existing patio may be covered with appropriate boards to prevent damage to the surface.
- 7.4 Provided simple protective measures are employed, no damage to the tree should arise.

Existing patio to remain as ground protection

Protective fencing

- 8.4 The fence will be erected in the positions shown on the attached plan, TP 2609/2003/TPP and will be erected to protect tree T1 before any work commences. The protective fencing will remain in situ until all construction works are completed.

- 8.6 **Ground protection**
The existing patio surface will provide adequate ground protection. The surface may be covered with boards etc to protect the existing surface if desired.
