**DESIGN AND ACCESS STATEMENT**

**STEEL FRAME TO SUPORT THE EXISTING FIRST AND  
SECOND FLOOR BALCONIES TO THE REAR ELEVATION**

**LAWRENCE COURT  
120 MAIN ROAD, SIDCUP DA14 6NE**

**AUGUST 2021**

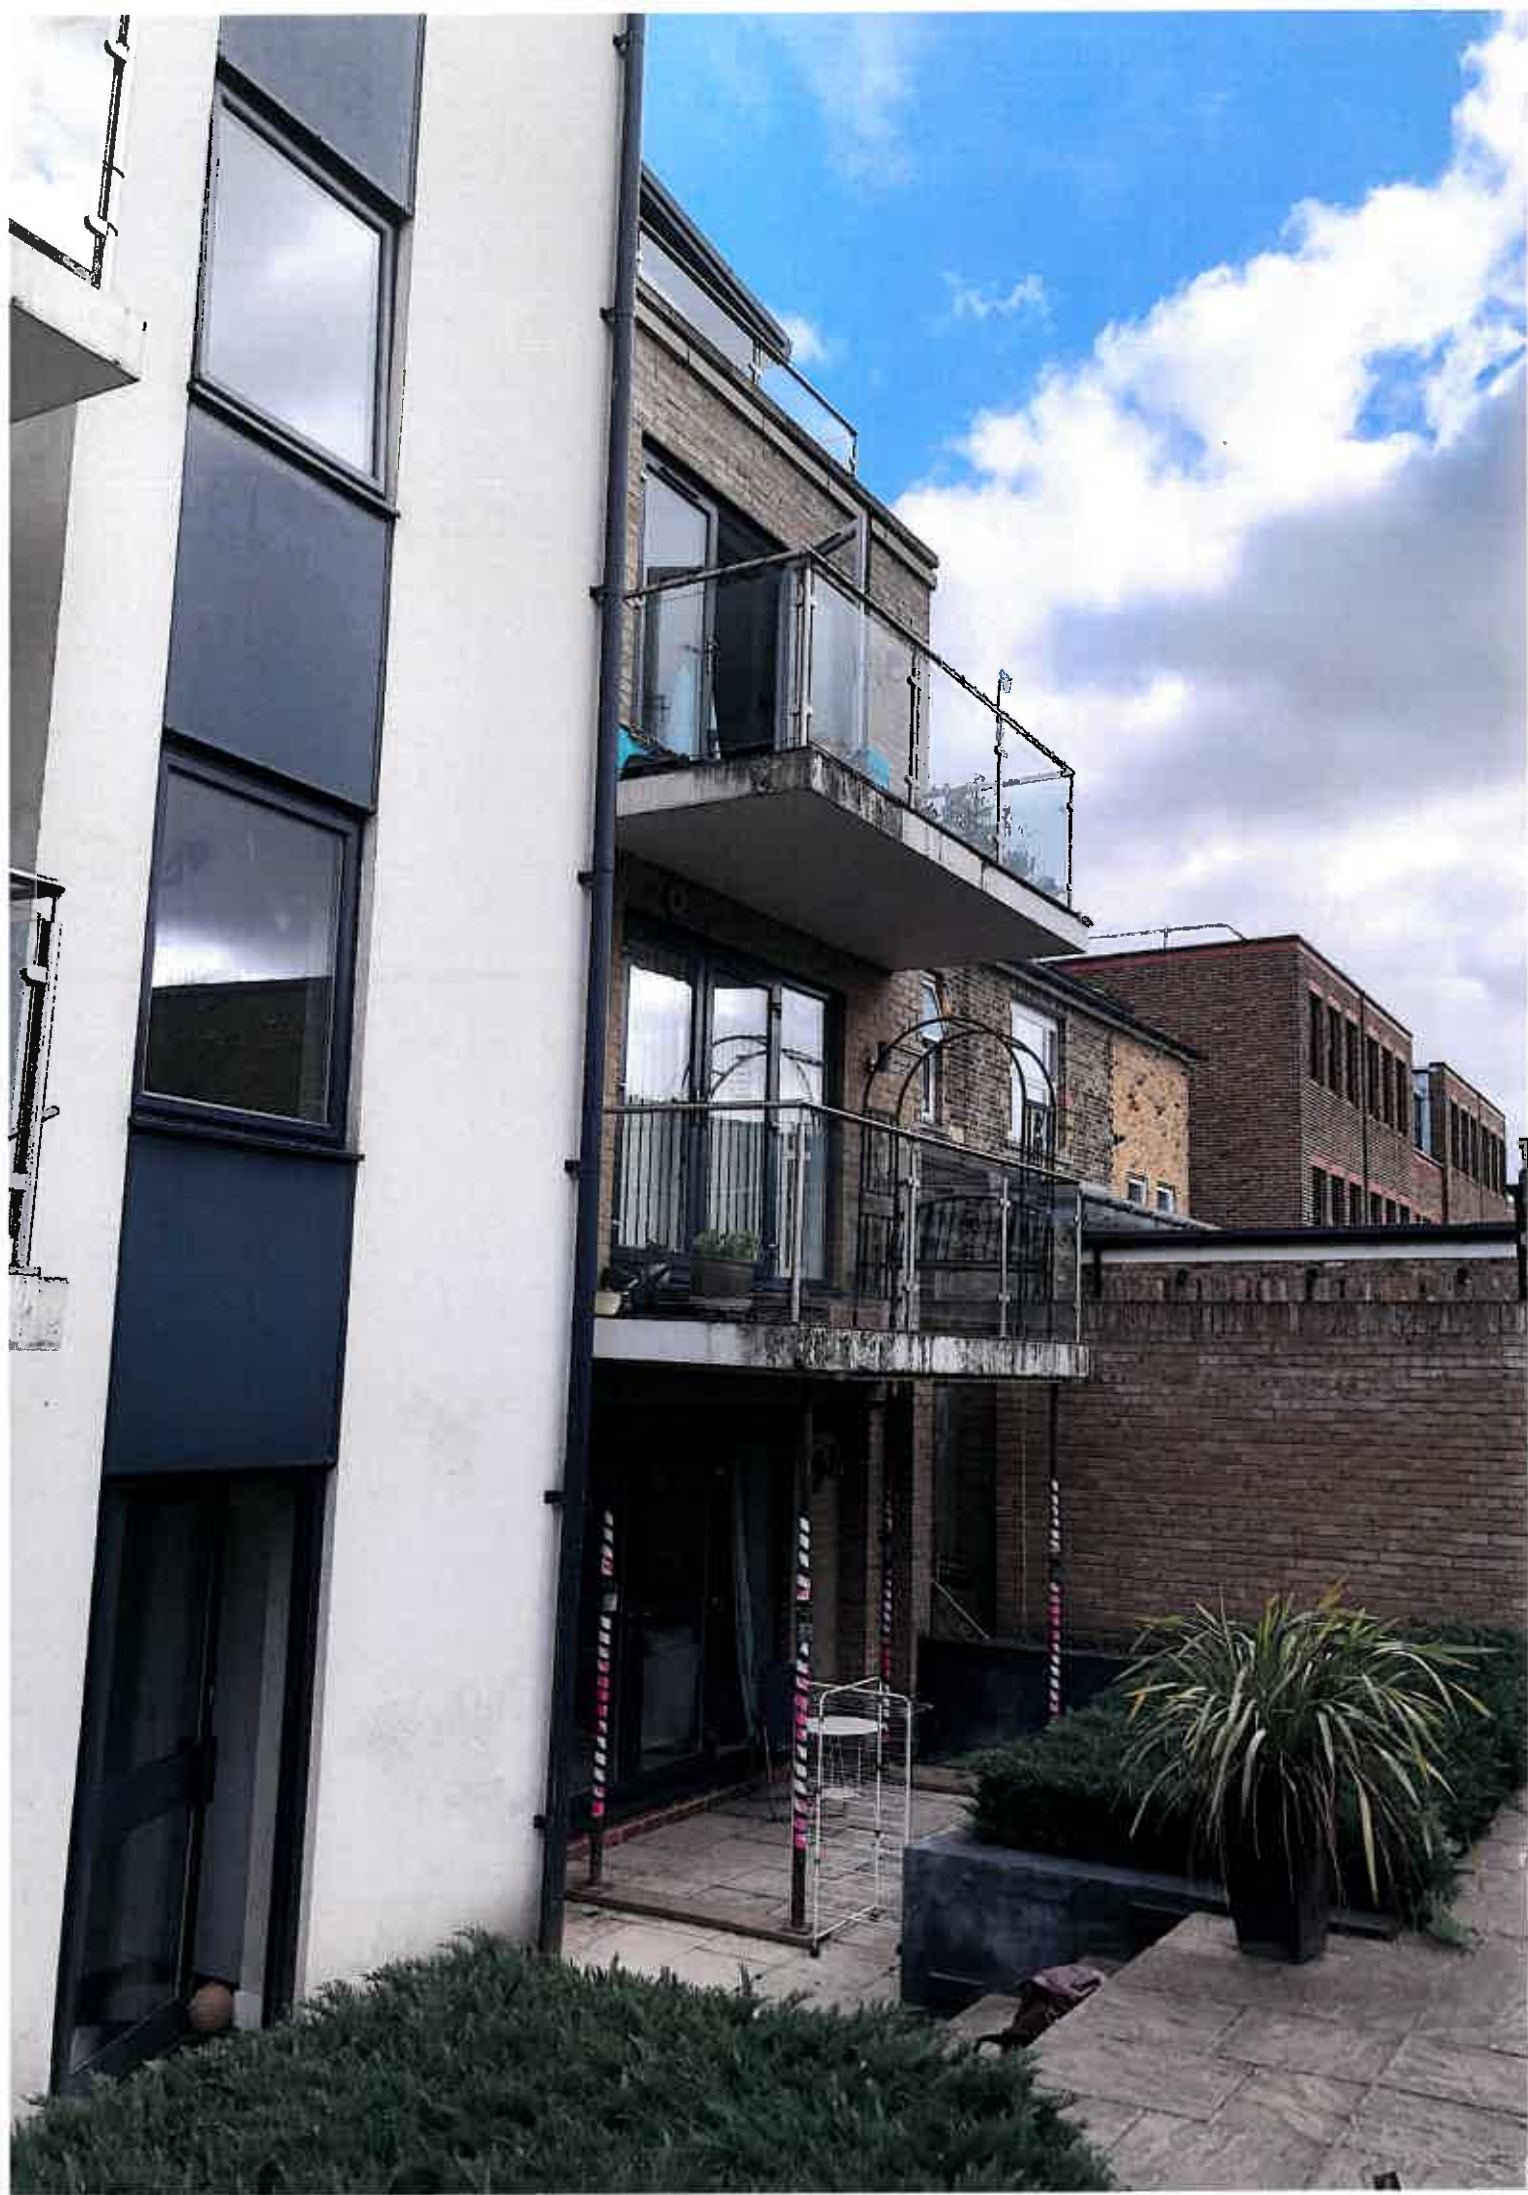
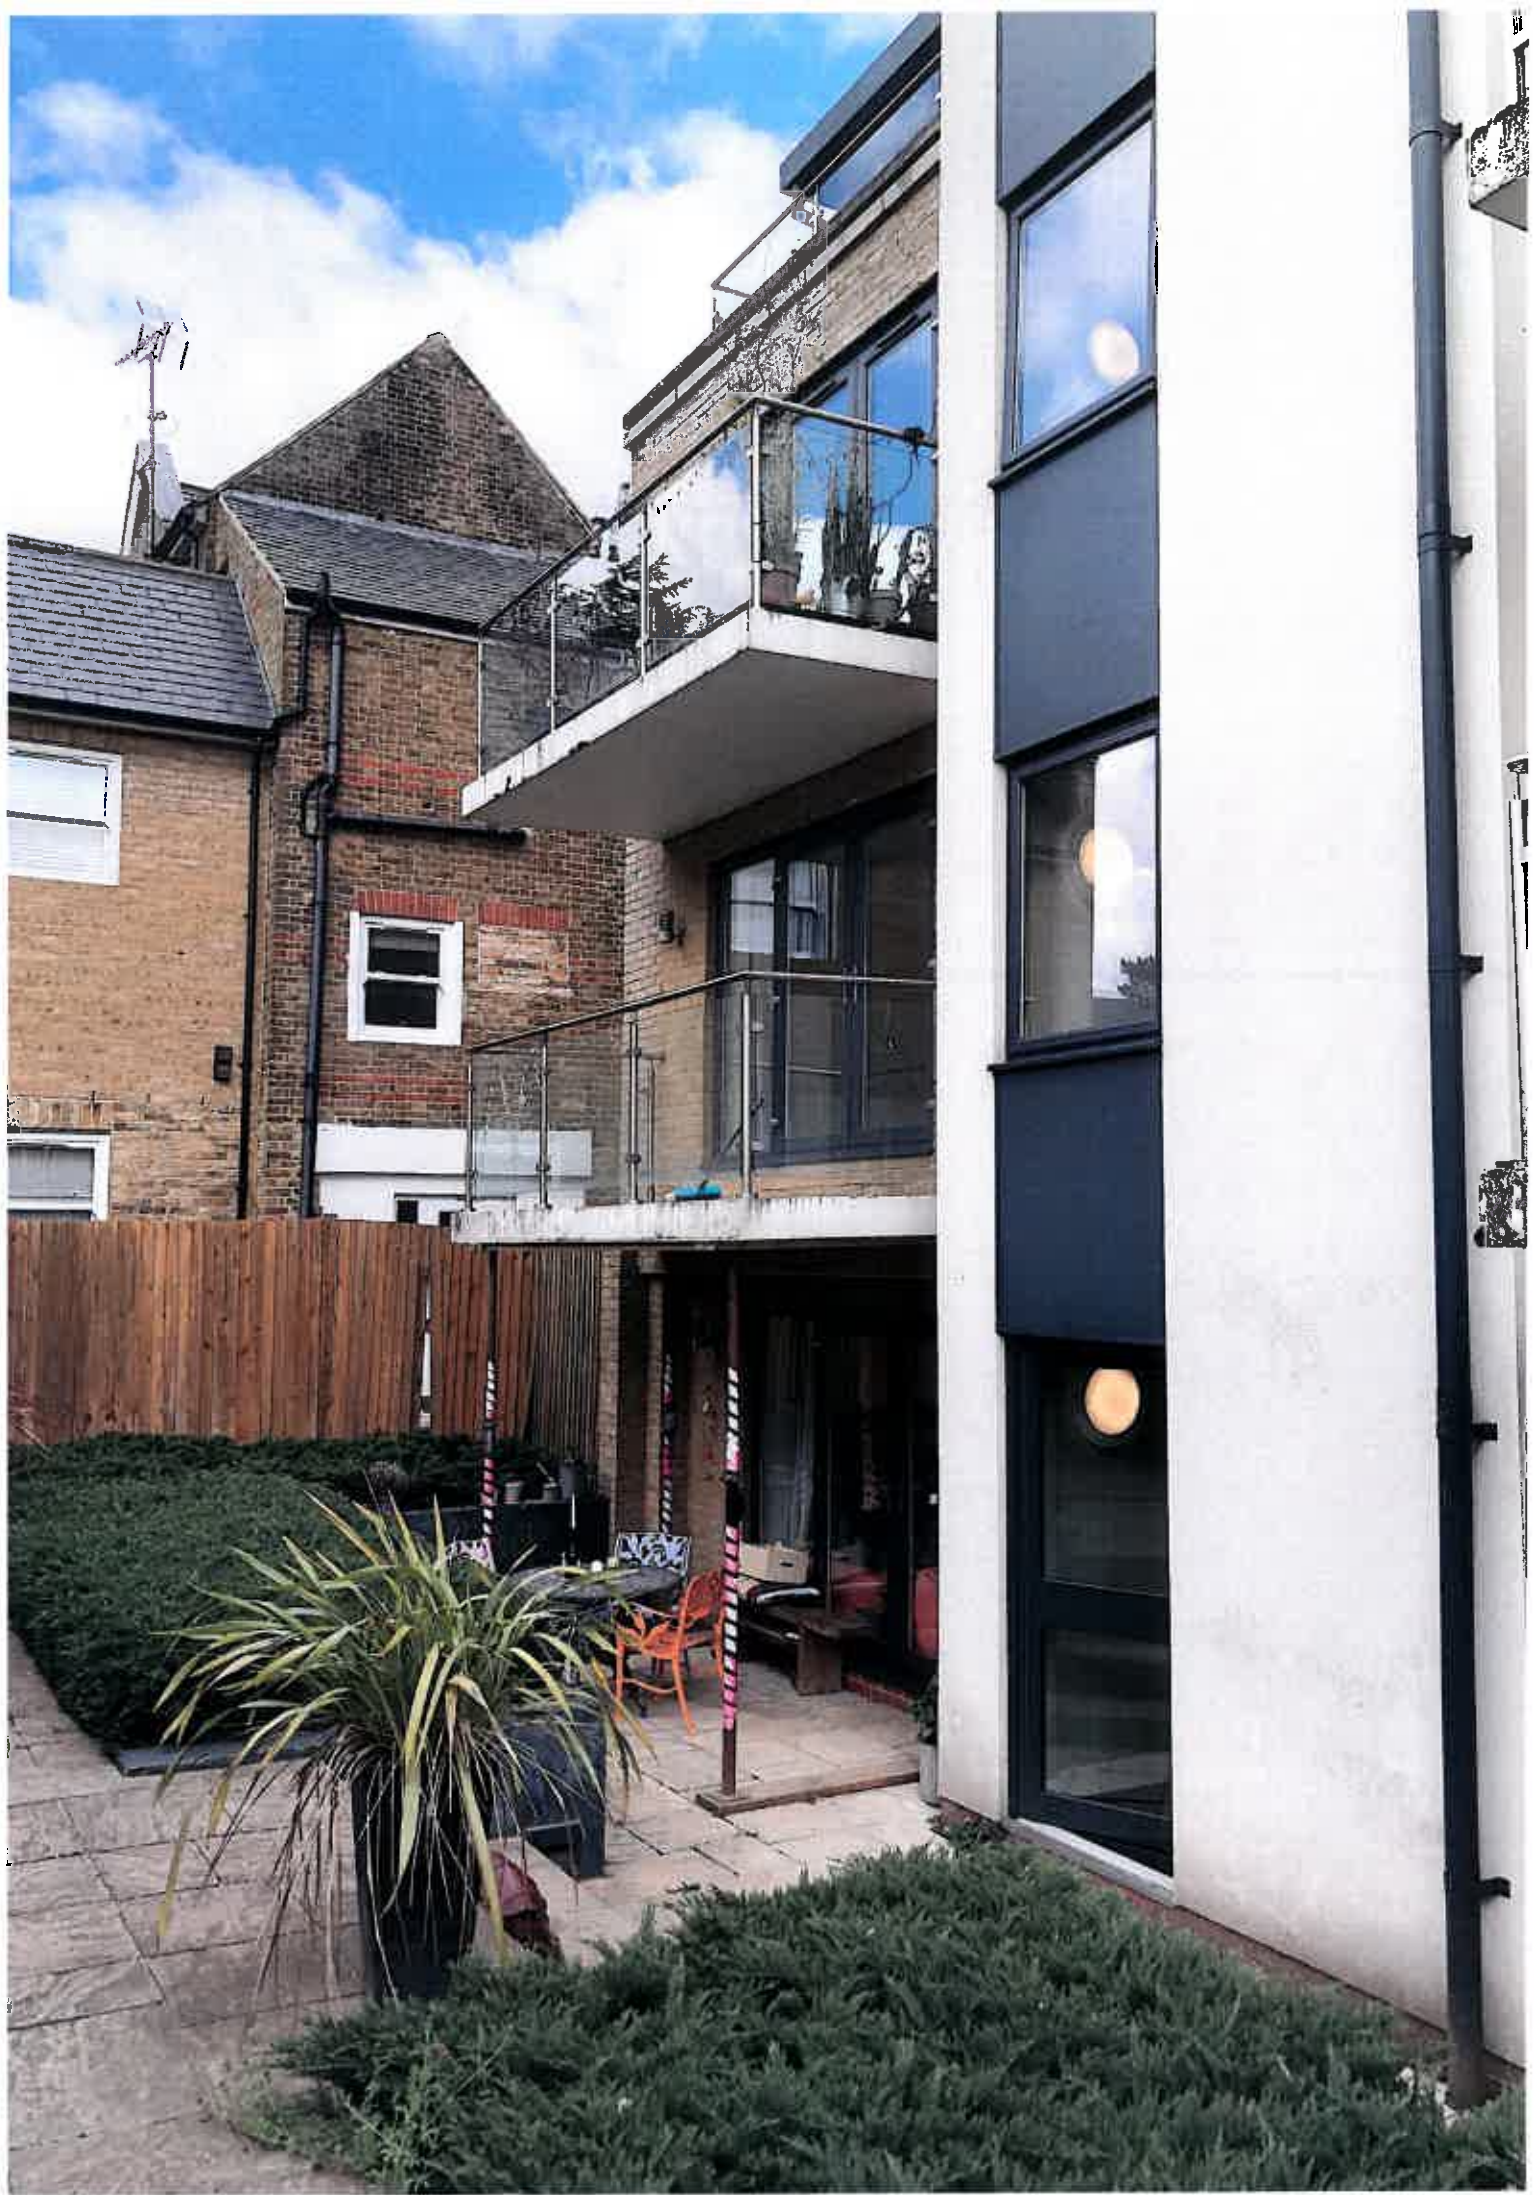
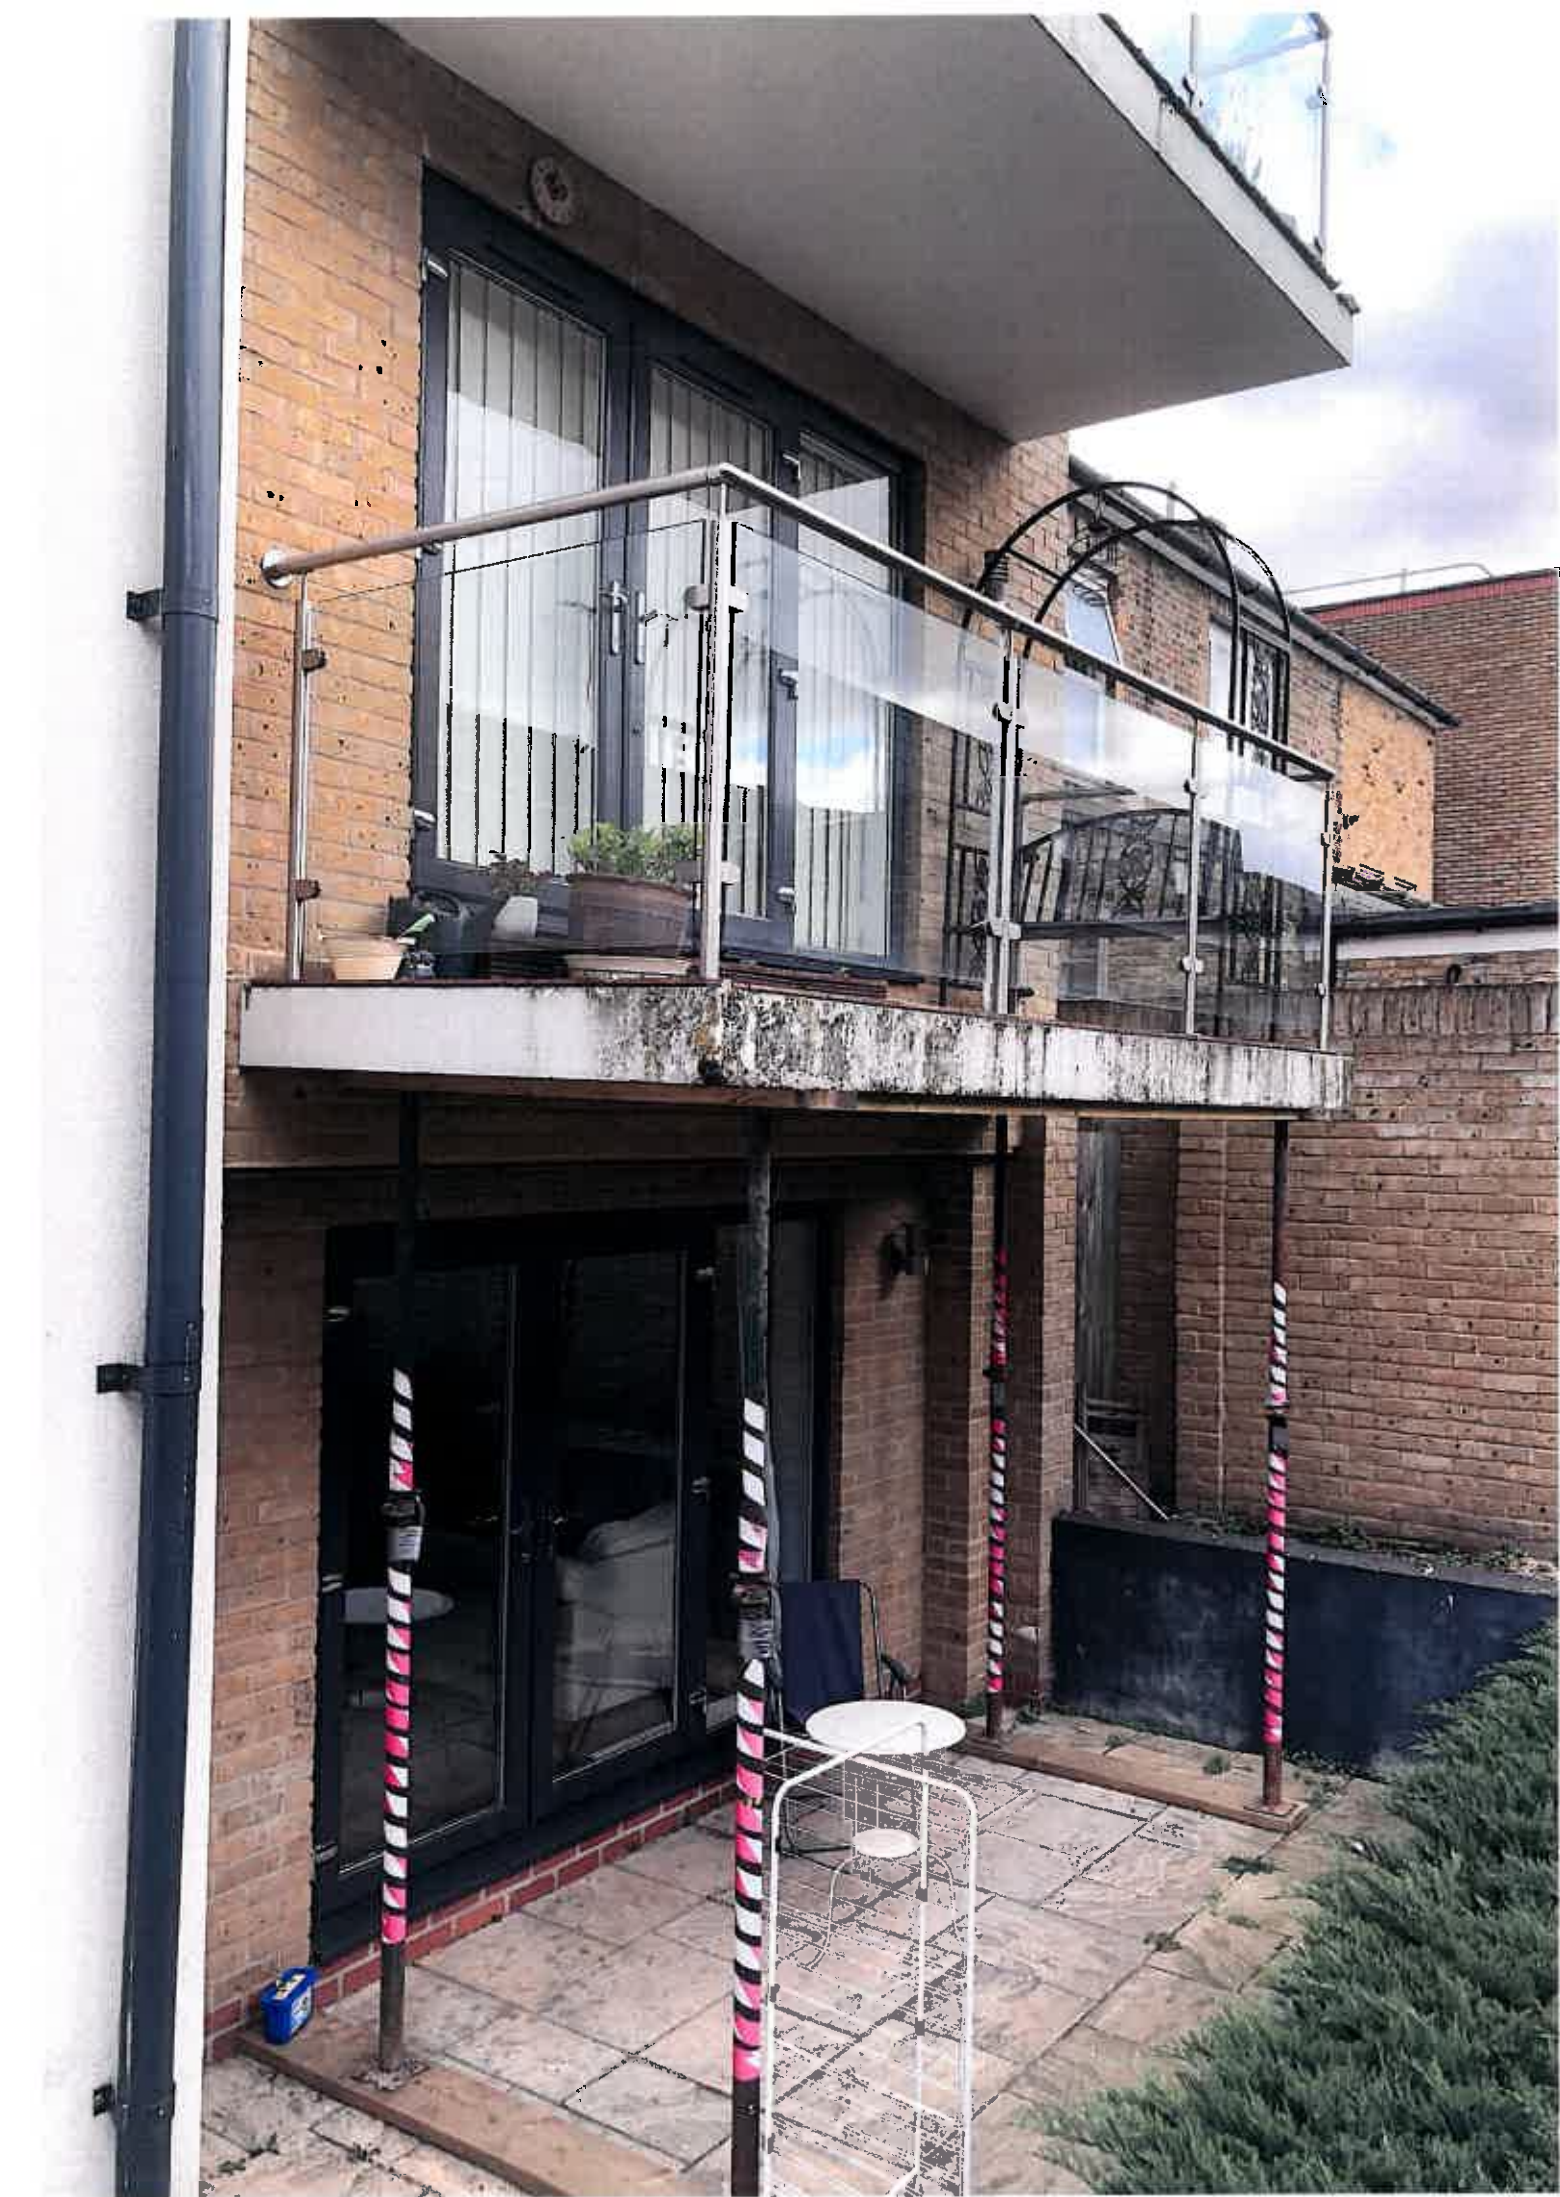
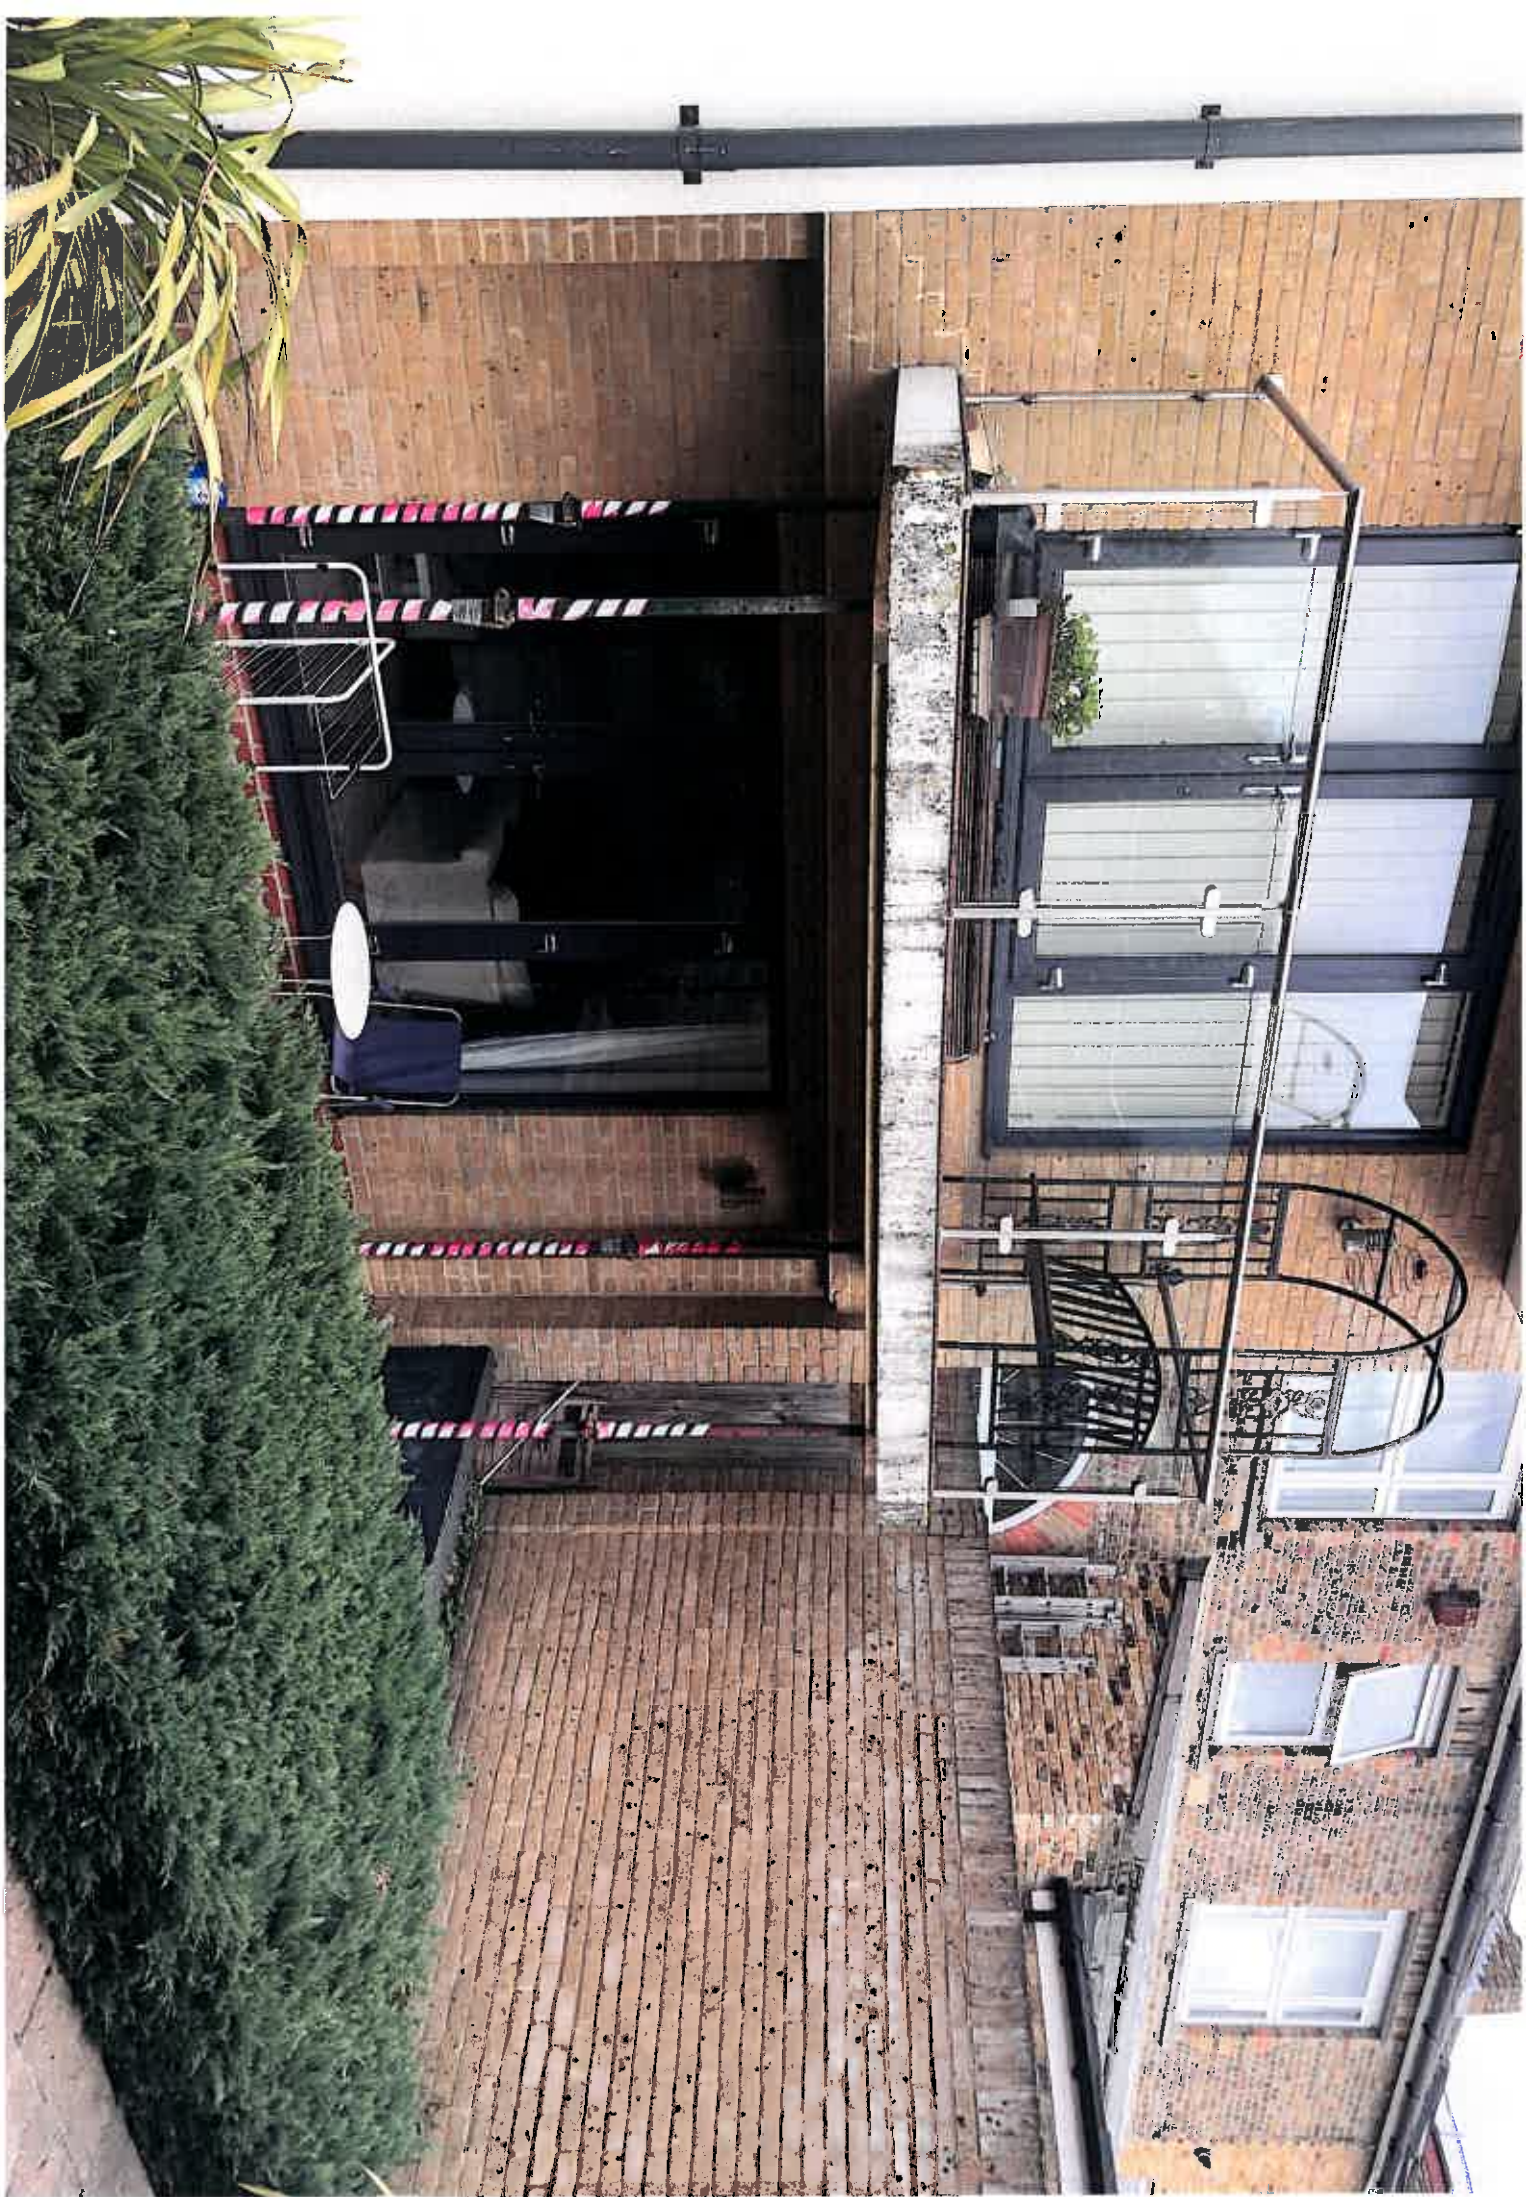
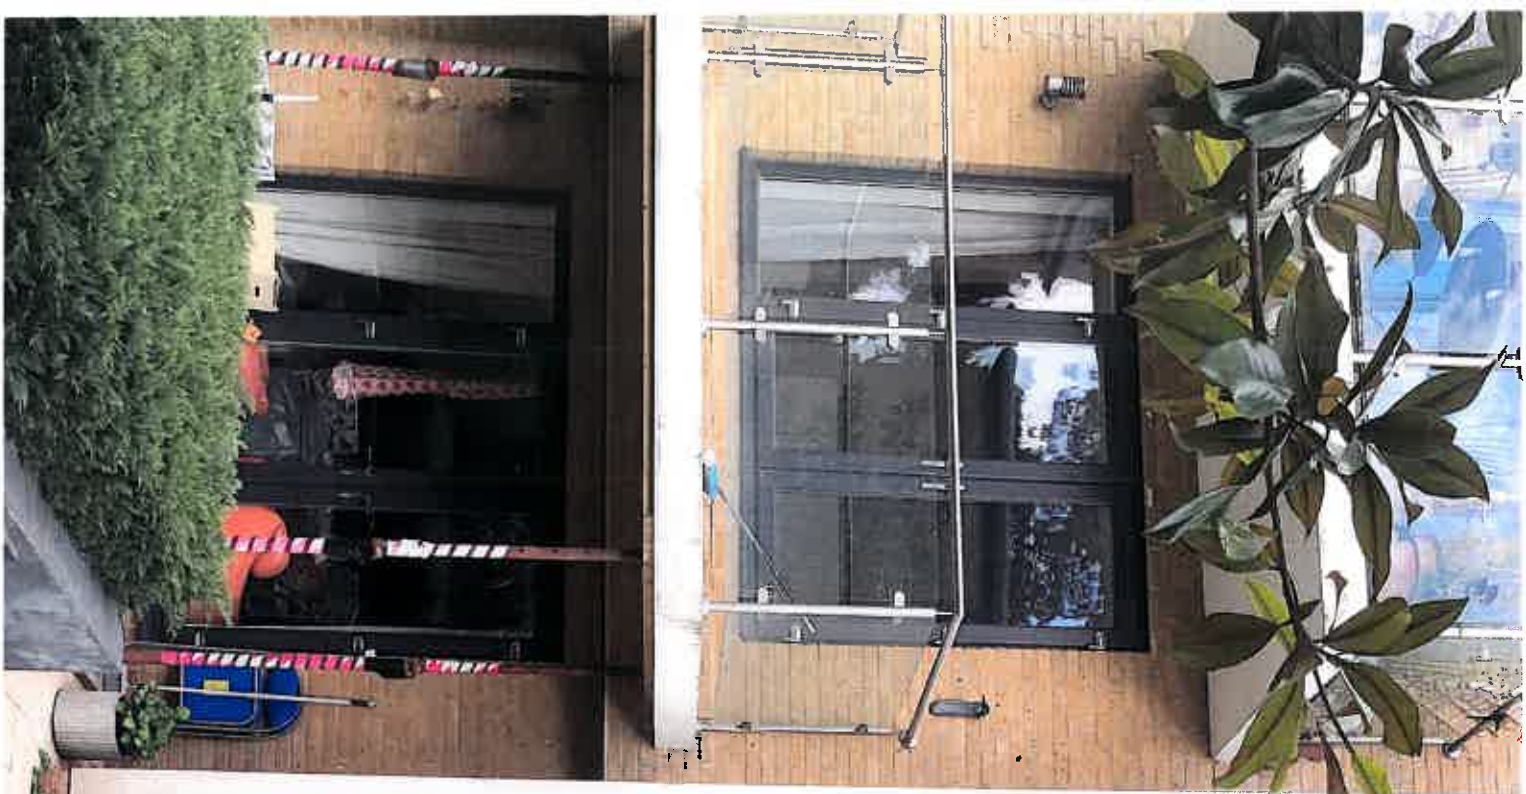
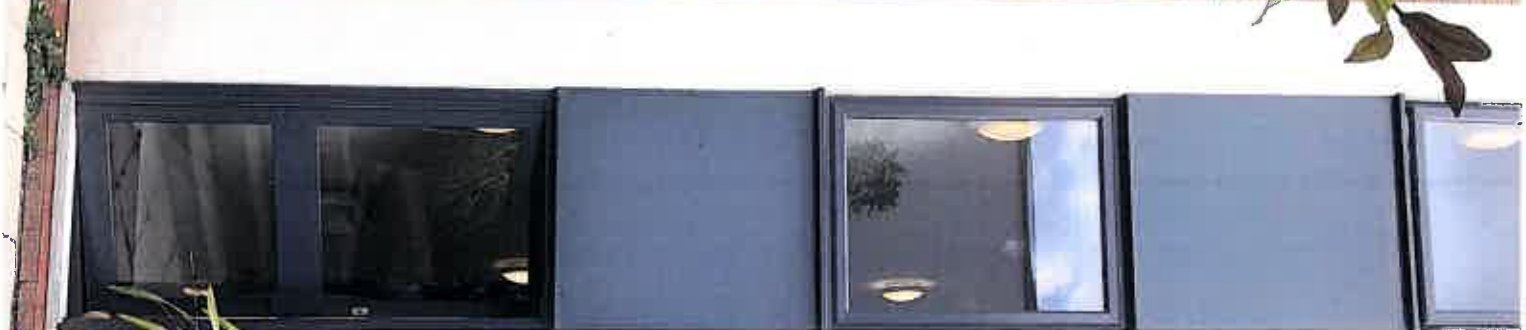
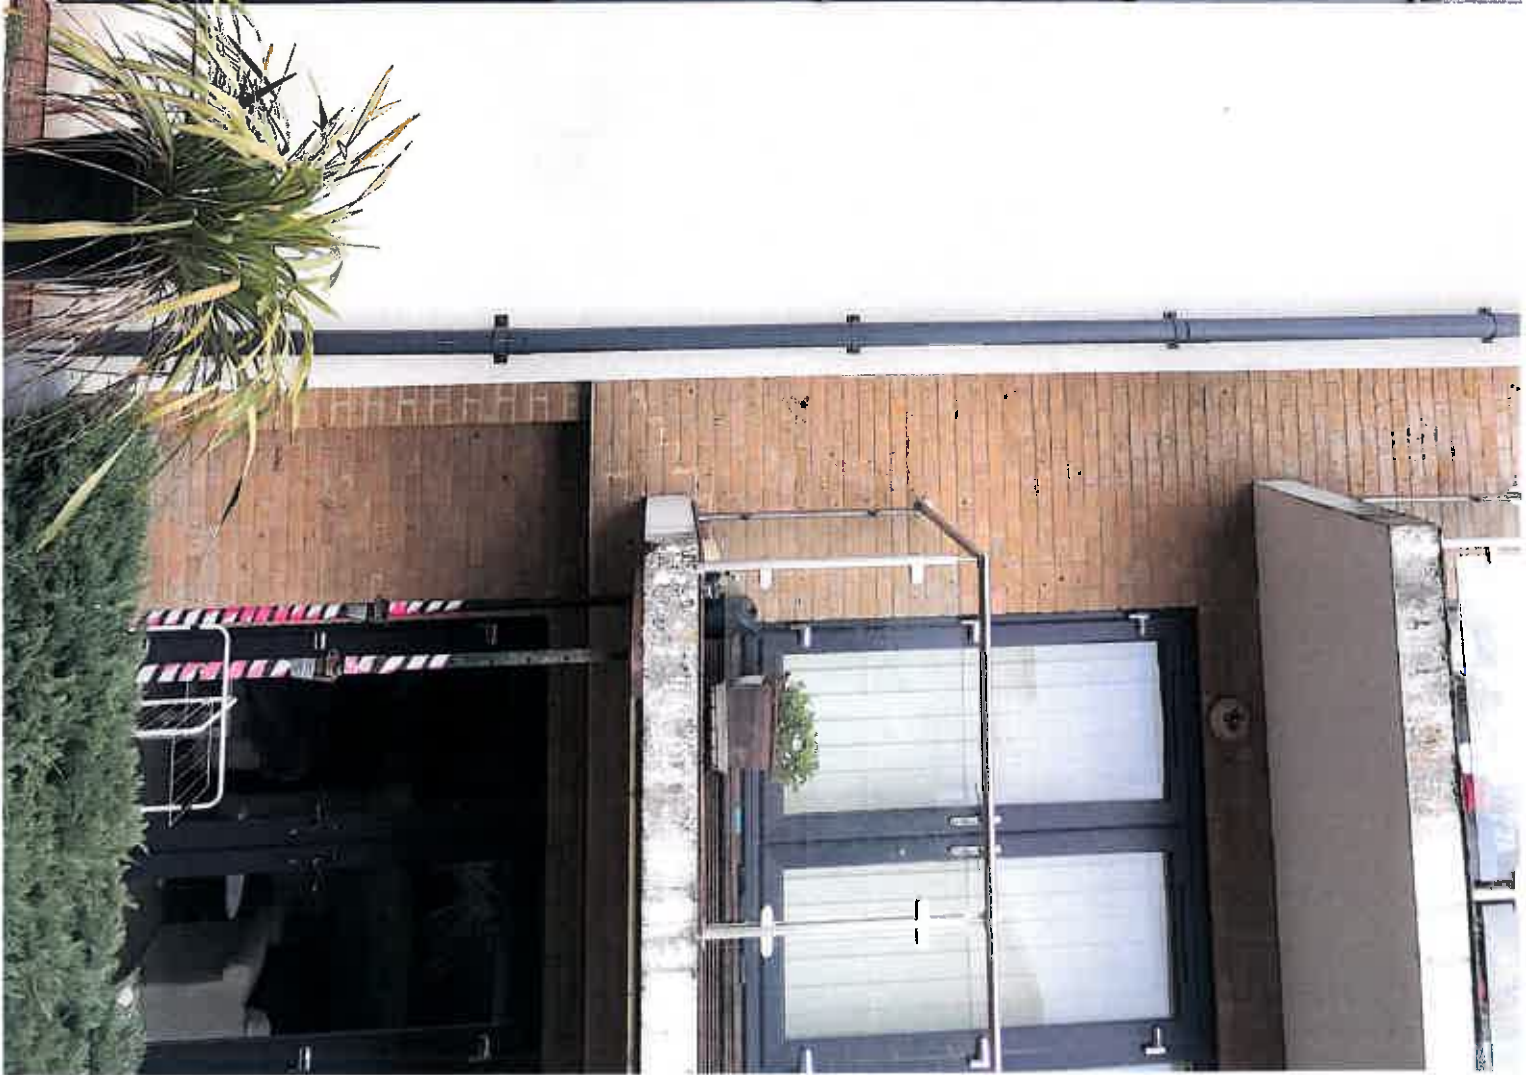
Photographs 01-05

As noted in the original NHBC inspection report dated October 2020, the in-situ reinforced concrete balcony slabs were seen to be separated from the main floor slabs by a 90mm wide thermal expansion joint. Unfortunately the expansion joints appear to have failed, allowing the balcony slabs to suffer excessive rotational movement. This has then transferred load, via the three courses of face brickwork, on to the long span steel lintel below, which appeared to consist of a 250x100mm RHS box section with an unstiffened 200x200mm angle welded to the side.

The 200x200mm angle supports the outer skin of brickwork, which has then taken the additional load from the rotating balcony slab. The angles have then suffered excessive rotational deflection, which has resulted in significant cracking to the external face brickwork (refer to attached photos).

It has been decided that, to prevent further outward rotational movement, it would be best to install new columns to support the outer corners of the balcony slabs. These columns will need to be founded on new pad footings, and taken up to support the remaining second floor balcony slabs over. A downstand beam will need to be installed between the pairs of columns to support the outer edges of the balcony slabs.
