Arboricultural Report

BS5837 Tree Survey

**7 Shoreham House
Church Street
Shoreham
Kent
TN14 7RY**

**Date
3rd March 2021**

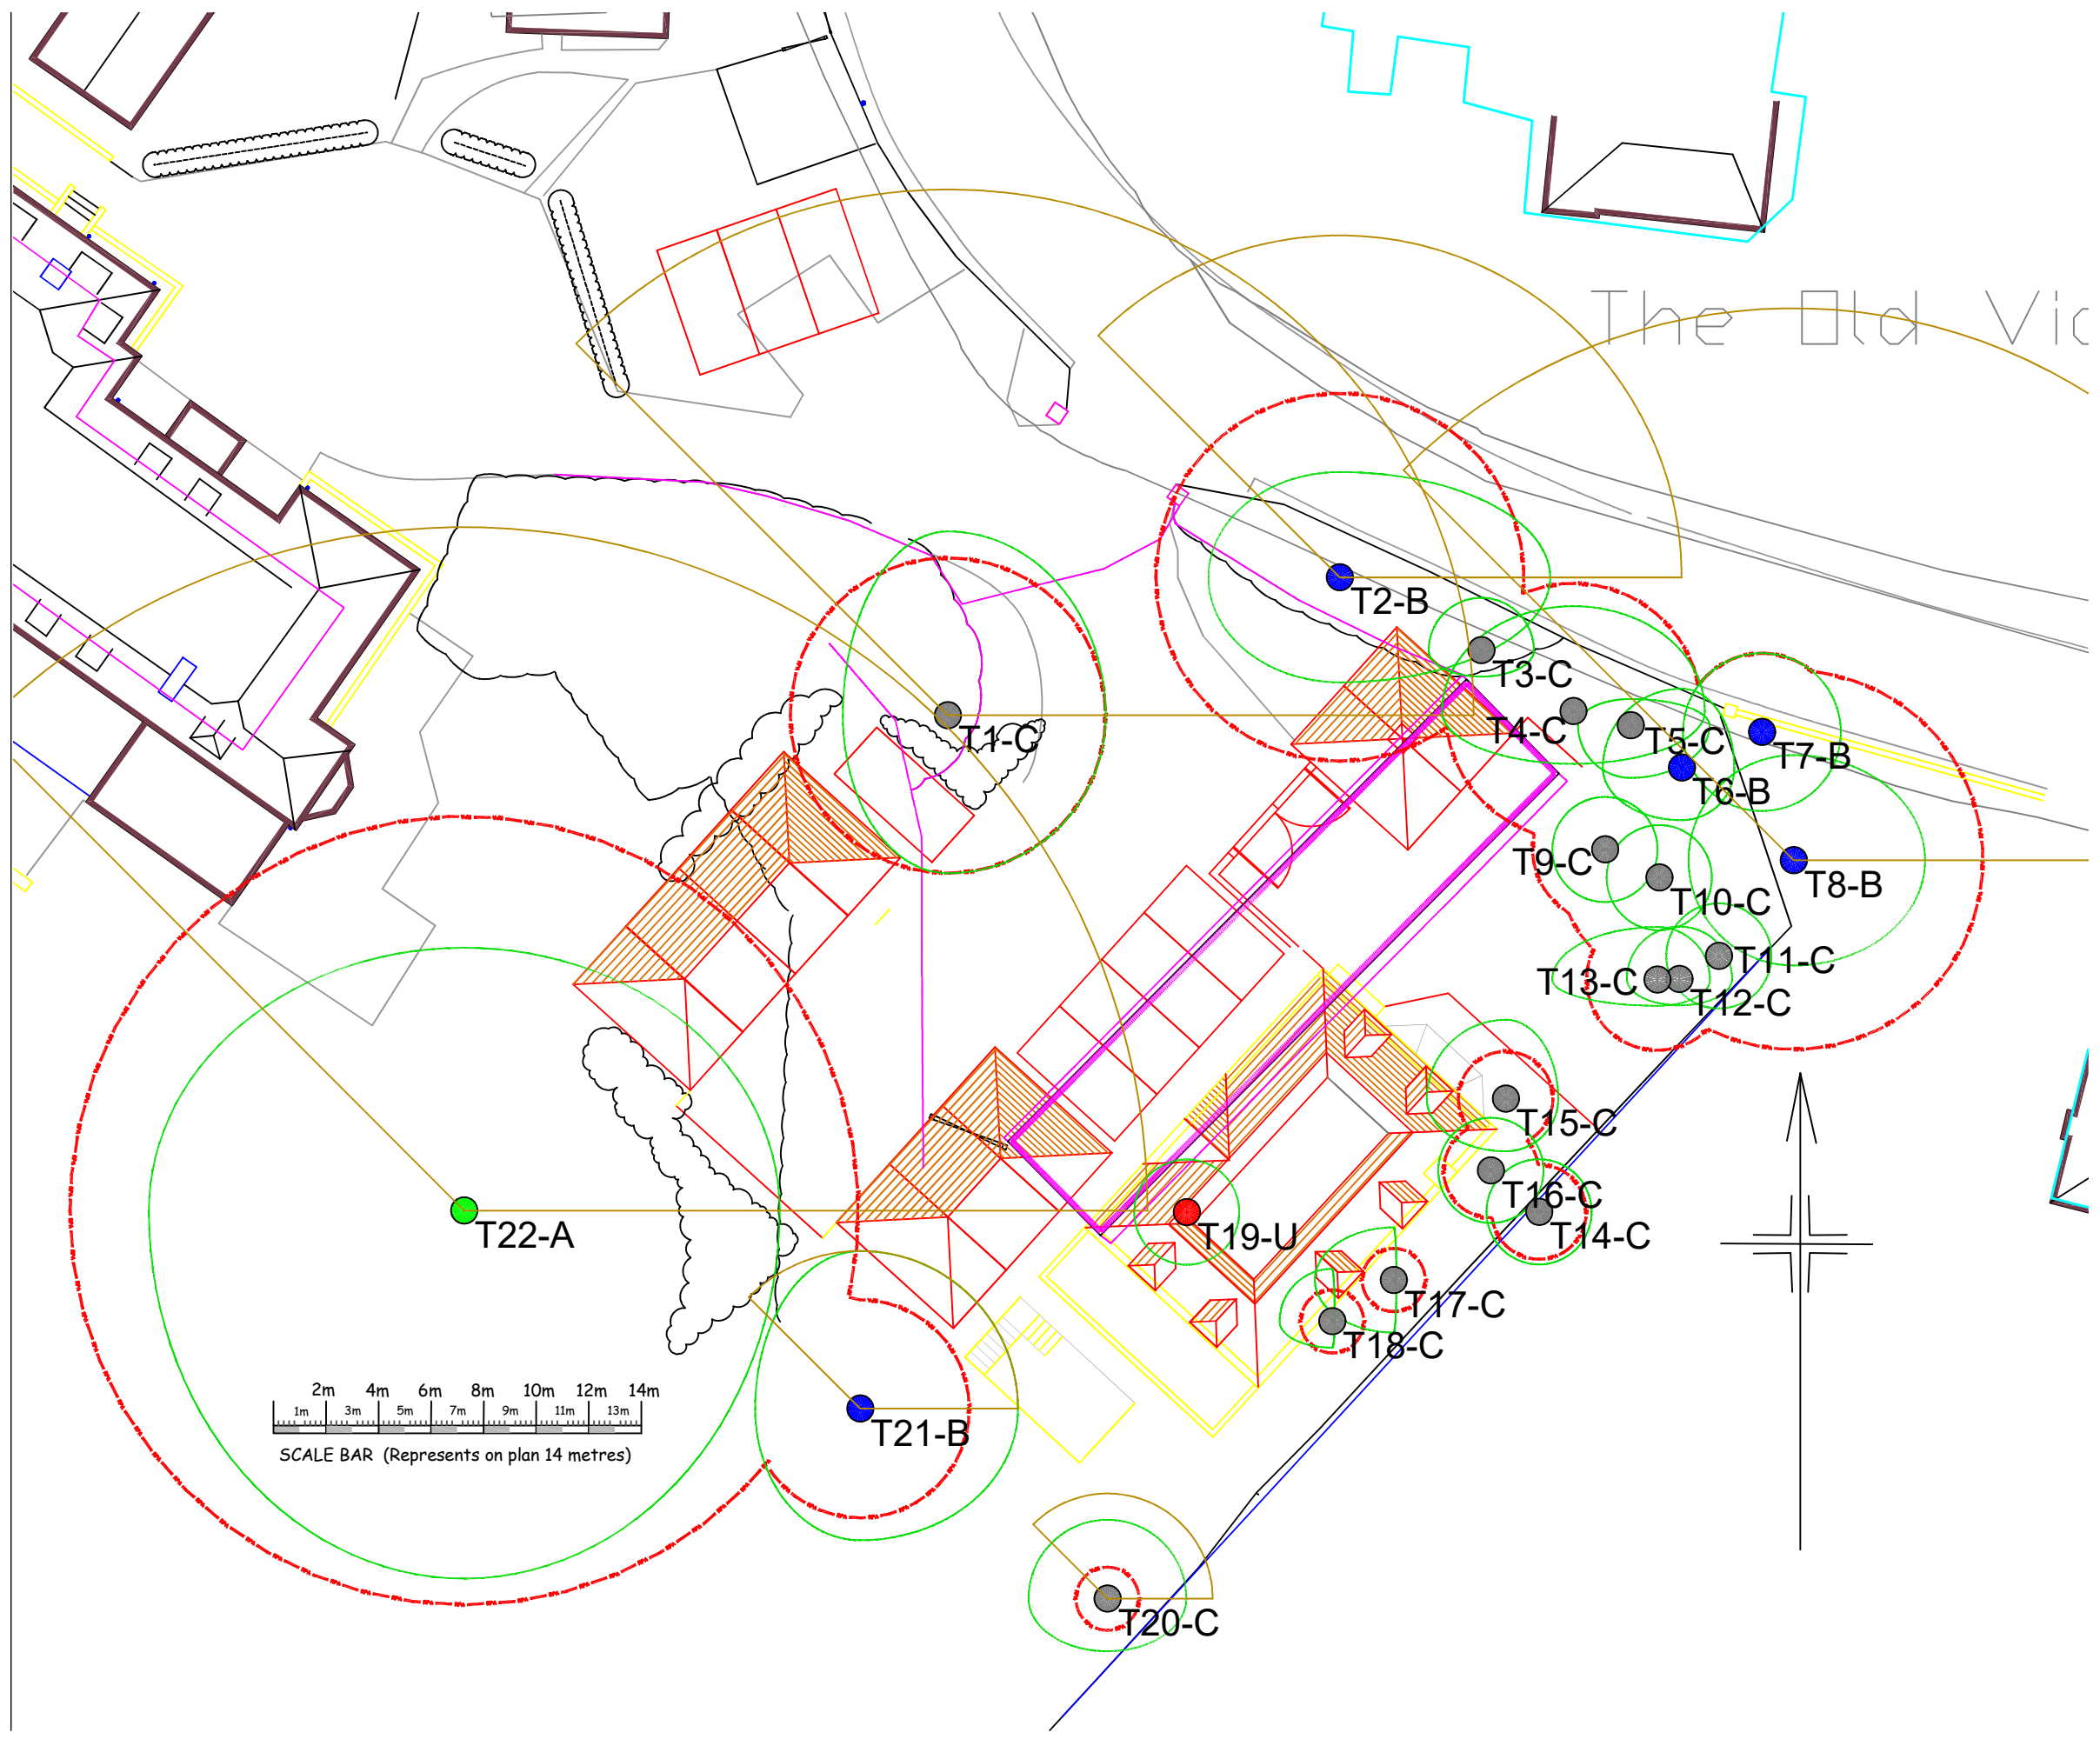
TREE SURVEY & CONSTRAINTS PLAN

- I would recommend the removal of the Sycamores (T9, T10, T11, T12 & T13), Elders (T3, T17 & T18), Holly (T15 & T16) and Lime (T4) in order to incorporate the new design and allow for new hard landscaping and as young **Category C** trees they should not therefore be considered as a constraint to the development.

- The poor physiological and structural condition of the Elder (T19) is such that its removal is recommended on purely arboricultural grounds regardless of whether the development is permitted or not. For the purposes of the survey, these trees have been recorded as **Category U** (BS5837: 2012, Table 1) being in a condition where they cannot be retained as living trees for longer than 10 years. These trees are extremely poor specimens with any remedial works considered unlikely to produce trees with any degree of longevity.

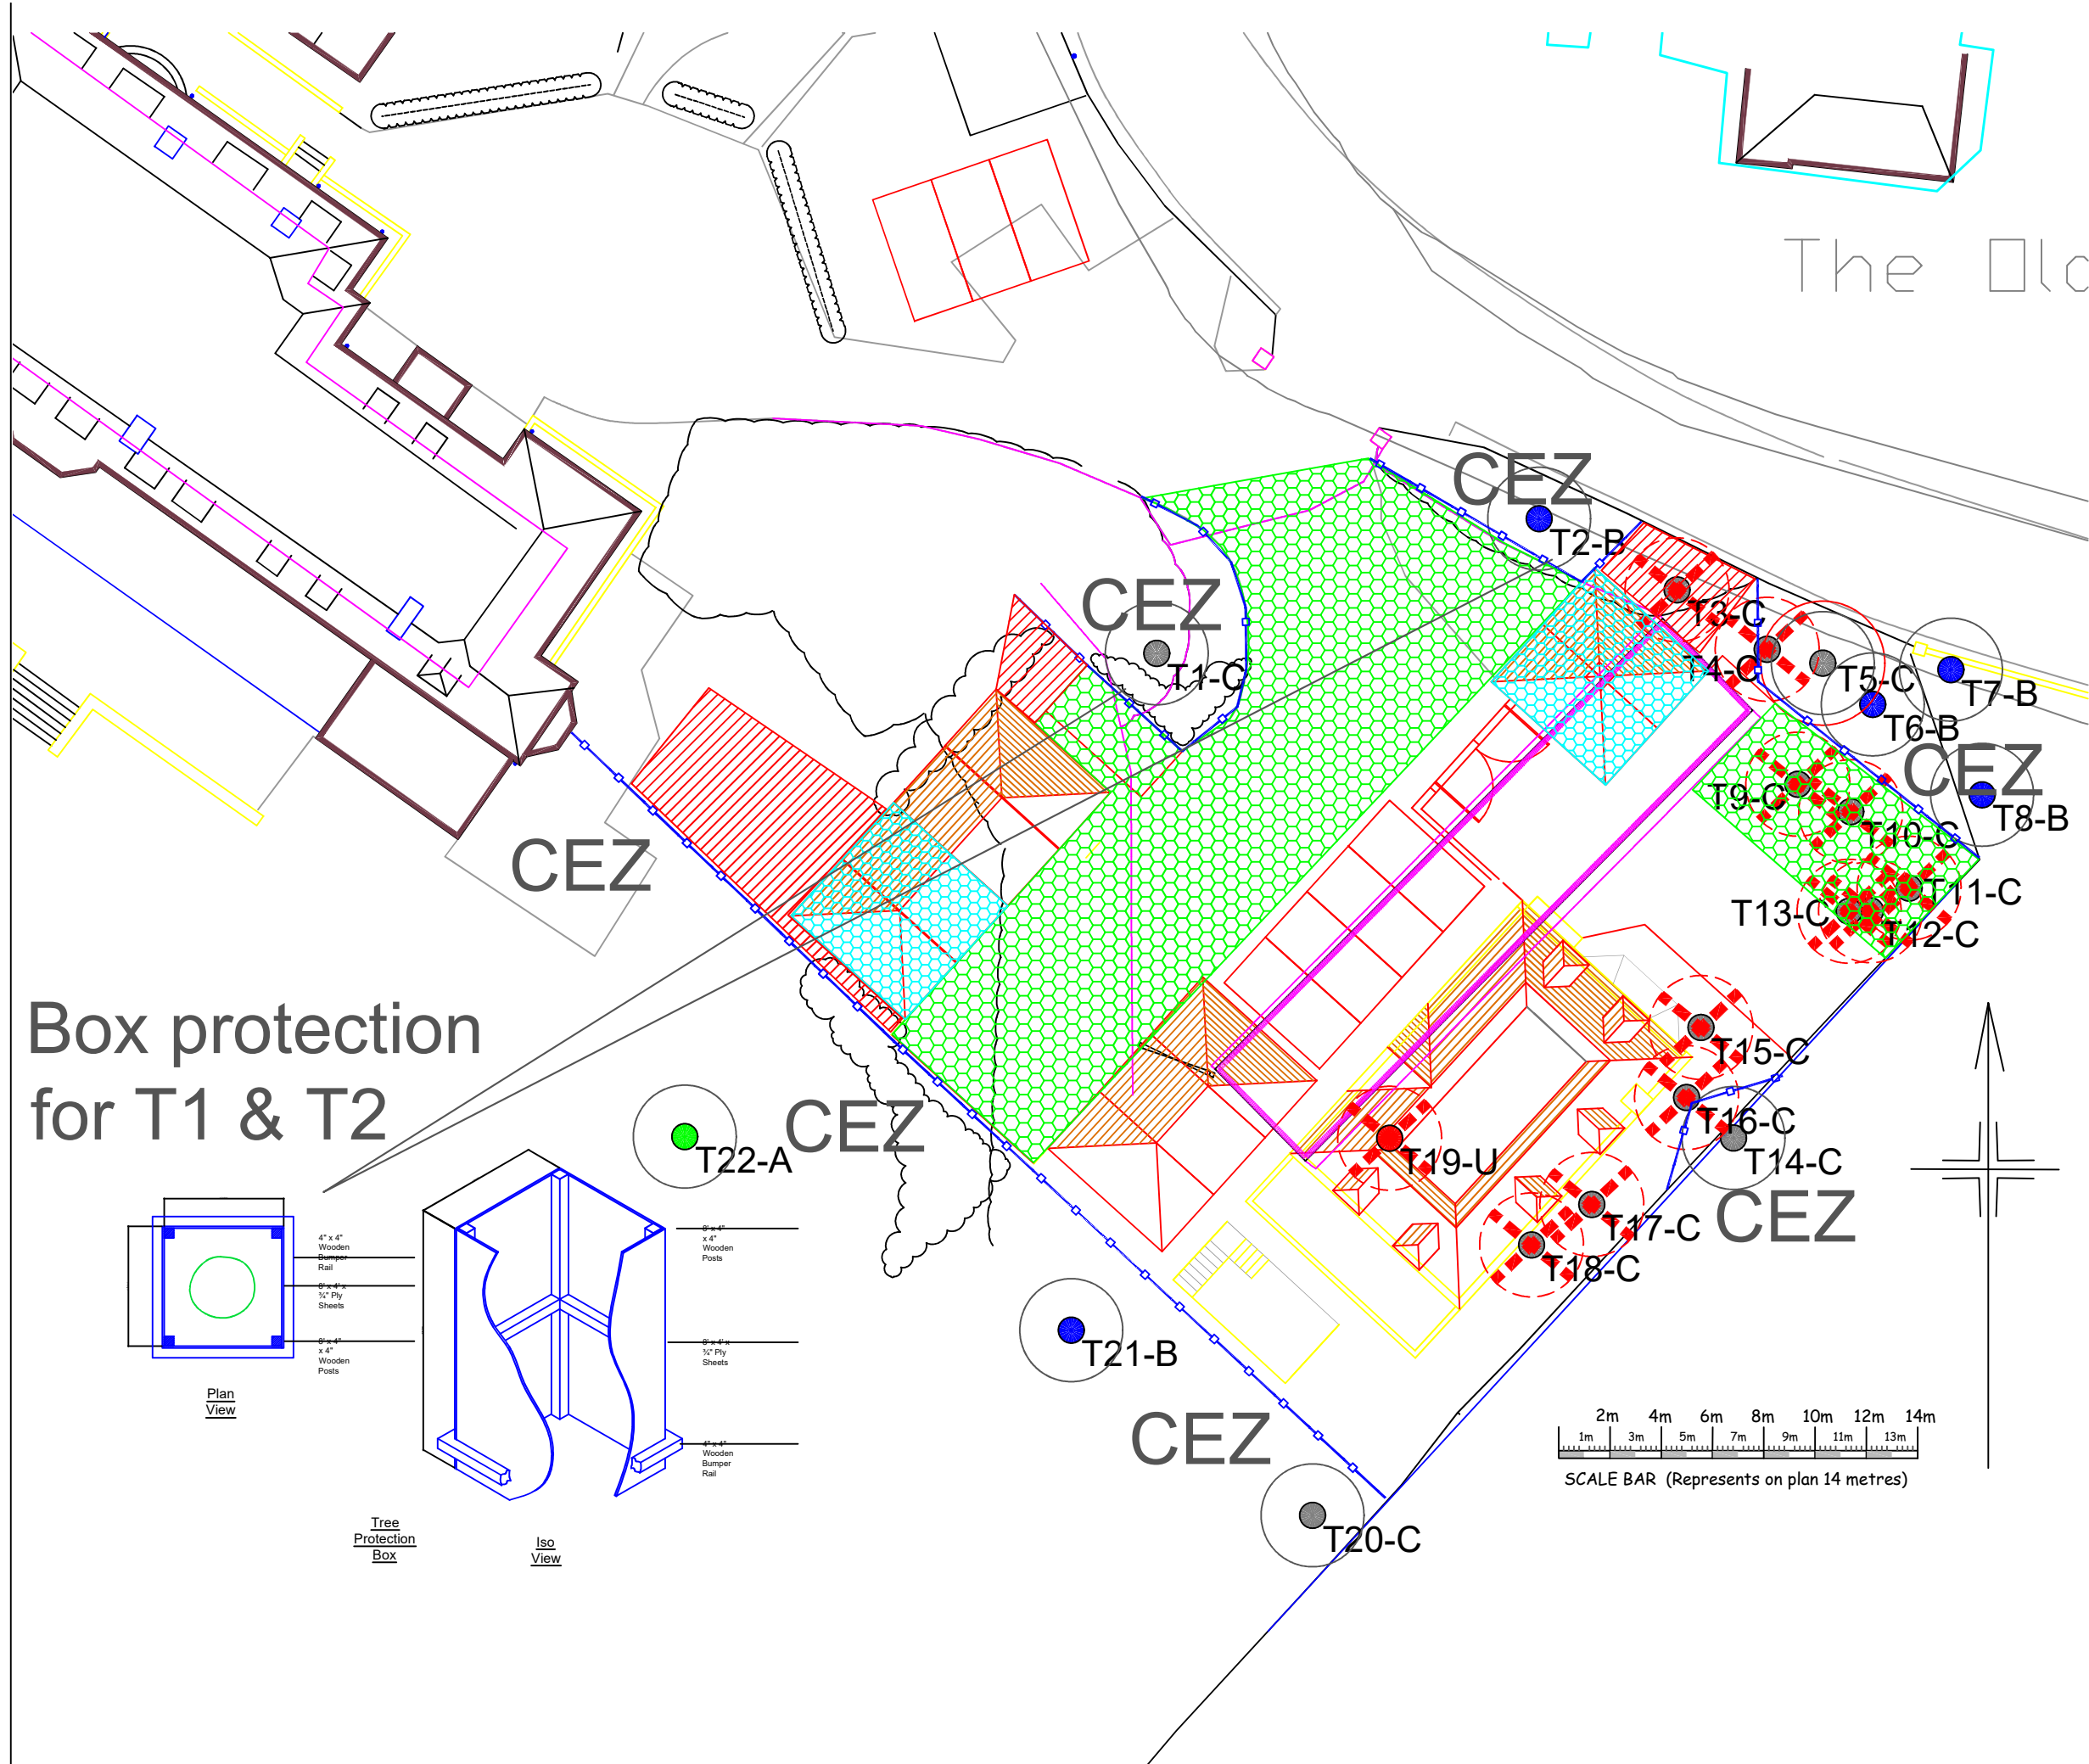
TREE PROTECTION PLAN

- The proposed new garages will require in an 12% incursion into the root protection area of the Yew T2 and a 5% incursion of the Cedar (T22) and therefore an above ground, cast in-situ raft foundation is recommended (subject to a structural engineer's design). The new hard surfacing will require a low-invasive surface solution (see below) which will improve the existing hard surfaced rooting area in the long term and does not exceed 20% of the existing unsurfaced ground (BS5837:7.4.2.3).

- New surfacing within the RPA's of the retained trees (shown in GREEN on the draft TPP) is to be installed by hand under site supervision by an arboriculturist (existing surface removal etc). New hard surfaces are to be installed with low invasive techniques using hand tools and the utilization of a cellular confinement system as part of the sub-base. This surface must be fit-for-purpose with specialist advice obtained from an engineer to meet the above performance specification. Proprietary products such as 'Cellweb, CORE, Terram etc' are available that can help deliver the performance specification e.g. www.geosyn.co.uk or telephone 0870 850 1018 (Geosynthetics Ltd). **Example Below**
