## **SYCAMORE COTTAGE, 40 WATER LANE, BUTLEIGH, GLASTONBURY – HERITAGE STATEMENT AND DESIGN & ACCESS STATEMENT**

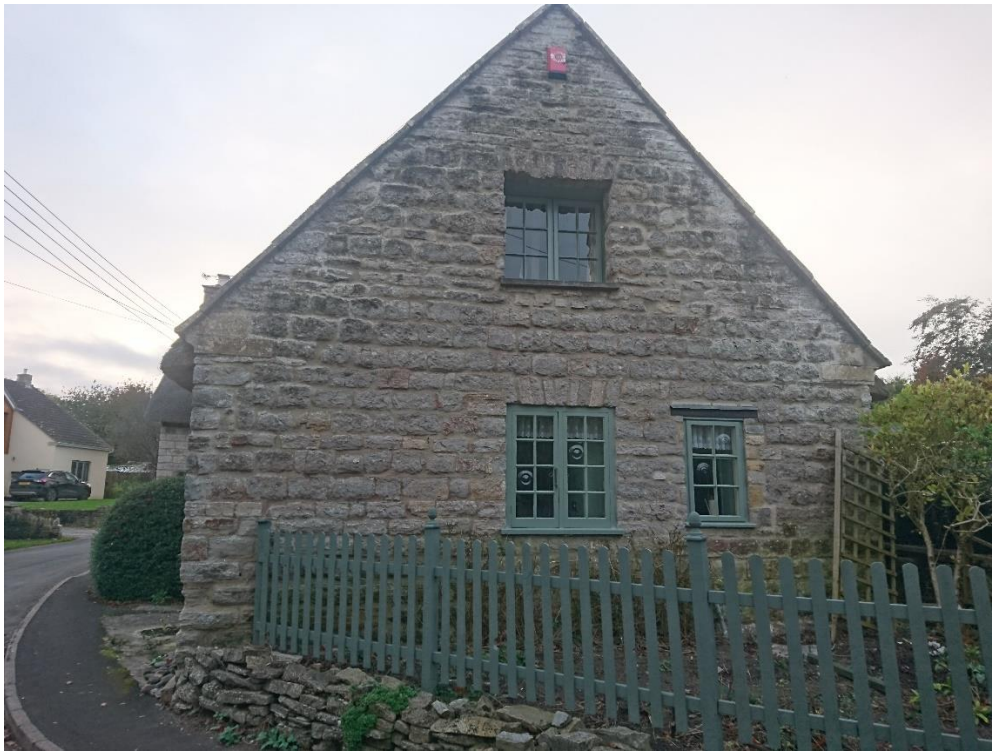
*Figure 1: Photo of gable end*

A photograph of the gable, which is to the former byre, is shown in Figure 1. Scaffolding will need to be erected against this gable. However, the scaffolding will not be required on the adjacent elevations.

Thank you for the kind invitation to provide a quotation for structural stabilisation works at the above-named property. The specification is based on our survey conducted on 26.07.2021. The following repair proposal is designed to restore the structural integrity of the masonry where cracking, bowing and delamination has occurred by the introduction of the Helifix system installed horizontally across existing cracks, additionally Helifix HD Bow ties/Cem ties installed to reconnect the external masonry back to first floor joists and internal masonry, thus offering substantial resistance to further cracking and outward movement.

1. Install 5 No twin bands of Helibar 60 stainless steel bed joint reinforcing, positioned horizontally to distribute the structural loads, 2 No drilled back (indicated black), as detailed on enclosed ASRS drawing. Installed in accordance with manufacturers method statement LB-04 or similar (copy enclosed).

2. Install 25 No single bands of Helibar 60 stainless steel crack reinforcing, positioned horizontally across existing crack, returned (indicated red), as detailed on enclosed ASRS drawing. Installed in accordance with manufacturers method statement CS-05 or similar (copy enclosed).

3. Install 5 No Helifix HD Bow ties through the external masonry into first floor joists, as detailed on enclosed ASRS drawing. Installed in accordance with manufacturers method statement HD Tie or similar (copy enclosed).

4. Install Helifix Cem ties, to provide a connection between the external masonry and internal masonry. To be positioned at 450mm centres horizontally, 450mm vertical centres. Installed to area hatched out blue only, as detailed on enclosed ASRS drawing. Installed in accordance with manufacturers method statement RF-01 (copy enclosed).

5. Install 10 No Helifix Pinning Cem ties, to be positioned as detailed on enclosed ASRS drawing. Installed in accordance with manufacturers method statement CS-09 or similar (copy enclosed).

6. Rake out all existing cracks and inject with thixotropic cementitious grout.
7. Inject cracks with resin.
8. Make good all areas of mortar disturbed by our installation.

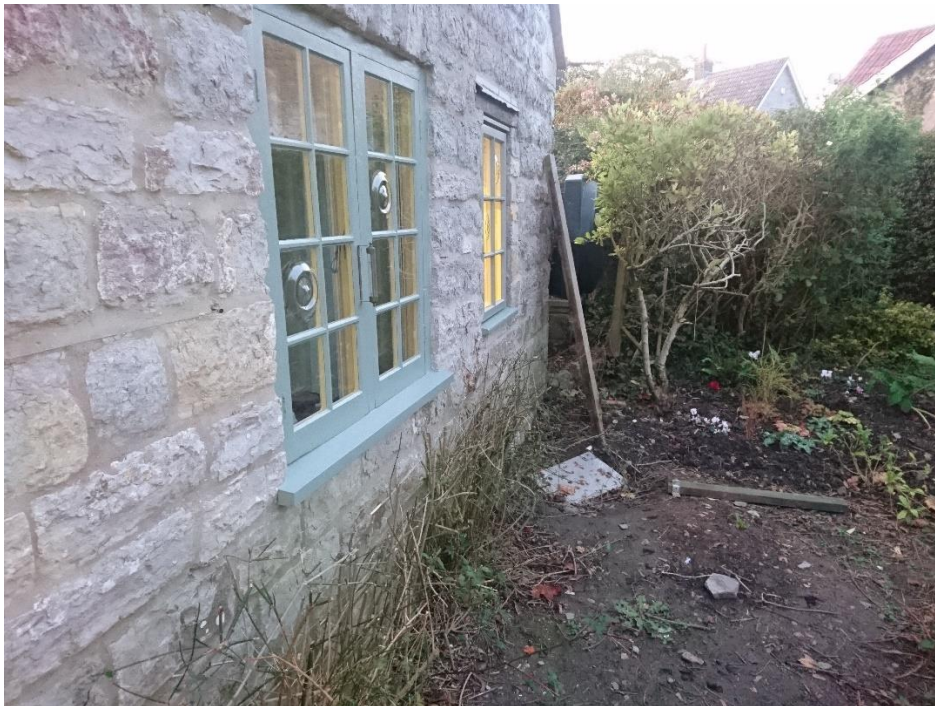
*Figure 2: Photo of garden adjacent to gable*

A photo of the adjacent garden is shown in Figure 2. There is a small jasmine hedge along the foot of the wall and several magnolia trees on a line from the north-east corner of gable. These shrubs have been neglected in recent years and are in poor condition. That said, care will be taken not to damage them during the works. Pruning will follow in the spring for both the jasmine and the magnolia.
