Arboricultural Impact Assessment

Kettlestone House, Kettlestone, Fakenham NR21 0BB

OAS 21-251-AR01

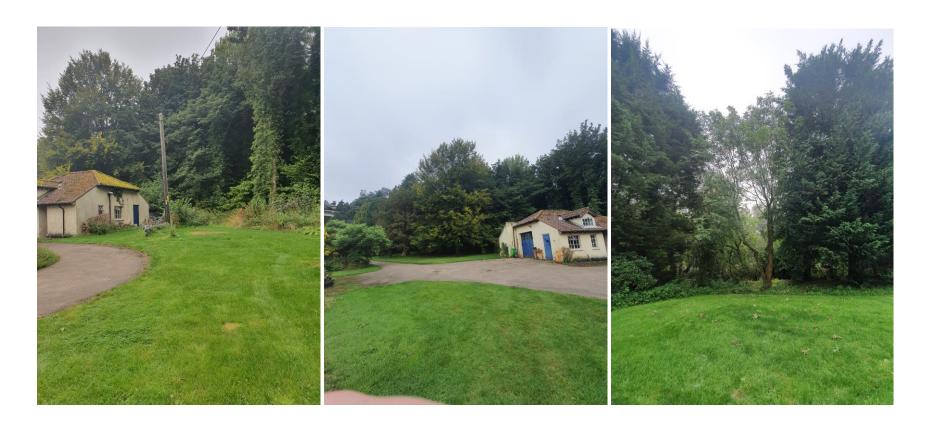
Showing area of proposed cart lodge extension, T1 in relation to existing garage and T11 between T10 & T12

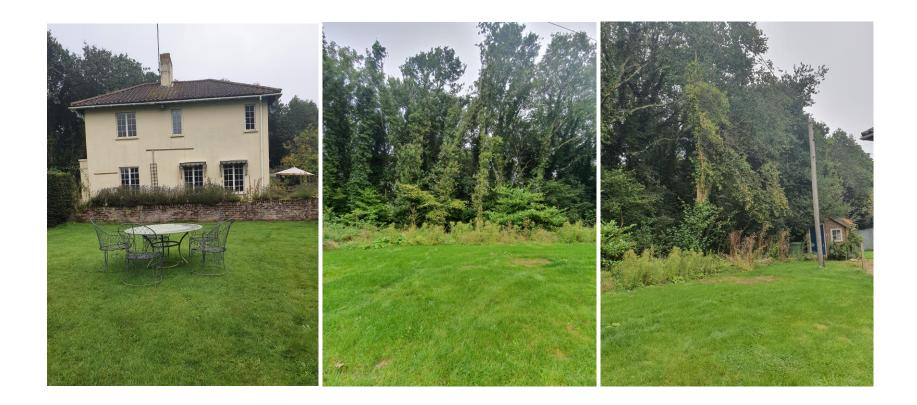
Showing location of proposed swimming pool, and images of woodland to north of cart lodge
