*Report No. BC/MB/10.21.05.*

# **Coal Mining Risk Assessment: Land at Fairview Garage, Pengam.**

***H C Capel and Sons Ltd.***

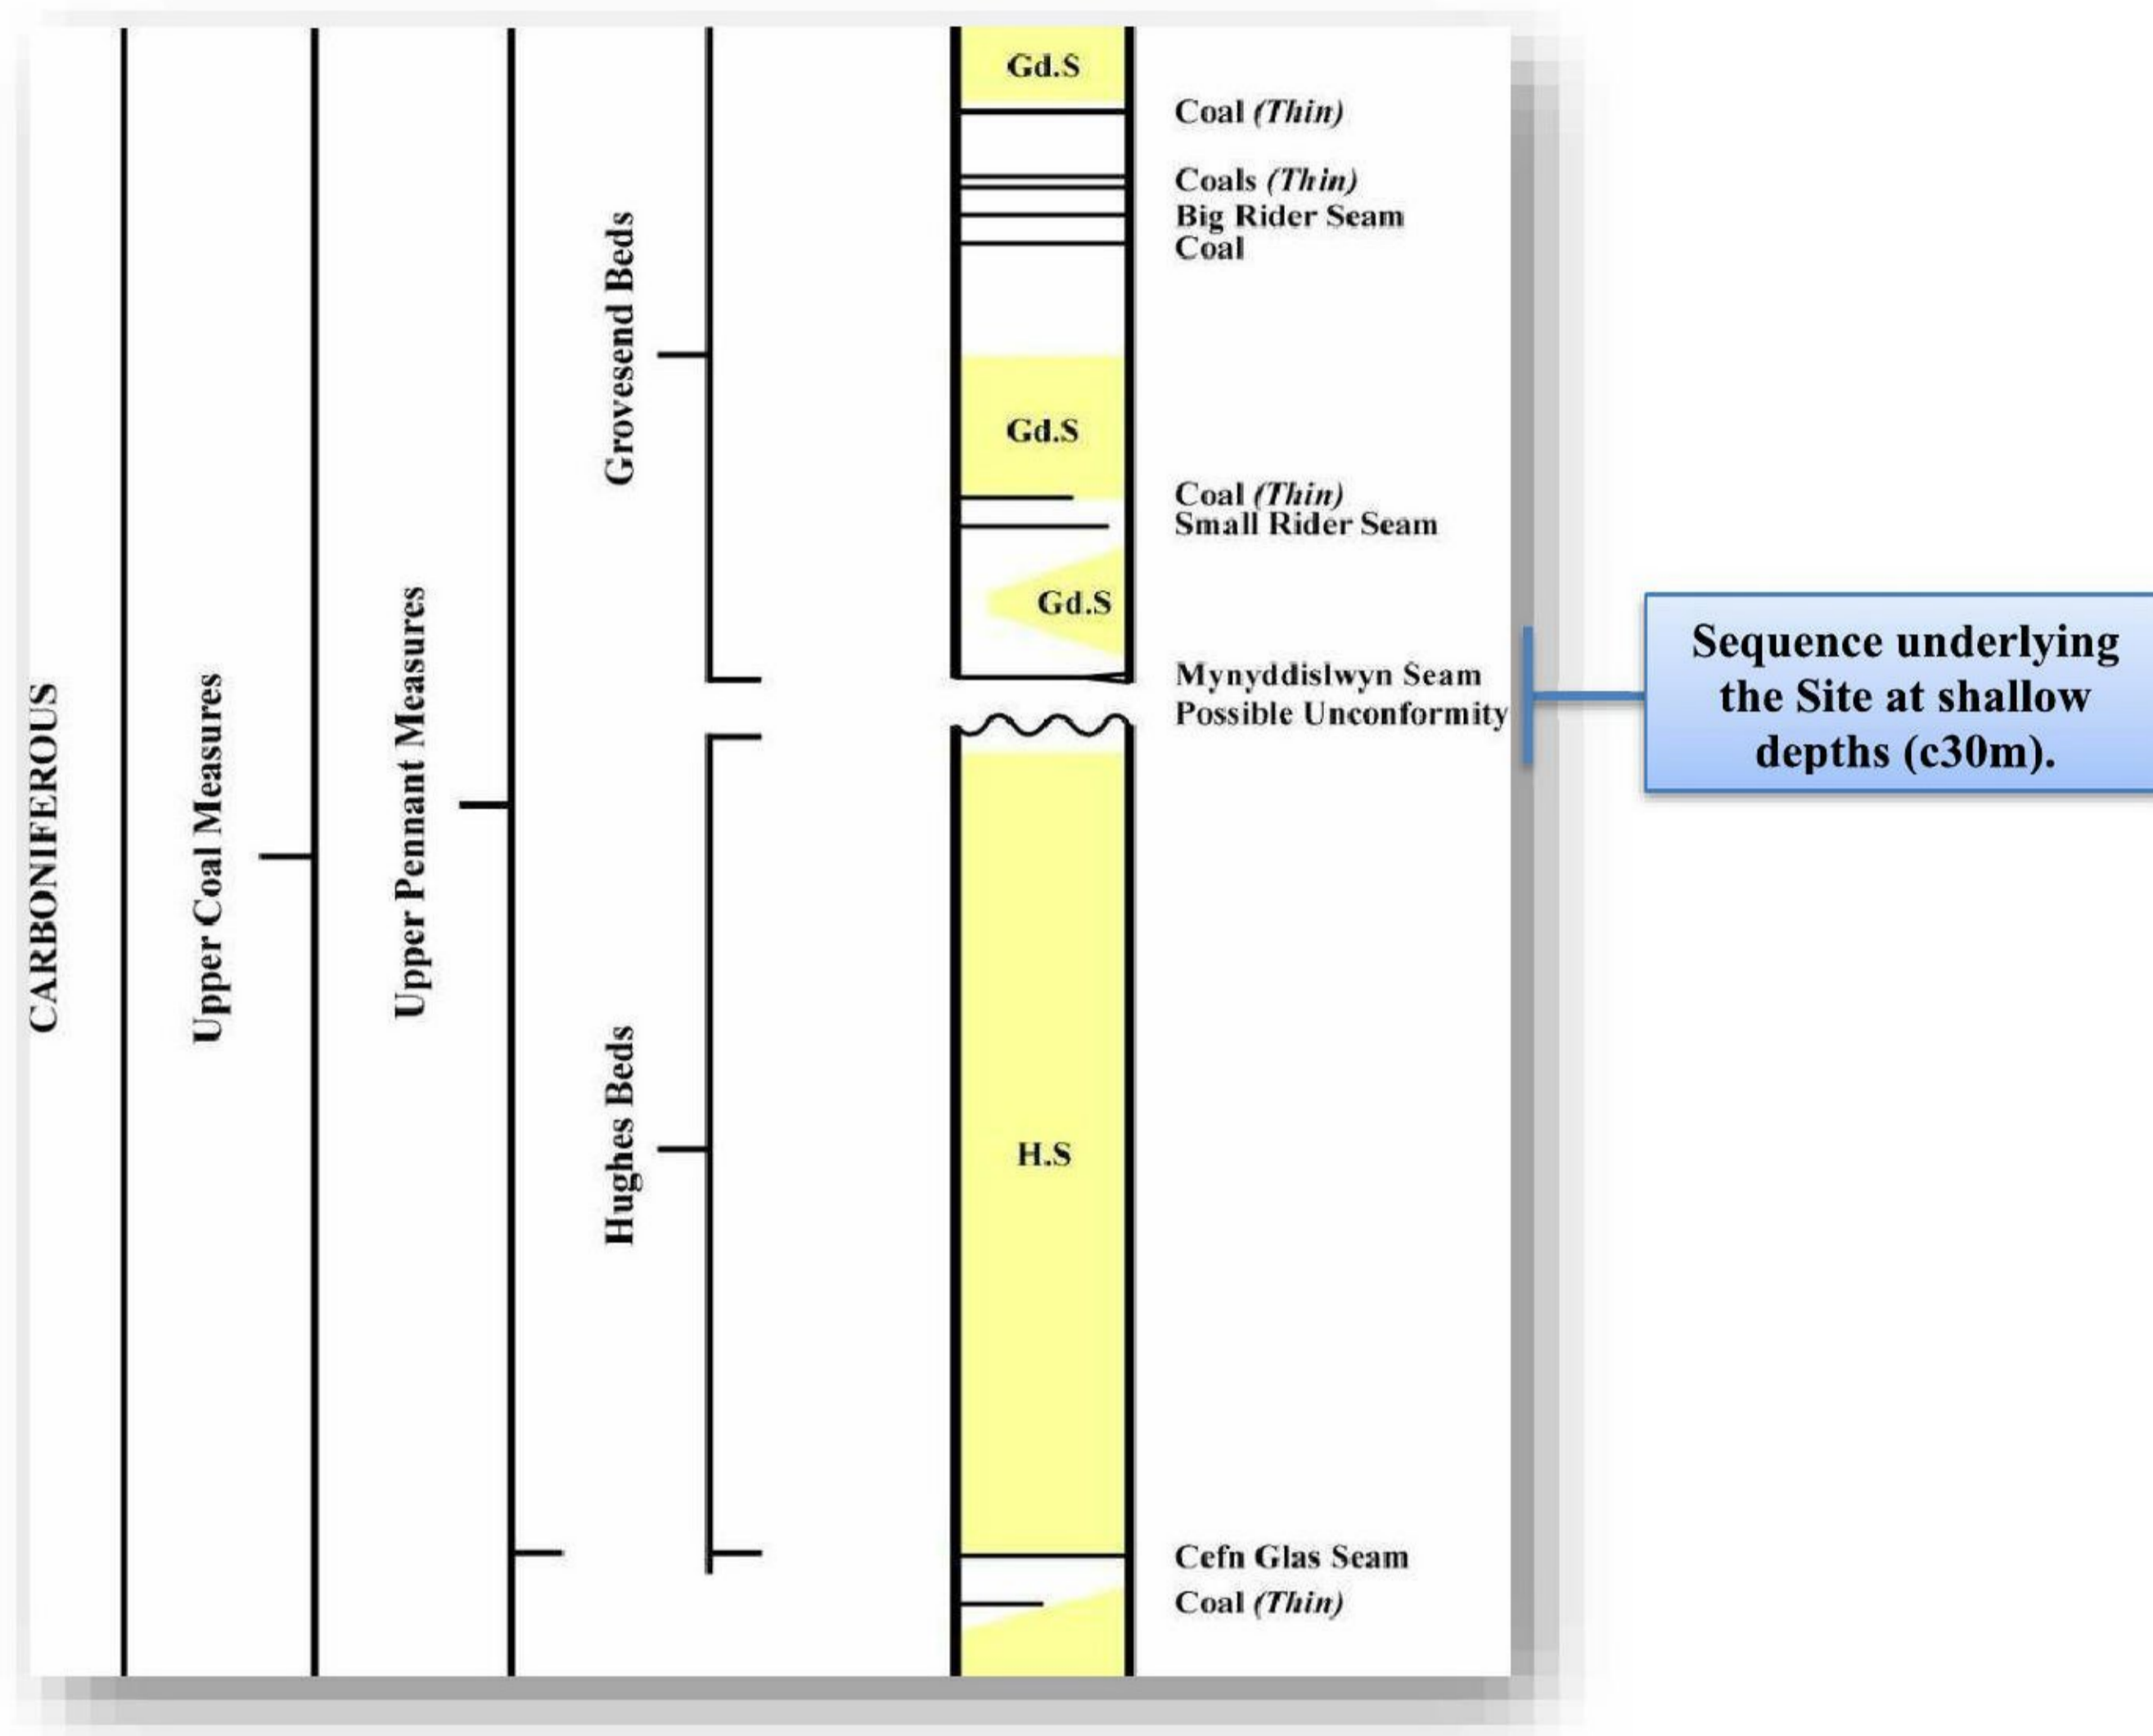
**Figure 1**  
**Part of the Stratigraphic Column.**  
 (BGS ST 19 NE)

The Grovesend Beds are dominated by sandstones with subordinate mudstones and siltstones. A few metres of soft black mudstone usually immediately overlie the Mynyddislwyn Seam, which is itself characteristically split in this area into two leaves of coal separated by a bed of mudstone that is typically 1m thick.

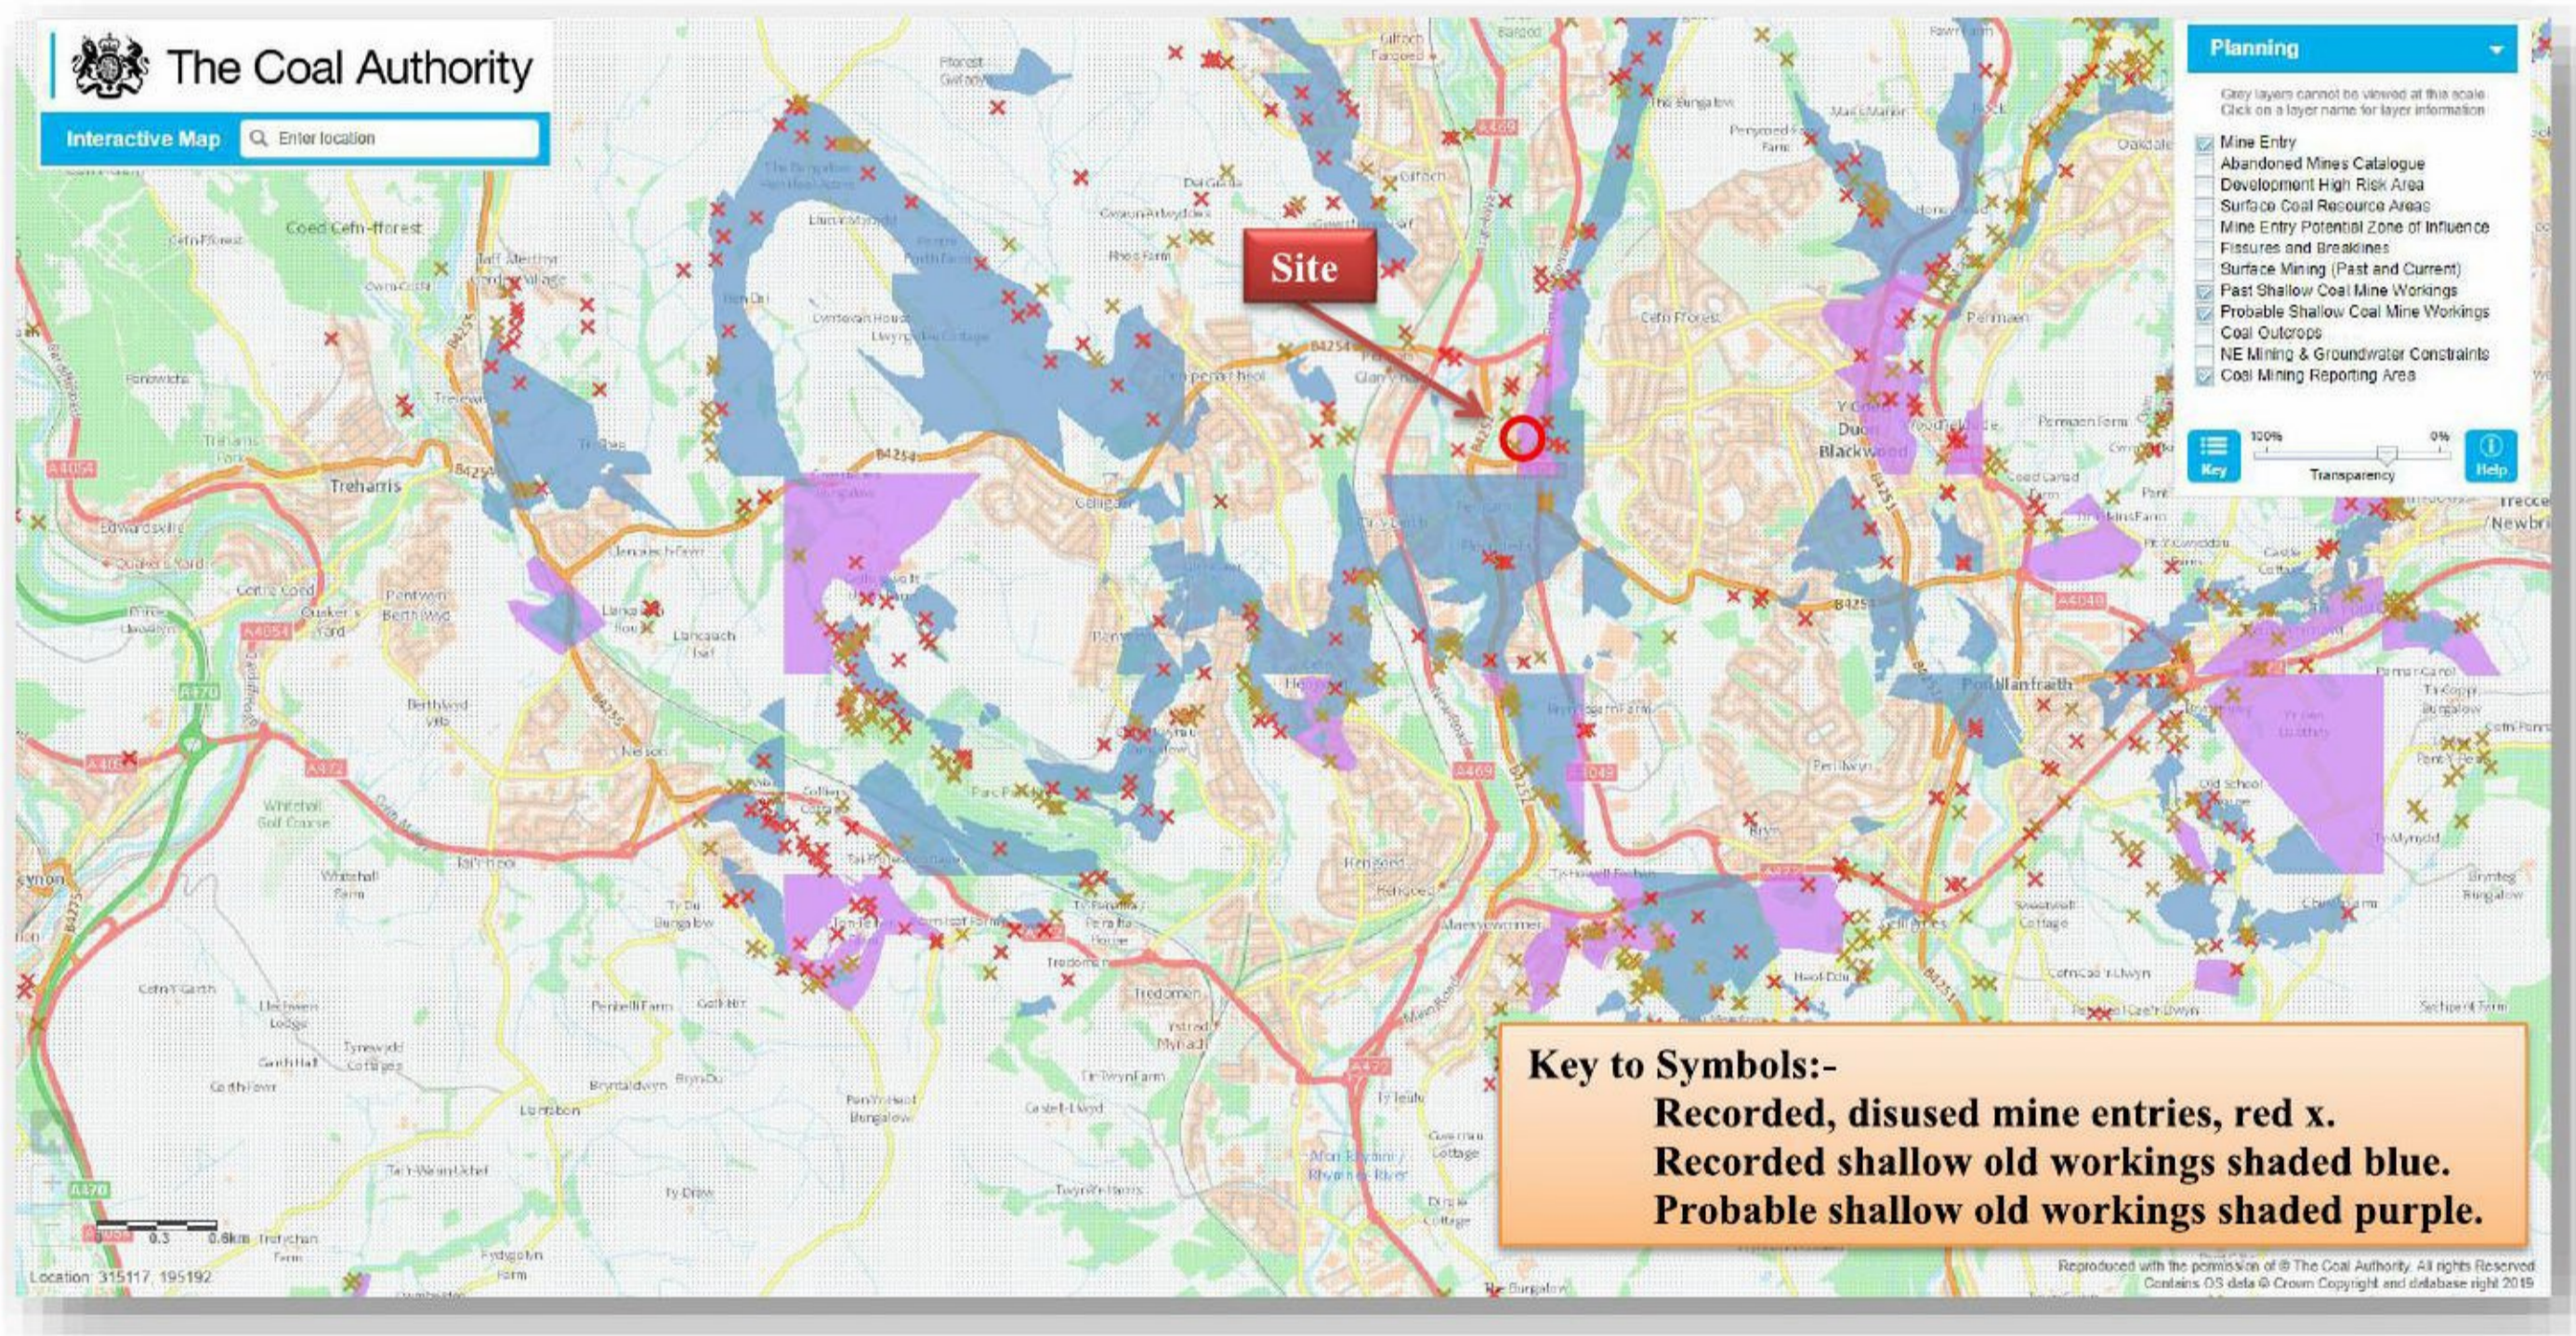
**Figure 3**  
**Print-out of The Coal Authority's Interactive Map**  
(Accessed 19<sup>th</sup> October 2021)

The Coal Authority's mining report identifies the presence of only a single, disused mine entry, a shaft, within the confines of the Site or 20m of its boundary. The shaft is shown to be approximately 12m east of the north-east corner of the Site, immediately beyond the A4049. The Coal Authority has no record of what steps, if any, have been taken to stabilise the shaft.

The nearby shaft is on third party land and so cannot be physically examined. The above recommended boreholes will provide information on the depth to rockhead that would be useful in informing an assessment of the risk from the shaft.

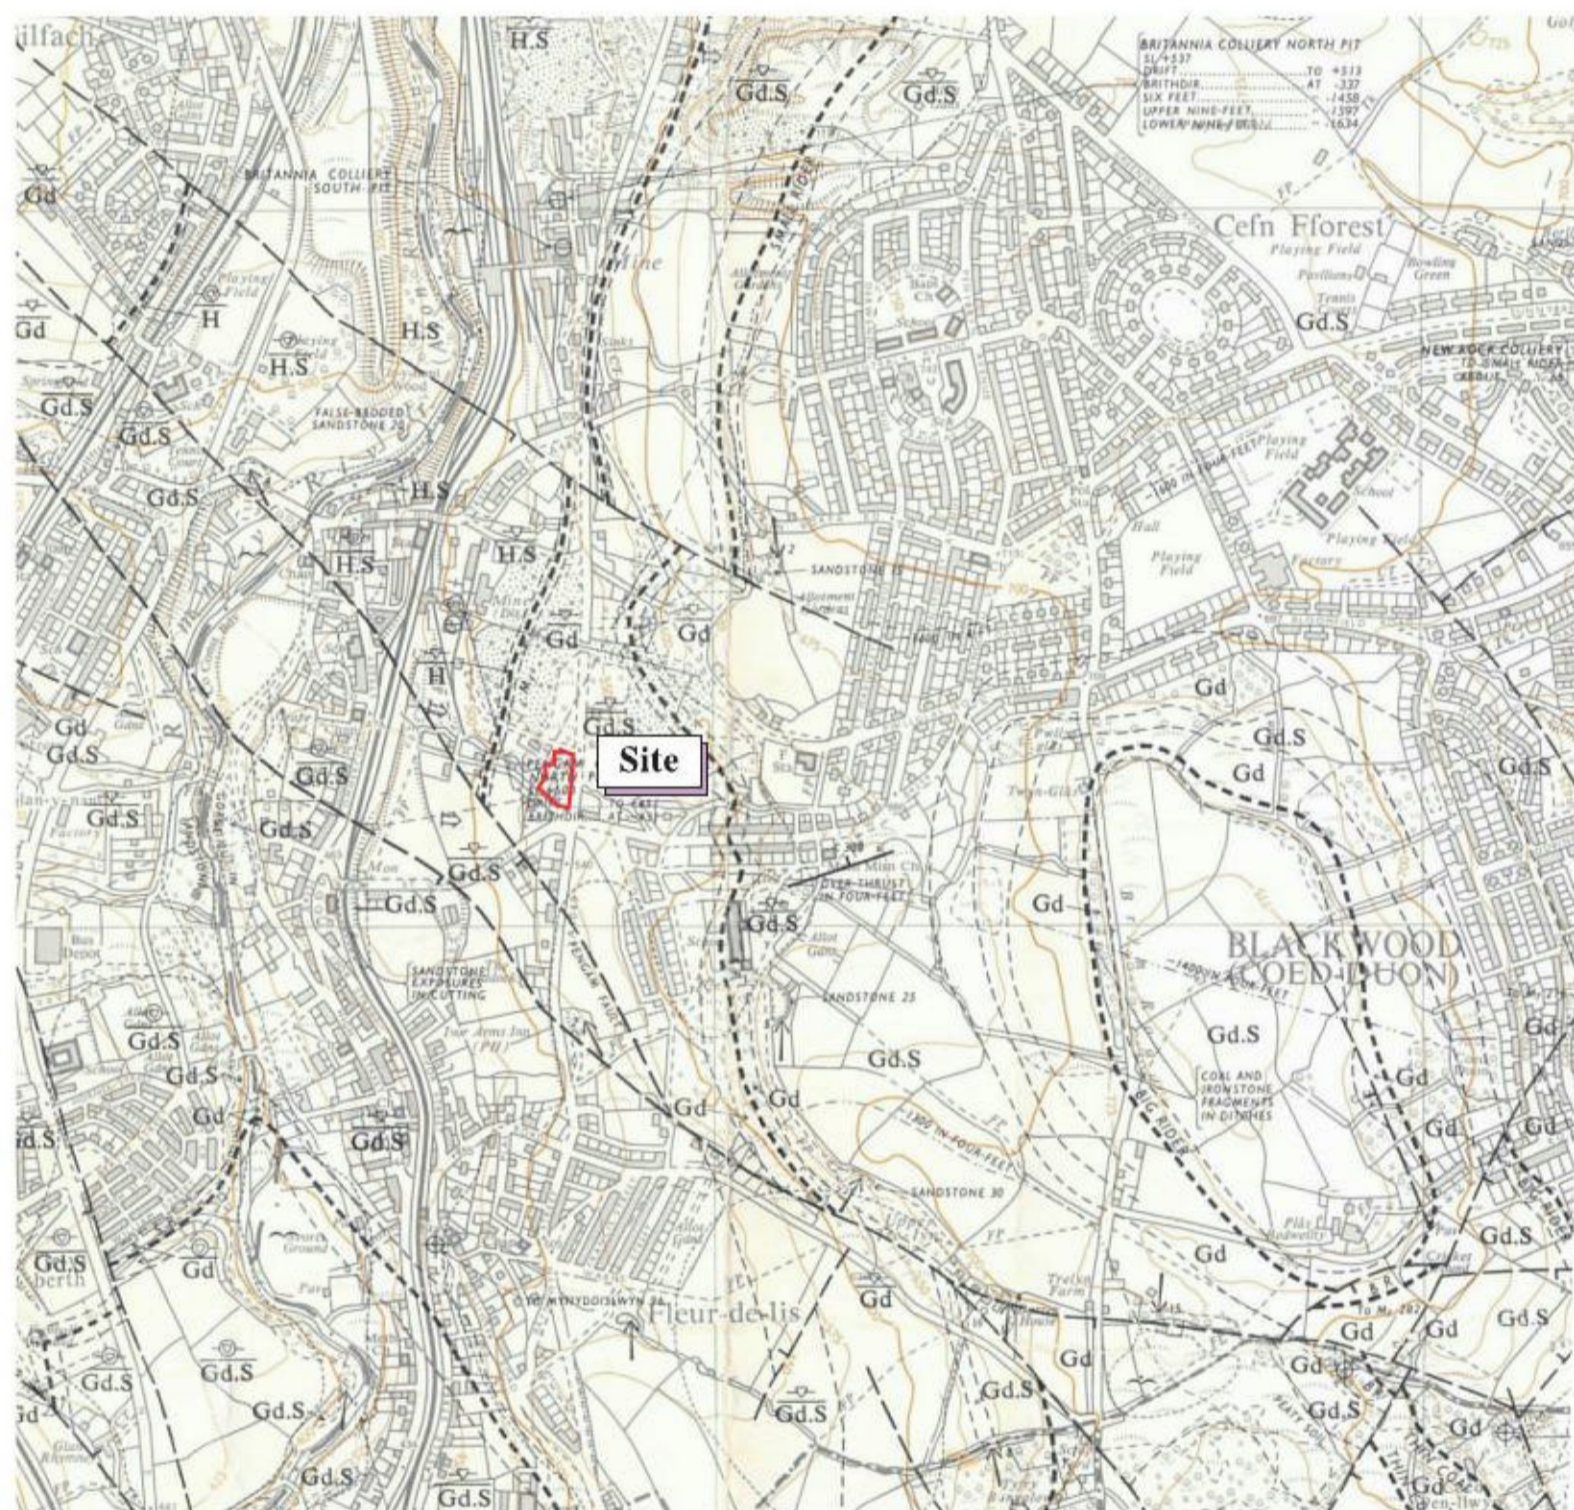
Drawing No: BC/MB/10.21.05.02.

The published geological sheet shows the measures beneath the Site to be overlain with deposits of Boulder Clay. We have no detailed information on the thickness and nature of the Boulder Clay in the vicinity of the Site.

The published geological sheet indicates that the Site is not affected by landslip conditions.

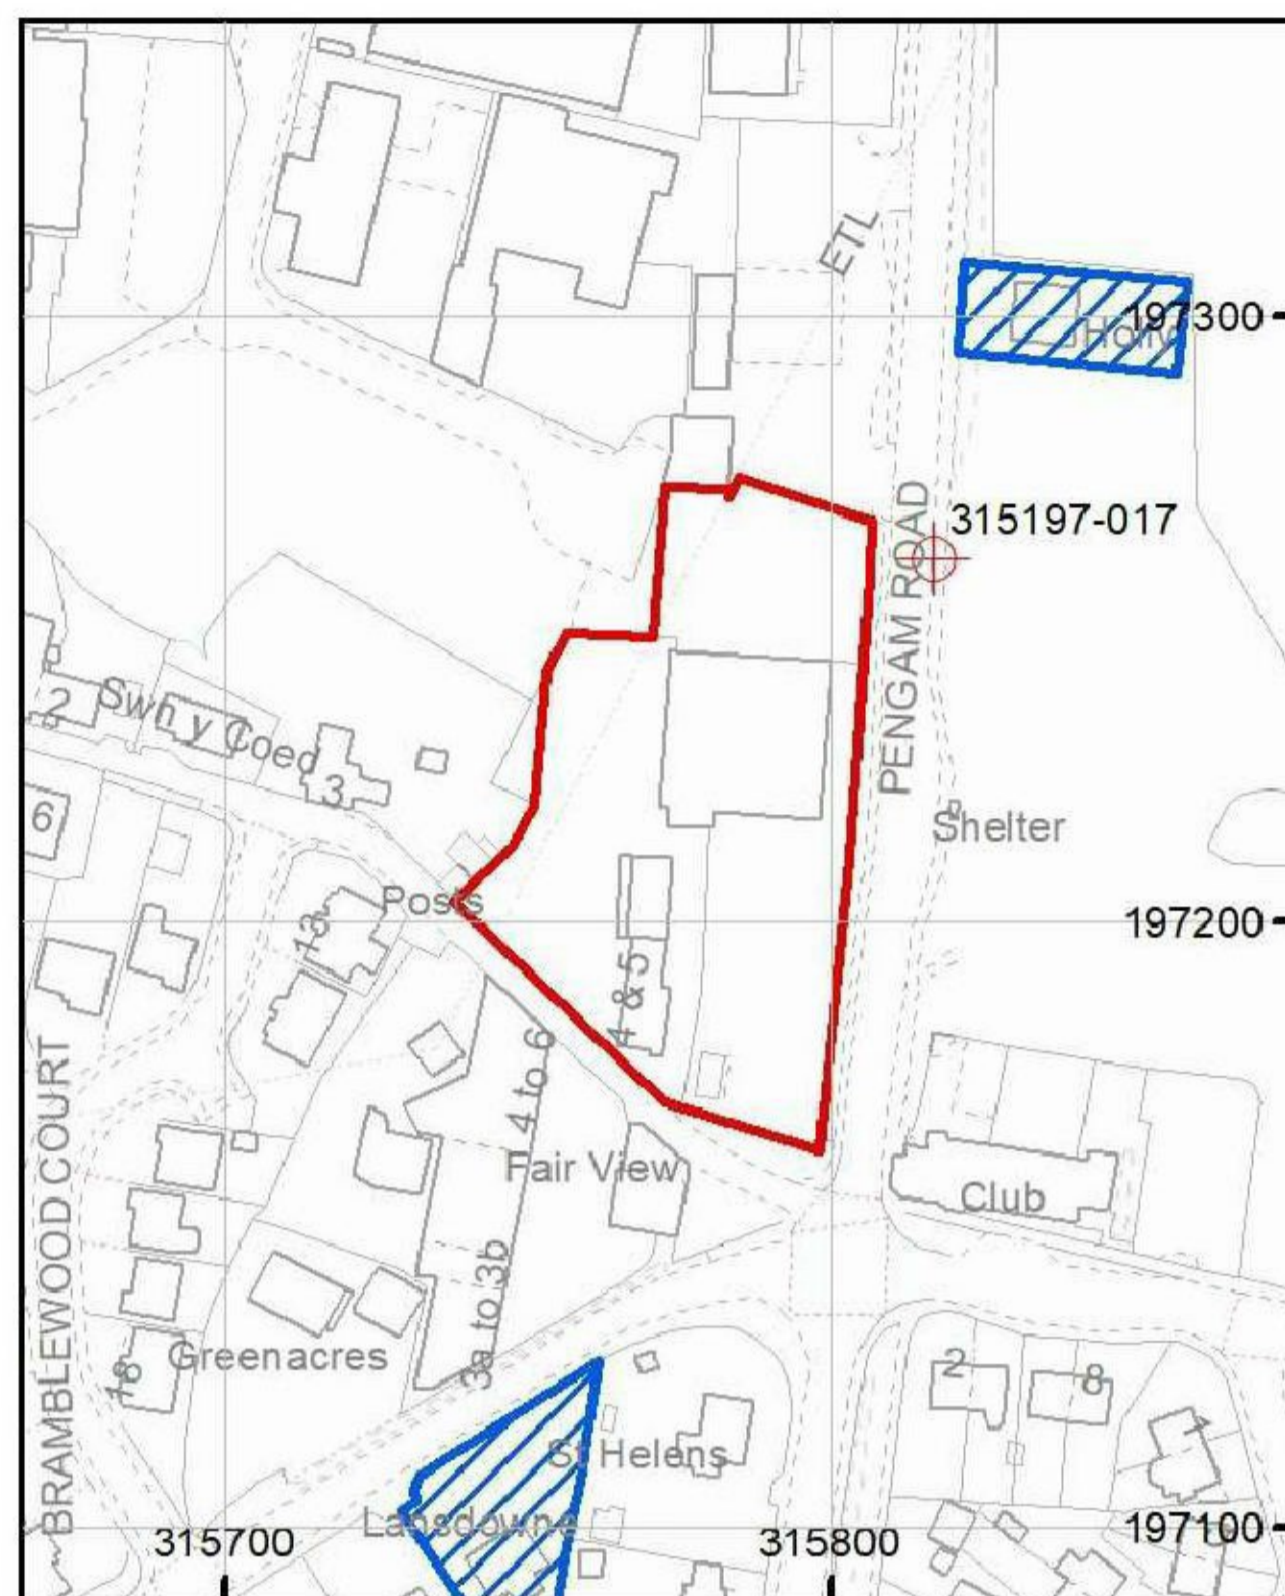
# Enquiry boundary

Within, or within 20 metres of, the boundary of the property there is 1 mine entry, the approximate position of which is shown on the enquiry boundary plot. For reasons of clarity, mine entry symbols may not be drawn to the same scale as the plan.

There is no record of what steps, if any, have been taken to treat the mine entry.

There are 2 claims within 50 metres of the property boundary that do not match the property address. These are shown on the enquiry boundary plot.
