## Protected Species Survey: *Final report* **Bankside Farm, Goole Fields**

September 2021

Archer Ecology Ltd

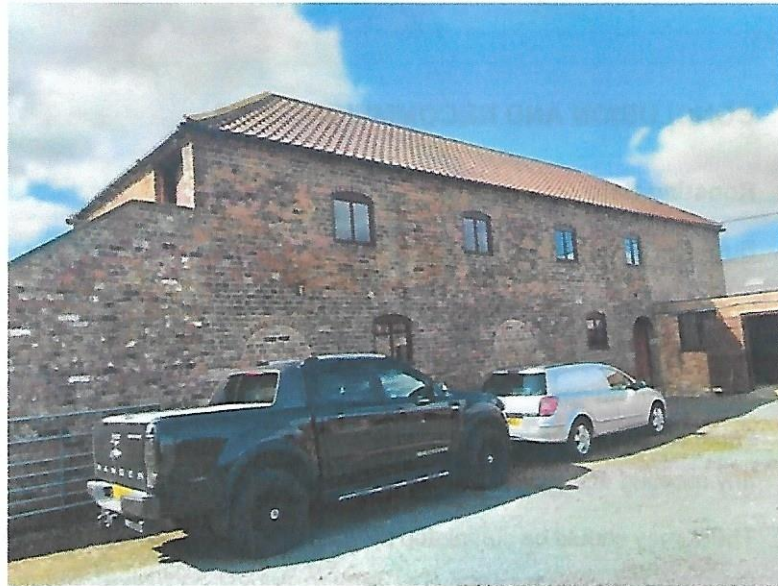
4.1.1 The main barn is a large, brick-built structure with a single-pitched, pantile roof (see Photograph 1, Appendix I). The barn comprises two storeys, with the first floor constructed of timber beams at a height of ~4m to the apex (ridge beam).

4.1.3 The rafters and ridge beam of the roof are overlain with intact, impermeable membrane throughout which presents a physical barrier to bats either entering or departing the loft space. However, there is a potential for bats to inhabit openings located between the underside of the pantiles and the roof membrane, albeit this potential was limited by the consistently intact condition of the roof.

4.1.4 Considering the quality and abundance of potential roosting features, the roof of the main barn was appraised as having 'low' potential to support roosting bats in line with BCT categories. The remaining external fabric of the structure was considered to offer 'negligible' potential to support bat roosts.

Photograph 1: Exterior view of the barn roof, showing intact pantiles

- 5.1.1 There are no further constraints with respect to modifications proposed to the interior of buildings 1-5 (i.e., the main barn and connecting outbuildings). However, should proposals incur modifications and/or disturbances to the roof structure of buildings 1, 2-5 it would be necessary for a single dusk emergence bat survey to be completed in advance to detect any roosting activity associated with the roofs.
- 5.1.2 The survey should be completed by suitably experienced ecologists and scheduled during the main bat activity period (i.e., May to August, inclusive) and during optimal weather conditions.

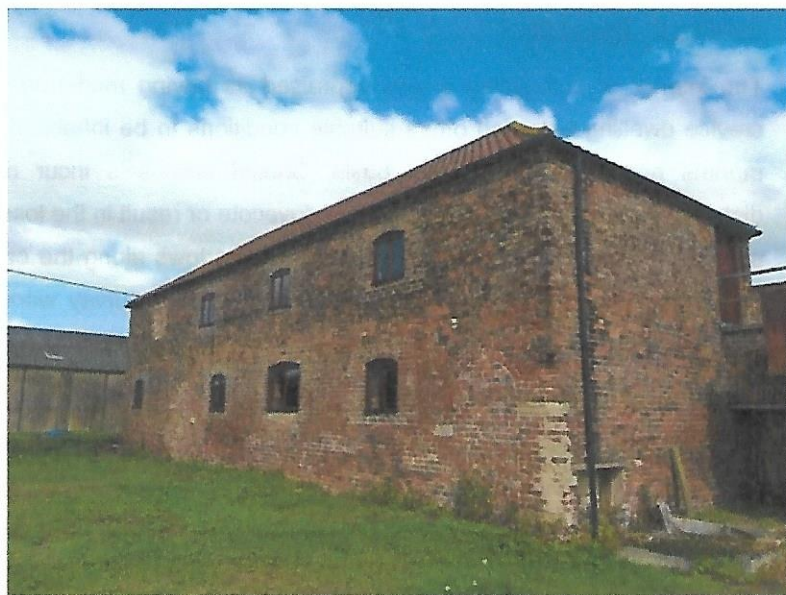
4.1.2 The external masonry of the main barn was observed to be in good condition generally with only minor spalling evident along the southern, rear elevation (see Photograph 2, Appendix I). However, this was considered to be of insufficient depth to provide potential bat roosting features.

Photograph 2: Exterior view of the barn's masonry showing minor spalling

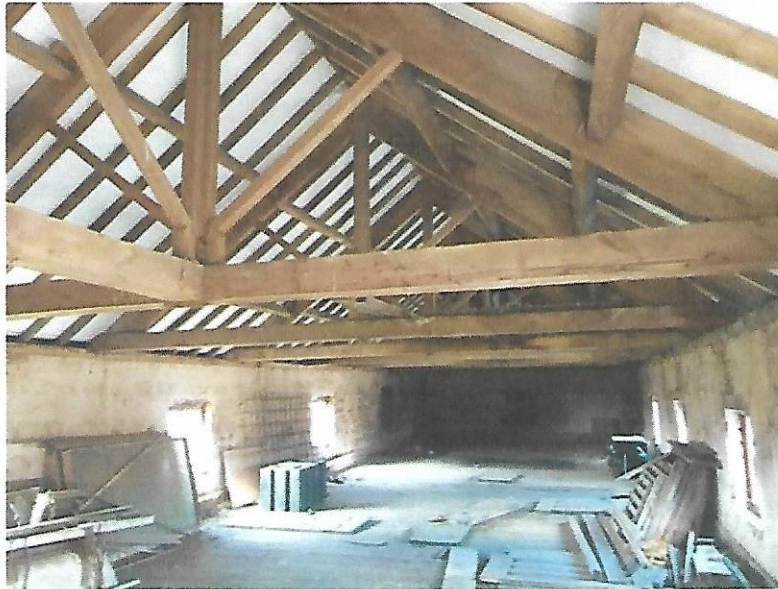
4.1.5 The interior of the main barn, including the loft space, was subjected to medium levels of ambient light which provides unsuitable conditions for bat inhabitancy (see Photograph 3, Appendix I).

Photograph 3: General view of barn roof internally, showing intact membrane

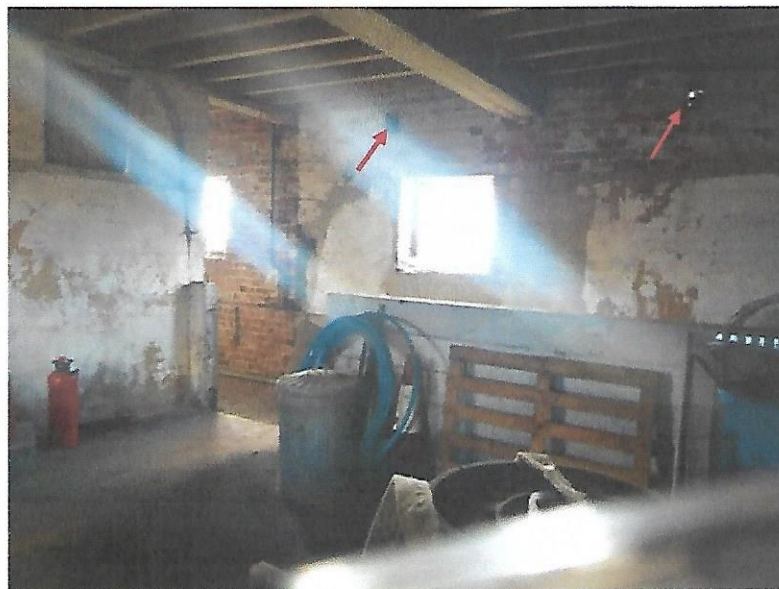
4.1.6 The ground and first floor comprise single, open rooms with intact brickwork. Potential roosting features were limited to shallow brickwork cavities associated with c.20 ventilation holes within the brickwork (see Photograph 4, Appendix I). The apertures are located along the upper extents of the ground floor walls and have the potential to provide access/egress points for bats into the barn. Detailed, elevated inspections of each aperture, and associated wall cavities, yielded no evidence of current or historic roosting

activity. Furthermore, dense accumulations of cobwebs and detritus were observed within the ventilation openings to indicate that bats have not historically or recently used these features.

Photograph 4: Interior view of barn, showing small ventilation holes

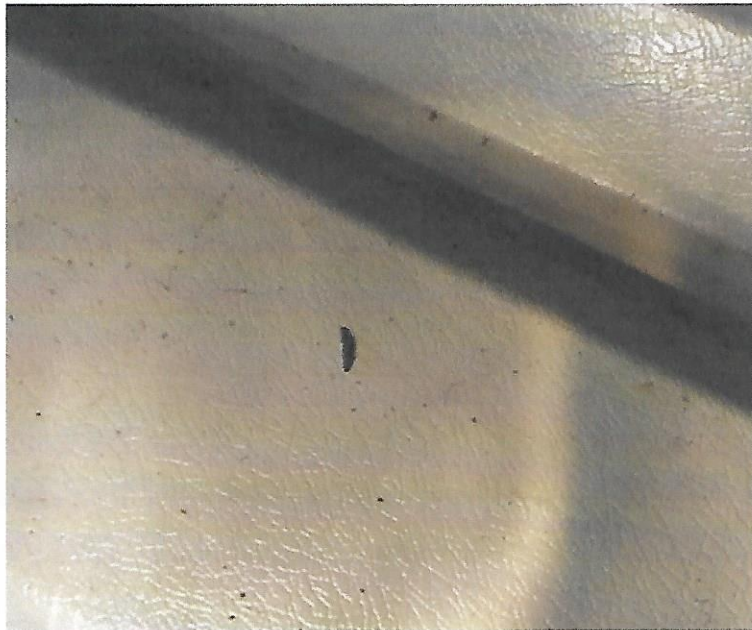
- 4.1.7 Evidence of recent bat activity, including two scattered guano, were recorded on the ground floor of the main barn (see Photograph 5, Appendix I); however, given a lack of potential roosting features inside the barn, this indicated nothing more than night foraging and/or exploratory behaviour.

- 4.1.8 Considering the quality and abundance of potential roosting features, the interior of the main barn was, thus, assessed as having 'low' potential to support roosting bats in it's current condition. Given that all potential roosting features could be fully inspected at the time of the survey, and an absence of bat occupancy confirmed, the client was advised to conceal all potential access points imminently to discourage bats from entering the building (see Photographs 6, 7, 8 and 9, Appendix I). This is to avoid the potential for the proposed works to result in adverse impacts to bats and their roost sites should the barn become inhabited by bats in future. Given the loss of access/egress points the barn was thereafter assessed as having 'negligible' bat roosting potential.

Photograph 5: Fresh dropping found in the barn

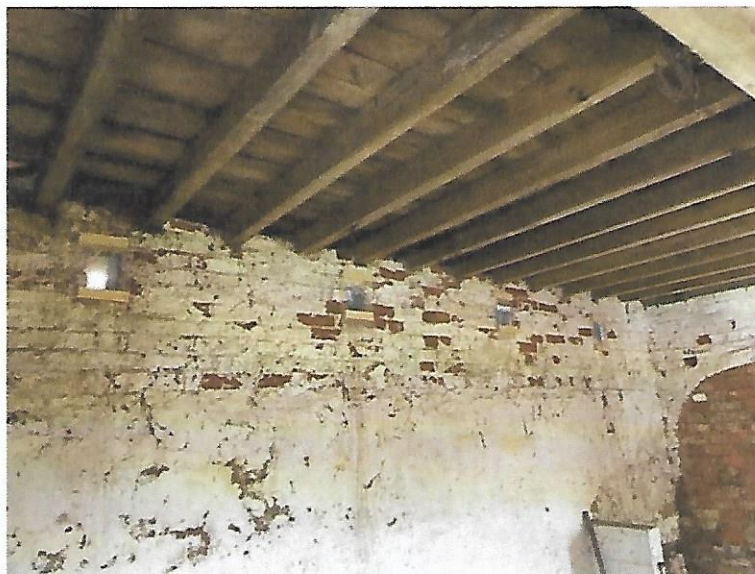
Photograph 6: Ventilation holes now covered with plastic sheeting to prevent access

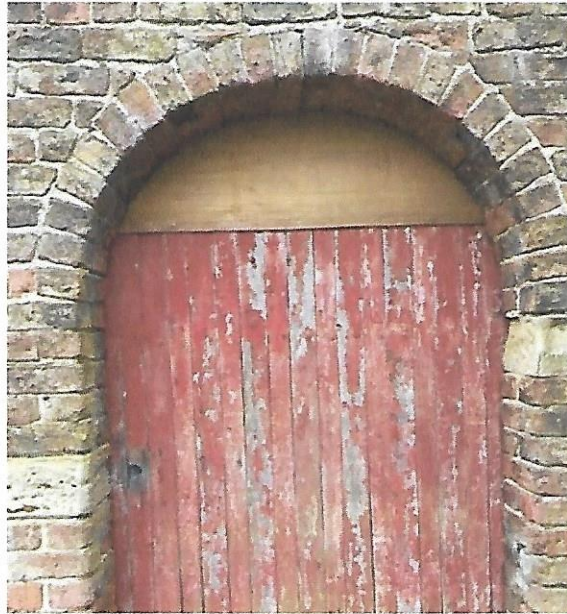
Photograph 7: Top of door now tightly concealed with wood panel

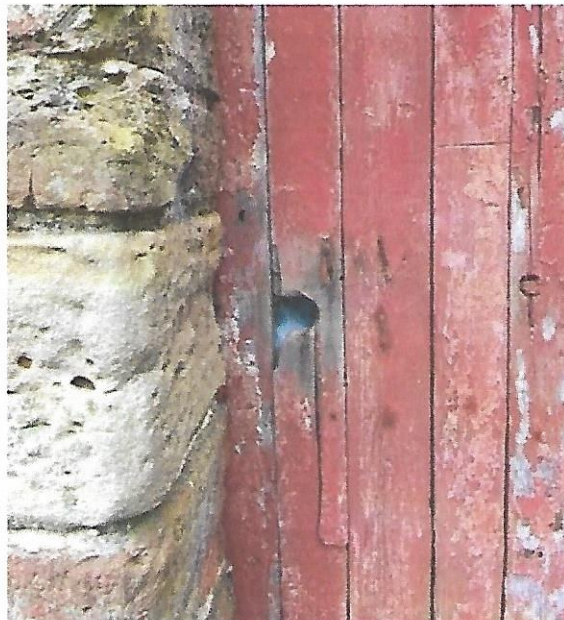
Photograph 8: Gap in door now tightly concealed with plastic sheeting

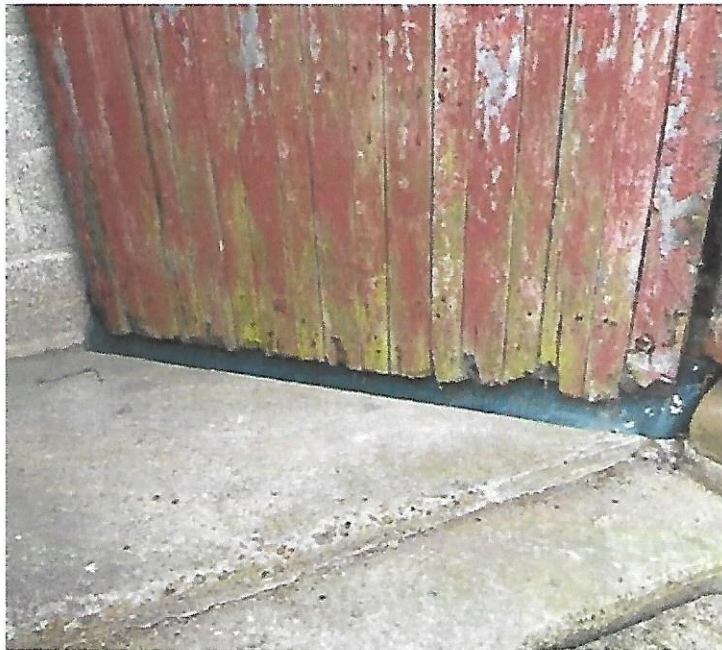
Photograph 9: Bottom of door now concealed with plastic sheeting

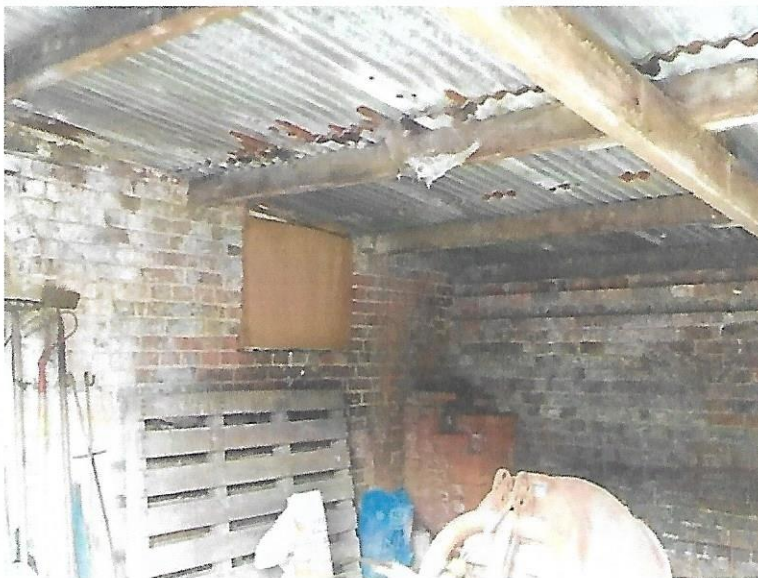
- 4.1.9 Outbuilding no. 2 comprises a single-story, brick constructed storage shed with a flat, corrugated panelled roof (see Photograph 10, Appendix I). The internal and external fabric of the building appeared to be intact throughout and no features with a potential to support roosting activity observed. Subsequently, the building was appraised as having 'negligible' potential to support roosting bats. Furthermore, no potential access/egress points, retaining connectivity to the building, were identified.
- 4.1.10 Considering a lack of potential roosting features, outbuilding 2 was appraised as having 'negligible' potential to support roosting bats in line with BCT categories.

Photograph 10: Ancillary building with corrugated roof

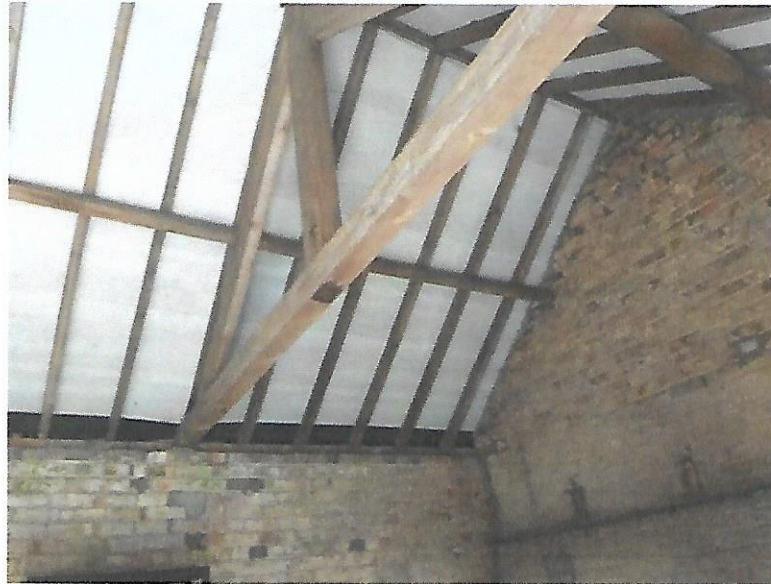
- 4.1.11 Outbuildings 3, 4 and 5 comprise former stables and storage units that are brick-constructed and support old timber beam roofs at a height of ~4m to the apex. The rafters and ridge beams were overlain with intact, impermeable membrane throughout which is

expected to present a physical barrier to bats either entering or departing the rooms (see Photograph 11, Appendix I). However, there is a potential for bats to inhabit openings located between the underside of the pantiles and the roof membrane, albeit this potential was limited by the consistently intact condition of the roof.

- 4.1.12 Considering the quality and abundance of potential roosting features, the roof of the outbuildings 3, 4 and 5 were appraised as having 'low' potential to support roosting bats in line with BCT categories. The remaining, exterior of the buildings and the internal fabric was considered to offer 'negligible' potential to support bat roosts.

Photograph 11: Interior of main barn with lined, intact membrane

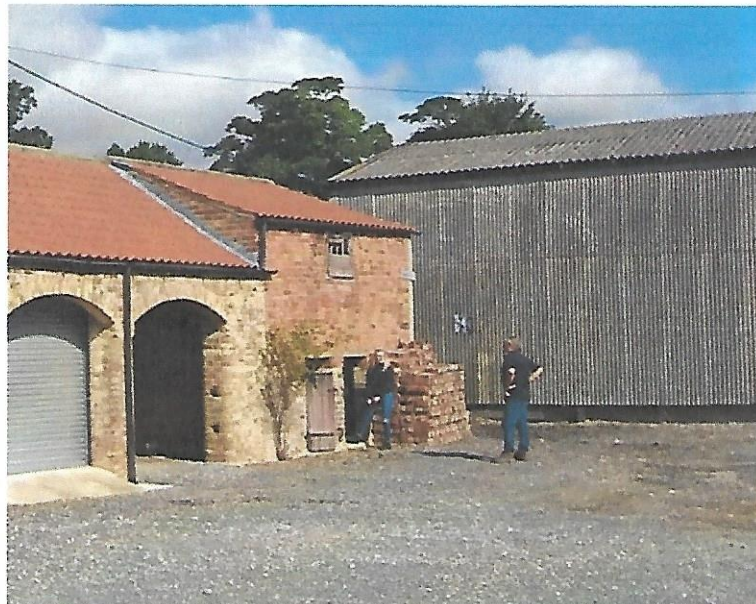
- 4.1.13 Outbuilding 6 comprises a redundant, two-storey dovecote which is brick constructed and supports a pitched, timber roof clad with pantiles (see Photograph 12, Appendix I). The building features open doorways and windows along the eastern and southern elevations which offer optimal access/egress points for bats (see Photographs 13 & 14, Appendix I). The interior of the building also presented numerous potential roosting features in the form of structural crevices, masonry defects and openings between the walls and the timber framework. A single bat dropping was observed on the door jambs and bottom sill of an open doorway leading to the upstairs void (see Photograph 15, Appendix I). The guano appeared to be relatively new and likely deposited this season (i.e., mid-2021). However, observations of all potential roosting features associated with the interior of the structure yielded no evidence of roosting activity although the potential for the structure to be inhabited by bats in future should not be discounted.

- 4.1.14 Considering the quality and abundance of potential roosting features the internal fabric of the dovecote was appraised as having 'moderate' potential to support crevice dwelling bats, including summer and transient roosts. The roof of the dovecote was further appraised as having 'low' potential to support roosting bats.

Photograph 12: Exterior view of the dovecote which shows intact pantiles

- 5.1.3 The interior of outbuilding 6 was appraised as having moderate potential to support crevice dwelling bats and offers suitable conditions to be inhabited during the summer months and/or on a transient basis. Should proposals incur modifications and/or disturbances to the internal fabric of the dovecote or result in the loss of potential access points presented by the open doorways and windows along the eastern and southern elevations, it would be necessary to carry out further survey works to the building in advance. In line with this roosting category, two nocturnal bat activity surveys would be required in ahead of the works to detect any roosting activity associated with the building.

- 5.1.4 The surveys would comprise a single dusk emergence and dawn re-entry survey to be completed during the main bat activity period (i.e., May to August, inclusive). The surveys should be completed by experienced ecologists and during optimal weather conditions.

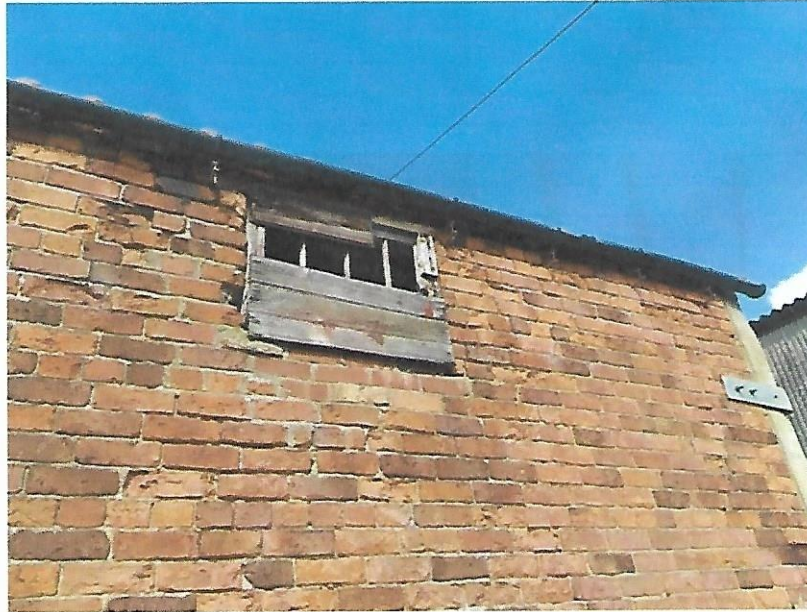
Photograph 13: Outbuilding 6 potential access point for bats at high elevation

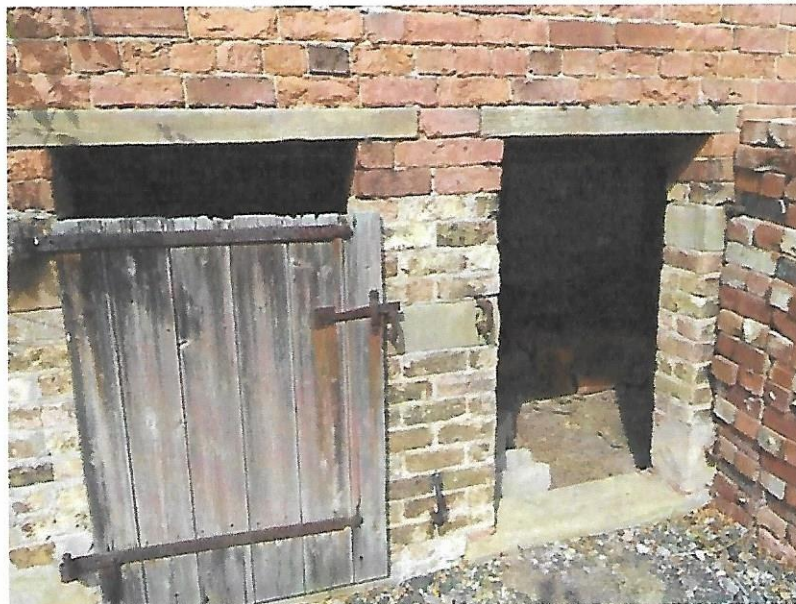
Photograph 14: Outbuilding 6 with potential access points for bats at low elevation

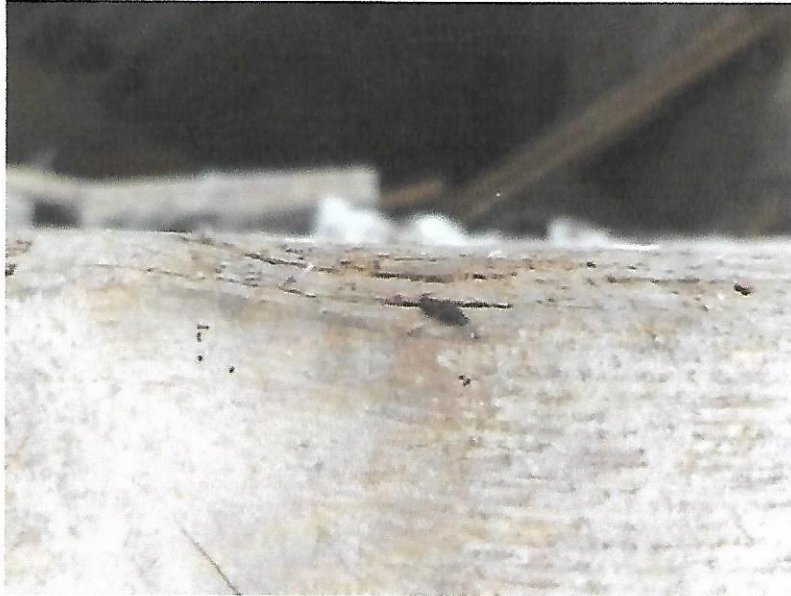
Photograph 15: Fresh dropping on door sill in dovecote
