Conversion of  
**Carrycoats Coach House**  
to Dwelling House  
2033

HERITAGE STATEMENT

November 2021

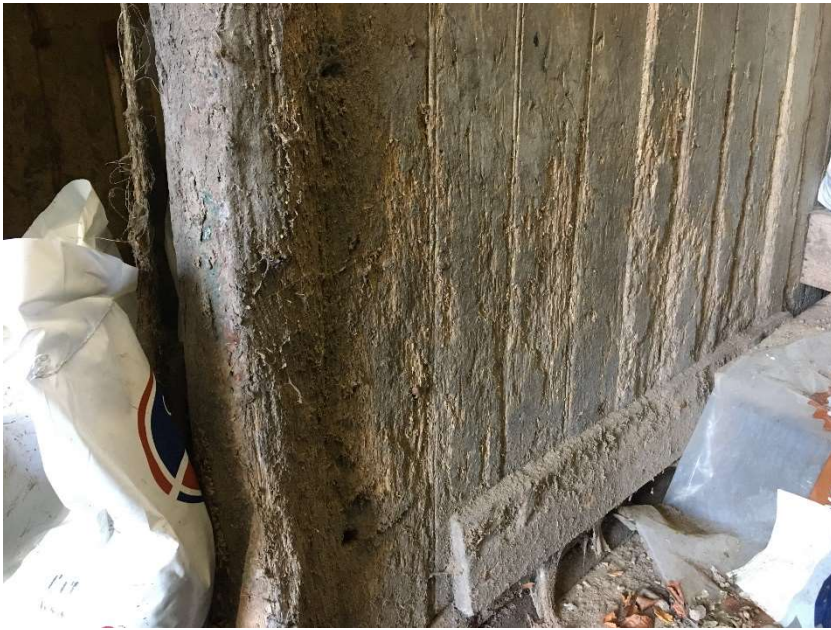
Photo 10  
Internal view of stabling partition  
with chewed surface and  
woodworm infestation.

8. Remove remnants of former stabling and install new timber stud partitions to enclose lobby and WC. Re-set 2No. end panels from former stable within lobby.

8. The remains of the former stabling are in a poor condition except for the two end panels which are to be conserved and re-set within the lobby.
9. Existing stone walls at ground floor are to be propped and 2No. new door openings formed. Salvaged square stones are to be re-set to form jambs, set in a lime mortar. This will involve the removal of 4m<sup>2</sup> of rubble masonry and the excavation of 4m<sup>3</sup> of earth in order to install the staircase. Otherwise the existing layout of the building is retained.

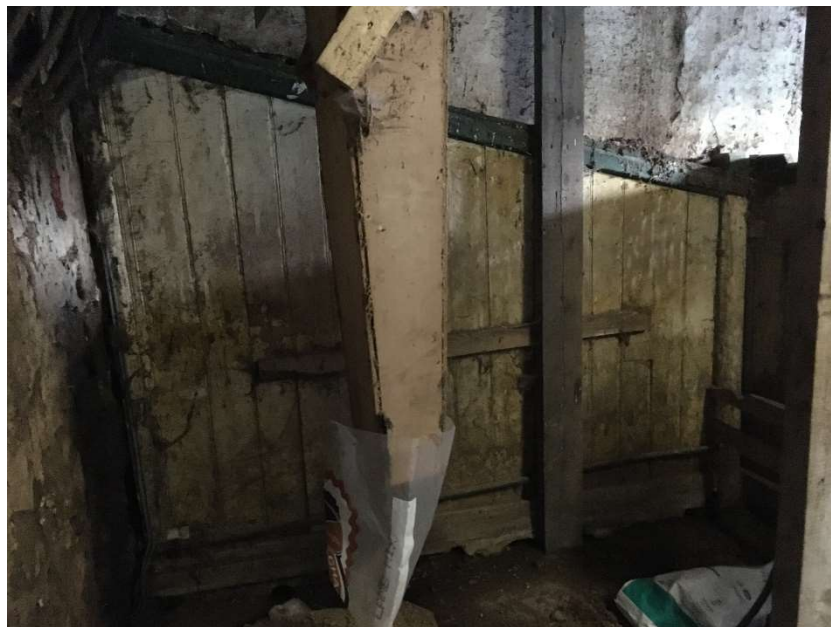
Photo 11  
Internal view of former stable east  
end panel behind 1960s feed  
hopper.

13. Removal of mid C20 plywood feed hoppers will cause no harm to the original fabric.
14. Walls and roof soffits are to be lined with timber studs, insulated and plasterboard finished. This will be constructed with a ventilation gap to allow the original structure to breathe, whilst reducing the carbon footprint of the property.

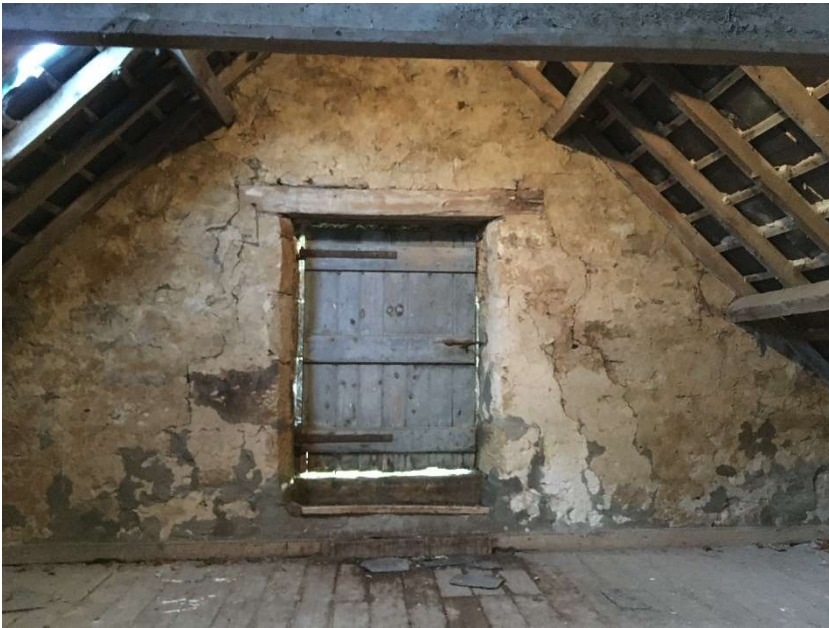
Photo 13  
Internal view of hayloft with cracked masonry and wet floor after recent water ingress through slates.

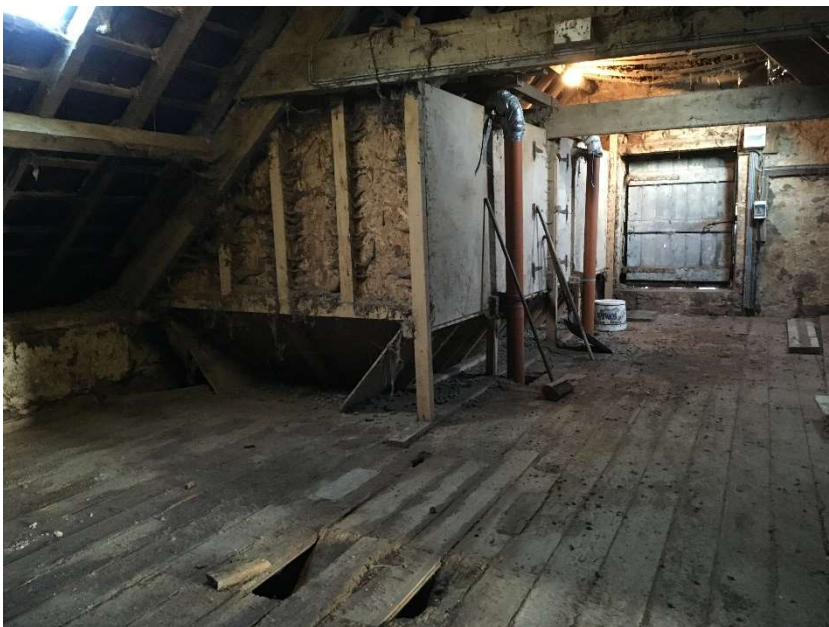
Photo 14  
Internal view of former hayloft with 1960s feed hoppers and weak floor saturated after recent water ingress through slates.

15. Internal plumbing and wiring is to run in the timber linings and floor voids.
16. Remove woodworm infested first floor, treat joists with preservative and renew softwood floorboards.

15. Internal plumbing and wiring will be run through the new linings and between floor joists to cause minimal damage to the original fabric.
16. Replacement of dangerously weak floorboards and treatment with preservative will extend the life of this floor.

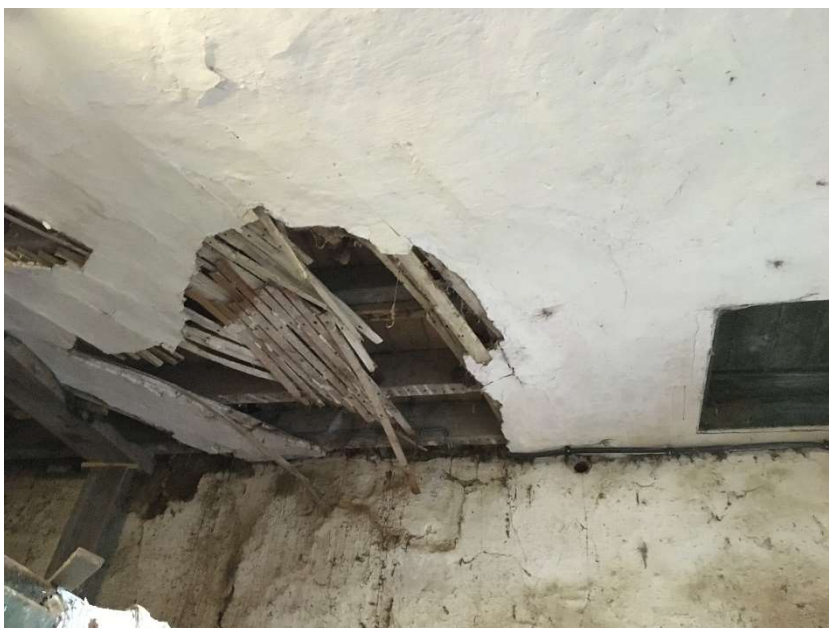
Photo 15  
Internal view of damaged lath and plaster caused by water ingress through roof.

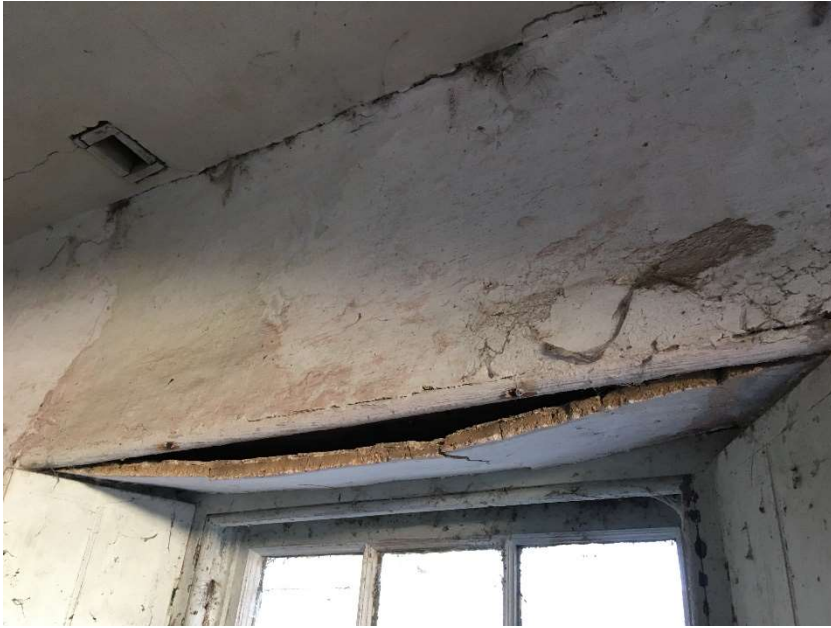
Photo 16  
Internal view of damaged lath and plaster caused by water ingress over window.

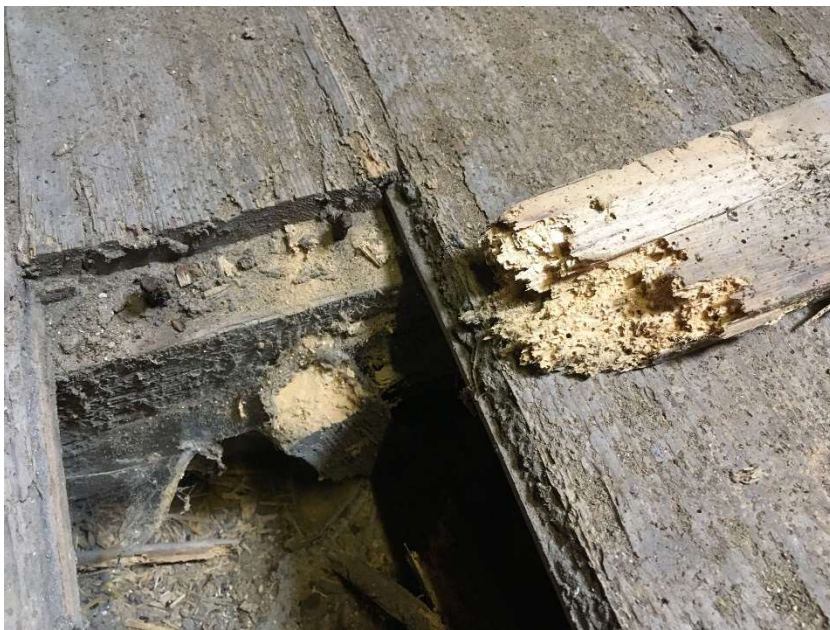
Photo 17  
Close up of floor boards in former hayloft in fragile condition owing to woodworm infestation.

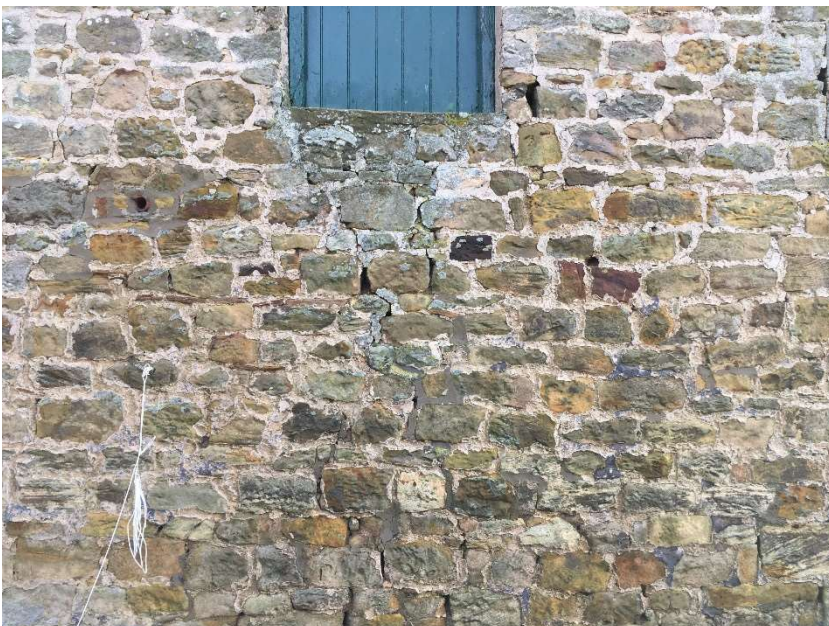
Photo 18  
Close up of cracked masonry on east gable.

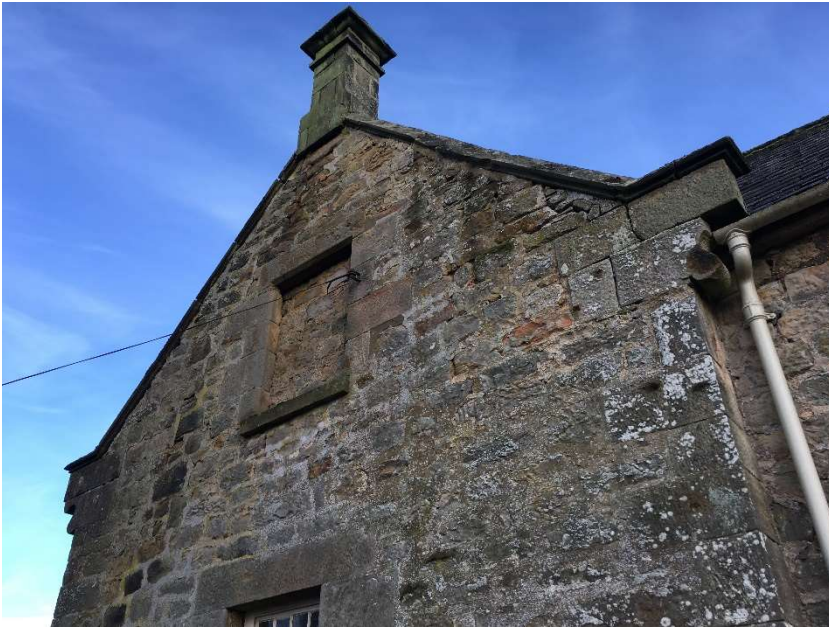
Photo 19  
Close up of cracked and broken  
kneeler stone to west.
