**Bramley Tree
Consultancy Ltd**

BS5837 Tree Survey

**Land off Canwell Drive,
Canwell,
Sutton Coldfield,
B75 5SG**

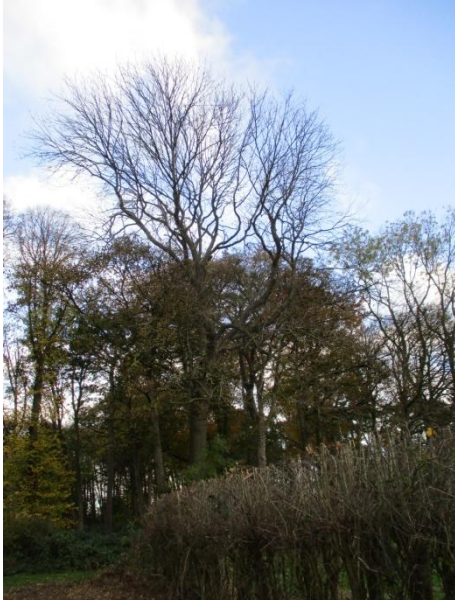
- 6.8** T02 Ash, is situated to the south of the barn and has a limited life expectancy, the tree's crown is slightly sparse, and there is an amount of dead wood present along with a number of lost limbs. T03, Sycamore is growing in close proximity to the Ash and has therefore resulted in a tree of suppressed form.

Ref	Species	Comments	General Observations	Measurements	Measurements 2	Retention Category	RPA
H01	Common Hawthorn (<i>Crataegus monogyna</i>)	Situated to the south of the barn	Small Hedge	Height (m): 2 Stem Diam (mm): 150 Spread (m): 0.5N, 0.5E, 0.5S, 0.5W Life Stage: Semi Mature Rem. Contrib.: 10+ Years	Physiological Cond: Good Structural Cond: Good Bat Habitat: None	C2	Area: 42 sq m.
T02	Common Ash (<i>Fraxinus excelsior</i>)	Situated to the south of the barn	Number of lost limbs within the crown, major dead wood present within crown, crown is looking sparse	Height (m): 28 Stem Diam (mm): 870 Spread (m): 12N, 11E, 7.5S, 6W Crown Clearance (m): 5 Lowest Branch (m): 7(W) Life Stage: Mature Rem. Contrib.: 20+ Years	Physiological Cond: Fair Structural Cond: Fair Bat Habitat: Medium	B1	Radius: 10.4m. Area: 340 sq m.
T03	Sycamore (<i>Acer pseudoplatanus</i>)	Situated to the south of the barn	Tree is suppressed by T02, forming an asymmetrical crown	Height (m): 14 Stem Diam (mm): 460 Spread (m): 5N, 7.5E, 6.5S, 3W Crown Clearance (m): 5 Lowest Branch (m): 5(W) Life Stage: Semi Mature Rem. Contrib.: 10+ Years	Physiological Cond: Good Structural Cond: Fair Bat Habitat: None	C2	Radius: 5.5m. Area: 95 sq m.

Photo One – Showing H01 – T03

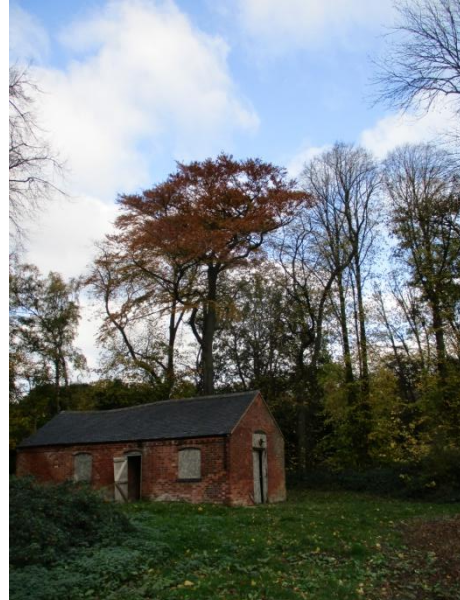
- 6.9** T04 - Lime, is a large mature tree to the east of the barn. The tree becomes twin stemmed at approximately 4m, although the union appears to be in good condition.

- 6.10** T05 – Beech, is a large beech tree situated to the east of the barn, there is an open cavity at approximately 6m high on the stem. The extent of the cavity should be assessed prior to development, this is to assess whether any mitigating works need to be undertaken to allow for retention.

- 6.11** G06 – Mixed species, is a section of semi wooded area to the south east. This woodland extends outside of the development site and is made up of mainly Lime, Acer and Beech. The woodland would create a nice feature within the area if the barn is developed.

T04	European Lime (<i>Tilia x europaea</i>)	Situated to the east of the barn	Stem bifurcates at 4m	Height (m): 15 Stem Diam (mm): 500 Spread (m): 6.5N, 6.5E, 8S, 7W Crown Clearance (m): 5 Lowest Branch (m): 5(NW) Life Stage: Semi Mature Rem. Contrib.: 20+ Years	Physiological Cond: Good Structural Cond: Fair Bat Habitat: Low	B1	Radius: 6m. Area: 1 sq m.

Ref	Species	Comments	General Observations	Measurements	Measurements 2	Retention Category	RPA
T05	Common Beech(<i>Fagus sylvatica</i>)	Situated to the east of the barn	Open cavity on the stem at approximately 6m. Cavity extant should be assess prior to development.	Height (m): 22 Stem Diam (mm): 840 Spread (m): 7.5N, 7.5E, 10S, 7W Crown Clearance (m): 6 Lowest Branch (m): 6(W) Life Stage: Mature Rem. Contrib.: 20+ Years	Other Reference: Distance1: 4.8 Distance2: 4 Custom Number 3: Physiological Cond: Good Structural Cond: Fair Bat Habitat: Low	B1	Radius: 10.1m. Area: 320 sq m.
G06	Mixed Species Group (Group, mixed species)	Situated to the east of the barn	Mix of Lime, Acer and Beech creating semi woodland area.	Height (m): 22 Stem Diam (mm): 590 Spread (m): 5N, 5E, 5S, 5W Crown Clearance (m): 8 Life Stage: Mature Rem. Contrib.: 30+ Years	Physiological Cond: Good Structural Cond: Good Bat Habitat: None	B2	Area: 311 sq m.

Photo Two – Showing T04 and T05 with G06 to the rear

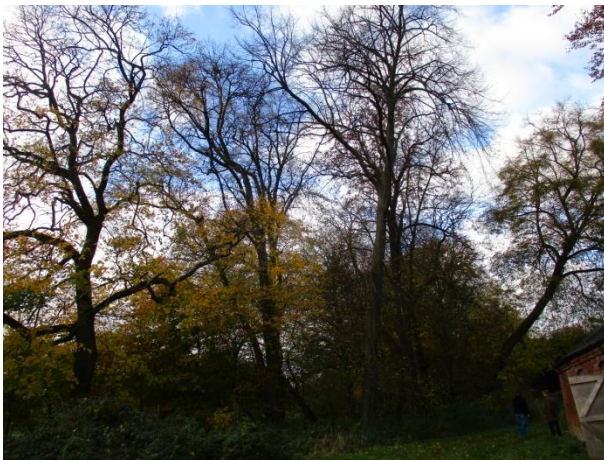
- 6.13** T08, T13 – Lime and T12 – Sycamore are large mature trees that are to the north and west of the barn. The trees are in good condition and due to their size they contribute highly to the area.

- 6.14** T14 – Lime, is a large heavily leaning tree on the edge of G15. The tree appears to be in good condition although growing at a severe angle. Due to its size and lean it is very visible, although it does lean out over what would be the access drive to the development.

Photo Three – Showing T12 – 14 with G15 to the rear

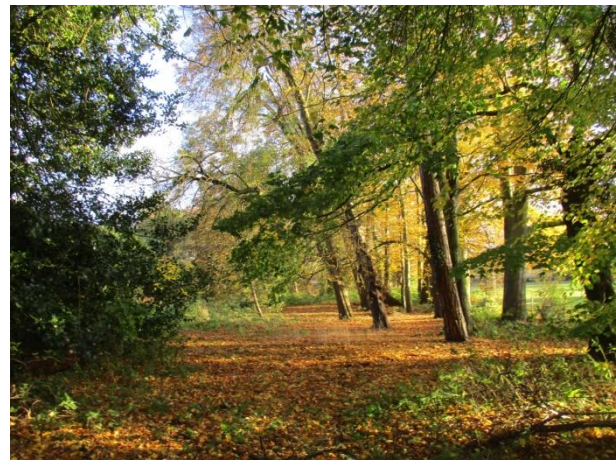
- 6.15** G15 – Mixed species, is a woodland strip that runs down the west boundary of the site and made up of predominately Horse Chestnut, with some Lime, Beech and Pine. The area is mainly made up of mature trees although there are some semi mature trees dotted around. The majority of the Horse Chestnuts are displaying signs of bleeding canker with major dead wood also being present. The semi mature Horse Chestnuts appear to be displaying the worst symptoms of the disease. Due to the amount, condition and the age of the Horse Chestnuts it would be prudent to start a rejuvenation of this area.

Ref	Species	Comments	General Observations	Measurements	Measurements 2	Retention Category	RPA
G15	Mixed Species Group (Group, mixed species)	Situated along the access drive	Mixed woodland area, of predominantly Horse chestnut with some Lime, Pine and Beech. Horse Chestnut is displaying signs of bleeding canker and dead wood within their crowns. Younger specimens are especially affected.	Height (m): 28 Stem Diam (mm): 960 Crown Clearance (m): 0.5 Life Stage: Mature Rem. Contrib.: 30+ Years	Physiological Cond: Fair Structural Cond: Fair Bat Habitat: Low	B2	Area: 1498 sq m.
G16	English Yew (<i>Taxus baccata</i>)	Situated along the eastern boundary of the site	Row of yews along boundary edge, providing good screening	Height (m): 12 Stem Diam (mm): 450 Spread (m): 3N, 3E, 3S, 3W Crown Clearance (m): 0 Lowest Branch (m): 0 Life Stage: Mature Rem. Contrib.: 30+ Years	Physiological Cond: Good Structural Cond: Good Bat Habitat: Low	B2	Area: 423 sq m.

Photo Four – Showing G15 from the site access

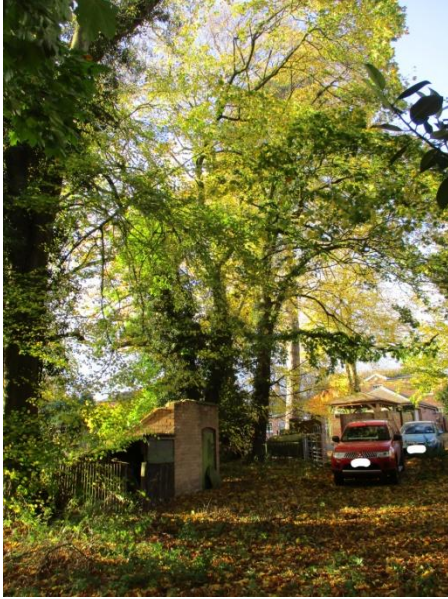
- 6.16** T18, T20 – Lime and T21 – Beech are large mature trees that are situated to the front of the site, the trees are in good condition and make stand out features as you access the area. T21 is situated within the driveway of the adjacent property. Between the trees is T19 – Sycamore which is heavily suppressed resulting in a tree of poor form.

Ref	Species	Comments	General Observations	Measurements	Measurements 2	Retention Category	RPA
T20	European Lime (<i>Tilia x europaea</i>)	Situated at the entrance to the site	Ivy on stem, tree is suppressed by adjacent tree	Height (m): 20 Stem Diam (mm): 630 Spread (m): 7N, 8.5E, 3S, 5W Crown Clearance (m): 4 Lowest Branch (m): 6(E) Life Stage: Mature Rem. Contrib.: 30+ Years	Physiological Cond: Good Structural Cond: Fair Bat Habitat: None	B2	Radius: 7.6m. Area: 181 sq m.
T21	Common Beech (<i>Fagus sylvatica</i>)	Situated at the entrance to the site	Tree situated on adjacent property. Ivy present on stem	Height (m): 24 Stem Diam (mm): 1030 Spread (m): 7.5N, 5E, 10S, 10W Crown Clearance (m): 5 Lowest Branch (m): 4(W) Life Stage: Mature Rem. Contrib.: 40+ Years	Physiological Cond: Good Structural Cond: Good Bat Habitat: None	A	Radius: 12.4m. Area: 483 sq m.
T22	Pedunculate Oak (<i>Quercus robur</i>)	Situated at the proposed new road access point	Tree is being suppressed by T23, leading to an asymmetrical crown	Height (m): 20 Stem Diam (mm): 60 Spread (m): 6N, 7E, 1S, 8W Crown Clearance (m): 5 Lowest Branch (m): 8(W) Life Stage: Early Mature Rem. Contrib.: 30+ Years	Physiological Cond: Good Structural Cond: Fair Bat Habitat: None	B2	Radius: 0.7m. Area: 2 sq m.

Photo Five – Showing T19 and T20

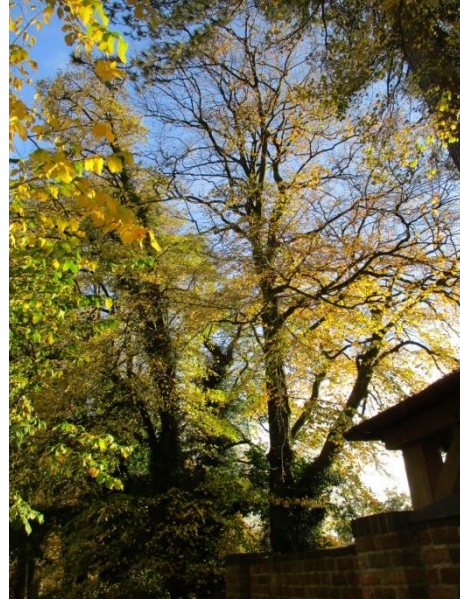
Photo Six – Showing T20 and T21
