Proposed Tree Work – Conservation area

Address: Humphreys Close, Aston Abbotts, HP22 4FB

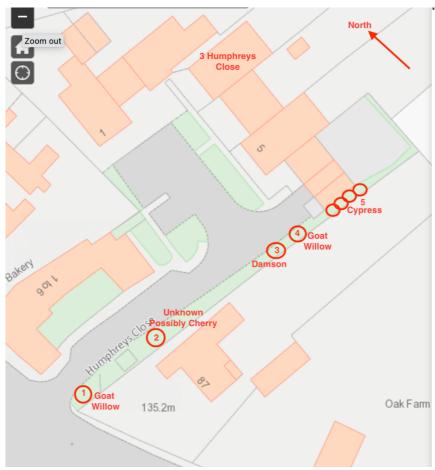
(Figure 1: Plan of impacted area)

As Humphreys close itself is a private close, we were assigned in our land registry deeds the green strip down the right hand side of the close as you look from the main road. Whilst we pay to maintain the native hedging along this length as it was planted by us we have not touched the trees labelled on the plan below since we moved here 18 years ago. These trees have grown far beyond their original size and are now not only hanging over our side but also the neighbours garden in Number 87 (Leafy Oaks). We have spoken to them and they are supportive of this request to tidy them up.

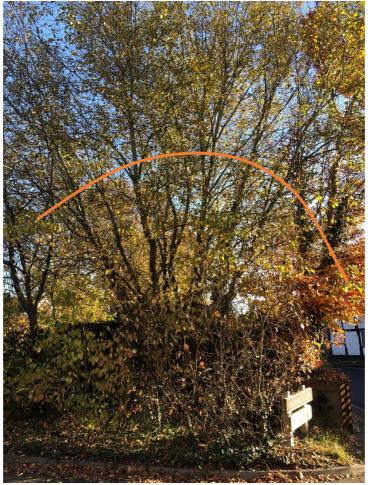
(Figure 2)

The tree closest to the close entrance labelled (1) we believe to be the same as the fourth one in a goat willow. This is very large right at the entrance and blocks the view turning out but also light from the nearby flats. It has also damaged the neighbouring fence as its grown too large at the base. We would propose to take this one back as highlighted with the orange arc

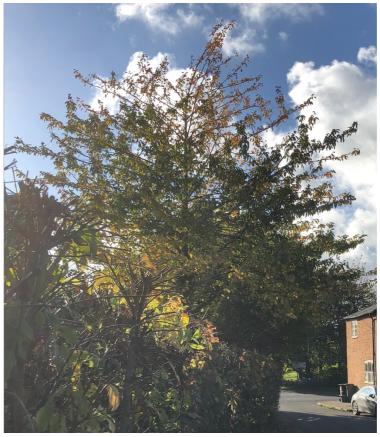
(Figure 3)

The next tree labelled (2) we believe to be some sort of Cherry (has blossom in the spring). The crown on this tree has grown too big and touches the neighbour's house over the fence. Our proposal with this is to thin the crown back and shape the tree better. I would estimate about 30% from the lower branches and less 10-15% on the upper ones to reshape into more of an oval.

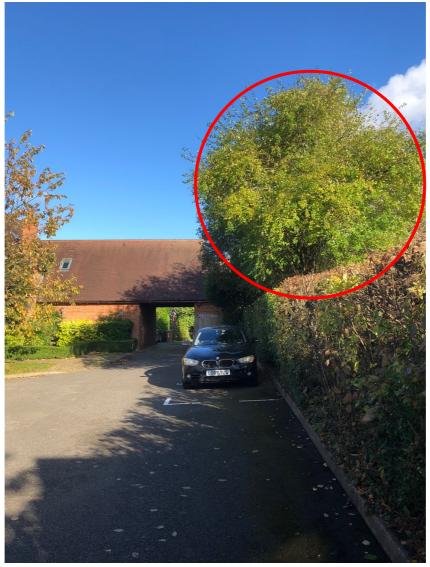
The next tree (labelled 3) we believe to be a Damson tree which has multiple trunks and is very large overhanging the parked cars and the boundary fence. Our proposal with this is to remove it completely. See following picture (Figure 4)

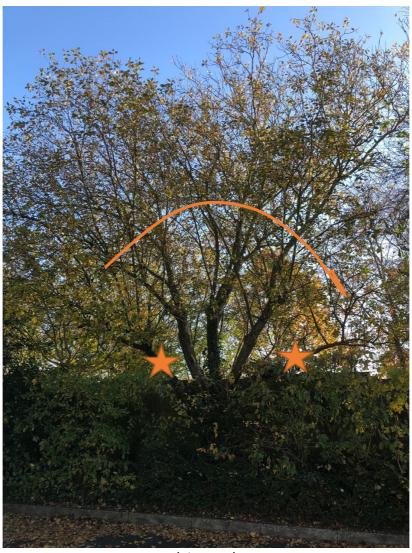
Tree labelled (4) we believe to be the same as the first one, a goat willow. This is very large and has been badly maintained prior to us moving so the tree has erratic growth and the tree is not balanced.

The following picture is the side view along the boundary where you can again see how much this hangs over the parking space and the boundary fence. These trees also emit sap during the spring/summer months which damages the paintwork on the cars parked underneath.

I believe this would be best taken back, the branches with orange stars completely removed and the top sections taken back by 30-40% to create an oval shape as indicated by the orange arc. As these trees grow very fast taking more shouldn't be an issue to the tree. The below picture (Figure 5) shows this tree head on.

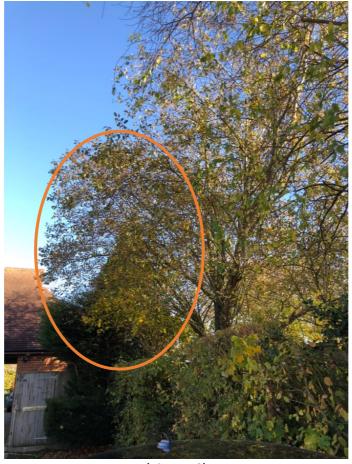
The further picture below (Figure 6) shows this same tree as it looks along the boundary including the overhang across the car parking spaces highlighted in orange

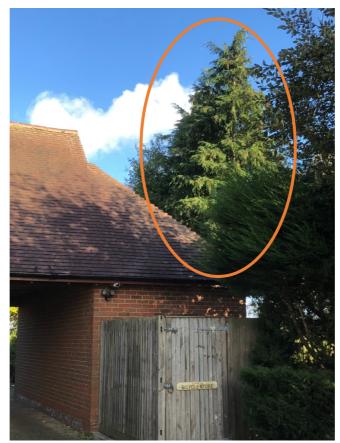
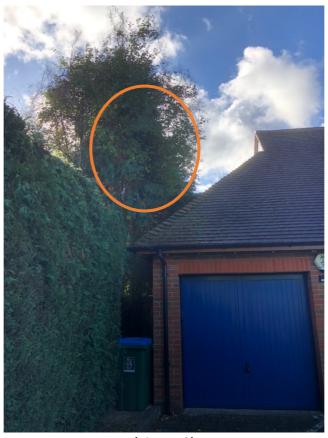
The set of 5 cypress trees labelled (5) on the drawing are right on the boundary line and touch our garage and have damaged the gutter and deposit dead material in there blocking the gutter and downpipes. Three of them are tall as can be seen from the picture in Figure xxx below, highlighted by the orange circle but the back two are much smaller, one of these is already dead apart from the top third. See below picture Figure 7 and 8

The proposal if possible would be to remove at minimum the three smaller ones and take the tops out of the two large ones to reduce them by a third. Second option would be to remove all five completely and replace with a native hedge
