## ALDI STORES LTD

Westgate, Skelmersdale

Coal Mining Risk Assessment

JMC/C3788/7390

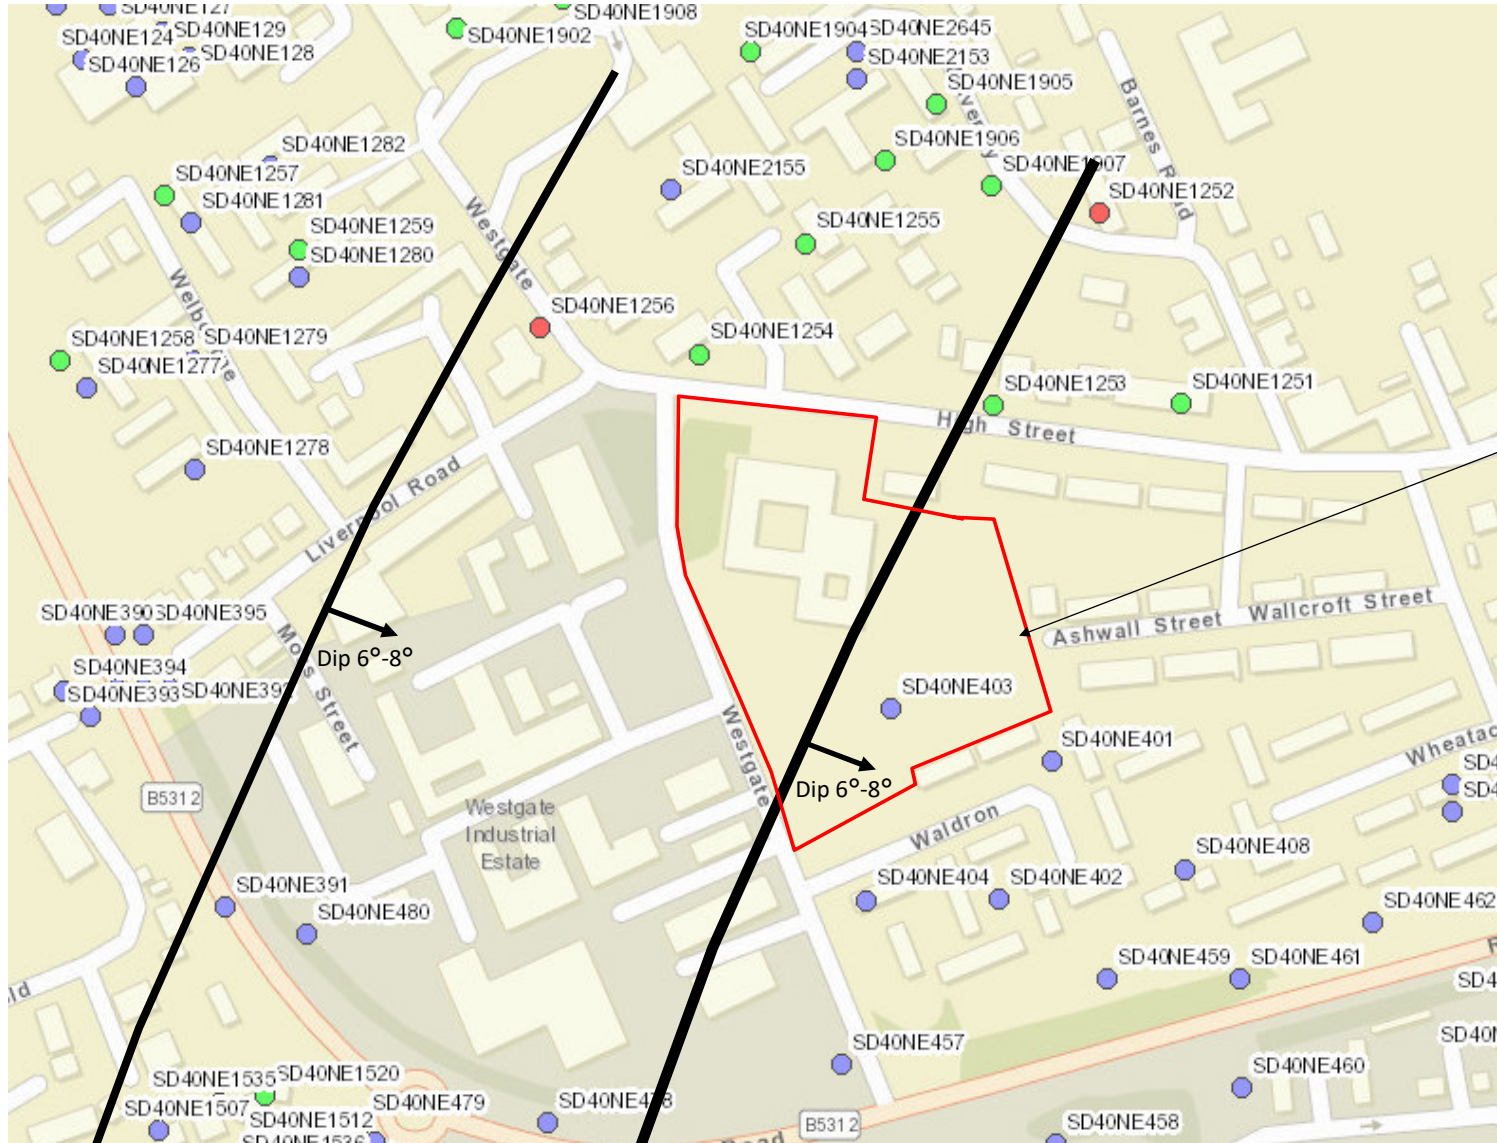
<b>ALDI STORES LTD</b>	
Westgate, Skelmersdale	
Boreholes and Coal Seams Extract	
Drawing No. C3788/03	
Scale: NTS	
Drawn By: JMC	Checked By: JMJ

3.3.2 Information from BGS borehole SD40NE1255 located circa 100m east of the Skelmersdale Earthy Delf seam shows workings have been encountered at 9.4m to 14.63m bgl (5.19m thick). Based on the assumed dip of 6°-8° this would place the seam at depths of around 10m-14m in this borehole location. This indicated the Skelmersdale Earthy Delf has been worked in this area however the thickness of workings is over double the size of the seam thickness.

3.3.3 BGS Borehole SD40NE1254 is located circa 120m east of this coal seam and shows coal at 13.86m (0.46m thick) and collapsed workings from 15.4m to 16.4m (1.00m thickness). Based on the assumed dip of 6°-8° this would place the seam at depths of around 12m to 16m in this borehole location. This borehole is adjacent to the site along the strike.

3.3.4 BGS Borehole SD40NE1253 is located 240m east of the coal seam and collapsed workings have been proven from 21m to 22.70m (1.70m thick). This borehole is adjacent to the site along the strike.

3.3.5 BGS Borehole SD40NE1252 is also located circa 240m east of the coals seam. This borehole encountered collapsed workings from 15.8m to 18.2m (2.40m) and coal from 18.6m to 18.8m (0.20m). Based on the assumed dip of 6°-8° this would place the seam at depths of around 25m to 33m in these locations. These two boreholes do not correlate with the depth of the coal seam however the accuracy of the location of the boreholes cannot be guaranteed and therefore these workings are assumed to be park of the Skelmersdale Earthy Delf seam.

3.3.6 The geological seams and BGS boreholes in relation to the site are shown on Drawing C3788/03. The BGS boreholes are presented in Appendix B.

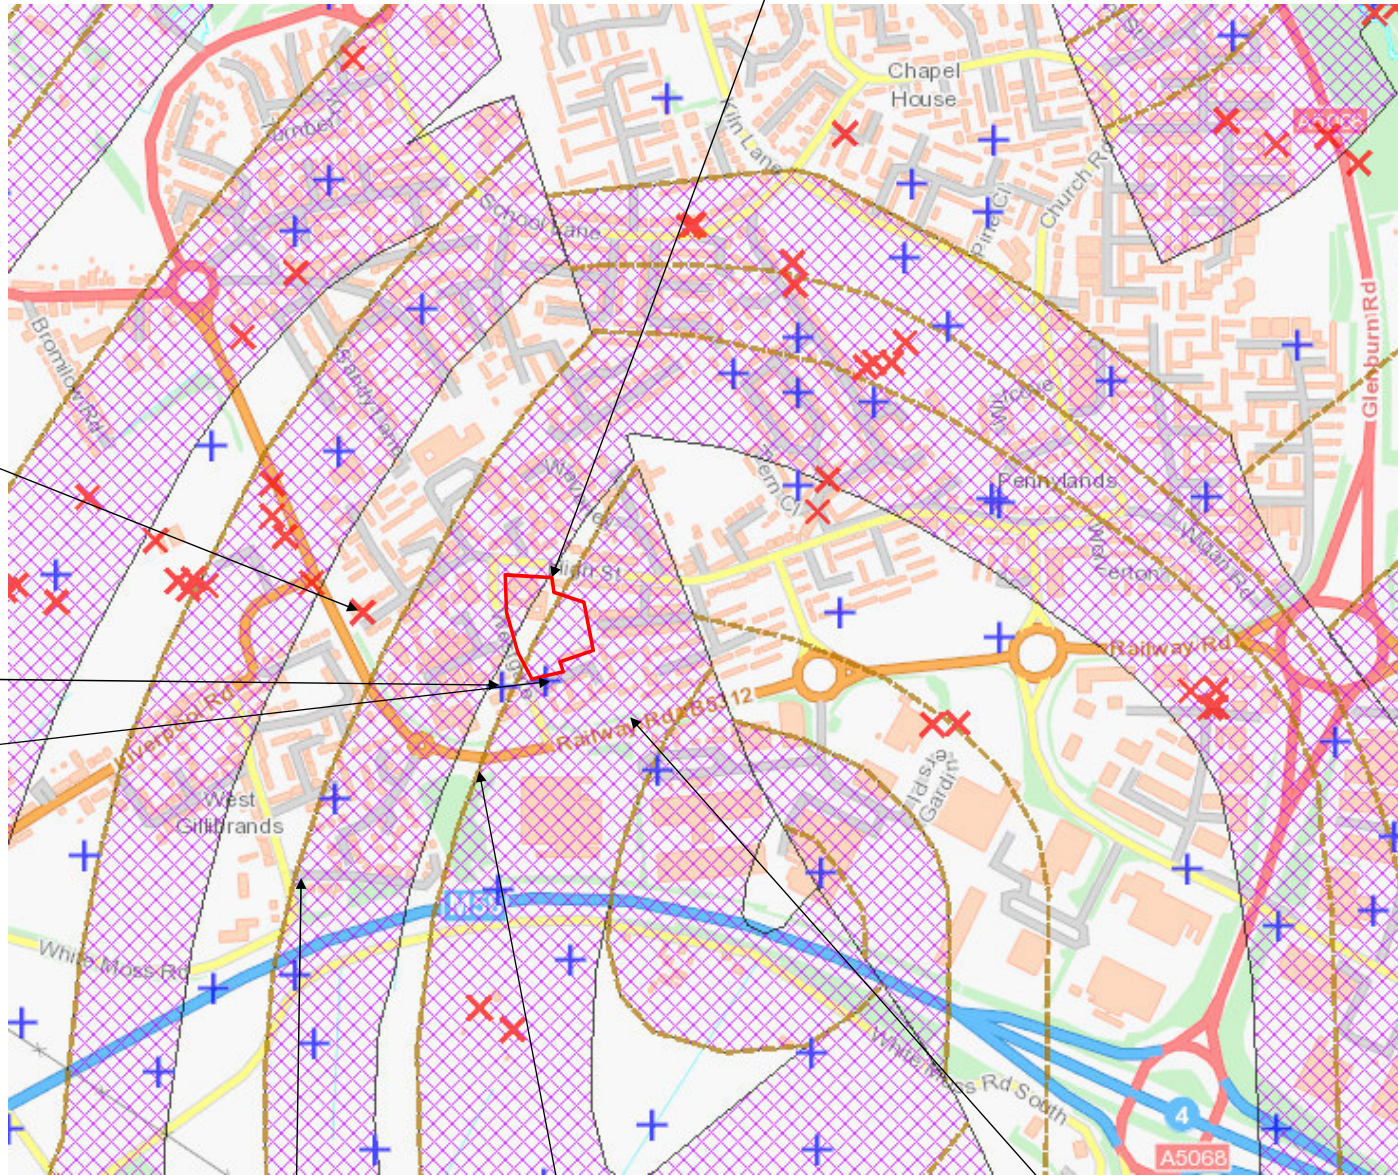
Drawing No. C3788/04

- 3.4.1 The Coal Authority interactive map indicates that site lies in a development High Risk Area.
- 3.4.2 The site is also shown to be area underlain by Probable Shallow Coal Mine Workings.
- 3.4.3 The site is also located in a Surface Coal Resource Area.
- 3.4.4 The site is located within the abandoned mines catalogue and the closest mine shaft is approximately 215m west of the site.
- 3.4.5 There are two points located on the interactive map relating to working dates along the unknown coal seam which indicate the coal seam on site has been worked during the dates of 1880 and 1897.
- 3.4.6 The location of the site in relation to the Probable Shallow Coal Mine Workings and coal seams is shown on Drawing C3788/04.

4.3.1 A unknown coal seam is indicated to subcrop on site and dip to the east. According to information from the memoir this could be the Yard or Dam mine which are both thin coals however this could be considered to be workable thickness. No further information on these seams is held.

4.3.2 The risk to the proposed development from unrecorded mine workings is therefore considered to be **high**.

5.2.1 It is recommended that a coal mining investigation is undertaken to confirm the presence mine workings beneath the site and the depth and thickness of the unknown coal seam which sub crops on site and to confirm or otherwise if this has been worked.

5.3.1 As shallow mine workings are likely to underlie the site the proposed development will require treatment. This will comprise drilling and grouting. The section of the drilling and grouting will be determined by the coal mining investigation.
