Watering Farm

Heritage, Design & Access Statement

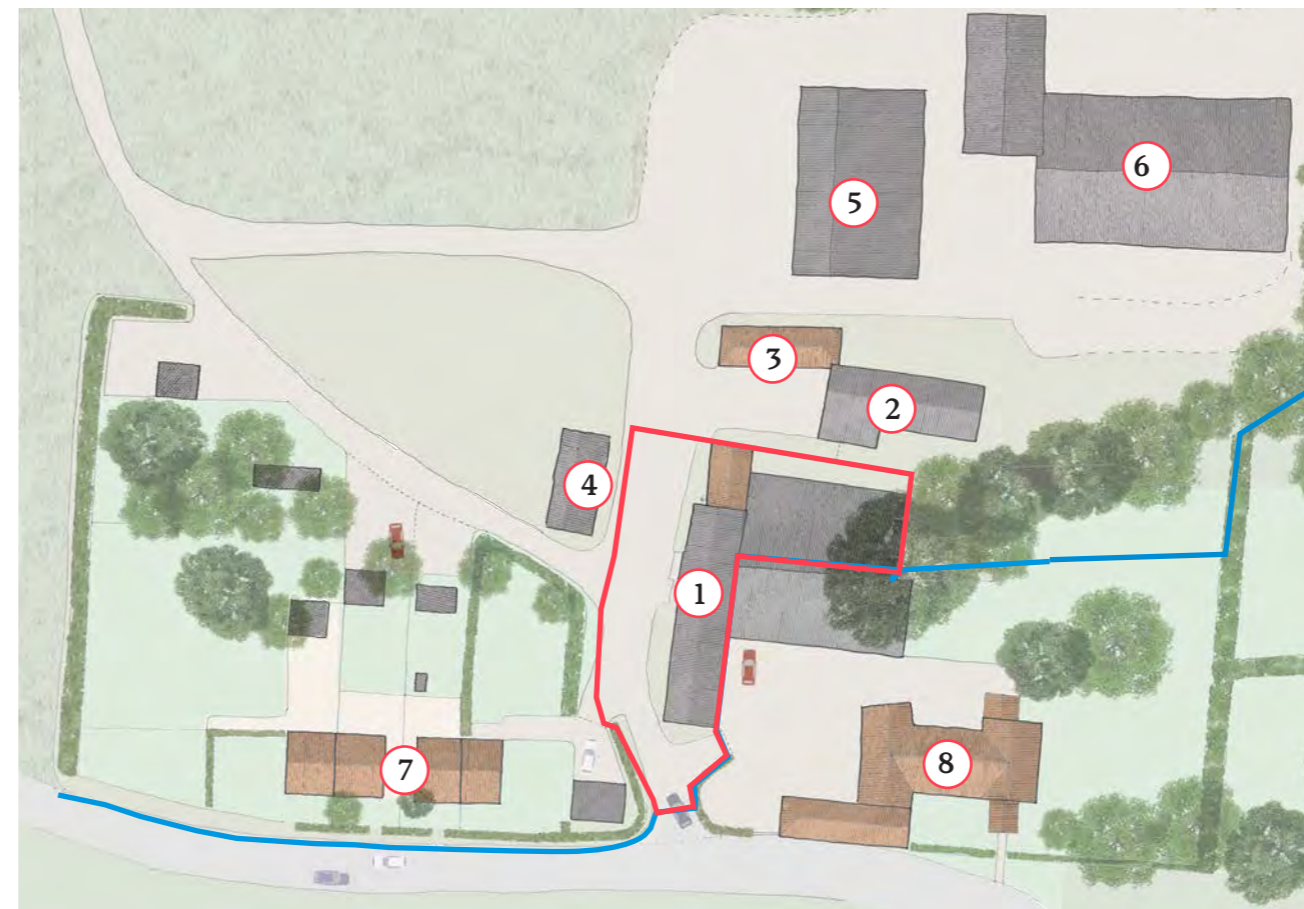
The Tudor Grange (8), which includes a Grade 2* listed farmhouse and a Grade 2 listed dairy and bakehouse building adjacent to the site, is not in the same ownership and will be unaltered.

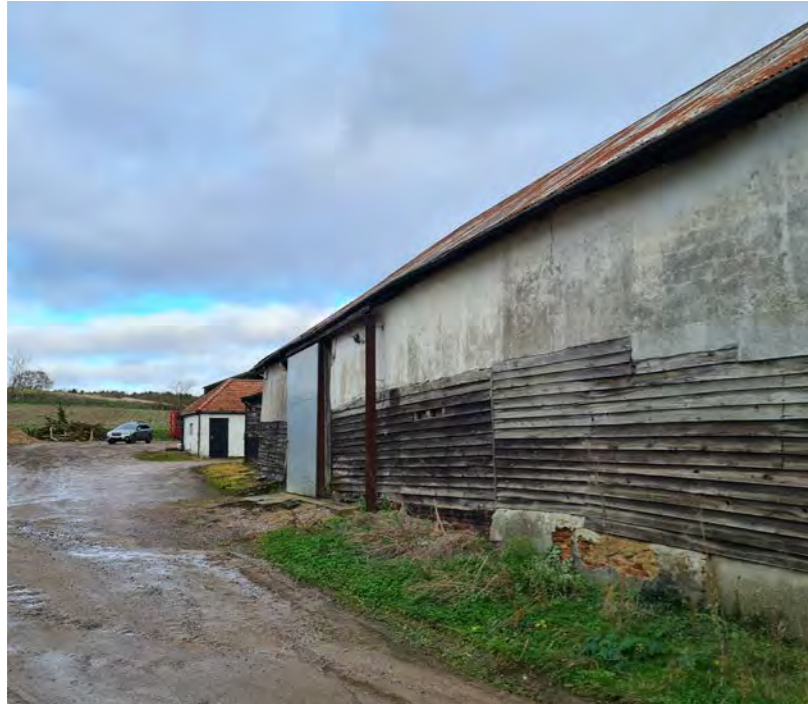
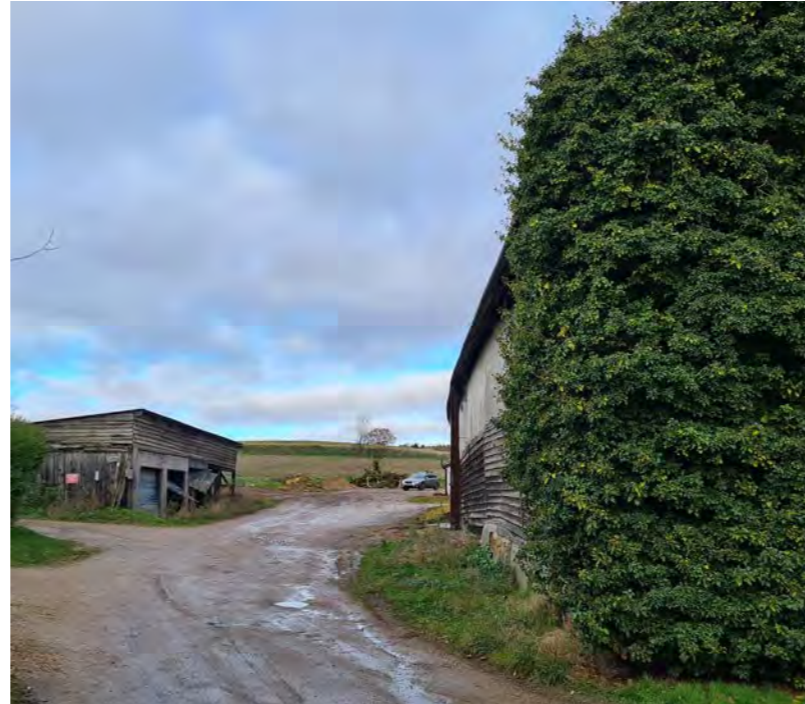
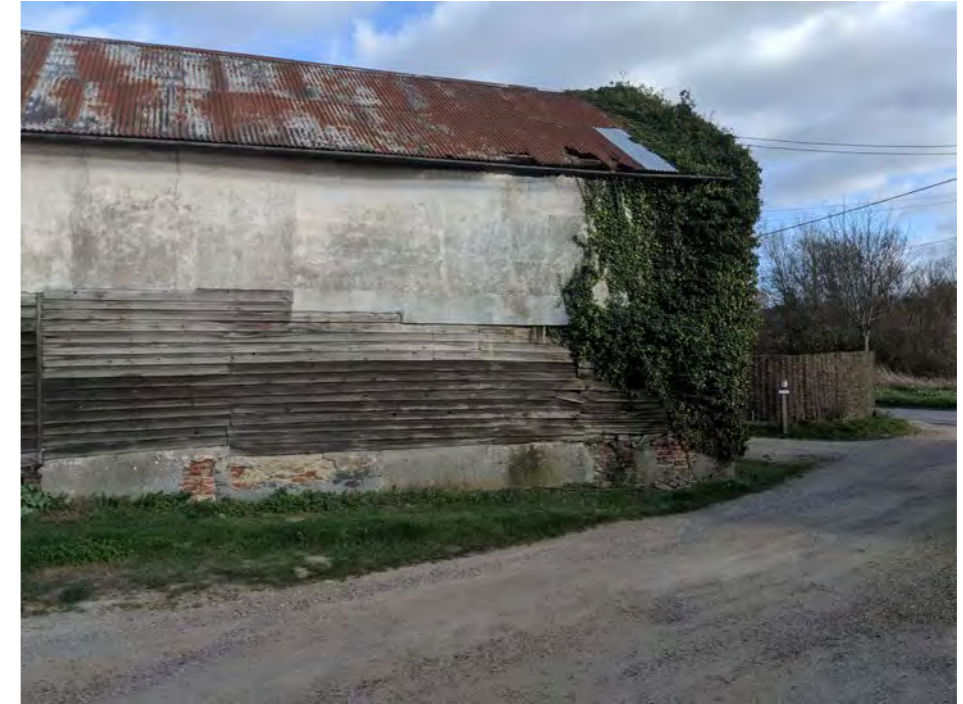
Condition of the exterior of the barn - showing poor existing condition, cement render at high level and over brick plinth.

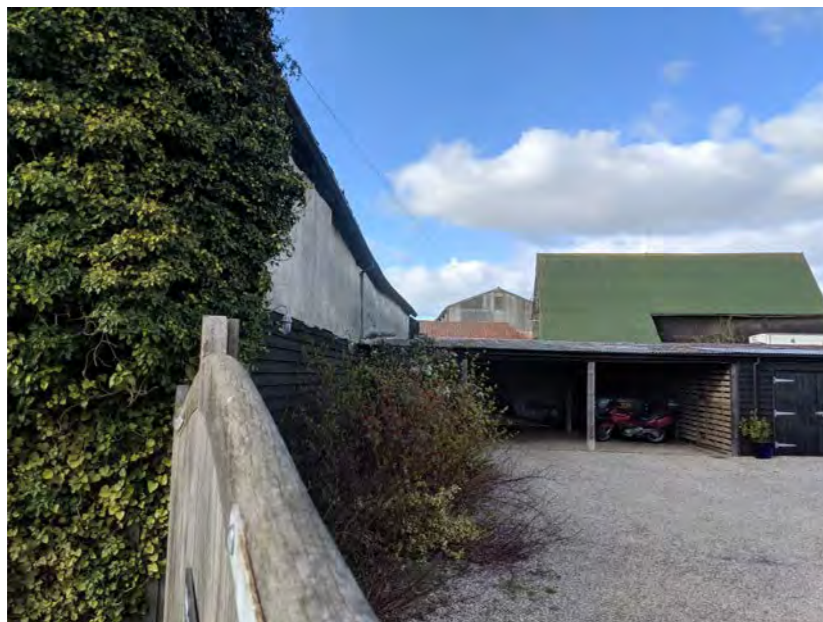
View of the east side of the barn (area to the left is outside of the application boundary and applicant's ownership)

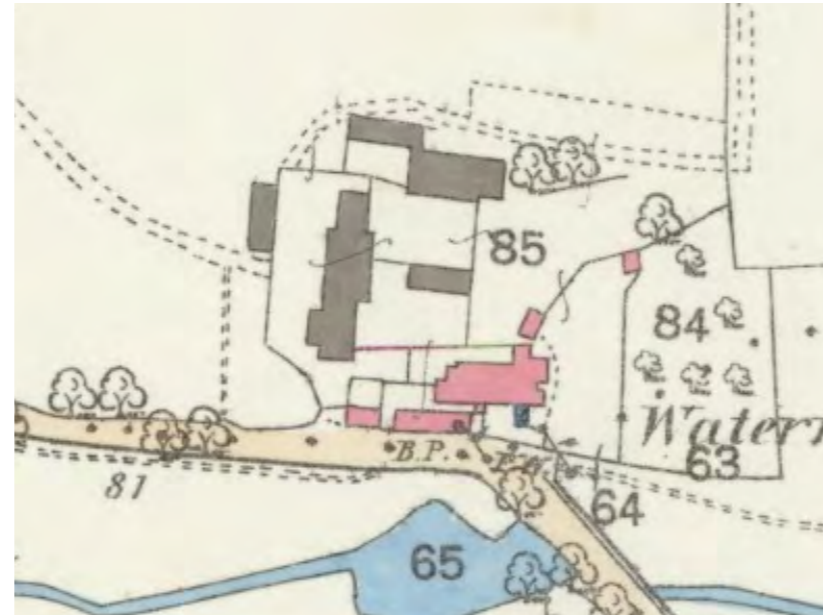
Extract from 1882 25 inch OS map

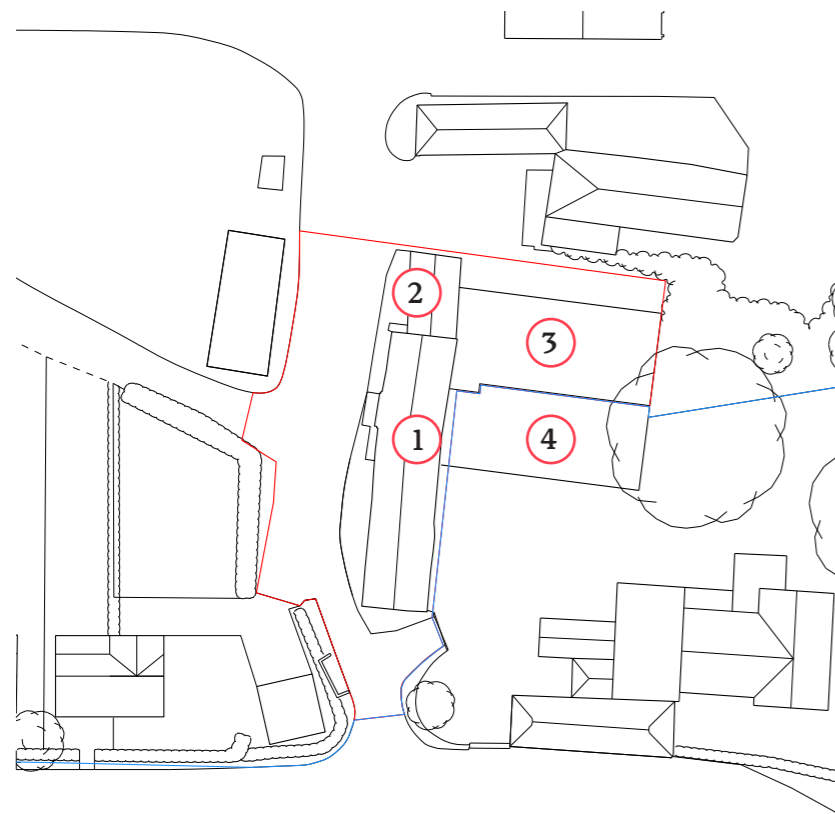
1. Main barn
2. Attached single storey shed
3. Attached modern lean-to (within application, proposed to remove)
4. Attached modern lean-to (outside applicant's ownership and therefore required to be retained)

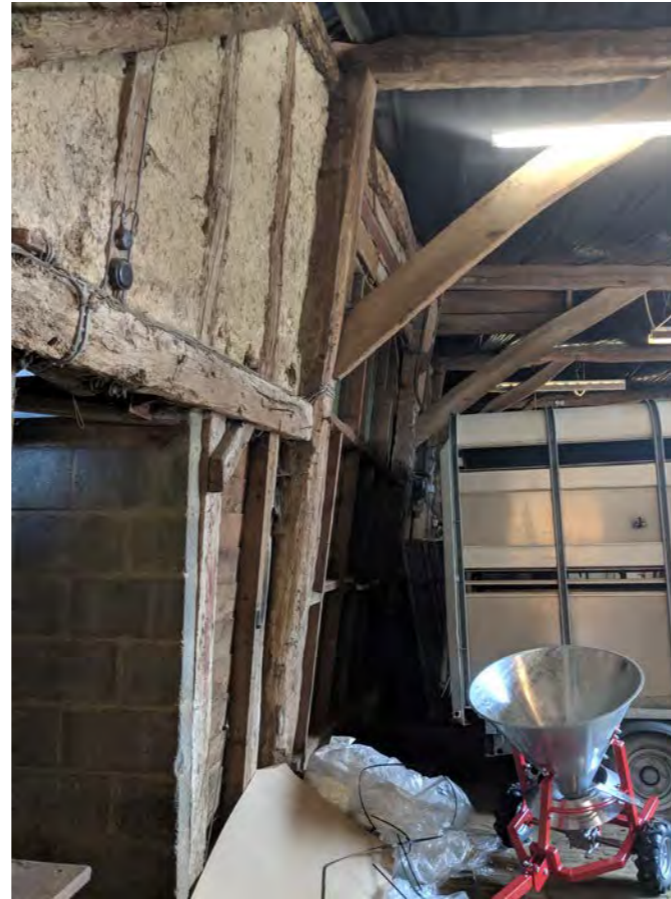
Current condition of listed barn's interior - wattle and daub panel can be seen along with modern concrete blockwork alterations, replacement and original frame elements.

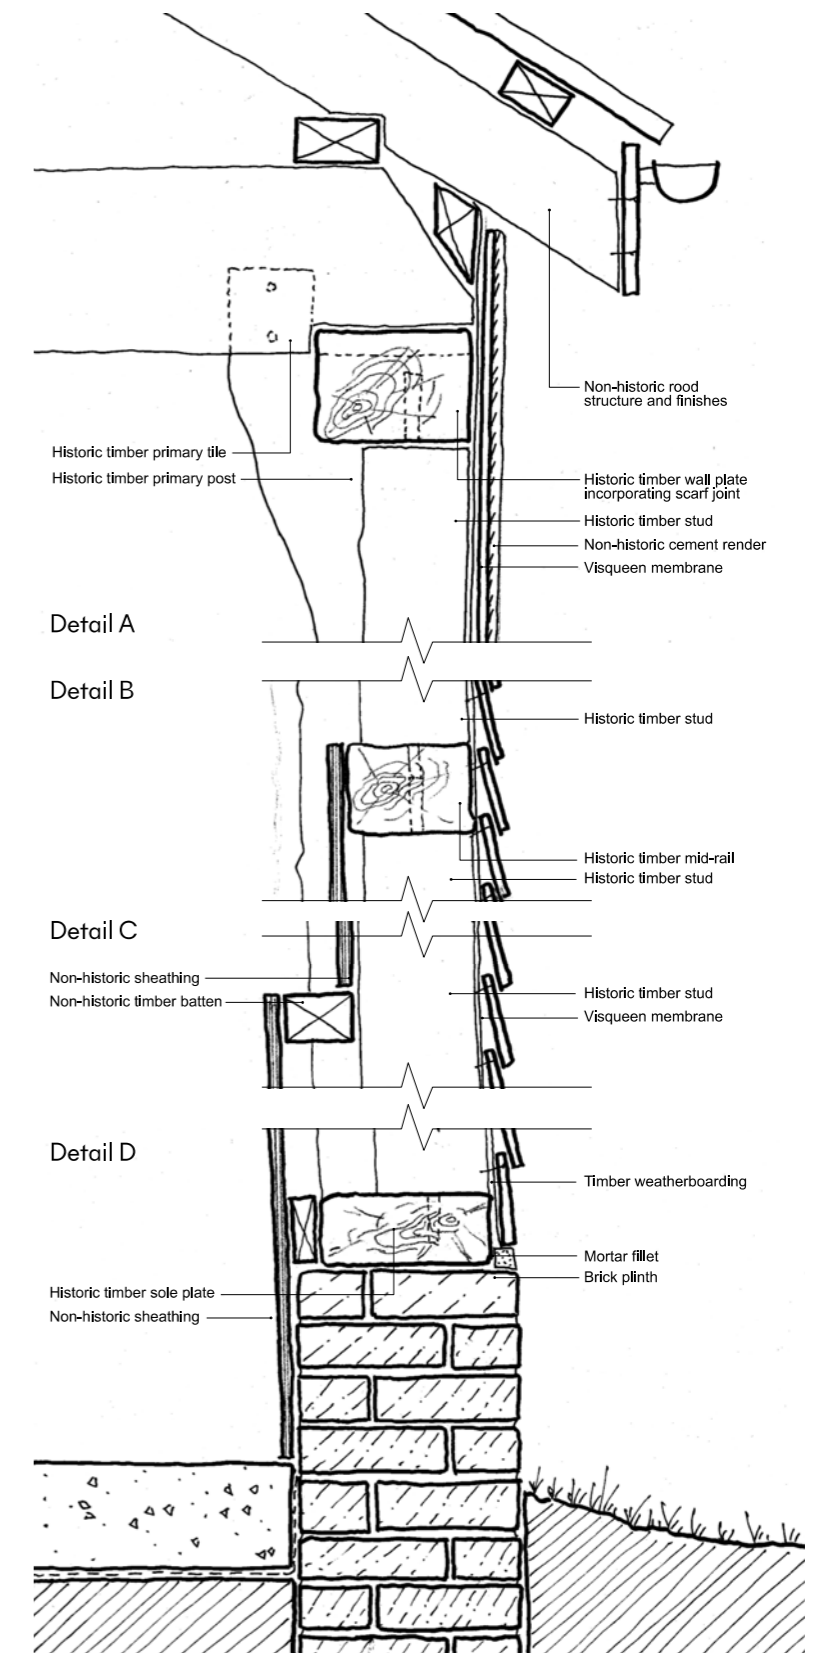
Typical section through existing fabric

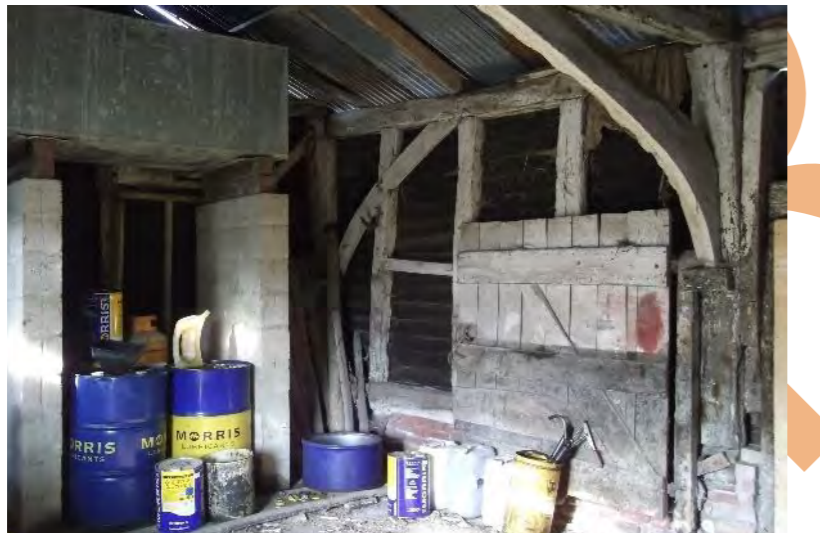
Wattle and daub panels: Wattle and daub panelling was an infill technique that continued to be used up until the C19th. As noted on the previous page some of the barn's wattle and daub panels have already been lost, however there are still several panels still in place to the upper parts of some of the walls. Many of these panels however are in poor condition and require proper attention. Some of these panels show examples of close studding.

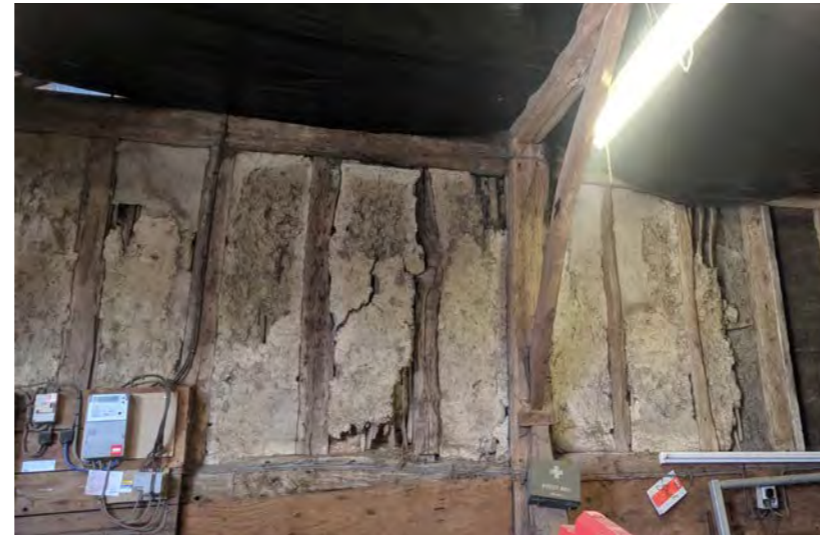
Brick floor: While the majority of the shed has a concrete floor there is an area of original brick flooring immediately inside the main entrance doors. It is believed that this may have been a threshing floor.

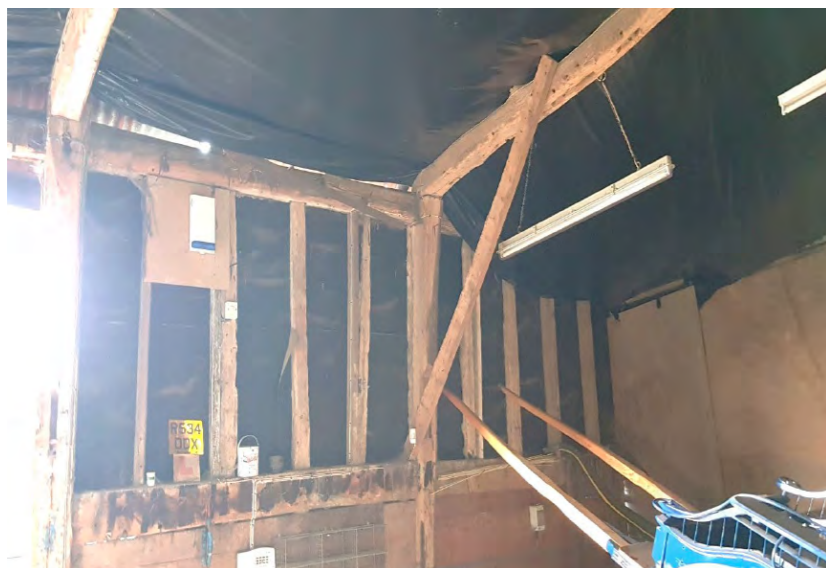
View 4: Looking west (Bay 1 and 2) - studs at upper level covered in sarking felt, principal post between bays 1&2 is in good condition but the bracing is non historic (3.2.55*)

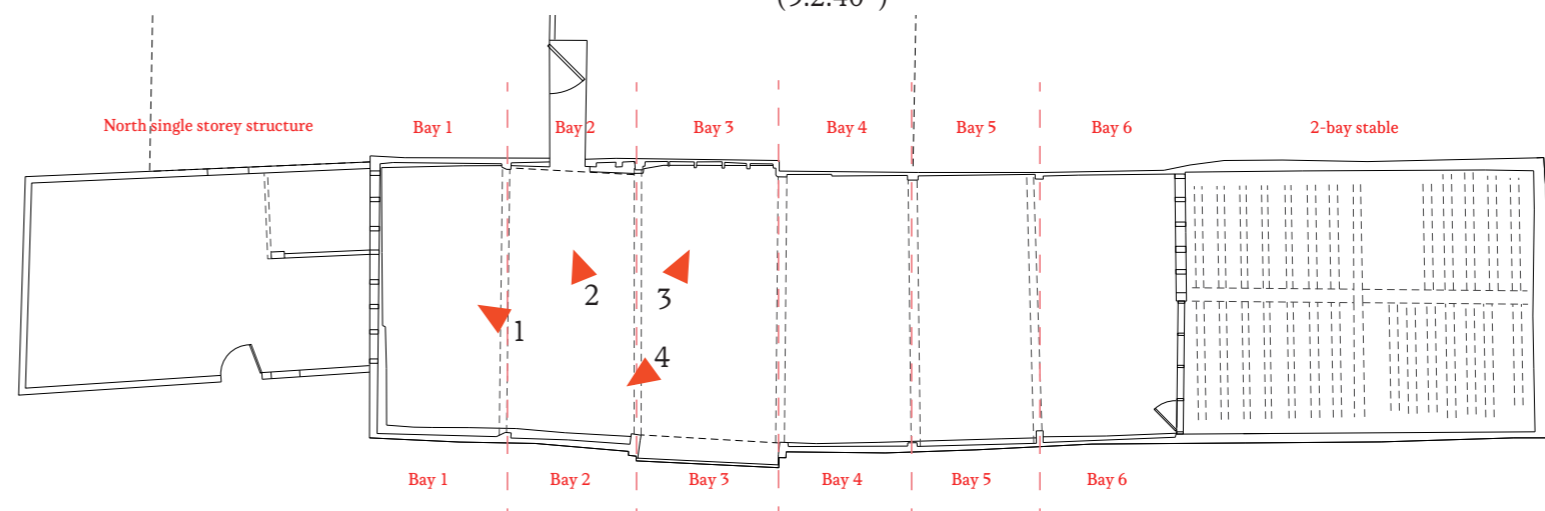
*References from the Structural Report

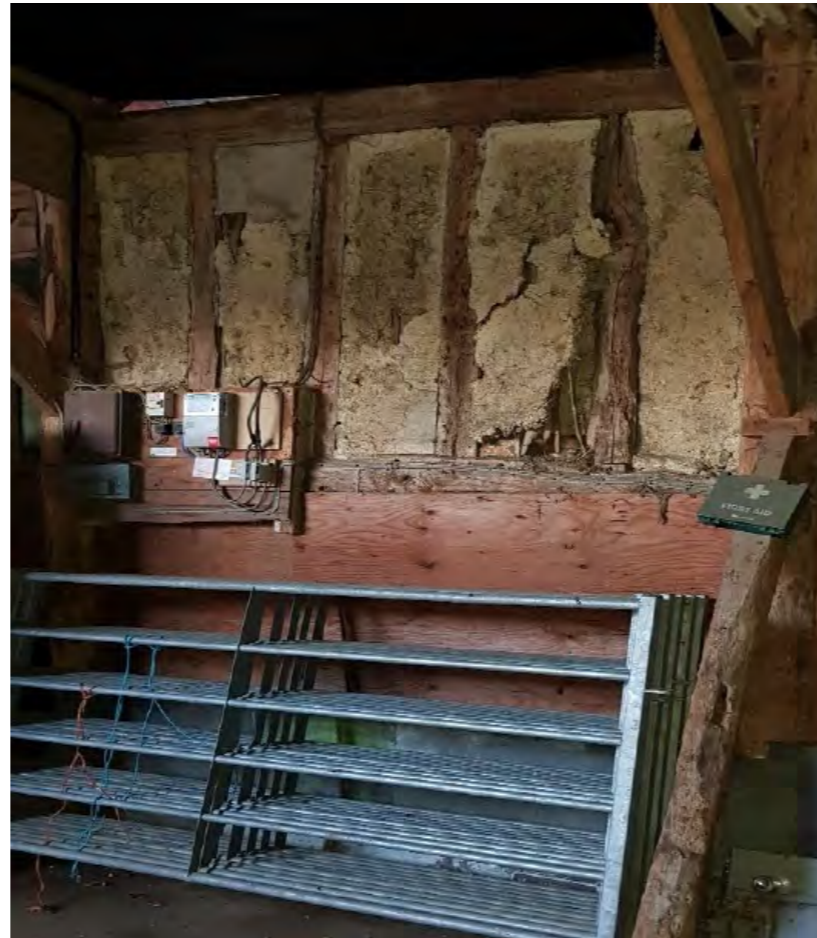
View 2: Looking east (Bay 4) - Mid rail plate has dropped and one of the posts is cracked and failed (3.2.46, 3.2.47*)

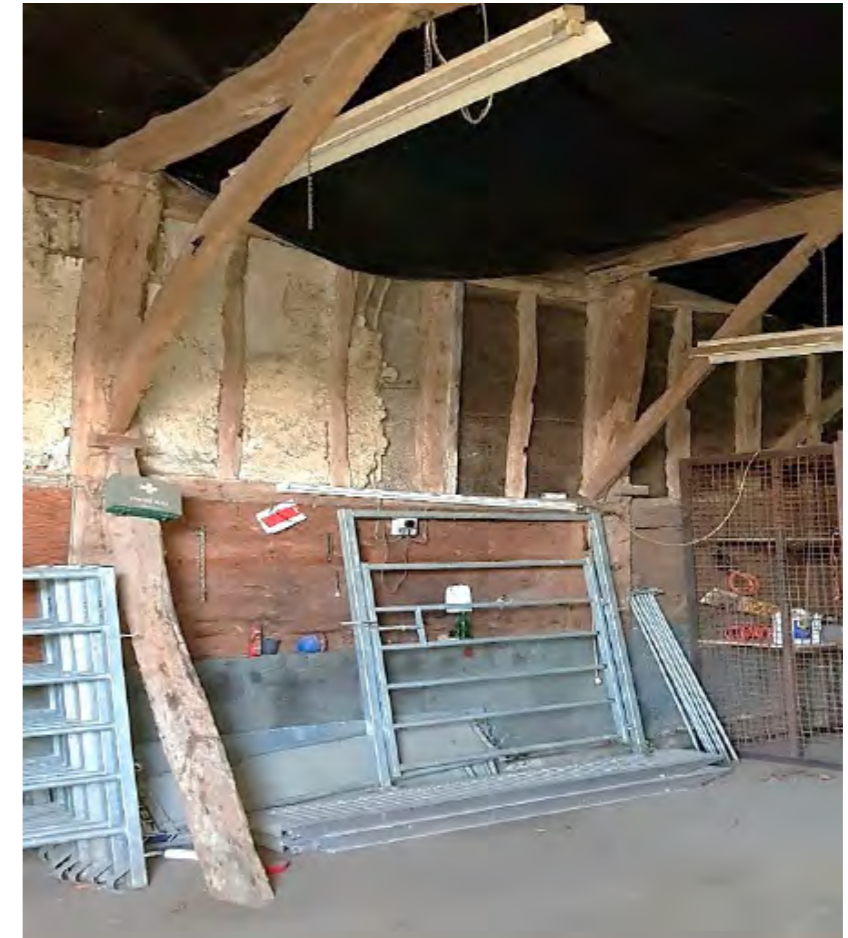
View 3: Looking east (Bay 5) - timber panels pulled out and replaced with sarking felt (3.2.50*)

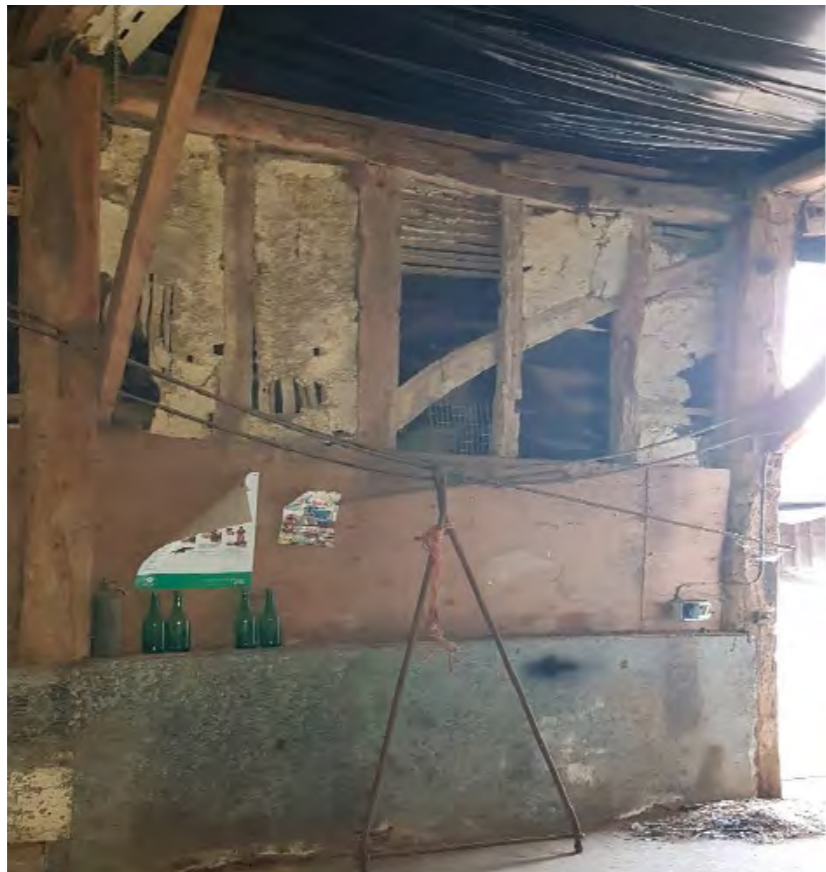
View 3: Looking west (Bay 4) - Timber post between bays 4&5 shows sign of decay and failure and it is not connected to tie beam

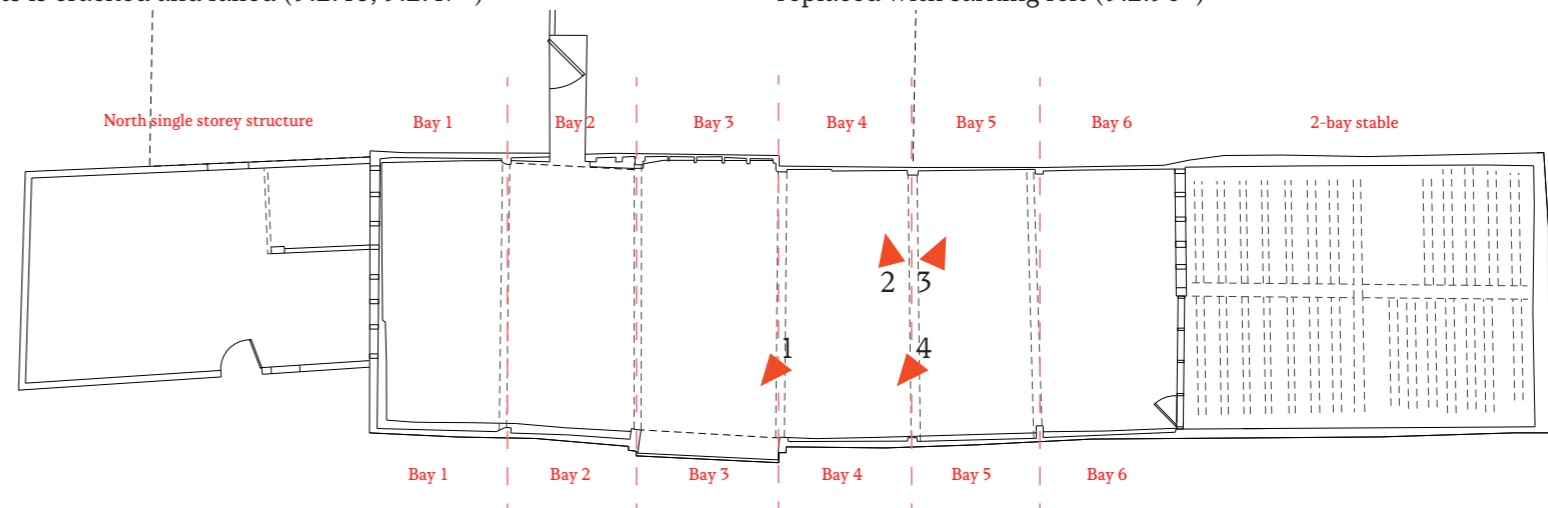
*References from the Structural Report

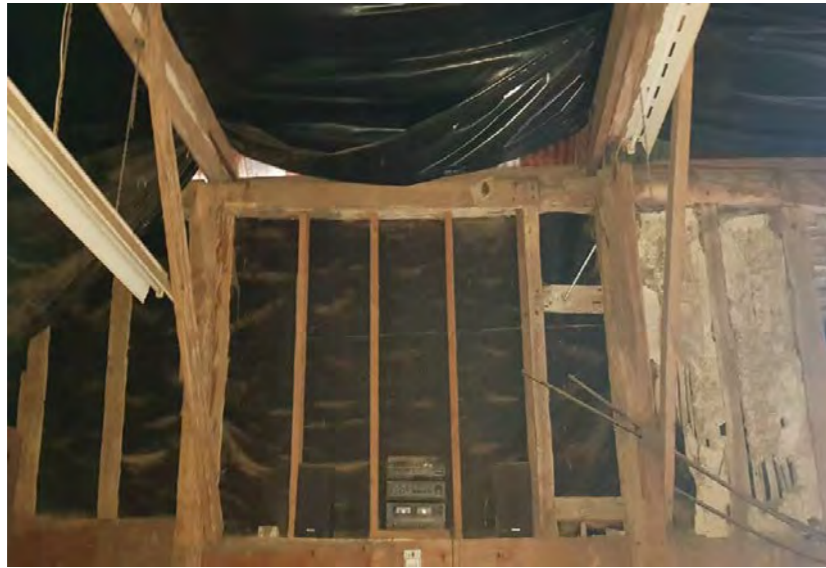
View 1: Looking west (Bay 5) - There is one original stud seen on the upper level, others replaced later (3.2.64*)

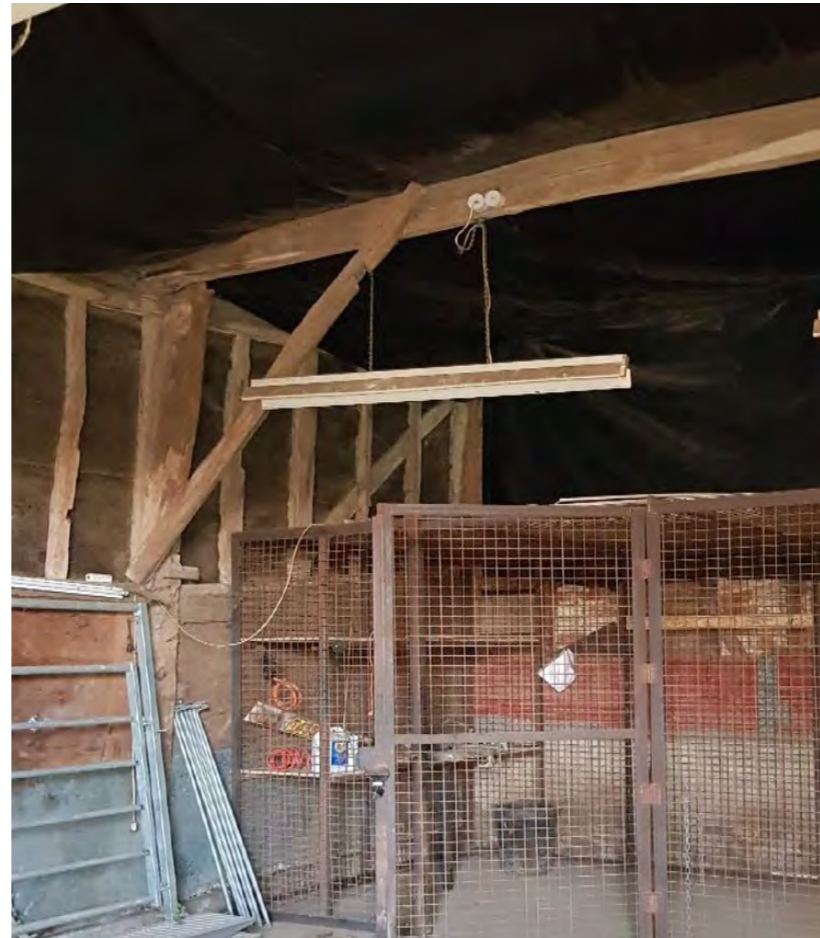
View 2: Looking east (Bay 6) - Survey undertaken on 11 October 2019 - no access to southern elevation at this time

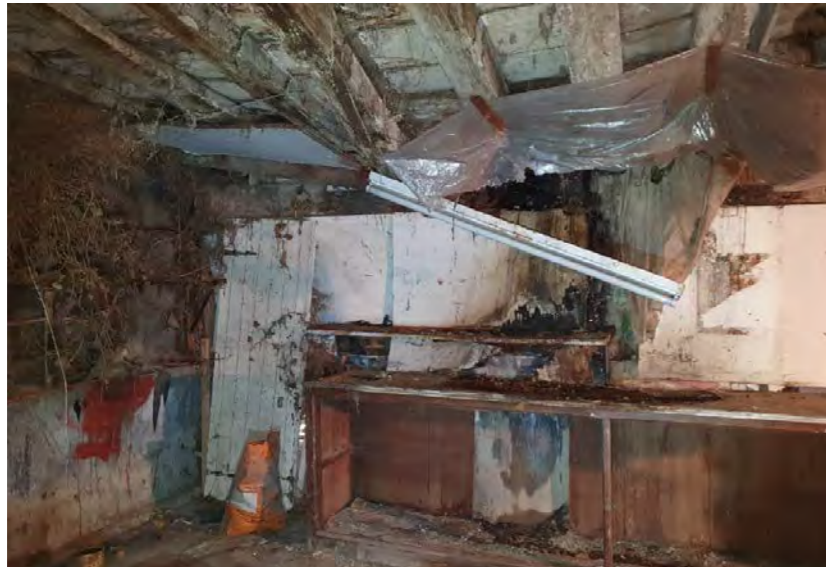
View 1: Looking southwest - Timbers been affected by rainwater ingress, studs and posts deteriorated (3.2.73*)

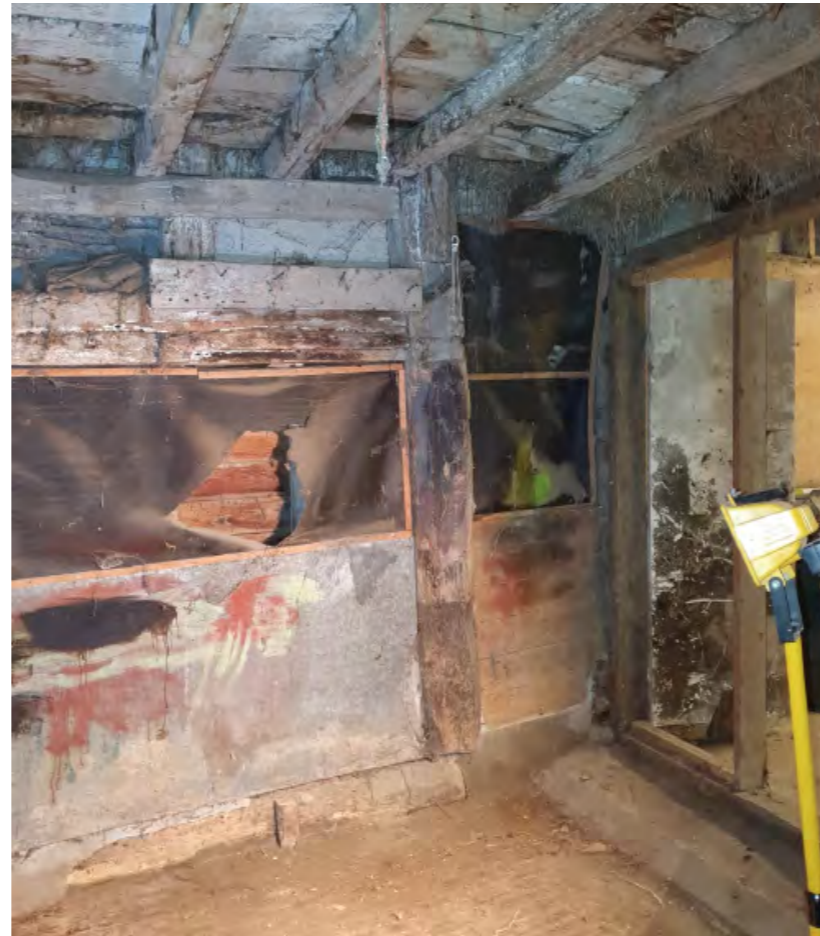
View 2: Looking west - non-historic timber material seen as well as plastic sheeting, sarking board and felt (3.2.75*)

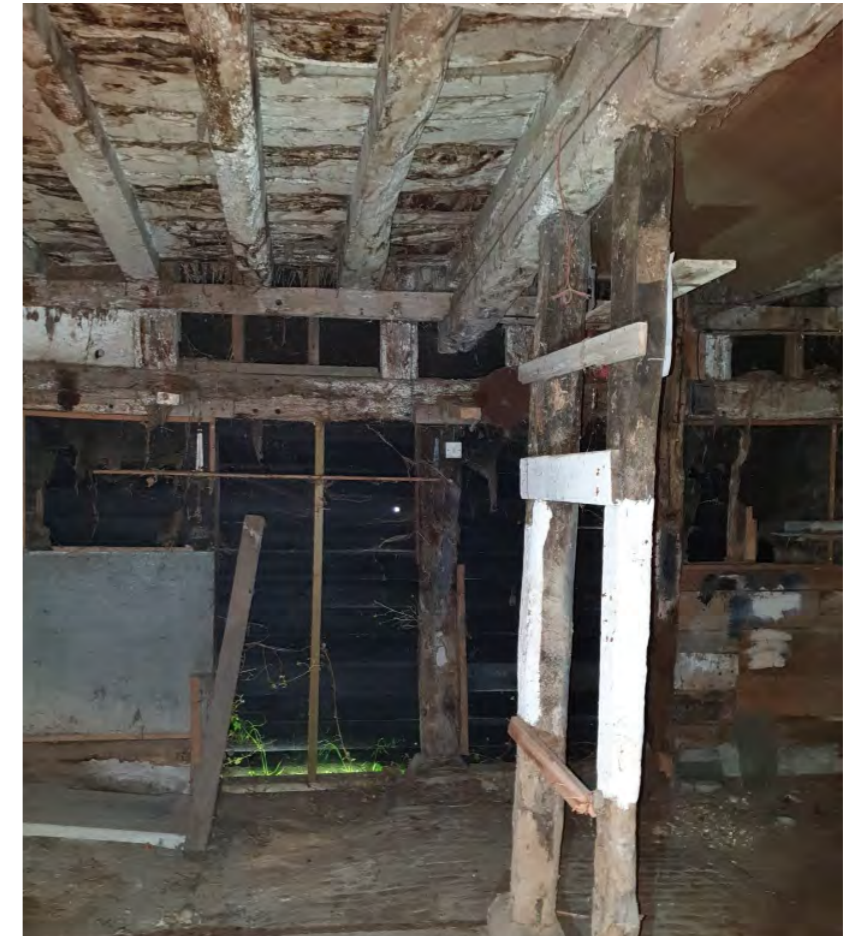
View 3: Looking east - historic material on this elevation is exposed and in better condition than on the West side (3.2.77*)

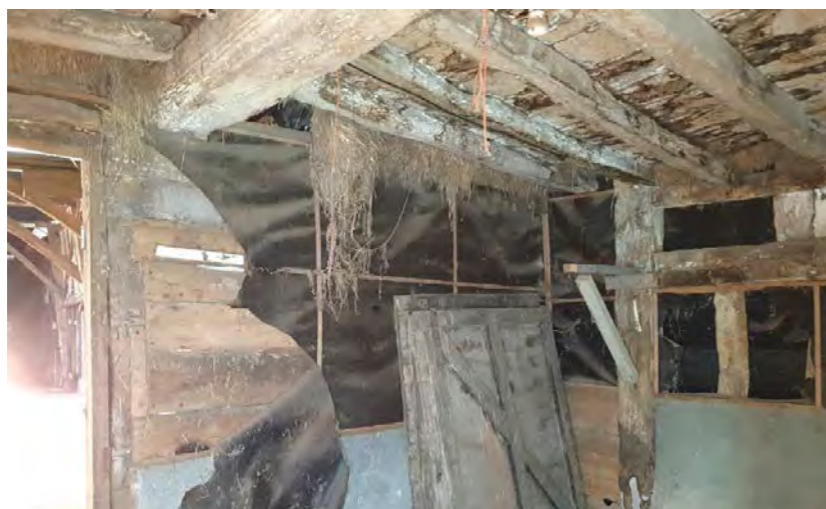
View 4: Looking northeast - historic boarded wall behind bituminous felt and battening (3.2.90*)

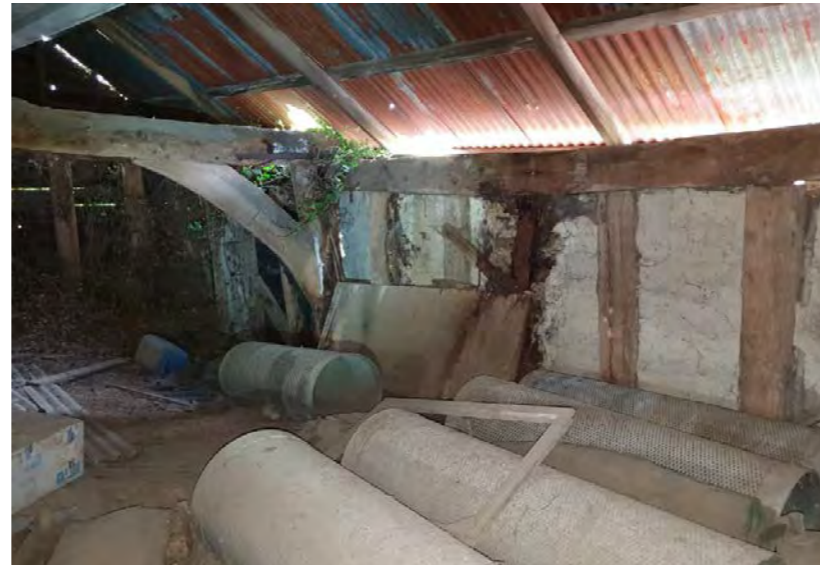
View 2: Looking west - timbers decayed at high level and water ingressed causing collapse of the lower section to SouthWest corner

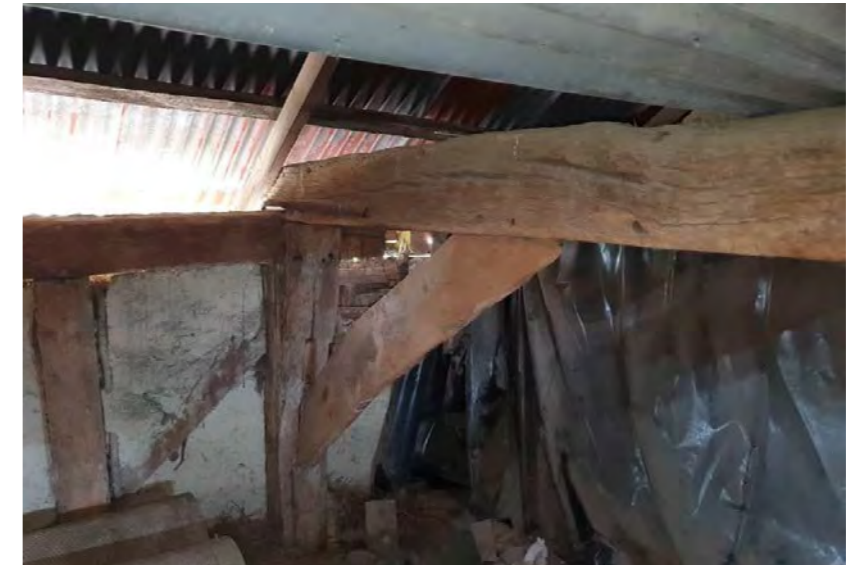
View 3: Looking east - elevation externally wrapped in a bituminous felt, studs and wall plates in reasonable good condition

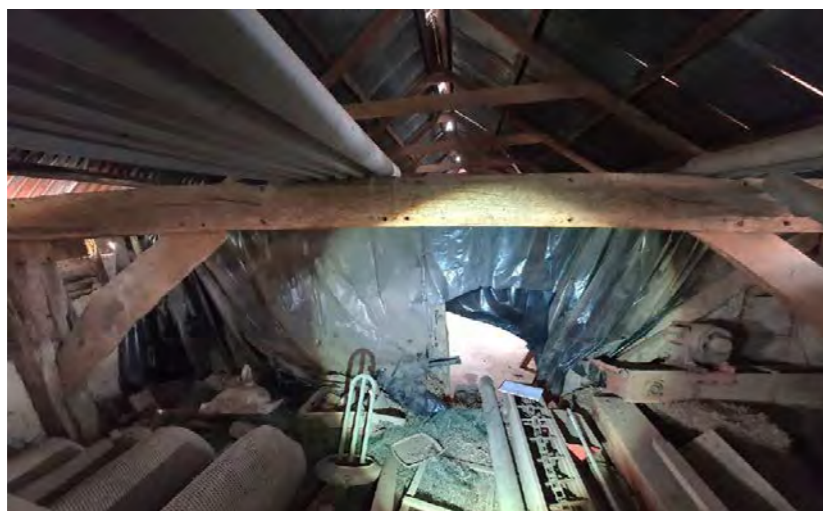
View 4: Looking north - principal tie beam running across the first floor, historic boarded wall cover in plastic sheeting, only acces to hay loft is visible

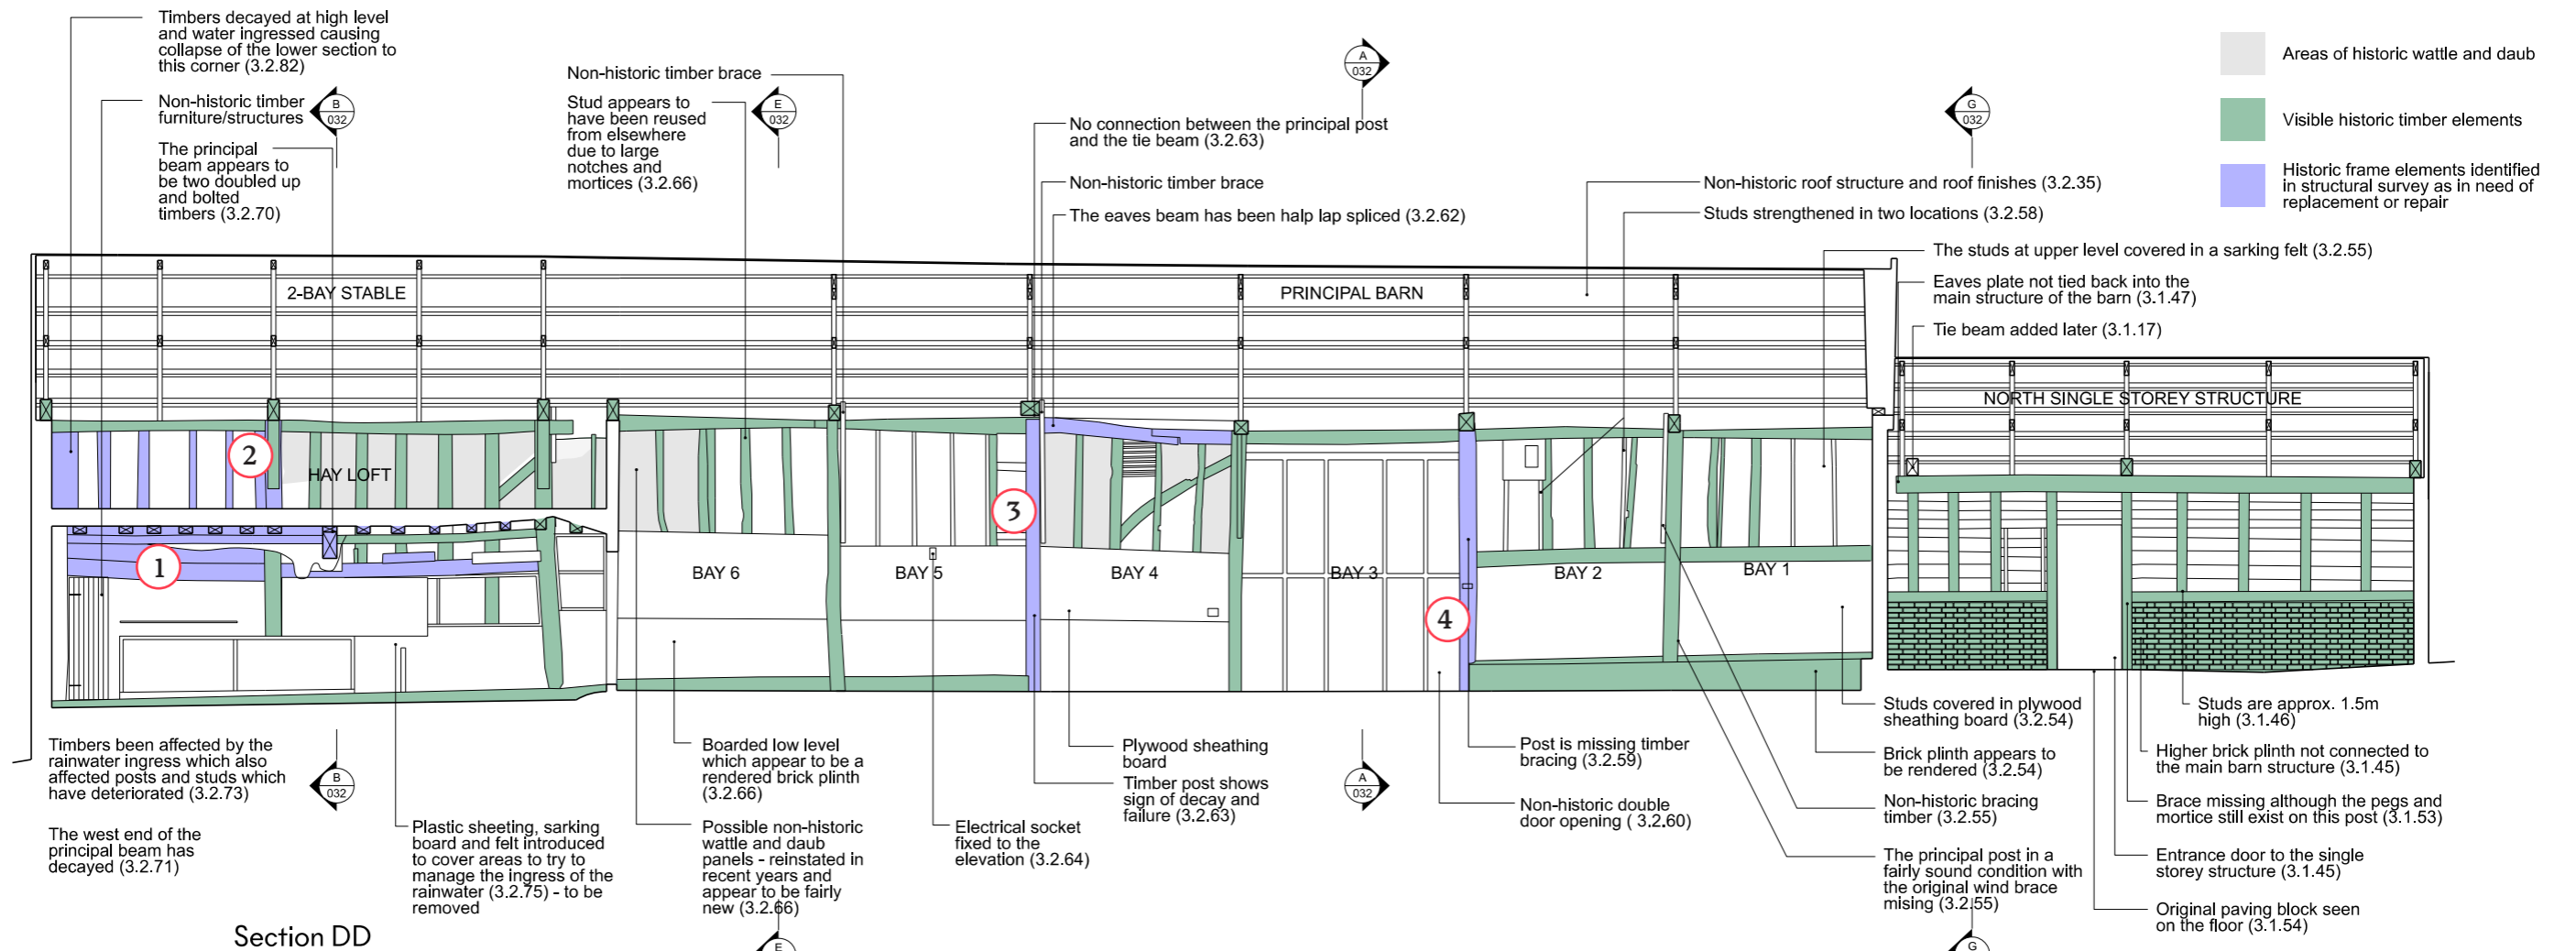
Listed barn - condition of west elevation

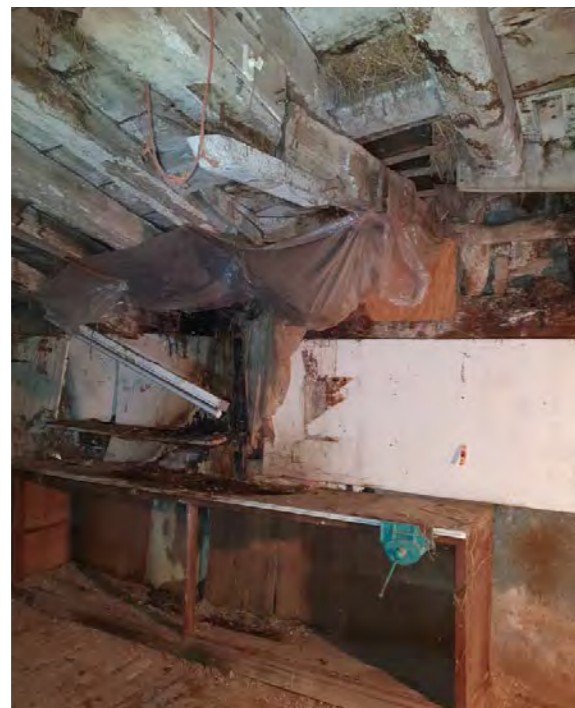
1 Timbers affected by the rainwater ingress, posts and studs deteriorated

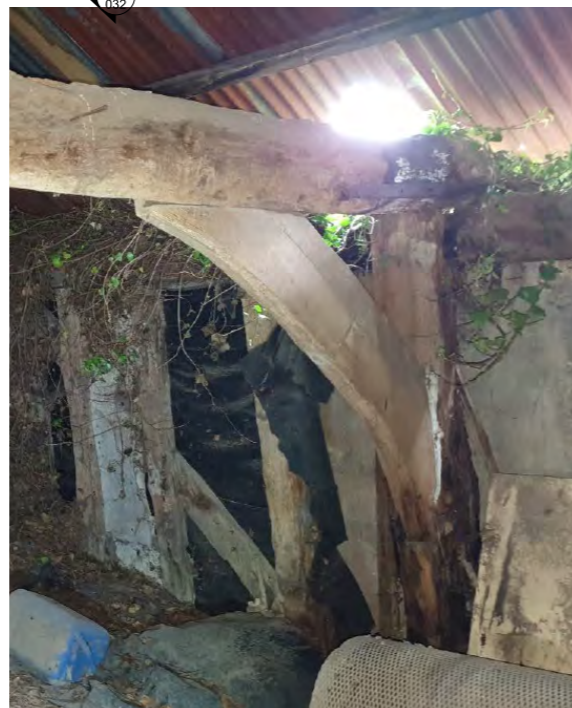
2 Timbers decayed at high level and water ingress causing collapse (3.2.82*)

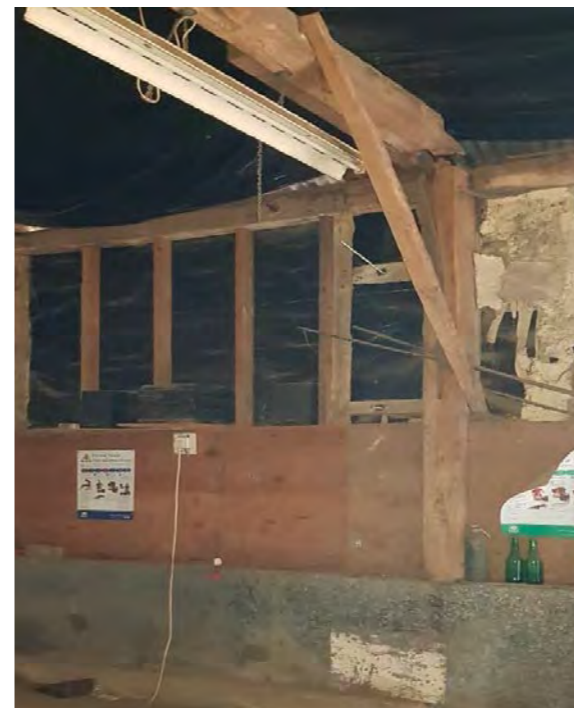
3 Timber post shows sign of decay and failure (3.2.73*)

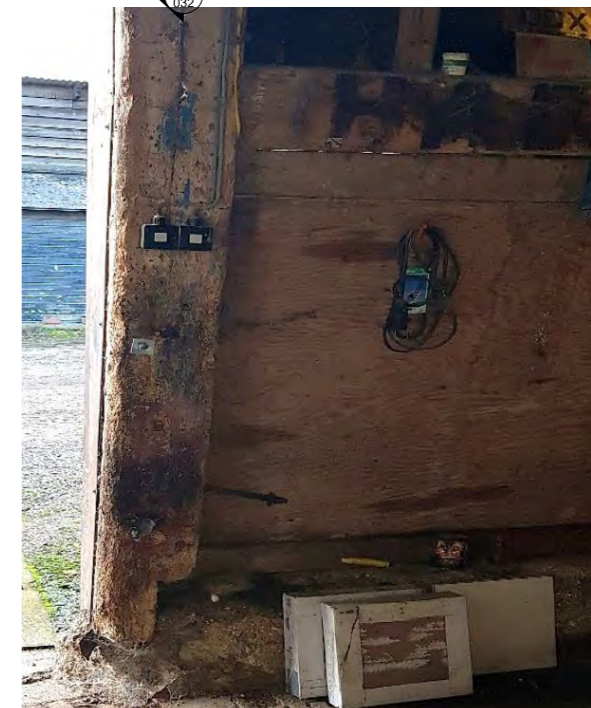
4 Post between bays 2&3 is inadequate (3.2.55*)
