Watering Farm

Heritage, Design & Access Statement

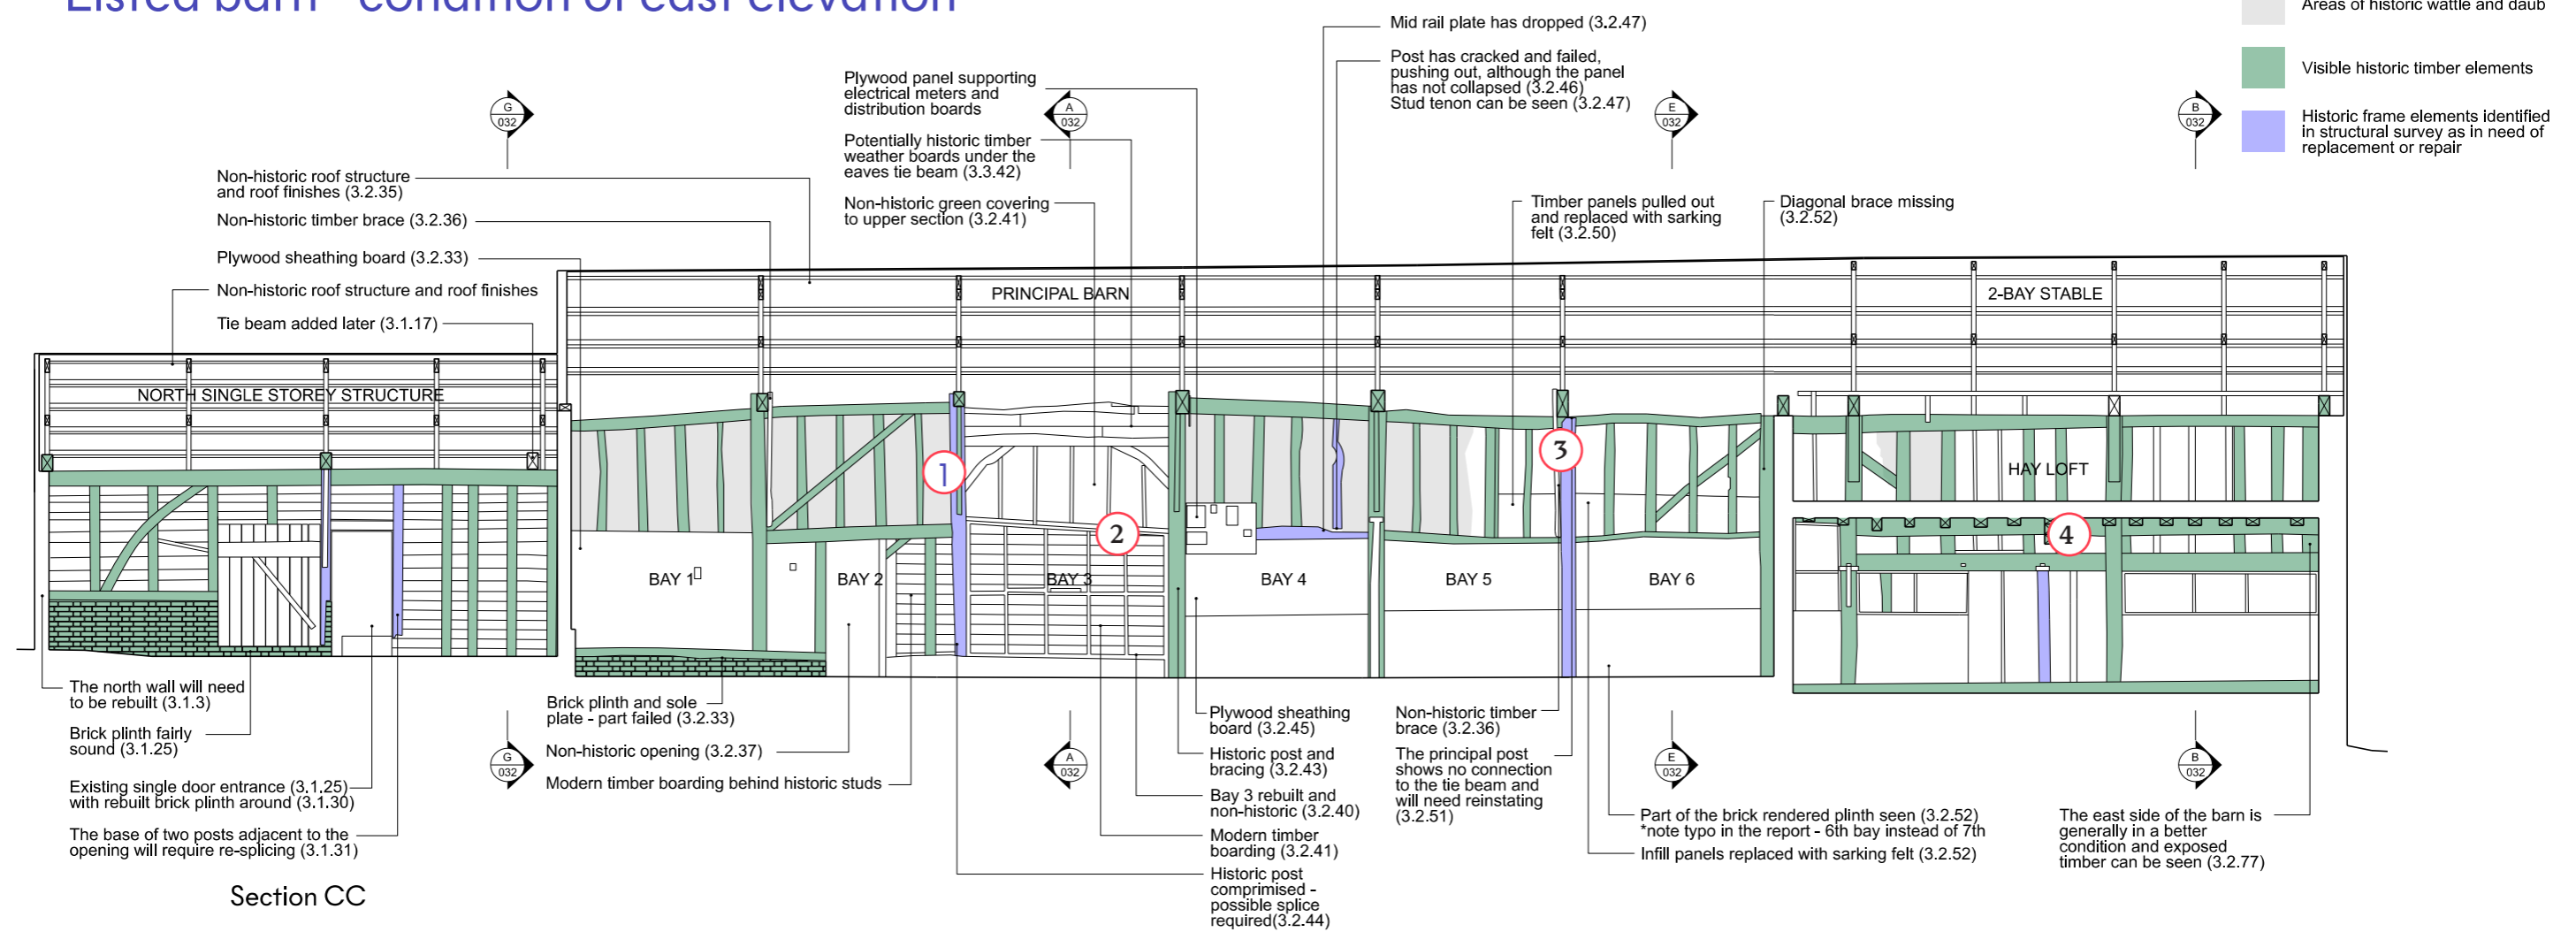
Listed barn - condition of east elevation

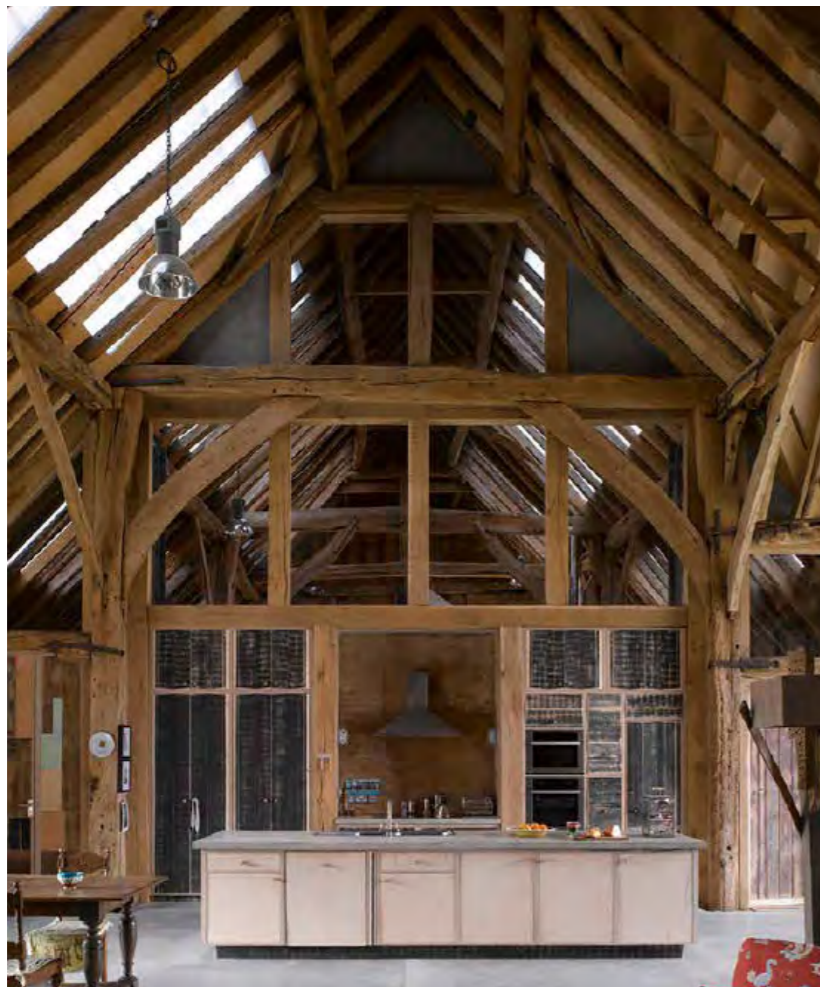
New residential building celebrates barn by exposing historic fabric (example from *Adapting Traditional Farm Buildings by Historic England*)

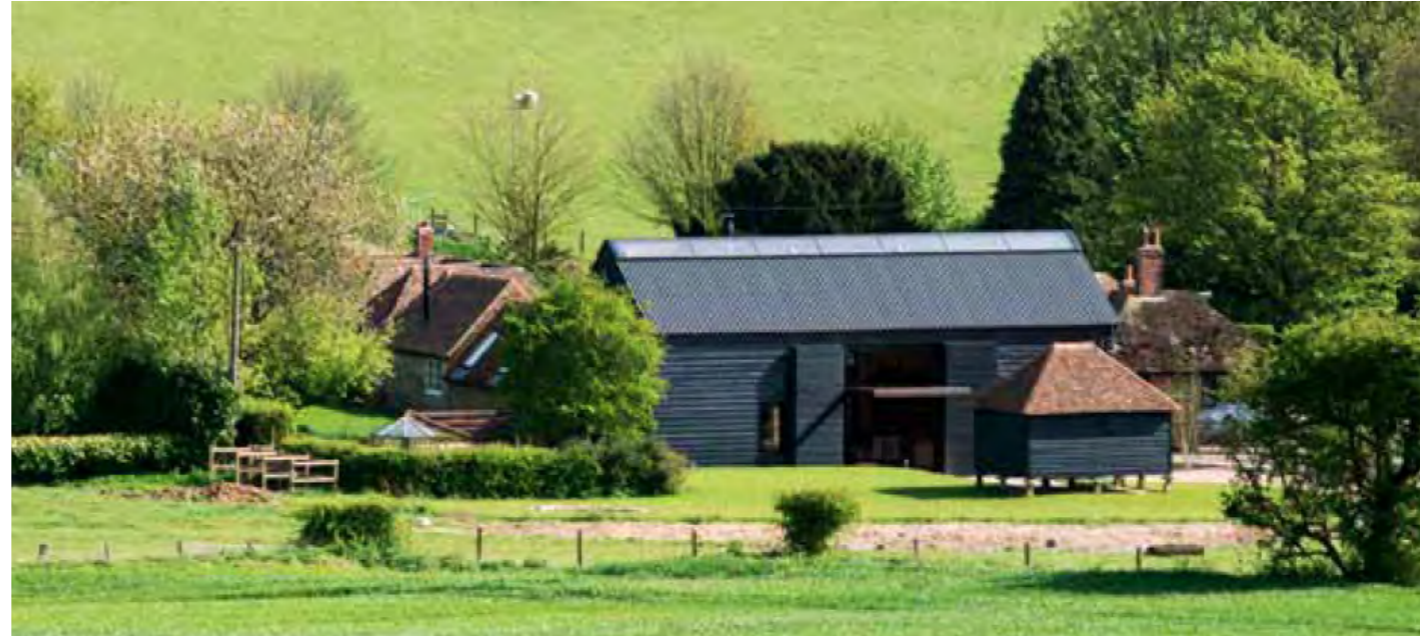
Timber framed barn has had a new steel and corrugated metal roof added with long linear rooflight

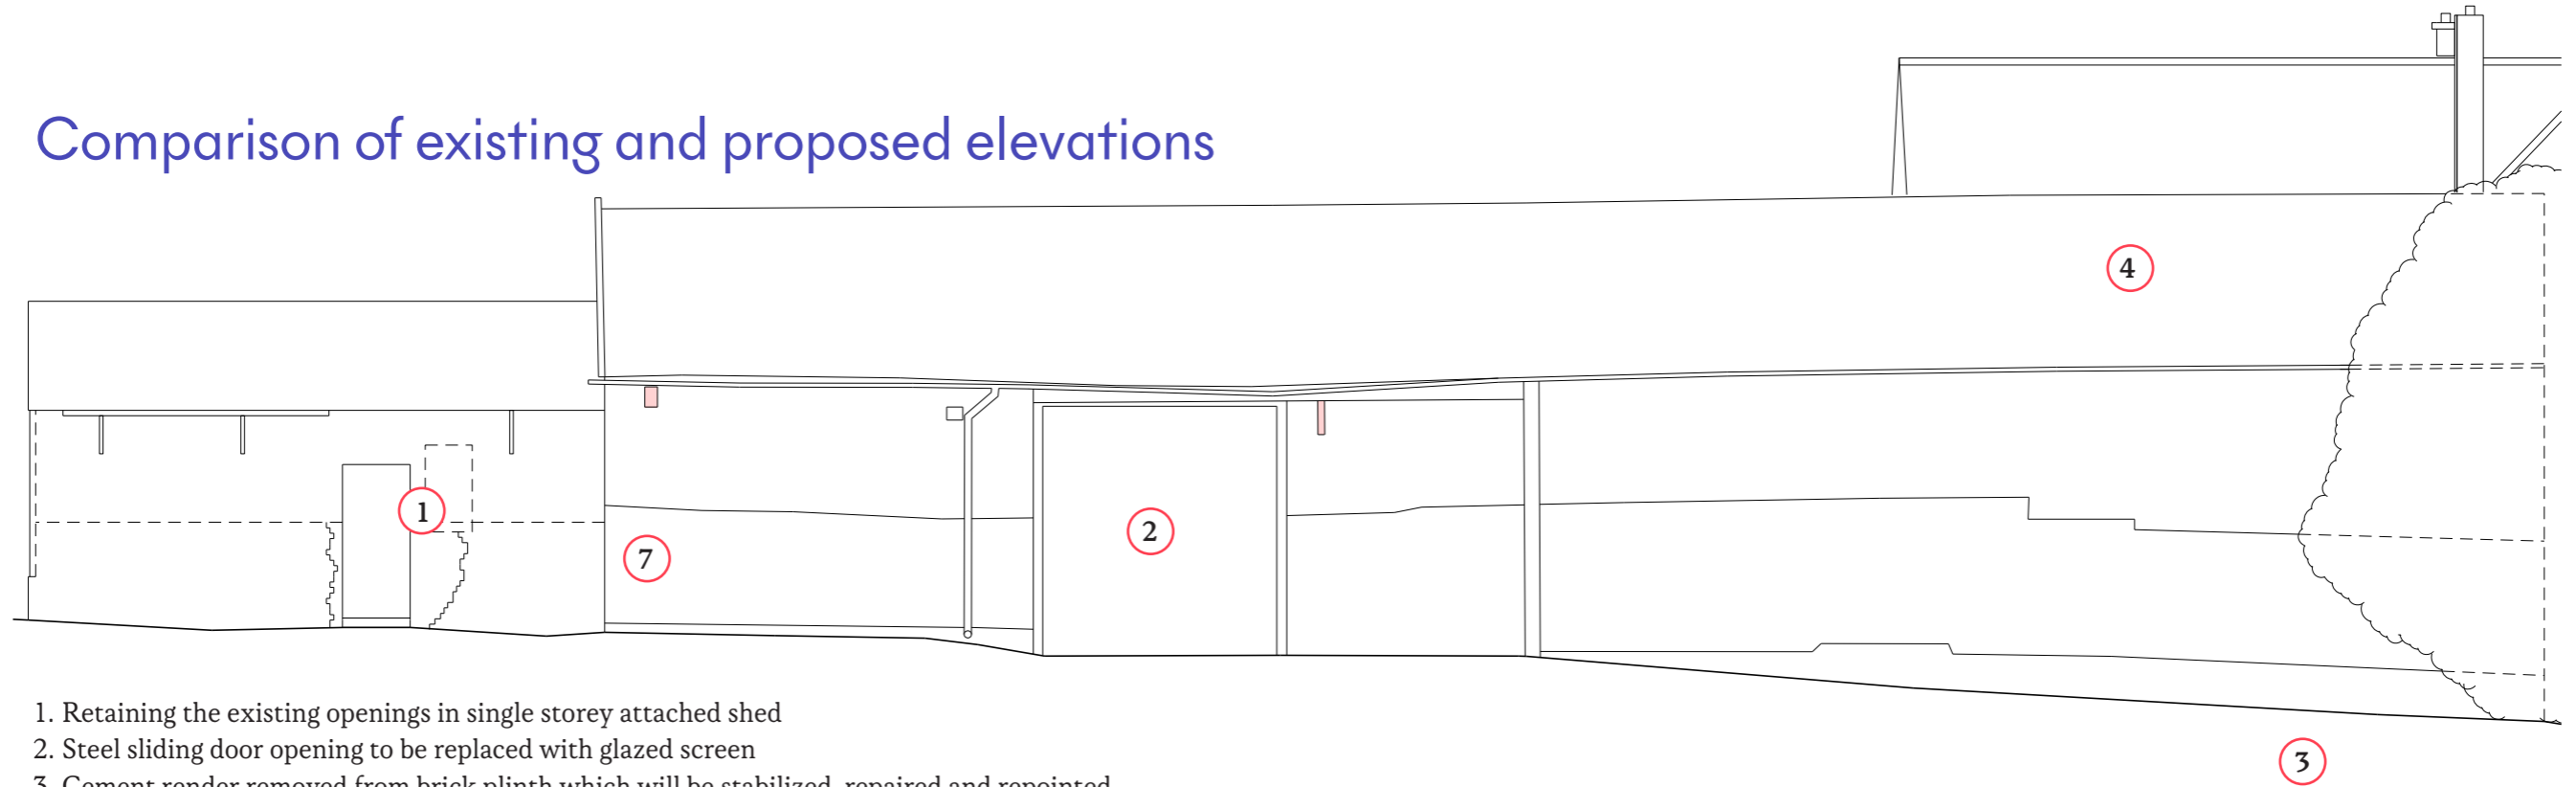
1. Retaining the existing openings in single storey attached shed
2. Steel sliding door opening to be replaced with glazed screen
3. Cement render removed from brick plinth which will be stabilized, repaired and repointed
4. Reinstatement of a steeper pitched roof in S profile sheeting to retain an agricultural appearance.
5. Rooflights located as close to the ridge as possible and of low profile design
6. Fenestration kept to minimum and designed with regard to location of historic studs and beams
7. Black weatherboarding above plinth level.

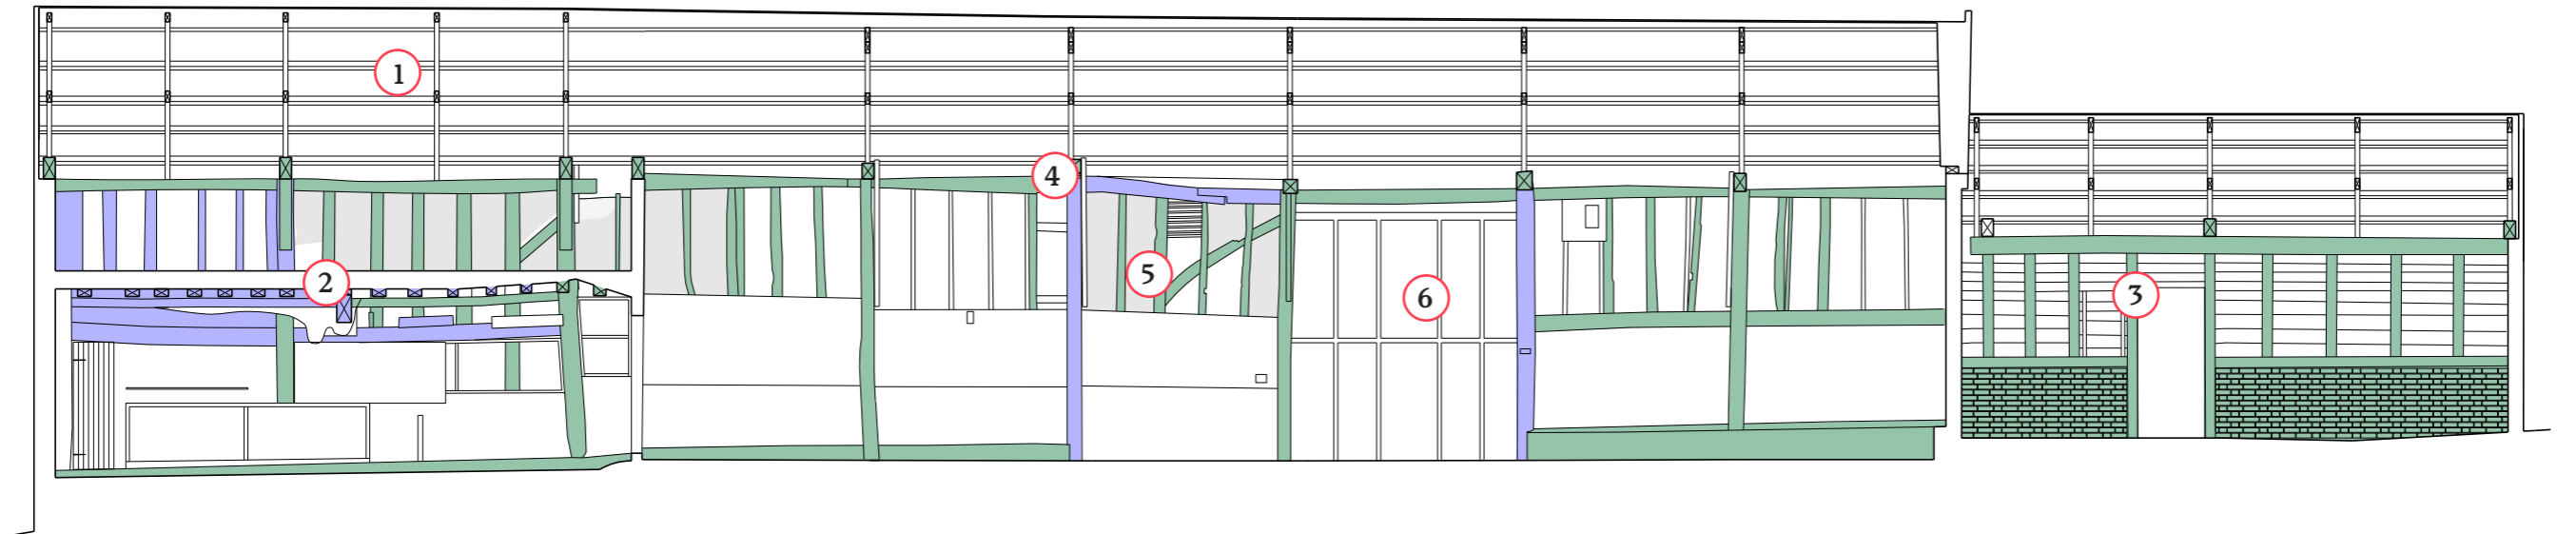
1. Reinstatement of a steeper pitched roof with an oak frame
2. Retaining historic mezzanine floor in 2-bay stable
3. Retaining existing single floor structure - entrance for the main building and garden
4. Retaining historic tie beams with only minor alterations to allow mezzanine to be accessed and used
5. Retaining historic studs and wattle and daub panels
6. Sliding door opening to be replaced with glazing
7. Replacing area of non historic infill framing with new glazed screen.

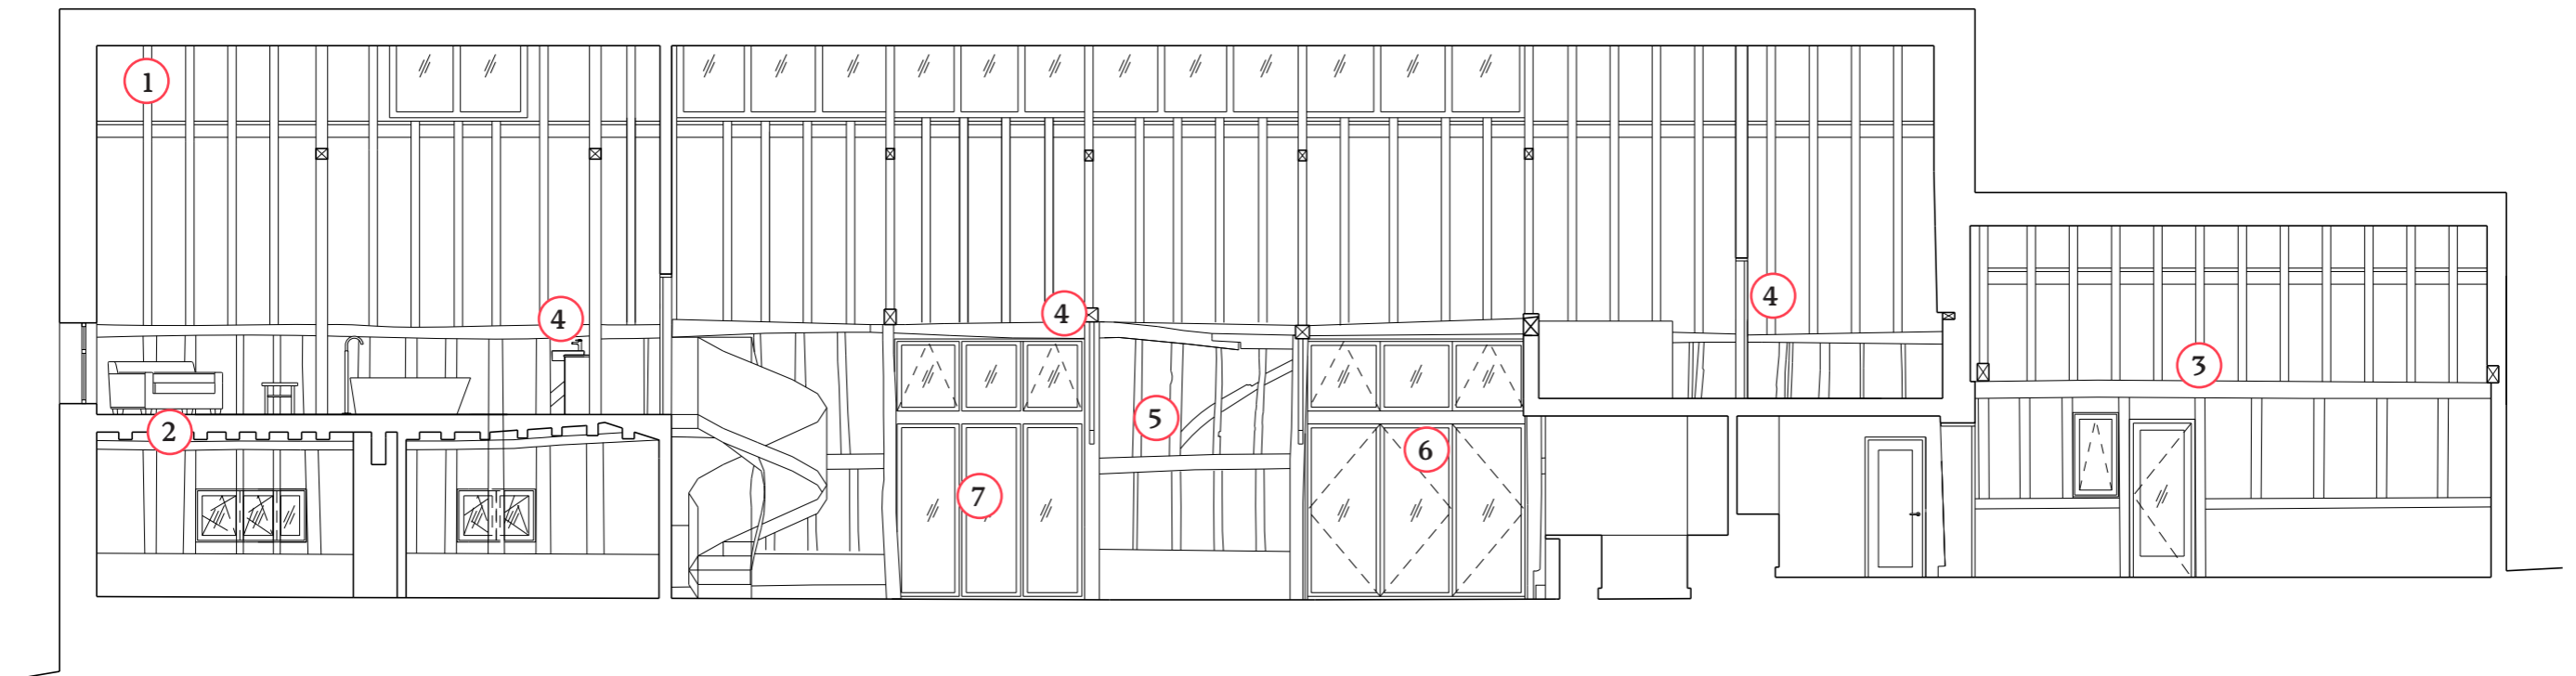
Comparison of existing and proposed internal elevations/sections

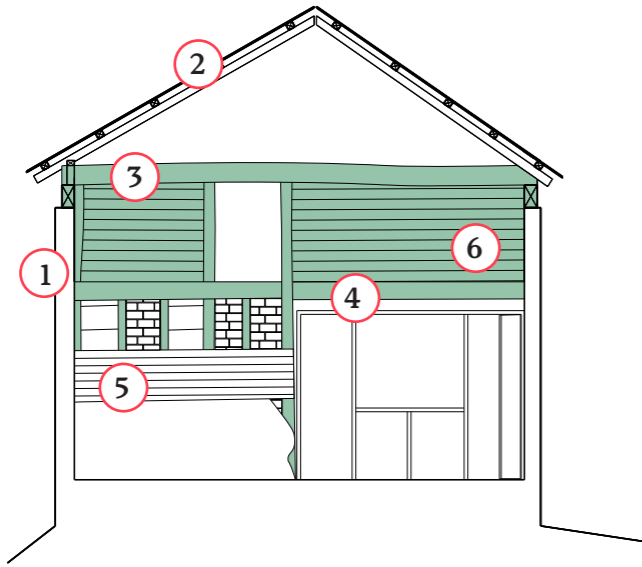
Section EE - existing

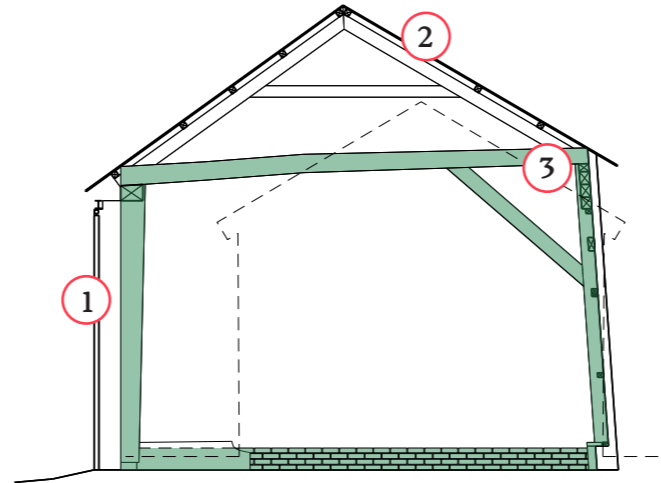
Section AA - existing

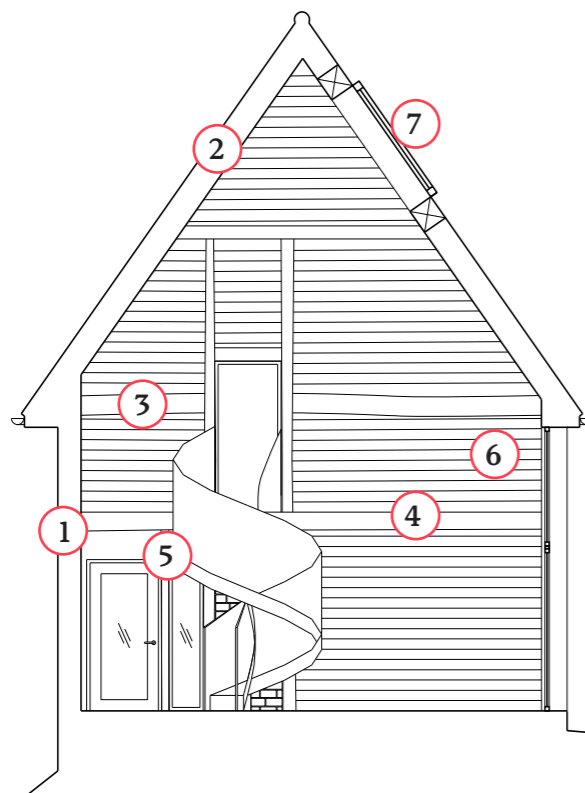
Section EE - proposed

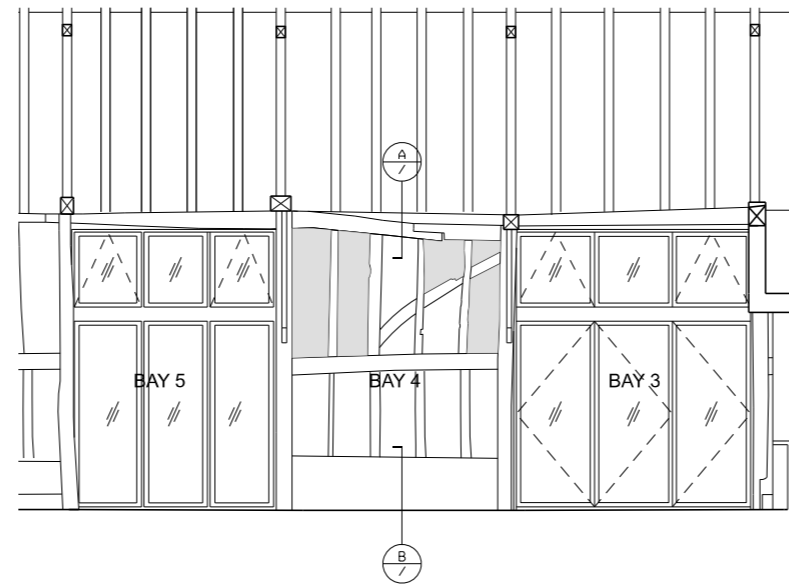
Wattle and daub panels to be preserved and historic timber structure to be revealed internally

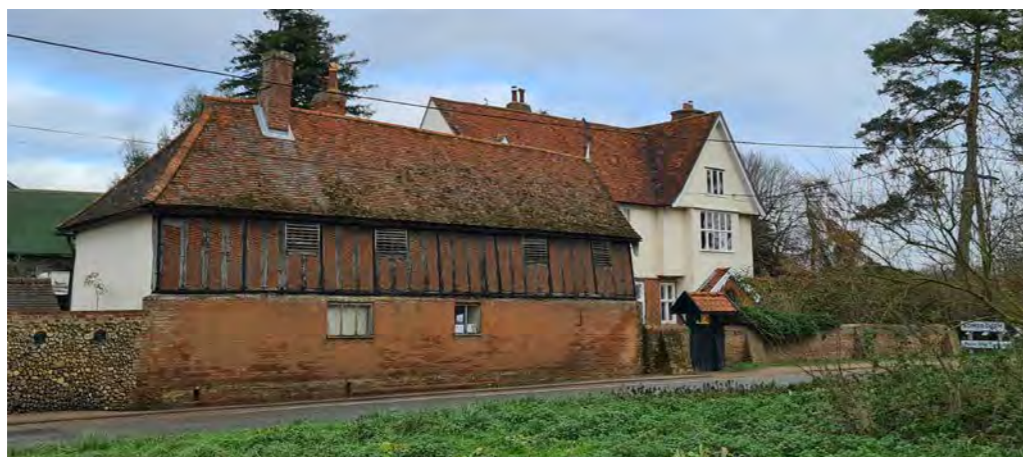
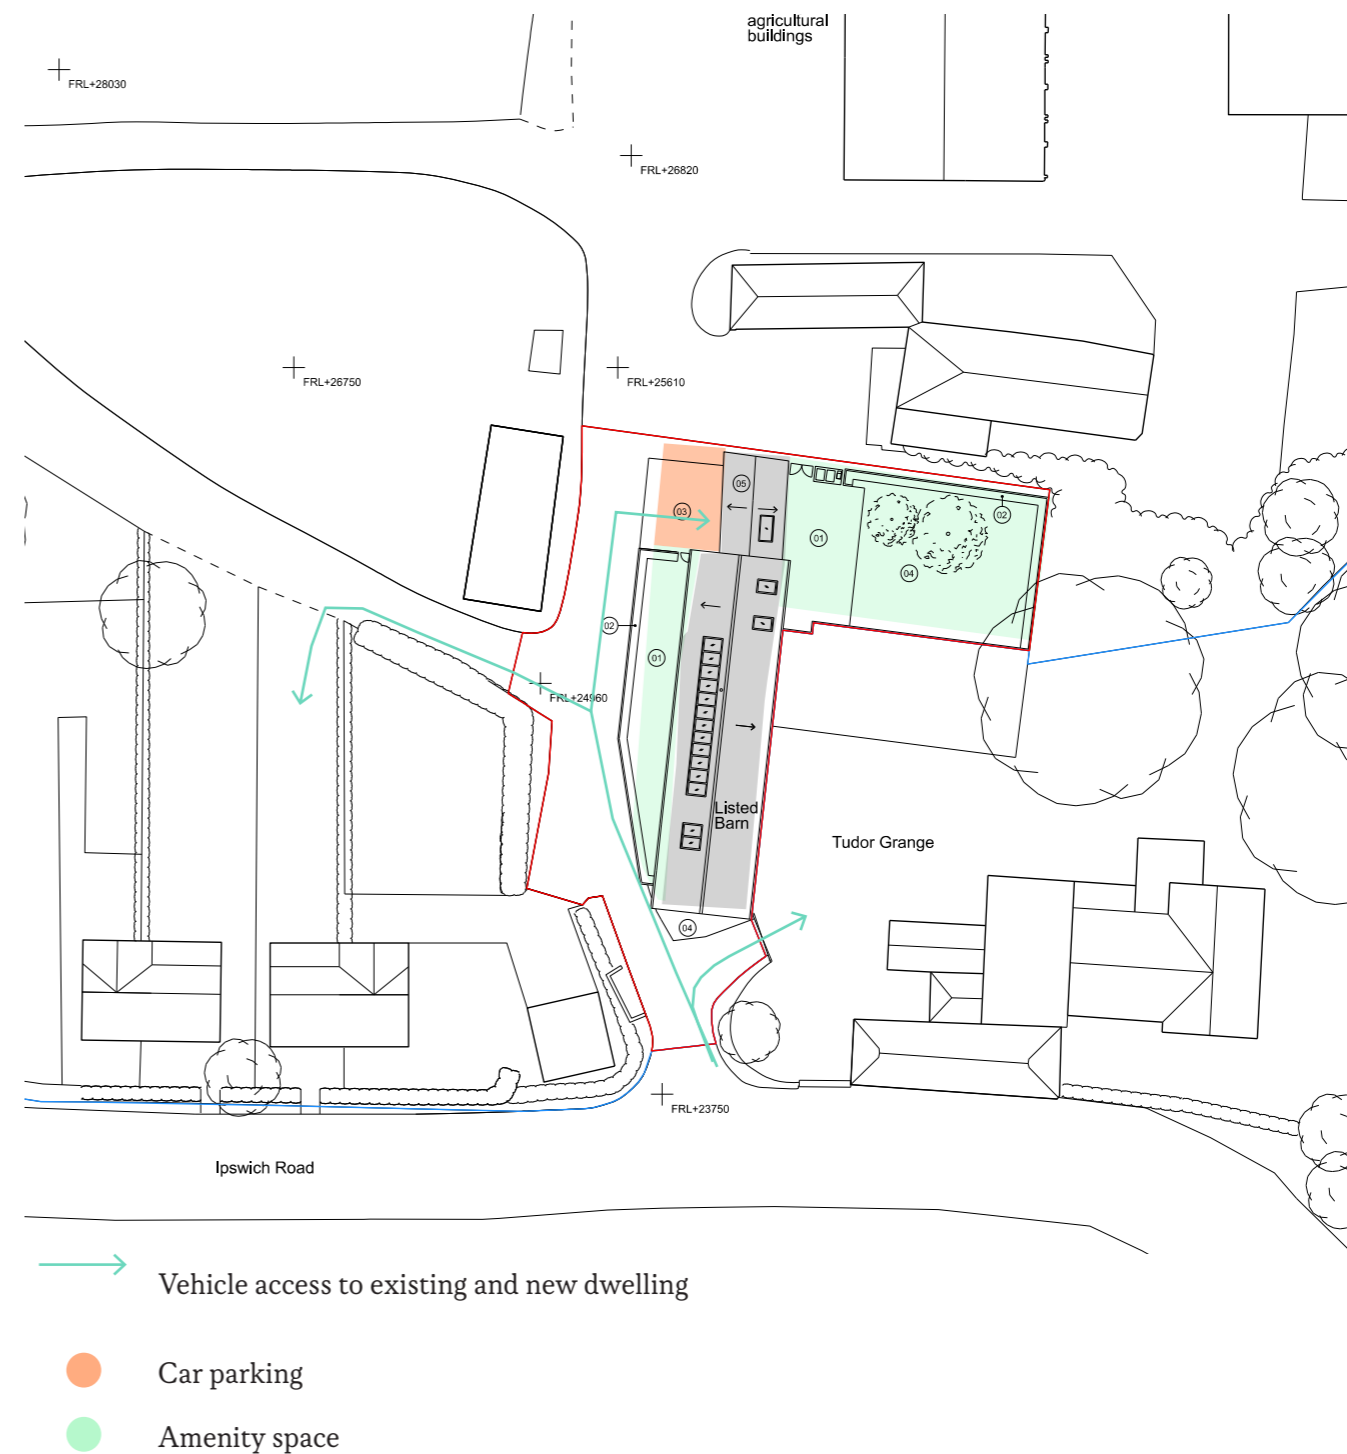
10. Assessment of impact on heritage significance
