BS 5837:2012 Tree Survey and Arboricultural Impact Assessment The Clifden Arms Clifden Rd, Worminghall, Aylesbury HP18 9JR

Report Reference: 301221/RP/CA

Tree Constraints Plan Reference: AA.TCP.01

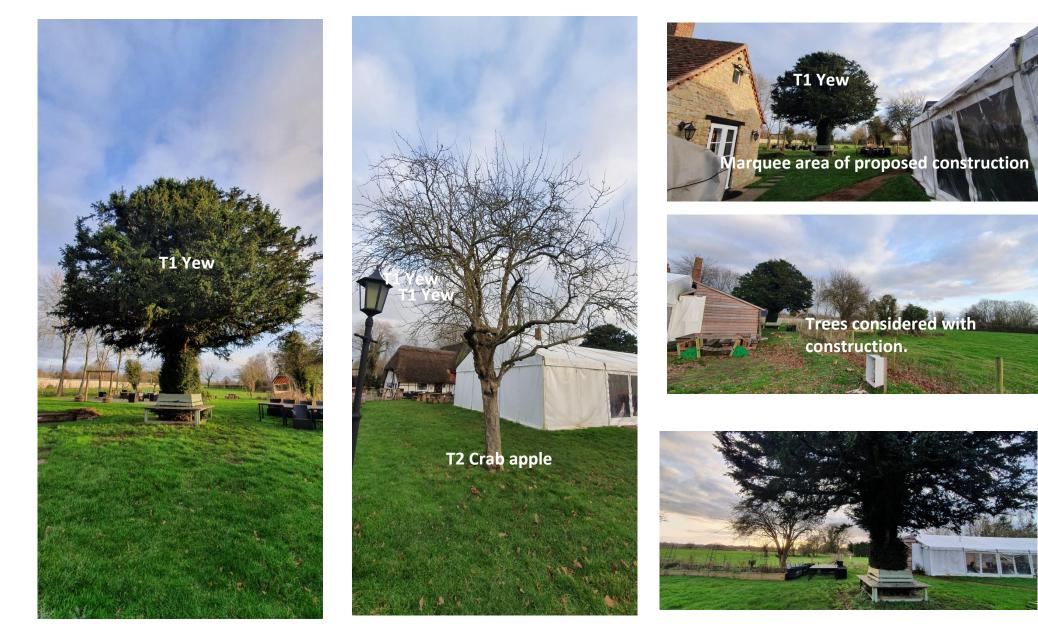
Appendix 3 Photographs.

- **4.4 T2** is a smaller crab apple tree which has been catogorised "B". The tree is not of good quality structurally but is an important lanscape and ecological asset. Historical pruning has caused decay to some of the limbs and this will be hard to remedy as more works will be detrimental to the tree. No works have been recommended for either tree.

- 6.3 T2 is a smaller crab apple tree which although catogarsed as 'B' does have a few historical damage aspects but is contributing a great deal to the local ecology and landscape. This tree can be protected by ground protection and fencing.
