Application for Works to Trees Protected by a Tree Preservation Order or in a Conservation Area

ARBORICULTURAL REPORT

Title: **Impact on Tree Stability at No 2 Low Town Arising from Development and Associated Access Construction on Land East and Adjacent to No 8 Low Town, Thornhill, Stirlingshire**
Planning Ref 20/00805/Full

Date: **December 2021**

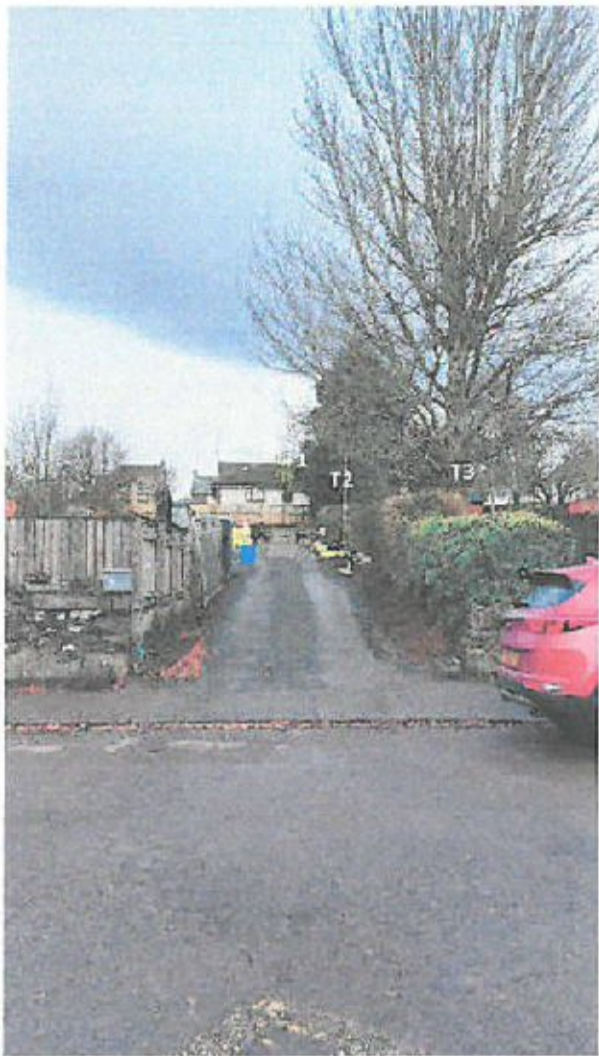
- No Root Protection Barriers were in place for any of the three trees T1, T2, T3, at the time of the site visit on 25.11.21 (Photo 1).
- It is unclear whether the positioning of trees T1 to T3 have been estimated or located via topographic survey for the site which may have an effect on the extent of RPAs within the development site. The trees do not appear on the scaled paper copy of MW Consultants Site Plan dated September 2021.

Photo 1 Trees T1 to T3
no protection barriers 25.11.21

1. T1 erect BS5837(2012) specified protection barriers ASAP to the extent of the AMTC Ltd designated RPA or canopy spread whichever is the greater to prevent soil compaction and/or damage during installation of the ground mounted solar pv panels.

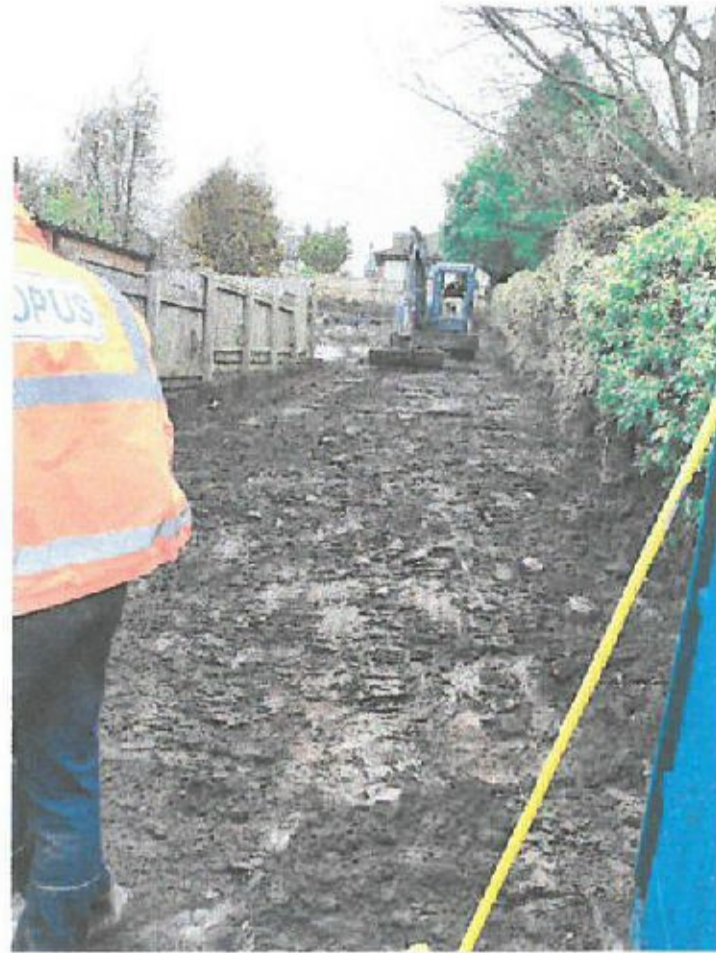
- It was evident that ground levels had been reduced within the RPA of poplar tree T3 and Norway Spruce T2 (Photo 2).
- The root flare of the poplar T3 on the windward west boundary viewed from no 2 Low Town garden ground, indicates that root growth in this direction i.e. towards the development site, was probable (Photo 3).

Photo 2 depth of excavations proximal to
T1- T3 taken by Mrs Henderson 27.10.21

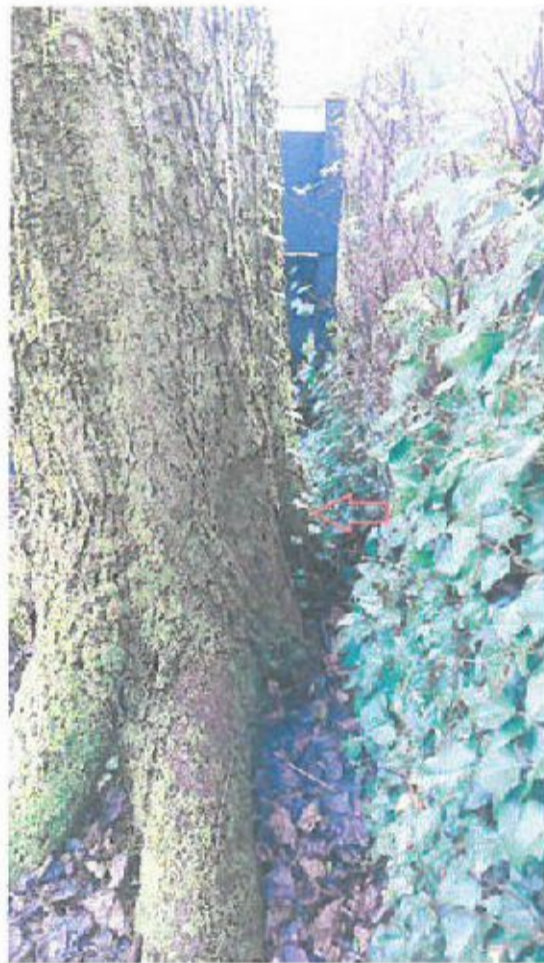
Photo 3 red arrow indicates
T3 root flare to west boundary
25.11.21

2. Remove T2 to ground level within the next three months
3. Remove T3 to ground level within the next three months and allow coppice growth.
4. Monitor hedgerow health up to two seasons post development with the developer making good any replacement planting required.

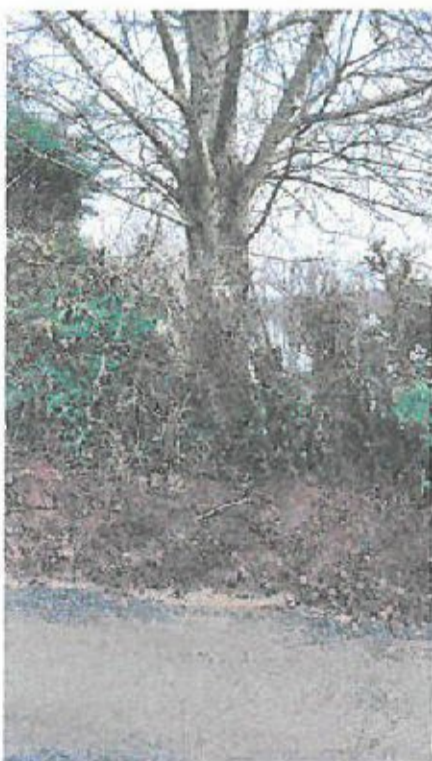
- The root zone of T3 viewed from the development site showed no presence of poplar roots because soil had been banked up onto the graded slope formed by the road excavation directly below the poplar tree (Photo 4). Soil would have to be removed to expose any underlying roots or parts thereof.

Photo 4 Soil
grading to form
banking at T3
25.11.21

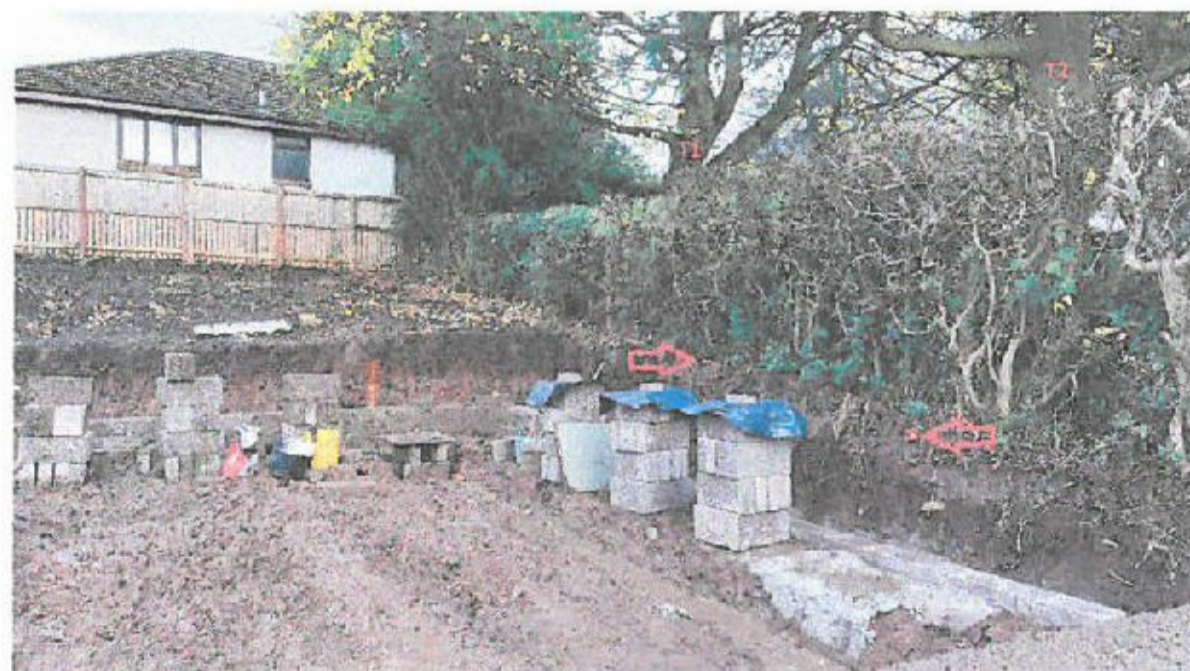
- The Norway Spruce labelled T2 clearly showed evidence of at least one severed lateral root of >25mm diameter, extending into the former undisturbed garden ground (Photo 5) with another severed root extending north along the boundary line. (Severed root measured approximately 6cm diameter (60mm).

11.2 There is evidence of significant diameter root severance of T2, the spruce tree, on the windward side which remained exposed at time of site visit. The location of the proposed dwelling house will result in a change in wind loading contrary to the loading and stresses tree T2 has already adapted to over time.

Photo 5 red arrows point to T2 severed spruce roots 25.11.21.

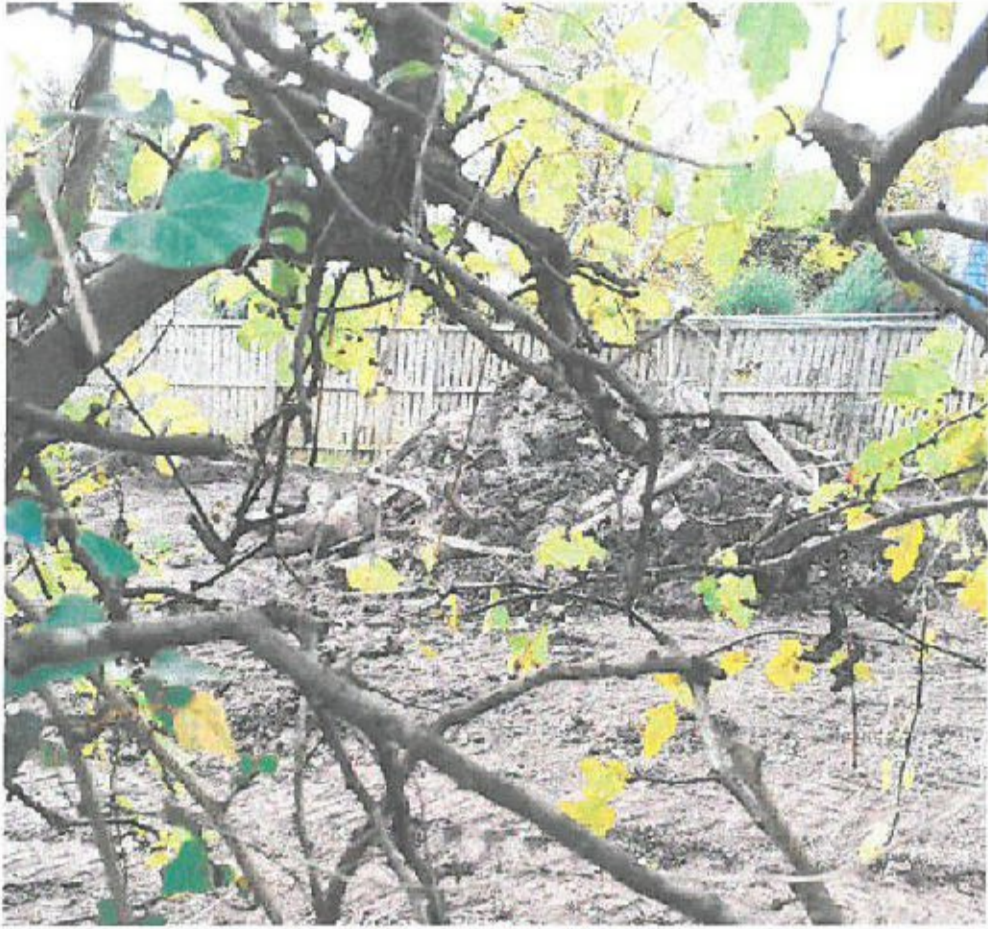
- A photograph taken by Mrs Henderson on the 22 October 2021 (Photo 6), six days prior to the date of the AMTC Ltd Arboricultural Report, shows debris which includes significant tree roots piled on the new access road formation. However, there is no way of knowing if these roots belonged to the Poplar tree T3 or came from some other mature tree outwith the development site.

Photo 6 Pile of debris containing tree roots taken by Mrs Henderson 22.11.21

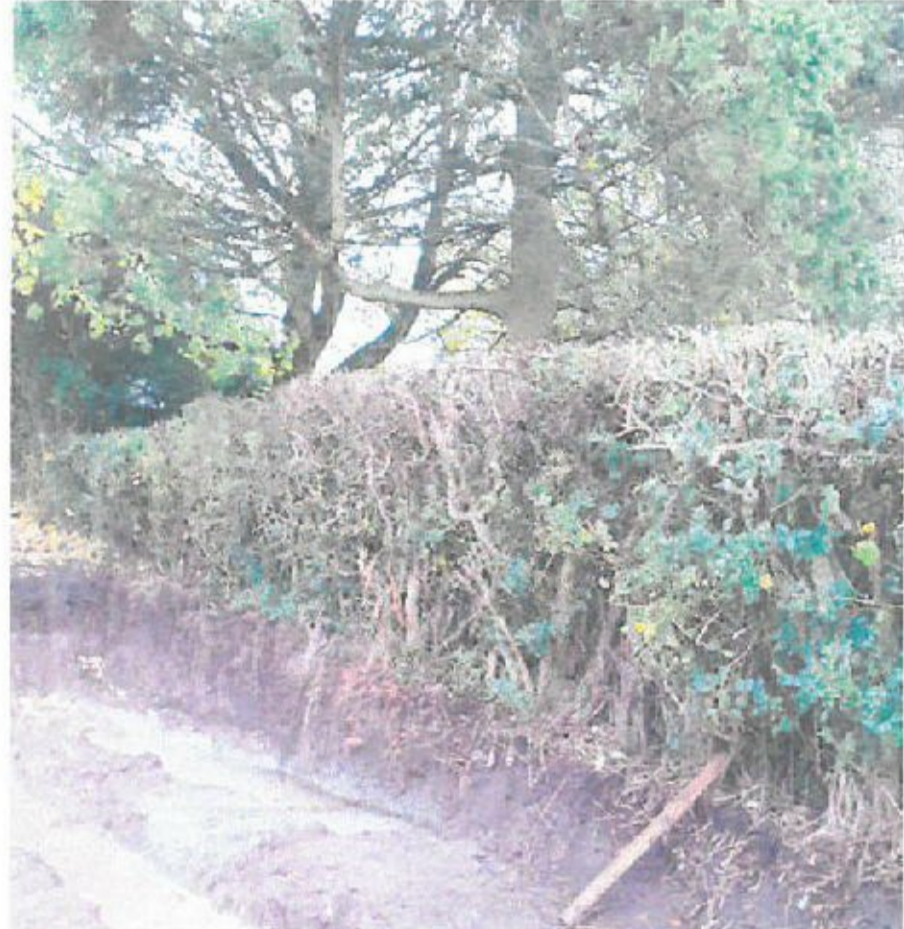
- Excavations have exposed hedgerow roots, some of which were severed and remained exposed (Photo 7).

Photo 7 Exposed hedgerow roots taken by Mrs Henderson 16.11.21

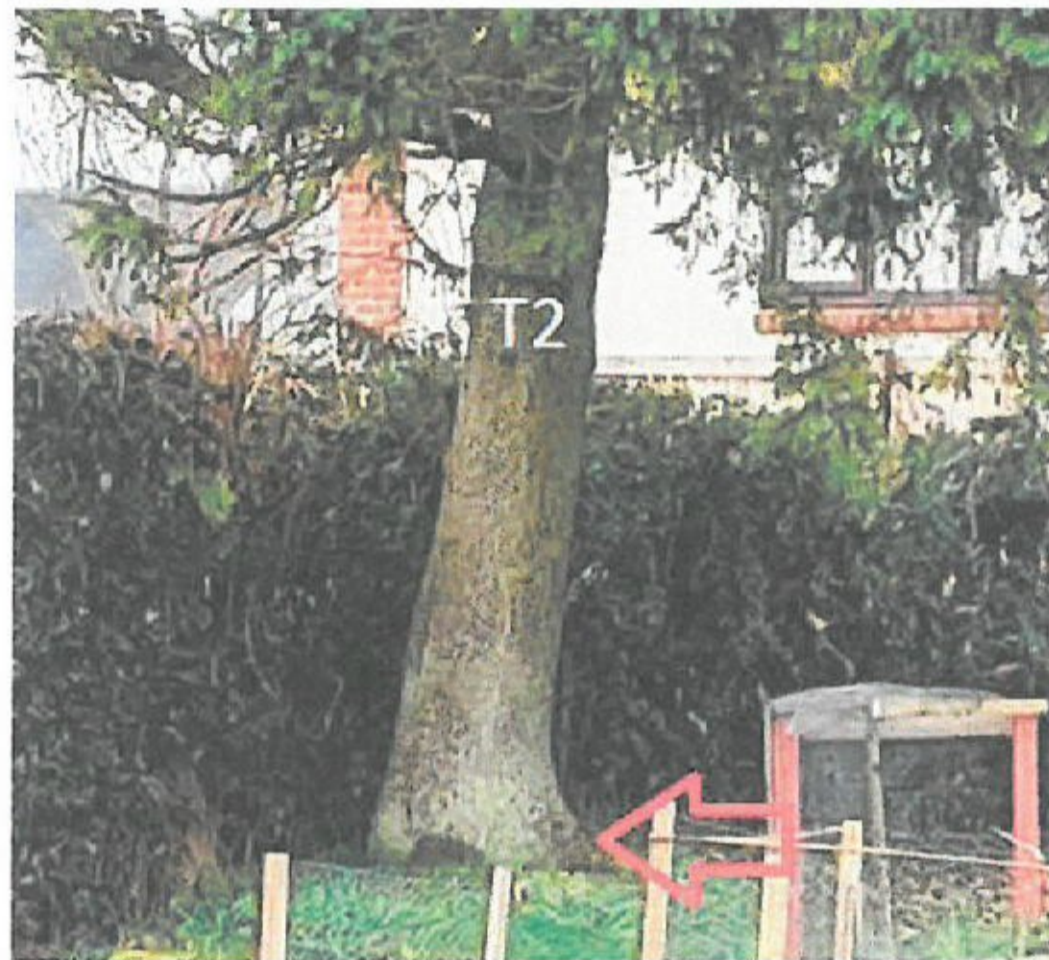
One response is for the tree to lay down reaction wood to adapt to the changing loads and stresses placed upon it, this takes time. In conifers this is generally laid down as compression wood, in T2 this can be observed in the buttress root on the leeward side (Photo 8). In broadleaves e.g. T3, tension wood is laid down in response to the prevailing winds with the formation of long rope-like tension roots on the windward side and sturdy buttress like roots on the leeward side similar to the roots observed on T3 on the leeward side (Photo 9). If tension roots on the windward side are damaged, severed or decayed, the likelihood of root failure is increased (Dunster et al (2017).

Photo 8 T2 Red arrow to compression wood on leeward side 25.11.21

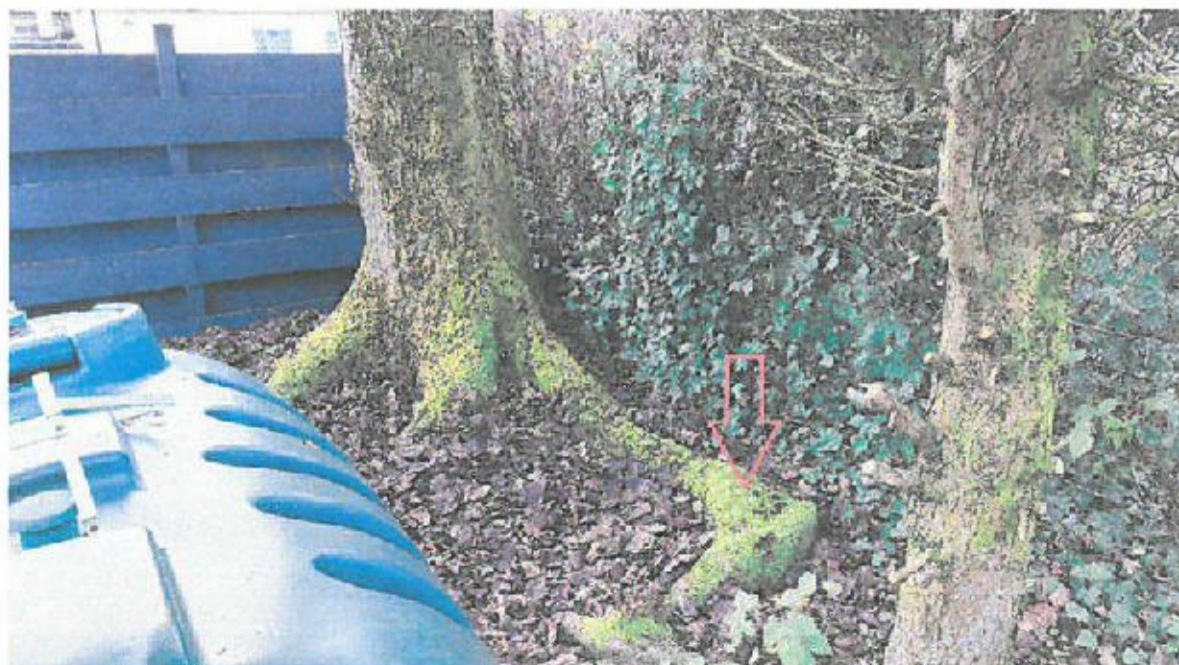
11.3 Roots will generally grow where soil is undisturbed. In the case of T3 the poplar, the Google Earth images mentioned previously do indicate that the soil in this location was mainly laid to lawn. It was concurred by Mr and Mrs Henderson; the soil at this location remained undisturbed for a number of years until the new development created a new entrance road. T3 would under these conditions with an unimpeded soil volume, be expected to form the rope like tension roots described earlier in this report on the windward side.

Photo 9 T3 Red arrow to sturdy buttress like roots on leeward side 25.11.21
