# Arboricultural Impact Assessment BS5837:2012

# Glendale, Sandersons Lane, Heskin

William Brockbank BSc

11/12/2021

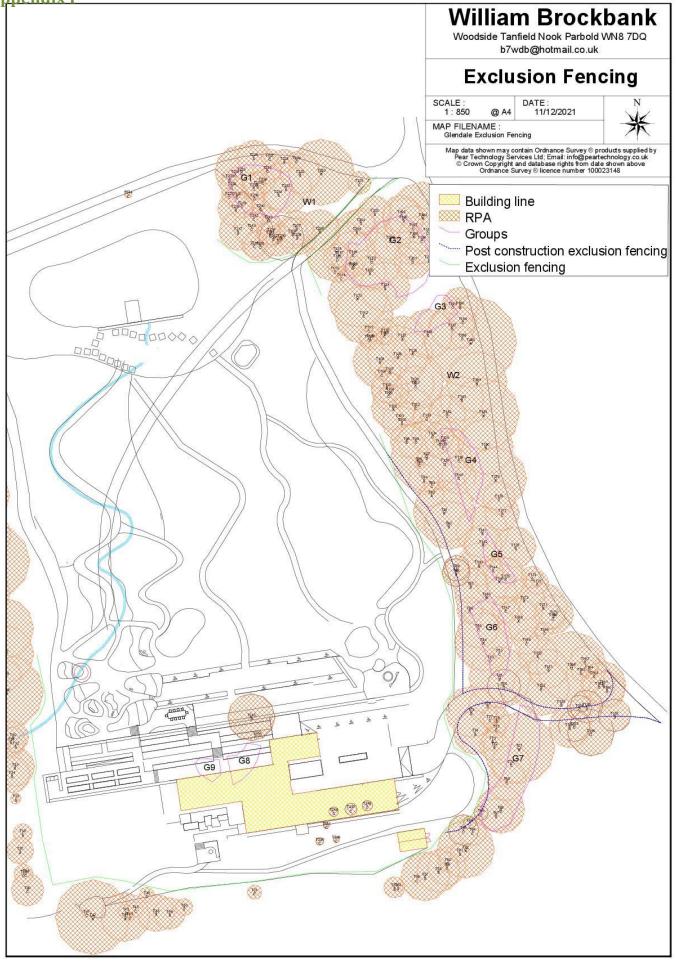
The proposed construction on the site will primarily affect the trees to the South and South-East of the site. Within the main build area T245, a mature Willow and lower class trees T246 through to T251 will be removed. The Willow has a prominent position within the existing site, however cannot be seen from beyond the site boundaries and provides no benefit to the surrounding area. This coupled with the large scale planting that is proposed as part of the project, appendix G, mitigates its removal. The lower class fruit trees, T246 – T251, will similarly be replaced within the proposed project in more suitable positions and

with higher quality plants, providing greater benefit to the site and surrounding wildlife. Within the main building area groups G8 and G9 will be removed, these Laurel and Rhododendron groups are of low overall value providing negligible benefit to the site.
