## Design, Access & Heritage Statement & Schedule of Works

Proposed recovering of roof, alterations and repairs to Blagdon Manor Farm, North Tamerton.

## Section 5 Schedule of Repairs

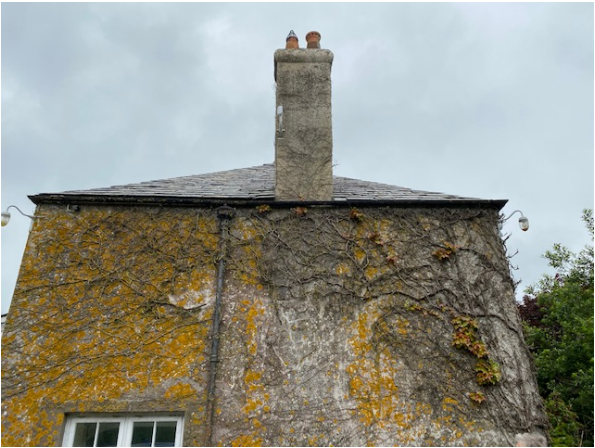
South West End

Weather and rain predominantly driven from the west has entered the structure through failings in the outer roof covering which has caused damp ingress internally and the roof requires recovering. The external wall surfaces and porch on the south western side have been effected by plant growth and it is proposed for this to be removed and the porch be replaced together with suitable rainwater gutters and downpipes to improve this front elevation.

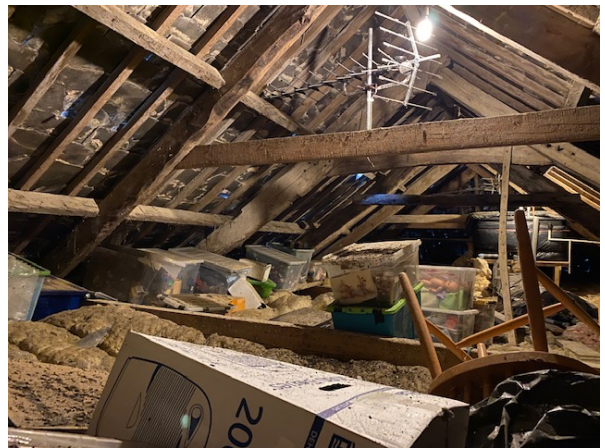
Main Roof Space

The roof timbers comprise of a raised collar oak trusses which span between the main external walls, and support timber purlins and rafters over. No roofing underfelt is provided.

The main roof structure appears sound but a thorough inspection will be given of the roof timbers upon removal of the outer slate coverings and an appraisal shall be given on their condition, against any wood beetle infestation, deterioration and decay that may be present and that may require any treatment or repair.

Should any active wood beetle infestation or decay be present upon removal of the existing roof covering, appropriate treatment of the roof timbers should be given by a PCA accredited timber treatment specialist using a method that is safe for bats such as pyrethroids and boron compounds (e.g. Permethin, Flurox.)

Upon recovering of the roof and to provide a secondary weatherproof barrier against any moisture that may enter the outer slate covering in keeping the roof timbers dry, the provision of a roofing underfelt shall be provided. This should be a Bitumastic Type 1F roofing underfelt as opposed to a modern breathable spun polyester type (refer to ecologists report).
