MAR
2020

Preliminary Roost Assessment (Bats)

6-8 CARLIN GATE
BLACKPOOL
LANCASHIRE
FY2 9QX

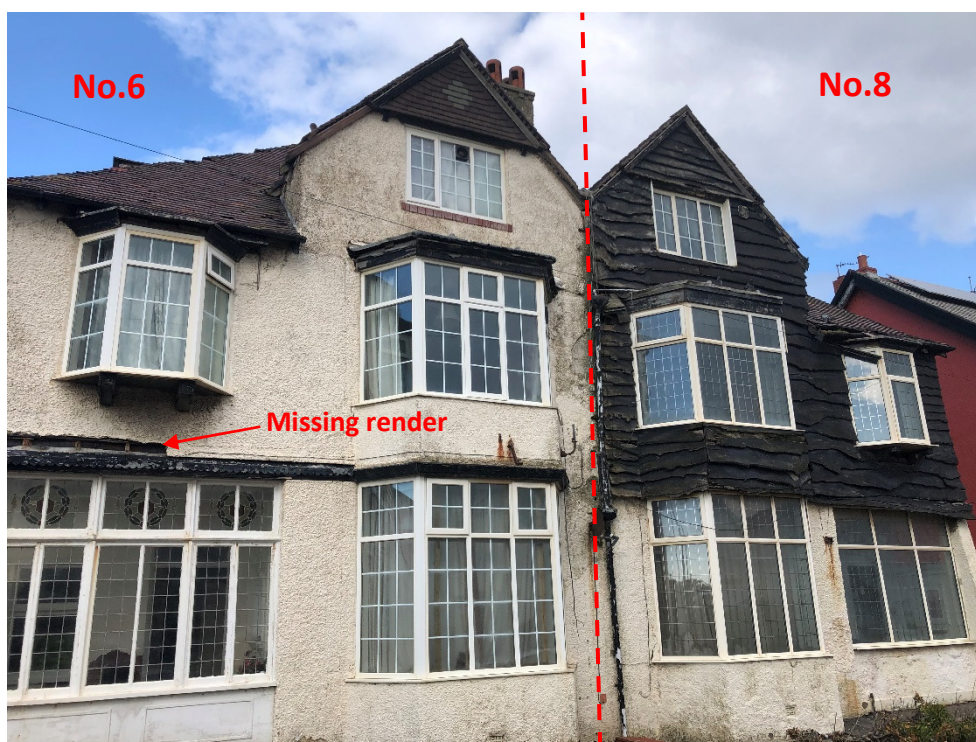
7.4 The windows are uPVC framed and are tight fitting. Damage has occurred to the render above one ground floor window and a large gap is present in the facing of the wall.

Photograph No.1: Frontage of 6-8 Carlin Gate (south facing).

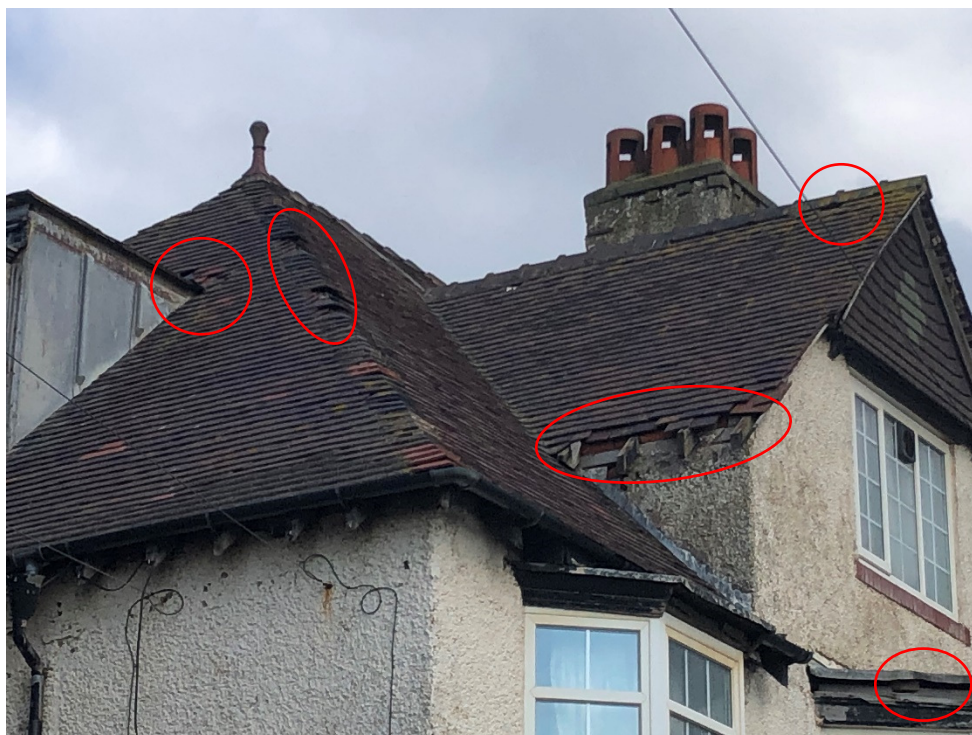
- 7.5 The roof displays numerous slipped and missing tiles. With many tiles missing along the hip of the roof. Gaps in the mortar are visible under the ridge tiles. Several courses of tiles are missing from the eaves of the pediment.
- 7.6 A dormer window is present on the west facing roof plane at the side of the property. Much damage is present to the roof covering at the southern edge of the dormer, allowing water ingress.

Photograph No.2: Roof of No.6 looking east. Showing damage to roof and lead flashing.

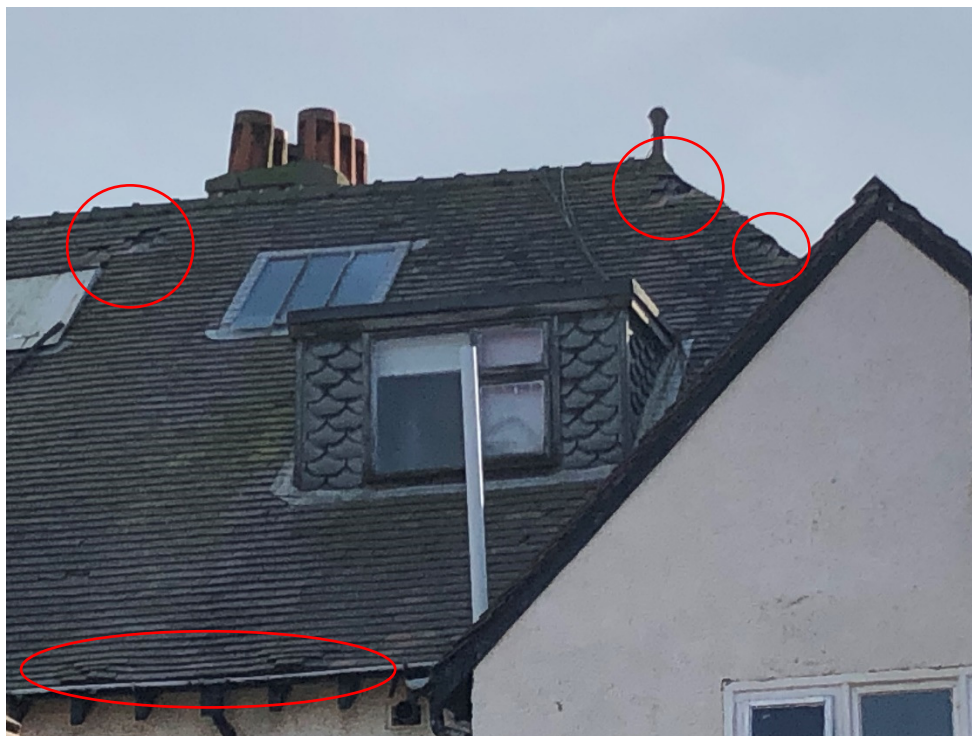
- 7.7 To the rear of the No.6, the property features a large skylight and dormer window. The latter is covered in hanging felt tiles, but these are likely to be shaded out, being on the northern side of the property. Again, the roof has suffered loss of tiles, particularly along the hip on the western side.
- 7.8 Internally No.6 has been used as residential accommodation but has been vacant for some time. The property has three floors. Much water ingress could be seen on the ceiling of the attic rooms and several holes in the ceilings are present through which the underside of the roof covering was visible. All curtains were checked for signs of roosting bats. None were found.

Photograph No.3: Rear of No.6, looking south.

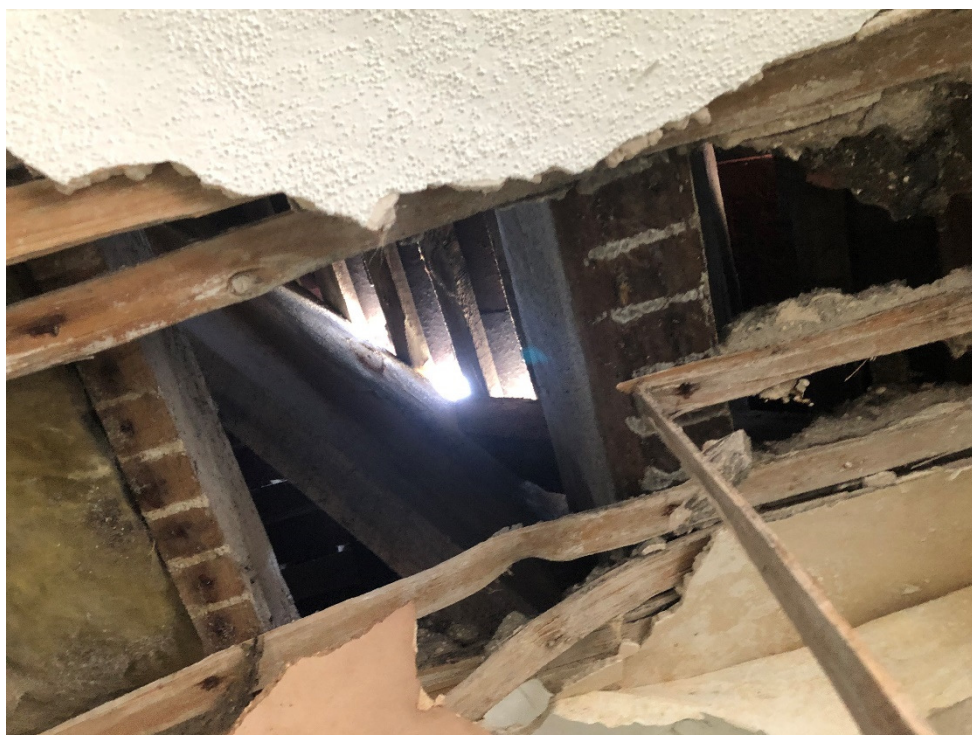
Photograph No.4: Hole in ceiling of attic room, showing tile covering is devoid of underlay and daylight is visible.

9.3 No.6 Carlin Gate is therefore considered to offer negligible roosting opportunity for bats. Whilst opportunity for bat ingress is plentiful with much damage having occurred to the roof covering, it is devoid of underlay and so not optimal for crevice dwelling species. The attic is considered likely to be draughty due to the number of holes in the roof covering through which daylight could be seen at the time of survey. The property has been vacant for some time and is cold and damp.

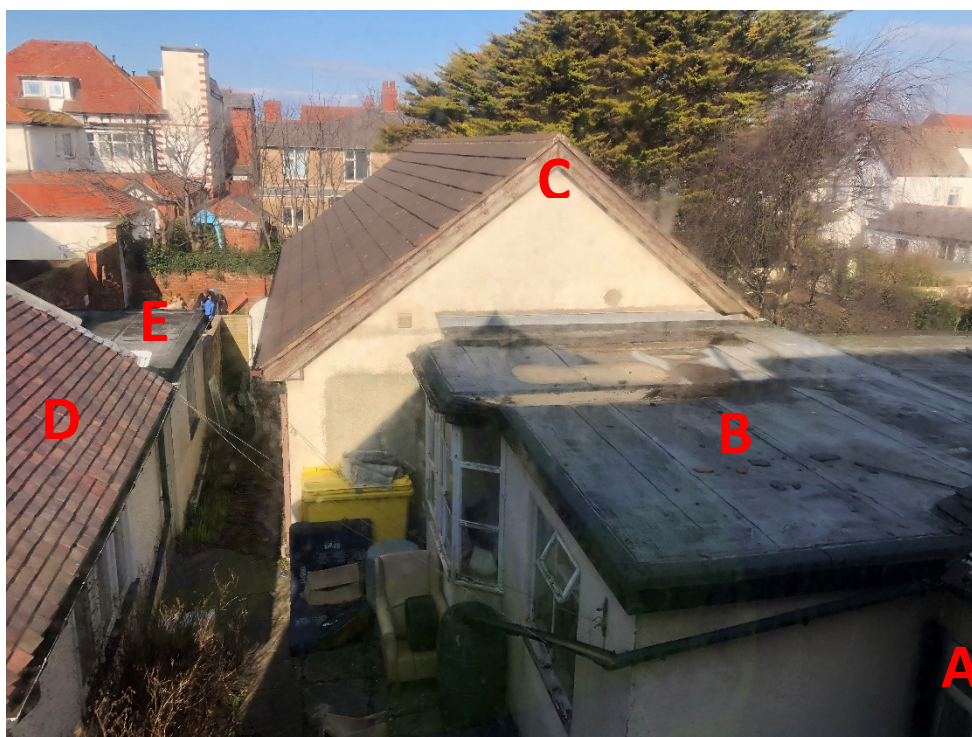
(Labelled A on proceeding photograph) is rendered with a pitched tiled roof which is in very poor condition. This connects to a single storey flat roofed structure (B) with deep timber barge boards.

- 7.10 The final extension is a large single storey workshop (C) which features a pitched tiled roof which has a bitumen felt underlay. Ridge tiles are present which are mortared in. The mortar is in generally good condition. Timber boxed soffits are present which are damaged along the west facing eaves. The north facing gable end features an offset barge board under which the top of the wall plate is visible.

- 7.11 Internal inspection revealed that water ingress has caused much damage inside the workshop, with the ceiling haven fallen through in one of the rooms inspected.

- 7.12 A detached single storey garage (D) is present on the western side of the property. This features a hipped tile roof and rendered walls. Lead flashing is lifting along the hips. A further single storey flat roof extension (E) is present on the north side of the garage. No access was available to the inside of the garage at the time of survey.

Photograph No.5: Collection of outbuildings to the rear of No.6.

9.4 Similarly outbuildings A, B, D & E to the rear of No.6 are considered to offer negligible roosting opportunity. Many of the structures are suffering from water ingress. Being located on the northern side of the three storey dwelling house, they are shaded from the sun and so are damp and cold.

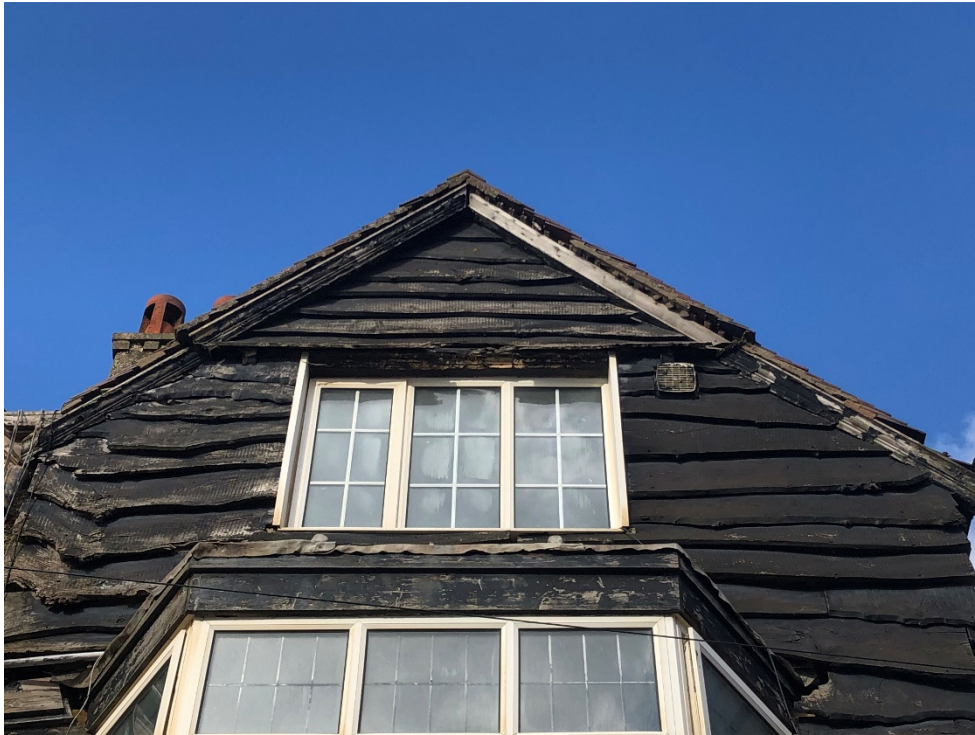
- 8.2 The cladding due to its naturally uneven surface and through warping possesses numerous gaps and crevices which are considered to offer suitable ingress for bats. The cladding being present on the southern and eastern façade offers favourable conditions for bat roosting as these facades will be warmed by the sun.

Photograph No.6: Timber cladding to the frontage of No.8 (south Facing), features numerous gaps and lifting where timber has warped.

9.8 In accordance with the "Bat Survey, Good Practice Guidelines" (Bat Conservation Trust 2016), No.8 Carlin Gate is considered to possess suitable features for roosting and ingress for roosting with optimal offsite habitat on the nearby golf course and rock gardens having a clear linear linkage along Carlin Gate (albeit not green infrastructure). These features could be used by low numbers of bats for roosting between April and October, which under the guidelines would classify the property as having '**low**' suitability for bat roosting.

9.10 **It is therefore recommended that a nocturnal bat survey be undertaken at this site to establish the status of the building in relation to bats, and to assess what impact the proposed works may have.**

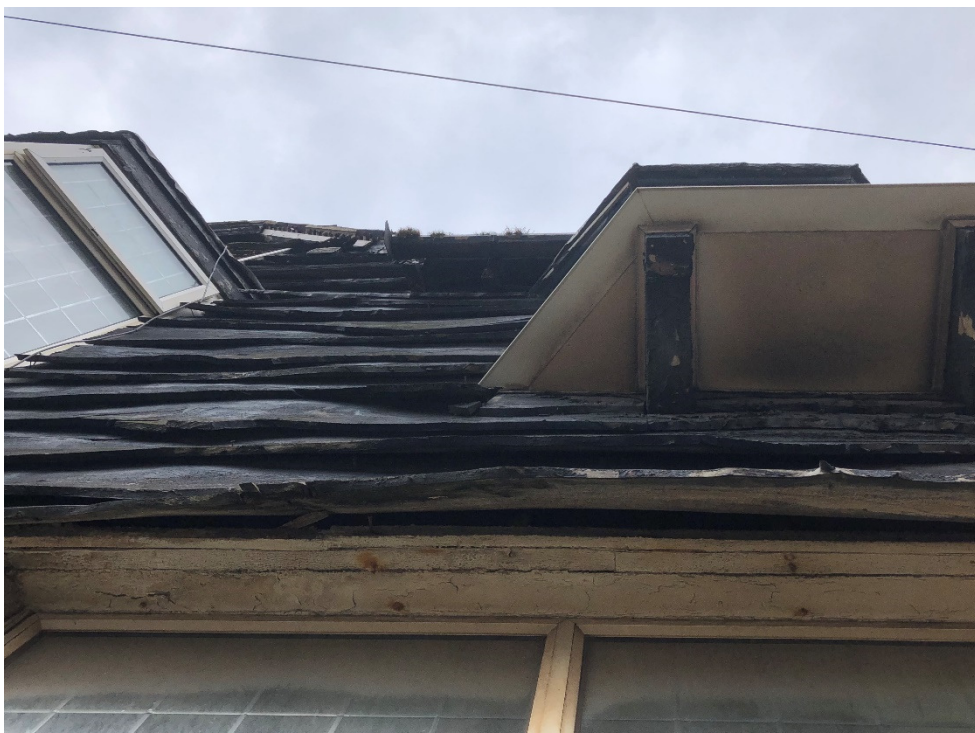
Photograph No.7: showing gaps and crevices under cladding.

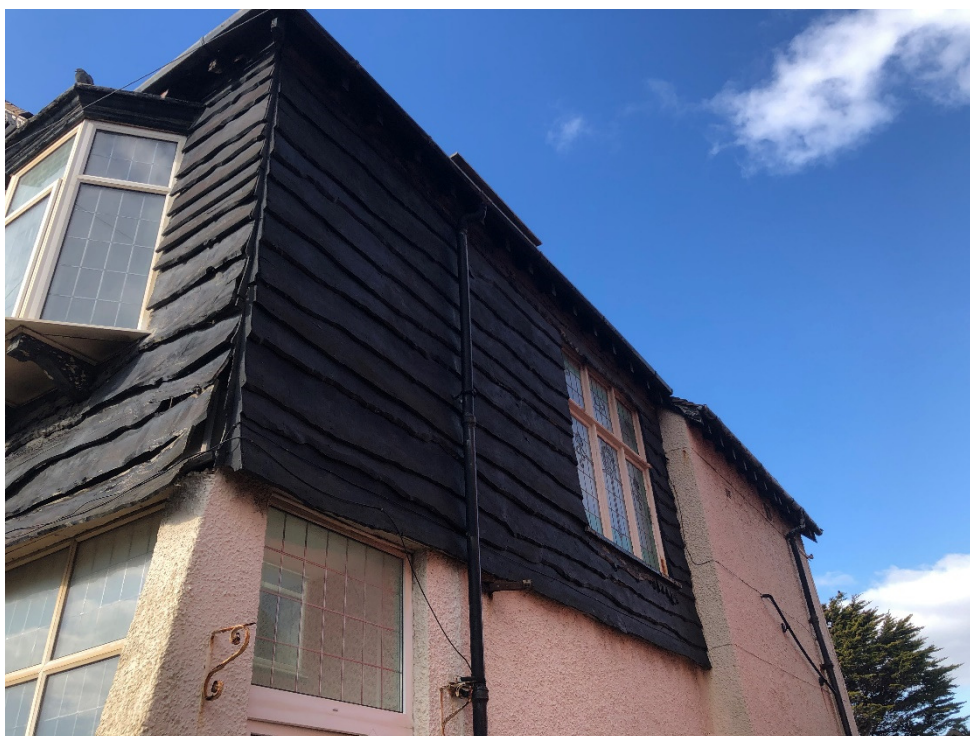
Photograph No.8: Eastern façade of No.8 also has timber cladding present. This is in much better condition than the frontage of the property, but crevices are still present due to the natural unevenness of the timber.

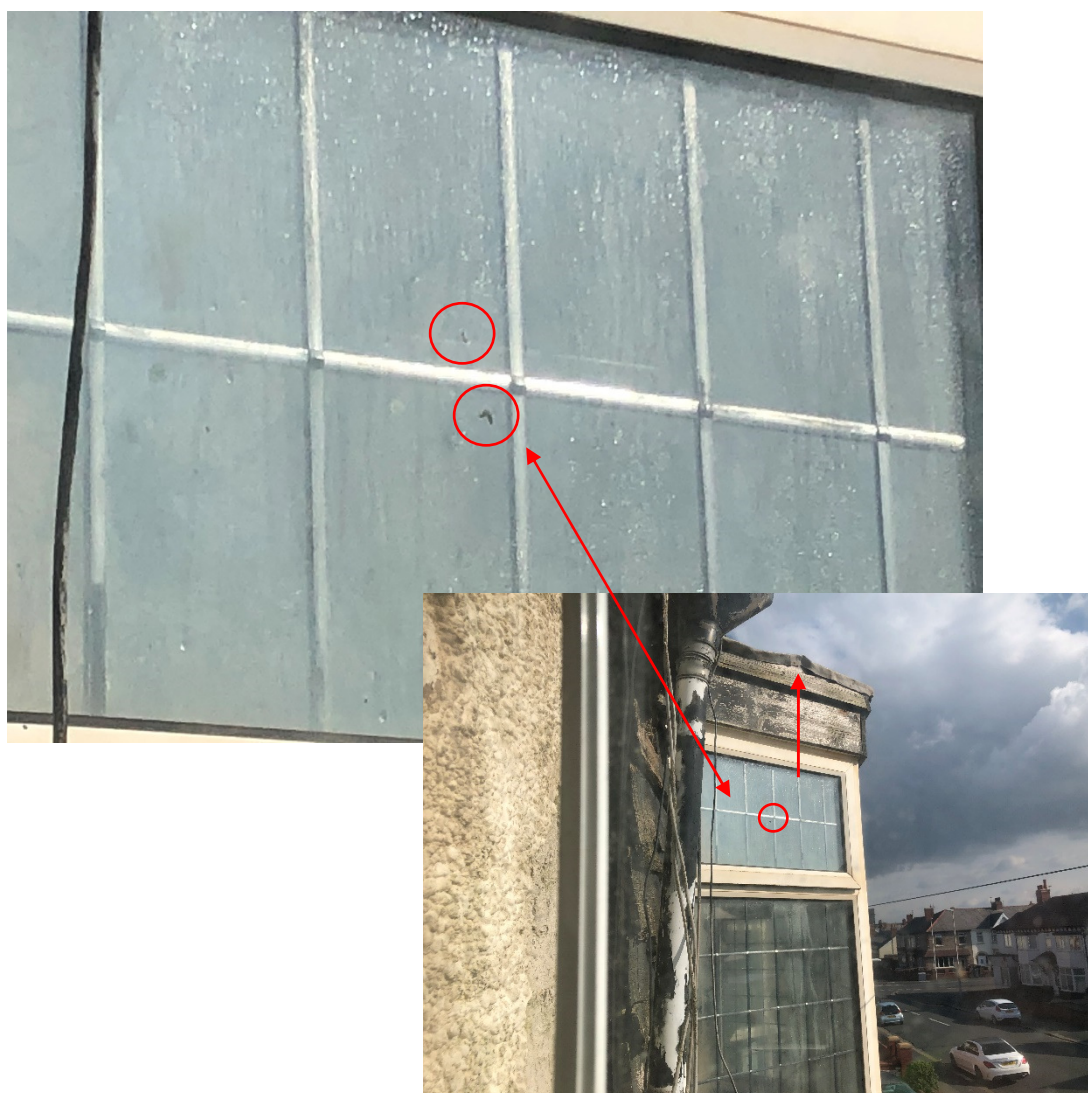
Photograph No.9: Potential bat droppings (x2) attached to second floor window of No.8 on the southern façade, as viewed from the upstairs of No.6. Lead flashing has lifted above location of the droppings and is considered to offer suitable ingress for crevice dwelling bat species.

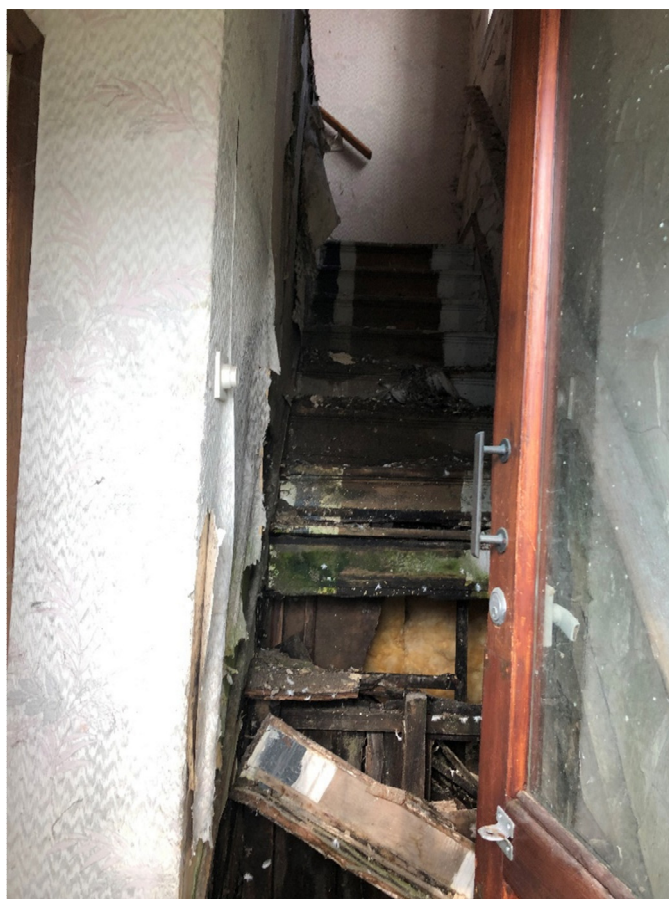
- 8.5 Access to the upper floors of property was not possible at the time of survey as the staircase had fallen though due to water damage. Therefore, the surveyor could not inspect the droppings at close range to provide a more accurate description of likely species.
- 8.6 The property has been vacant for over 10 years and much water ingress has occurred. The surveyor was only able to safely access the porch and lower hallway of the property. Numerous live and dead pigeons are present inside the structure, pigeon detritus and debris from fallen ceilings litters the floor.

Photograph No.10: showing inside of No.8 Carlin Gate. Stairs have rotted through and much detritus is present on the floors and surfaces.

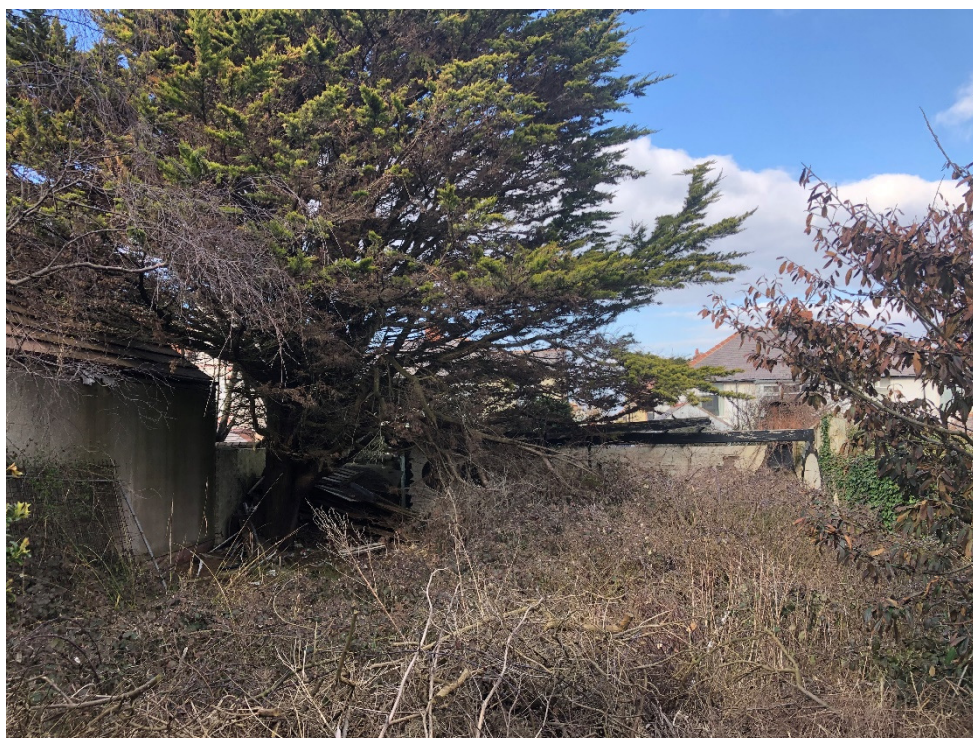
- 8.9 The garden of No.8 is heavily overgrown with bramble scrub and accumulations of brash and building debris litter the floor to the immediate rear of the structure.

- 8.10 A large cypress tree (species unknown) is present in the northwest corner. This was assessed using BCT 2016 guidelines for ground level assessment and is considered to offer negligible features suitable for bat roosting.

Photograph No.11: view of garden of No.8 looking northwards.
