DESIGN, ACCESS & HERITAGE STATEMENT

REPAIR AND RECONSTRUCTION OF SINGLE STOREY EXTENSION WITH ATTIC
AND ASSOCIATED STRUCTURAL REPAIRS TO MAIN HOUSE

MANOR FARMHOUSE, CHURCH ROAD, BRANDON PARVA NR9 4DQ

AMH 21-891 Rev. 00

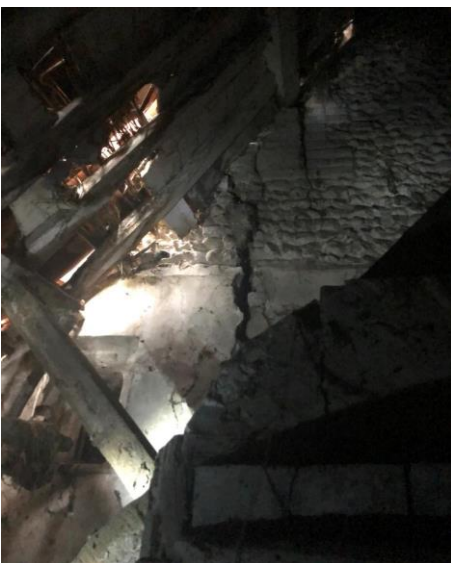
4.1 The east extension has suffered structural movement including subsidence, resulting in some significant cracking in several areas. There is also significant cracking to brick and flint masonry of the east gable of the main house which will need to be addressed as part of the works, although the full extent cannot be fully quantified until work commences. See photo 5.

5. Internal first floor - crack to main house east gable

1. Recording of the existing building.
2. Demolition of the east single storey extension, back to sound base or complete removal.
3. Salvage of all re-useable materials and any existing elements of the structure which are found to be adequate for retention.
4. Structural repair to the east gable of the main house – this work can only be fully assessed once the extension has been removed.
5. Re-building of the extension using salvaged materials. Bricks will be salvaged and reused to repair the retained areas. The front wall and part of gable rebuild in matching 3" bricks. First floor and roof timbers will be re-used in the structure, although it may be necessary to enhance or replace the floor and roof structures whilst incorporating the original timbers 'cosmetically' in the interest of conservation. The first floor level will be raised slightly to improve the accommodation.

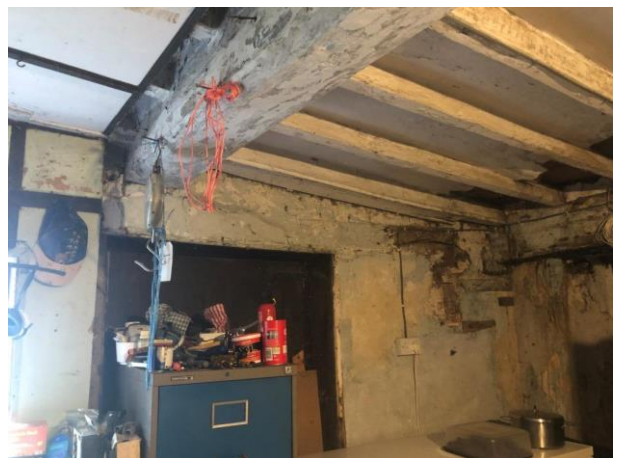
Late C19 alterations to the front elevation have resulted in the principal first floor beam bearing on to a timber lintel and narrow brick pier which is considered structurally inadequate. See photo 6.

6. Internal ground floor - floor beam into front elevation brickwork
