## Site investigation and percolation testing report

# Infiltration and percolation testing: Ad Rhyd-Blawd Farm, Llandrindod Wells

**Report reference:** 4196R1

**Date of reporting:** 3 May 2021

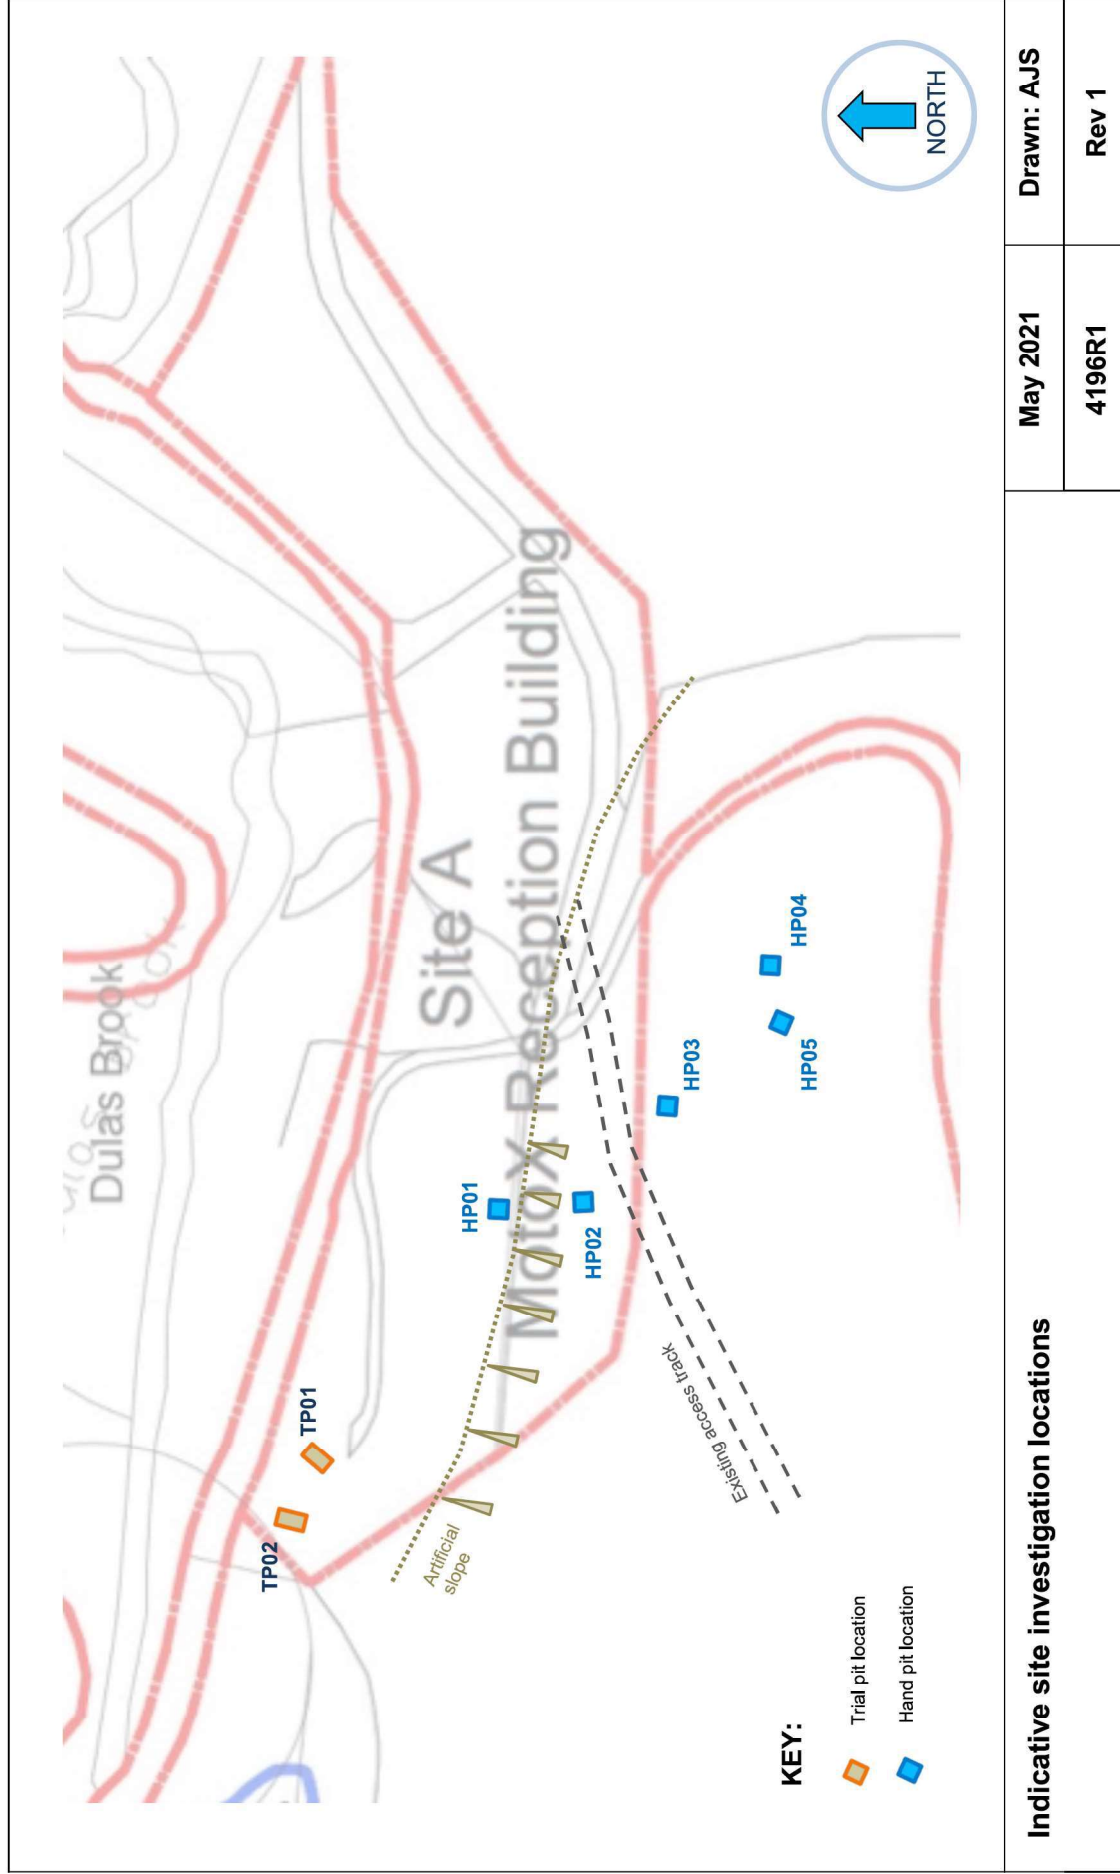
Figure 3.1 Site investigation location plan: Site A

- Grey-brown slightly gravelly clay was encountered to depths of between 0.7 m and 1.6 m bgl within the mechanically excavated pits (TP01 and TP02). These cohesive deposits were underlain by apparent weathered mudstone (recovered as angular gravel and cobbles).
- An upper soil layer was observed in several of the hand pits, comprising mid-brown slightly gravelly clayey silt with roots and rootlets. This soil layer, which was more friable / aerated than the underlying clay horizon, was recorded in HP03 (to a depth of 0.4 m); HP04 (to 0.15 m) and HP05 (to 0.3 m+). The soil layer was underlain by firm to stiff brown to dark grey gravelly silty clay to depths of up to 0.65 m.

There was no obvious ingress of shallow groundwater into any of the Site A trial pits during the site works with the exception of HP01 (located on the lower terraced area in the west of Site A). A gradual water seepage was observed into HP01 prior to the commencement of percolation testing; c. 5 cm of water was recorded in base of the pit 20 minutes after excavation (prior to testing). Following the inundation of the hand pit for testing purposes the water level gradually rose above the top of the hand pit level (c. 3.5 cm above the starting level, 5 hours after the start of the percolation test).

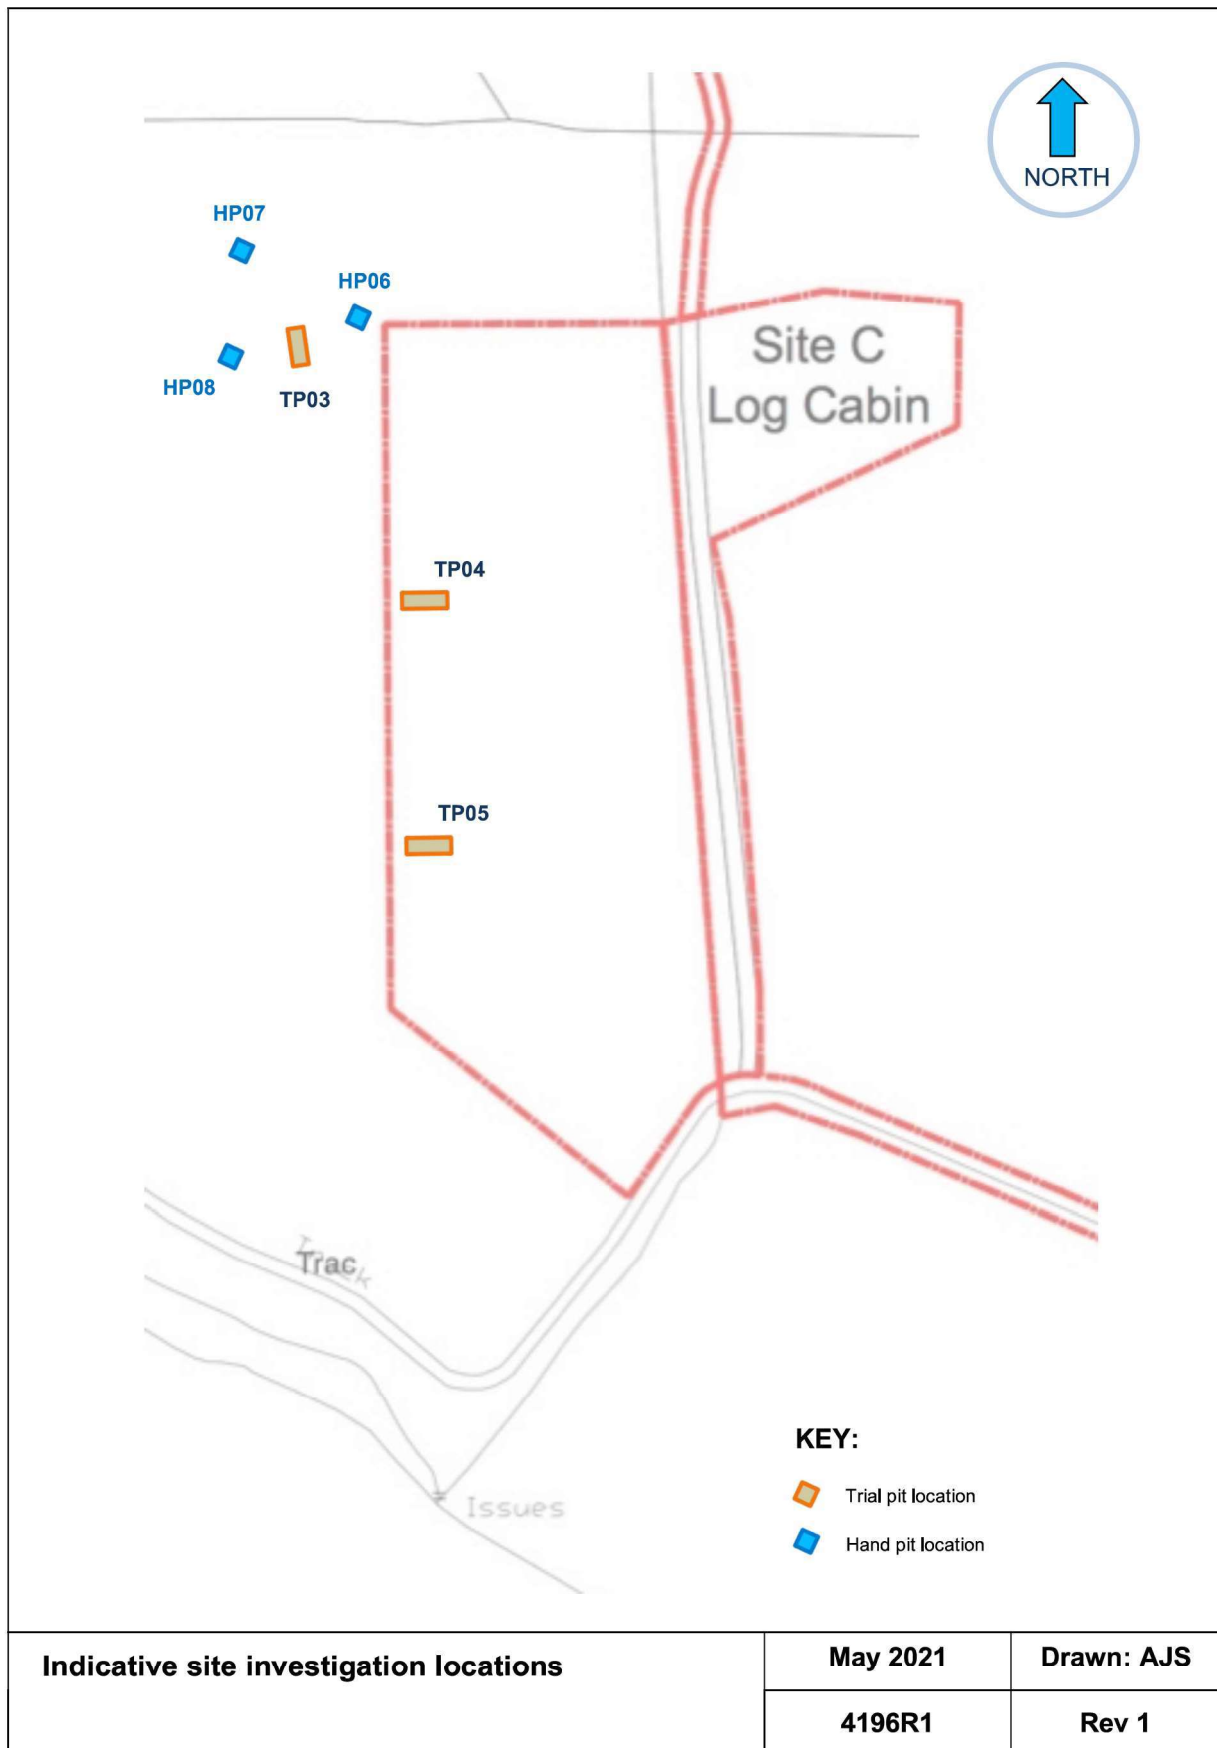
**Figure 3.2 Site investigation location plan: Site B**

- The three mechanically excavated trial pits (TP03 to TP05) encountered a 0.15 m to 0.3 m thickness of brown silty clay with roots (soil layer) overlying firm to stiff grey-brown clay (0.25 m to 0.7 m thick) and firm to stiff brown gravelly clay (over 1.15 m thick).
- A mid brown slightly gravelly clayey silt (soil layer) was also observed at the three hand pits at thicknesses of between 0.05 m and 0.2 m. This was underlain by firm to stiff brown to grey clay.

There was no obvious ingress of shallow groundwater into any of the Site B trial pits during the site works.
