PRELIMINARY ROOST ASSESSMENT

Oak House, 21A Acorn Drive, Oakenshaw, Crook, DL15 0TF

February 2022

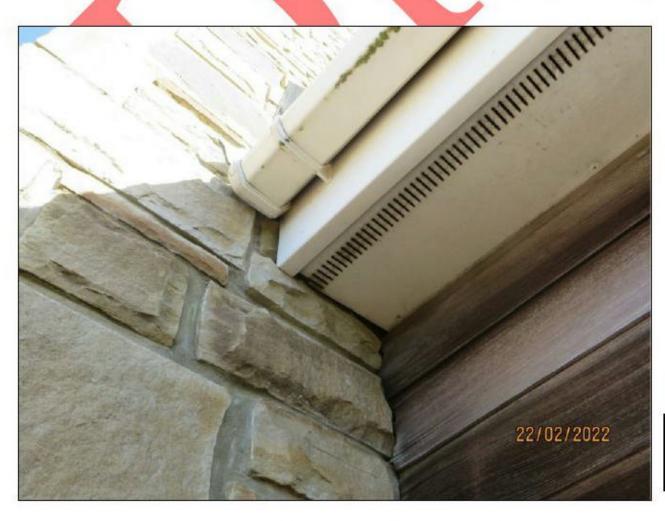
Two gaps were noted at the end of the uPVC soffit box on the conservatory proposed for demolition. Whilst bats may access these gaps, the low drop height for emerging bats and the uPVC construction makes it unlikely to be used by bats. A suitably qualified ecologist should be present to check for bats upon its' removal.

Figure 13. Gap present at end of soffit box on conservatory.

- Soffit boxes around the conservatory on the main house should only be removed with a suitably qualified ecologist present. Should bats be found then works would be required to stop until advice is sought from Natural England.

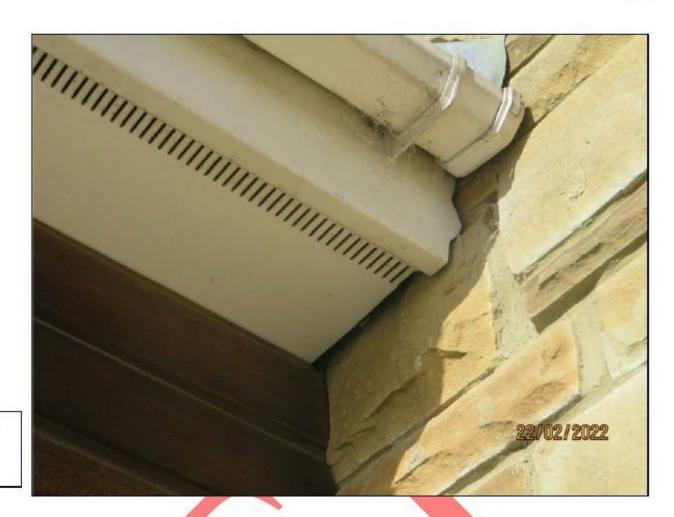
Figure 14. Gap present at end of soffit box on conservatory.

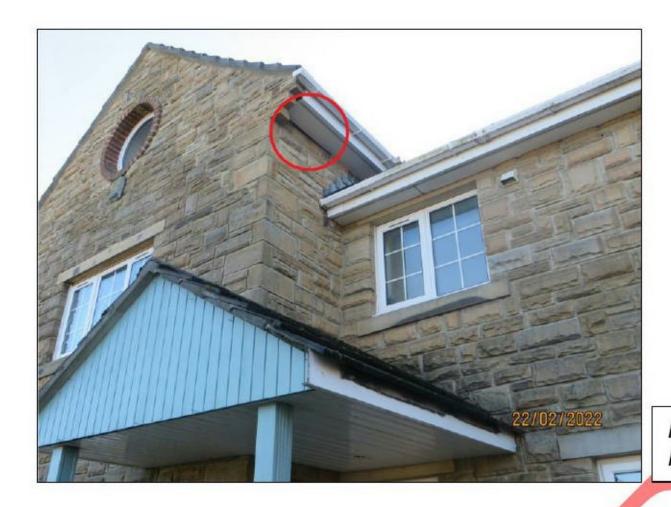
Figure 17. Gap present near soffit box. Not affected by development proposals.

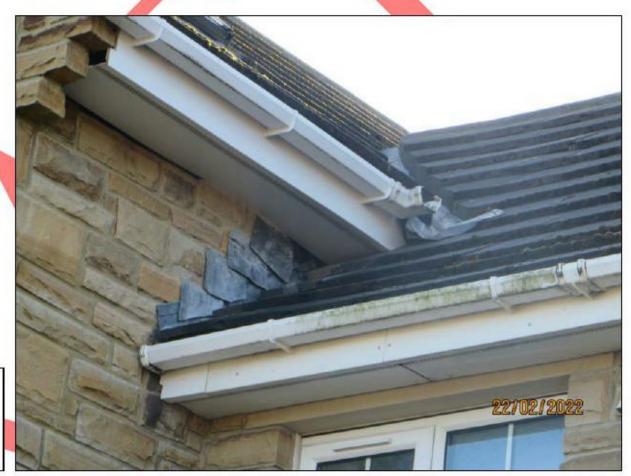
Figure 18. Gap present near soffit box and raised flashing. Not affected by development proposals.

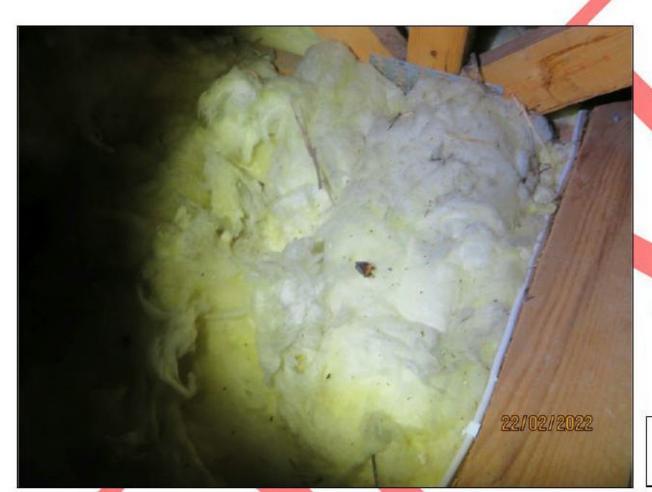
A couple of butterfly wings were noted in the loft void. Butterfly wings can be the remains of overwintering butterflies or can be the feeding remains of larger bat species such as natterer's or brown long-eared.

Figure 21. Butterfly wing in main house loft void.

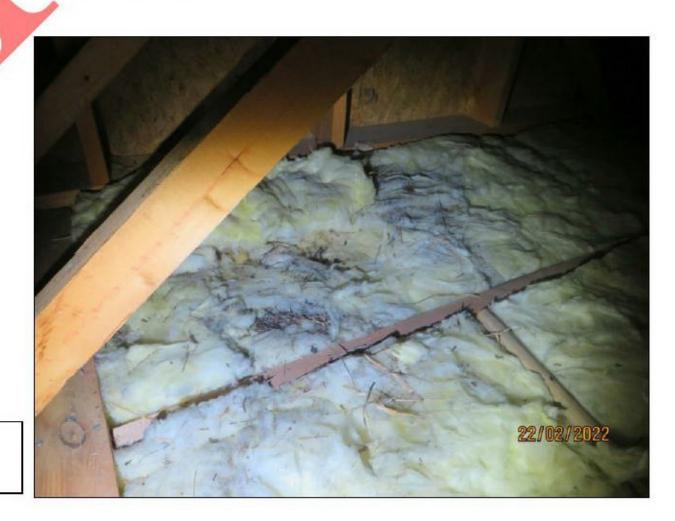
Figure 22. Remains of bird's nest within main house loft void.

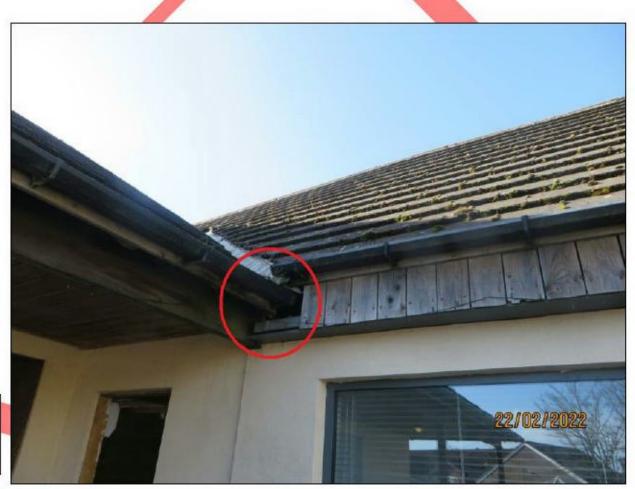
Figure 24. Gap present into wooden cladding on outbuilding.

Bat survey(s) should therefore be undertaken between May and August to get an understanding of the use of the outbuilding by bats. This is in accordance with the Bat Conservation Trust (2016) 'Bat Surveys Good Practice Guidelines'.

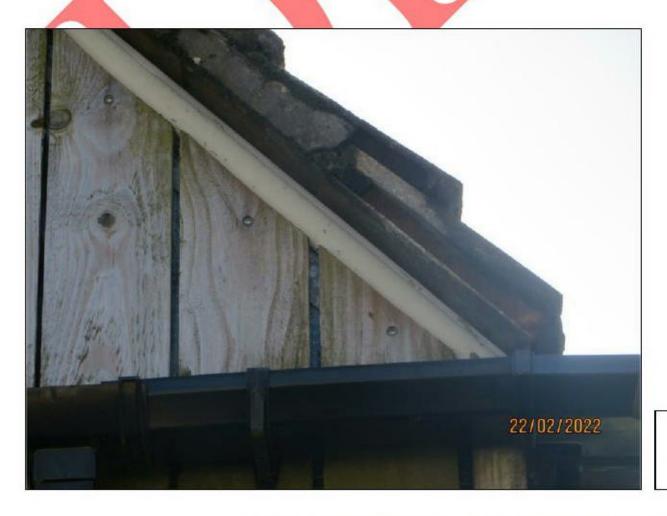
Figure 25. Gap at end tiles on outbuilding.

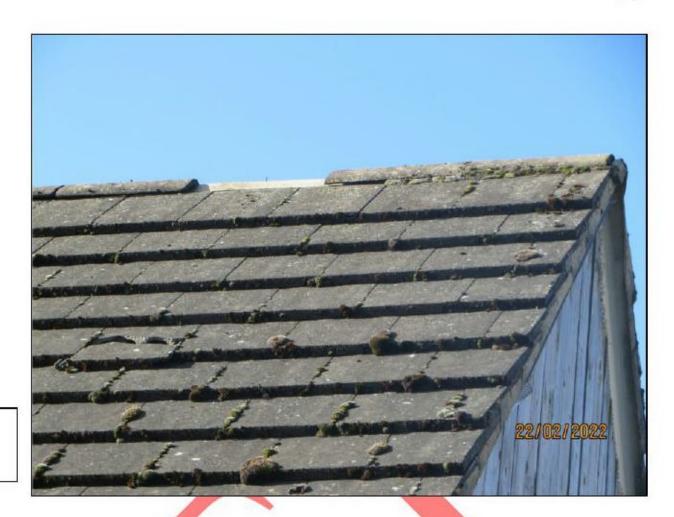
Figure 26. Missing ridge tile on outbuilding.

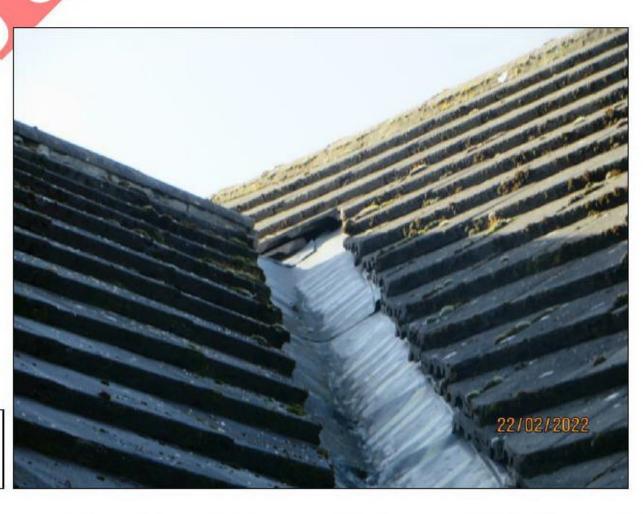
Figure 28. Gap present under rooftiles on outbuilding.

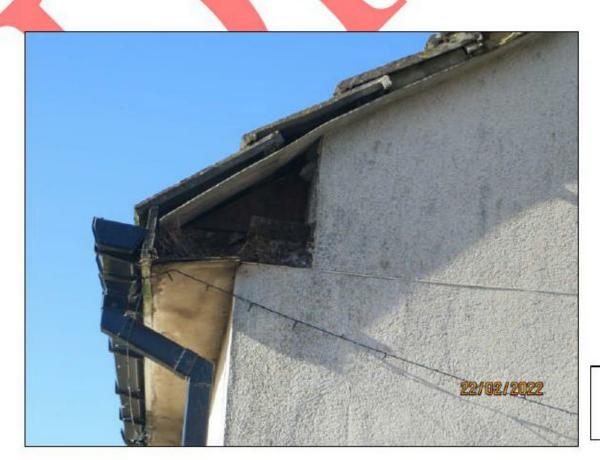
A remnant bird's nest was noted at the end of a rotten soffit box (figure 31).

Figure 31. Remnant bird's nest in gap above rotten soffit box.

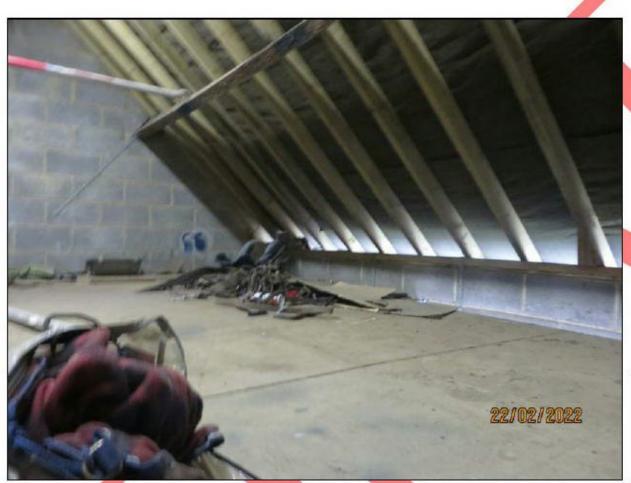
Figure 33. Storage area upper section where bat droppings found. Light ingress can be seen along wall tops.

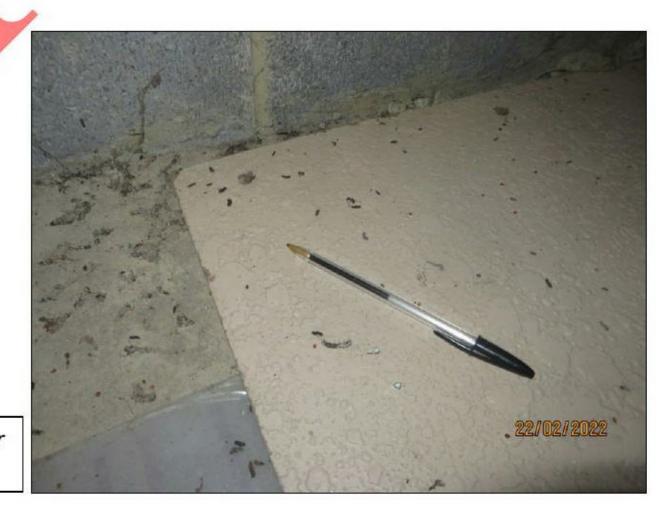
The outbuilding is deemed to be moderate potential for roosting bats. The presence of bat droppings confirms the building is a bat roost. These features will be lost/altered during the development and therefore further assessment is required to ascertain if the building is used by bats.

Bat droppings were found in the loft void area of the building, along with butterfly wings (figures 34 and 37). Butterfly wings can be the remains of overwintering butterflies or can be the feeding remains of larger bat species such as natterer's or brown long-eared.

Figure 34. Bat droppings found on upper floor of storage section of outbuilding.

A Natural England mitigation licence is likely to be required for works to the outbuilding.

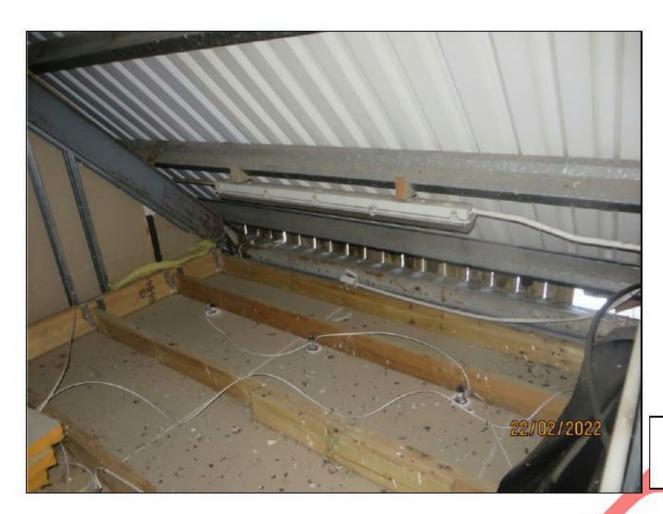
Figure 35. Bird droppings above 'Granny annex'.

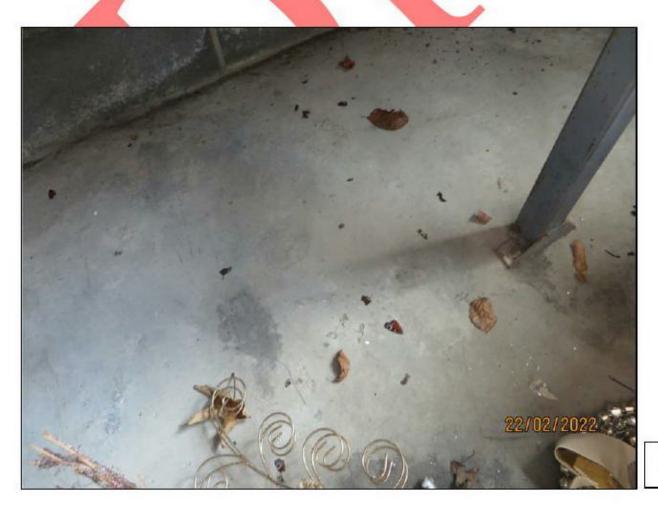
Figure 37. Butterfly wings in outbuilding.
