# Arboricultural Impact Assessment

Sandringham Stores, Visitors Centre, Sandringham Estate

Arboricultural Impact Assessment 1:125 @ A1 TS CHECKED 14.03.2022 N/A DRAWING NUMBER LIV/SANDSTRS/AIA/01 110122/02

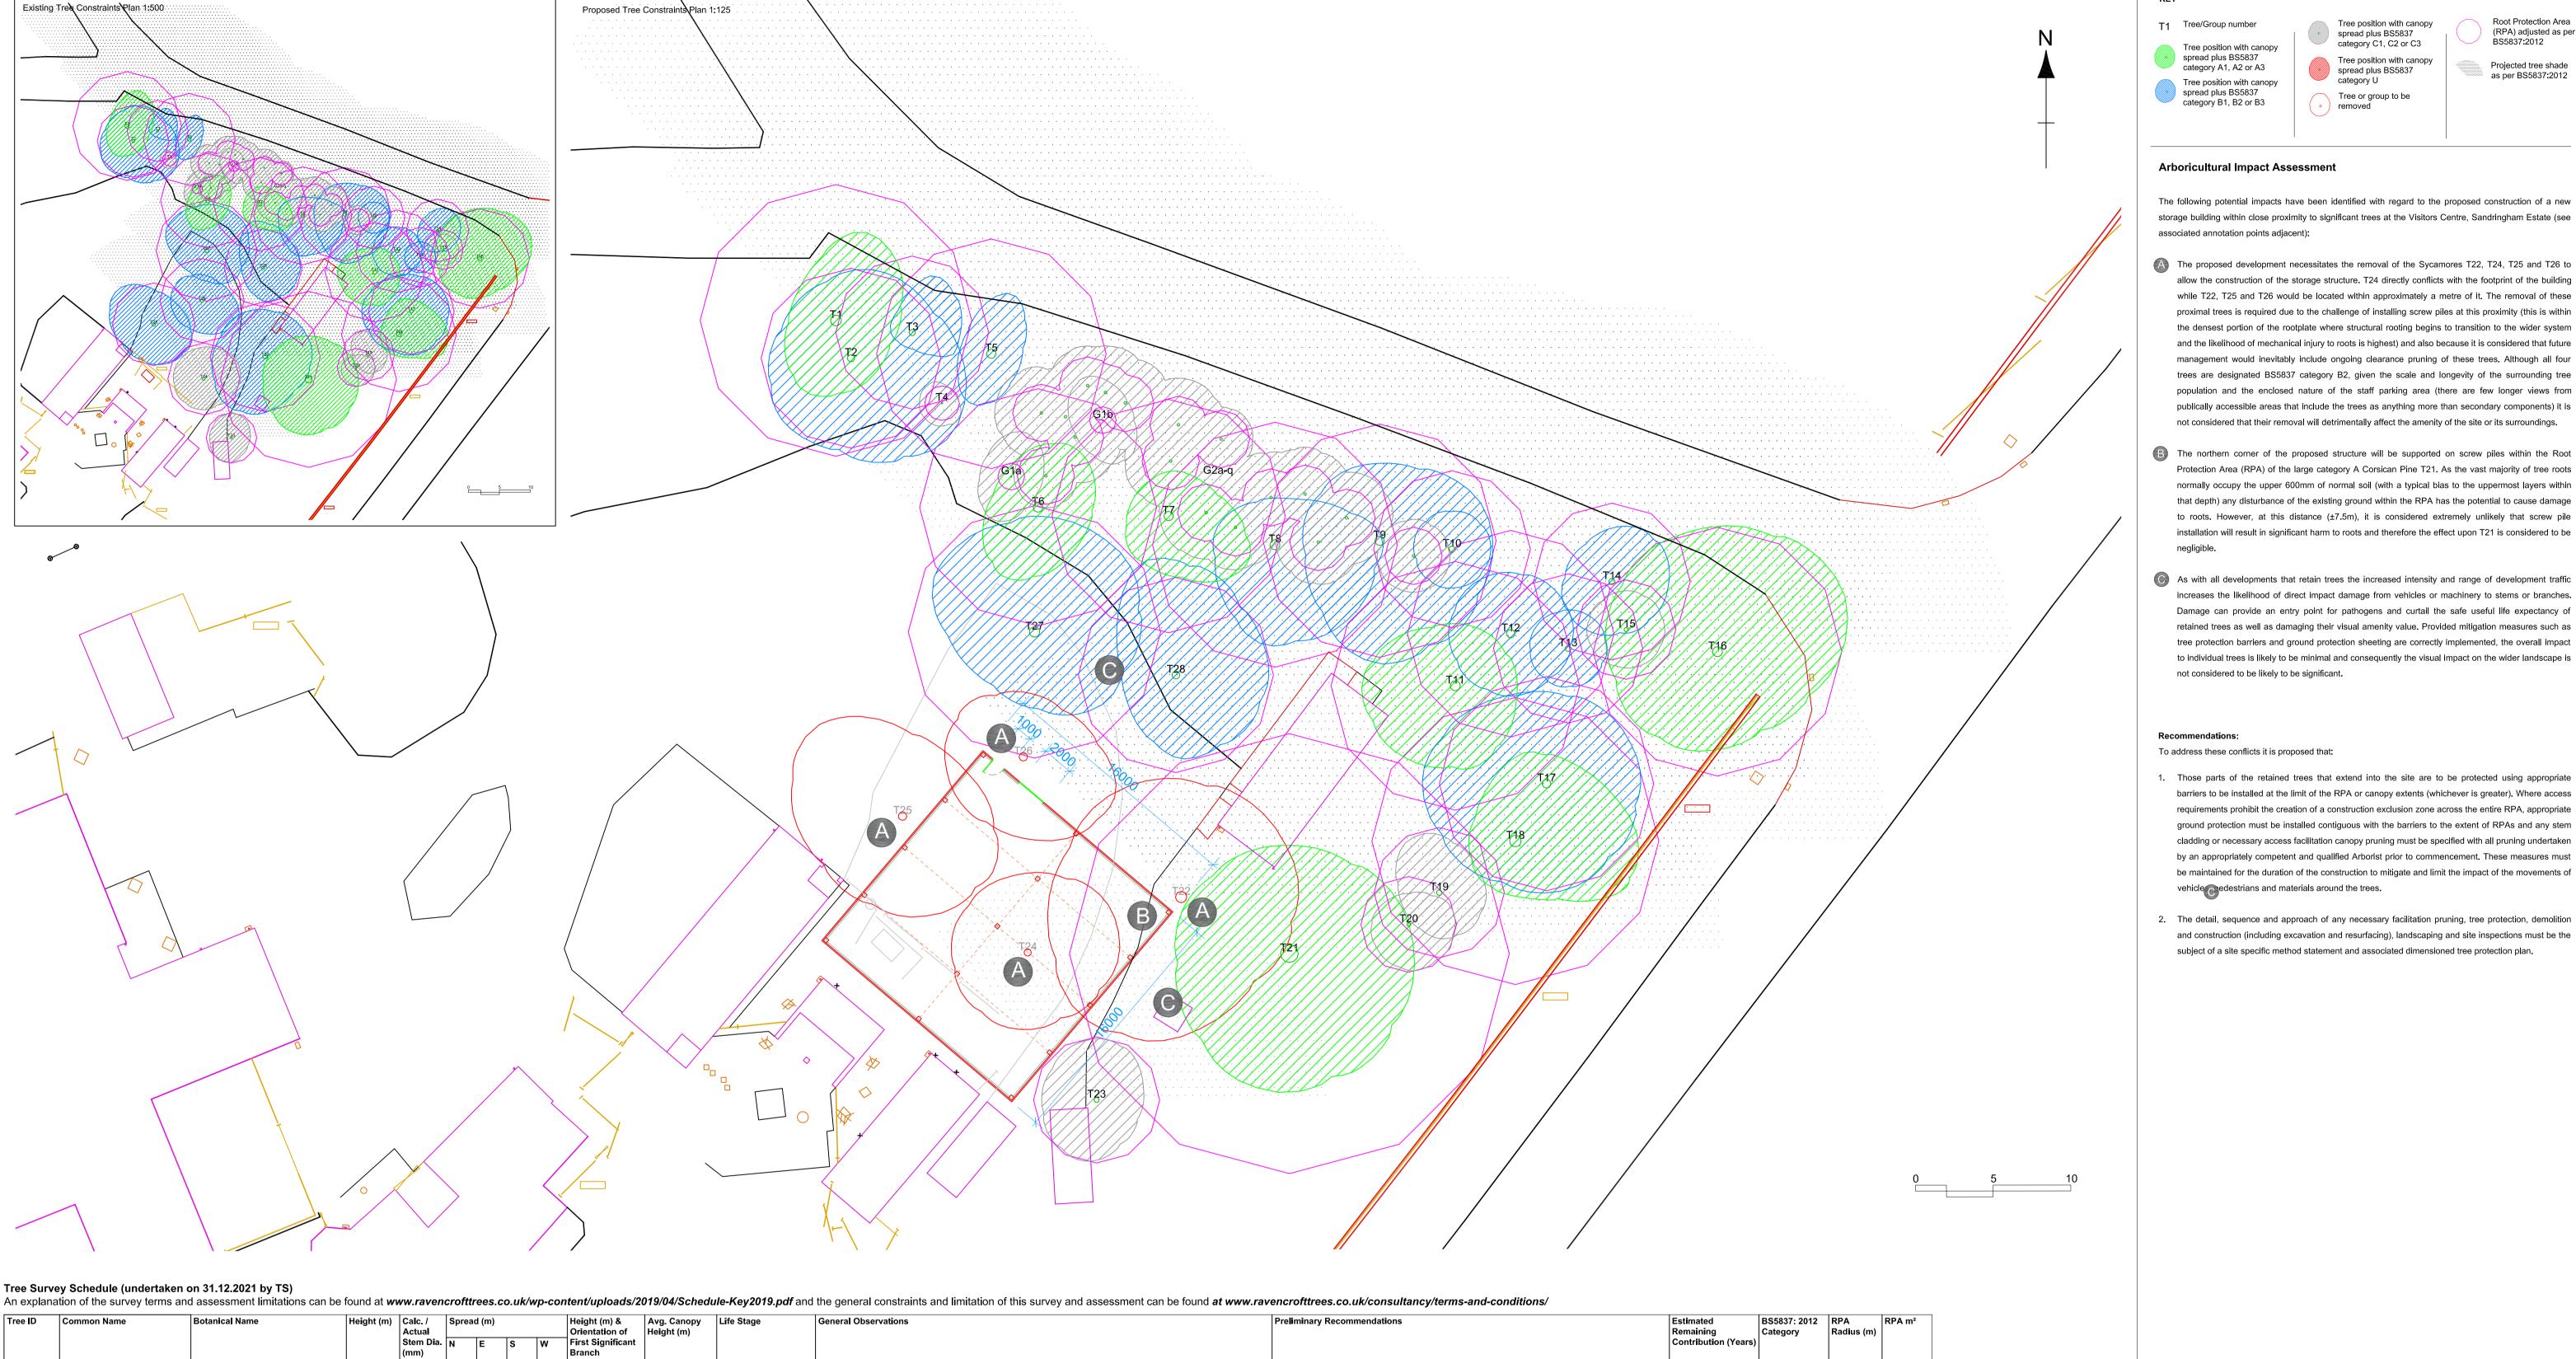
- The proposed development necessitates the removal of the Sycamores T22, T24, T25 and T26 to allow the construction of the storage structure. T24 directly conflicts with the footprint of the building while T22, T25 and T26 would be located within approximately a metre of it. The removal of these proximal trees is required due to the challenge of installing screw piles at this proximity (this is within the densest portion of the rootplate where structural rooting begins to transition to the wider system and the likelihood of mechanical injury to roots is highest) and also because it is considered that future management would inevitably include ongoing clearance pruning of these trees. Although all four trees are designated BS5837 category B2, given the scale and longevity of the surrounding tree population and the enclosed nature of the staff parking area (there are few longer views from publically accessible areas that include the trees as anything more than secondary components) it is not considered that their removal will detrimentally affect the amenity of the site or its surroundings.

- The northern corner of the proposed structure will be supported on screw piles within the Root Protection Area (RPA) of the large category A Corsican Pine T21. As the vast majority of tree roots normally occupy the upper 600mm of normal soil (with a typical bias to the uppermost layers within that depth) any disturbance of the existing ground within the RPA has the potential to cause damage to roots. However, at this distance (±7.5m), it is considered extremely unlikely that screw pile installation will result in significant harm to roots and therefore the effect upon T21 is considered to be

- As with all developments that retain trees the increased intensity and range of development traffic increases the likelihood of direct impact damage from vehicles or machinery to stems or branches. Damage can provide an entry point for pathogens and curtail the safe useful life expectancy of retained trees as well as damaging their visual amenity value. Provided mitigation measures such as tree protection barriers and ground protection sheeting are correctly implemented, the overall impact to individual trees is likely to be minimal and consequently the visual impact on the wider landscape is not considered to be likely to be significant.

- 1. Those parts of the retained trees that extend into the site are to be protected using appropriate barriers to be installed at the limit of the RPA or canopy extents (whichever is greater). Where access requirements prohibit the creation of a construction exclusion zone across the entire RPA, appropriate ground protection must be installed contiguous with the barriers to the extent of RPAs and any stem cladding or necessary access facilitation canopy pruning must be specified with all pruning undertaken by an appropriately competent and qualified Arborist prior to commencement. These measures must be maintained for the duration of the construction to mitigate and limit the impact of the movements of vehicle edestrians and materials around the trees.

- and construction (including excavation and resurfacing), landscaping and site inspections must be the subject of a site specific method statement and associated dimensioned tree protection plan.
