Farm buildings at Bedingfield House Farm

**Preliminary Roost
Appraisal**

December 2021

Reference: 40-2101-GE-BC

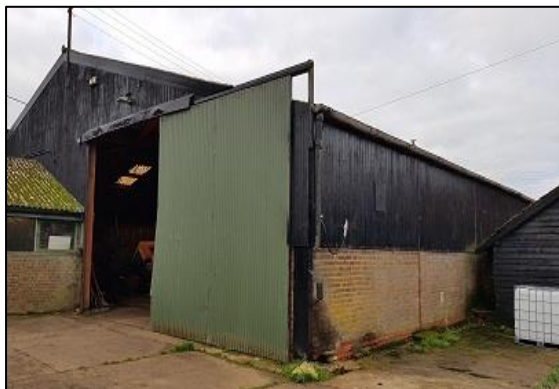
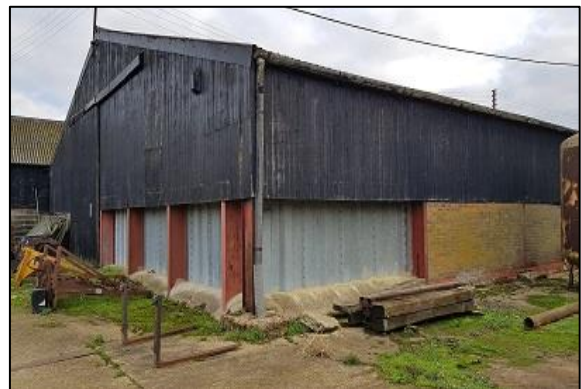
5.2.4 This was a metal framed building with corrugated roof, a brick base and single-skin vertical wood cladding (Figures 1 and 2). The building was still in current use as a grain store and the disturbance from vehicles and human activity was high.

5.2.5 The corrugated roof sheets appeared well sealed with some gaps at the gable end turnover/fascia. On inspection this was wide and well cobwebbed.

Figure 1: Building 1 – south-eastern aspect.

Figure 2: Building 1 – north-western aspects.

5.2.12 Building 1 was assessed as having **negligible potential** to support roosting bats. The exterior was generally well sealed with the interior being bright, draughty and heavily disturbed. The roof was unlined with metal supports.

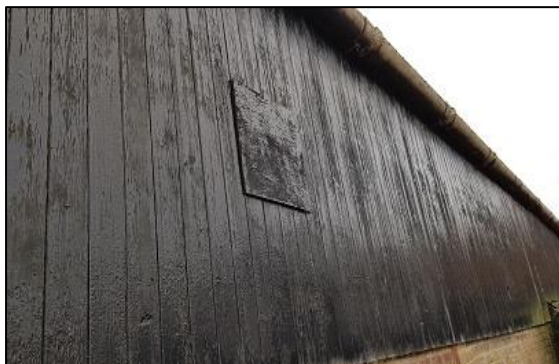
5.2.6 The vertical cladding was sealed with black bituminous paint although there were a few gaps giving access into the barn (Figure 3). The top and bottom of the cladding was well sealed with no cavities and the bottom edge was heavily cobwebbed.

Figure 3: Tightly sealed vertical cladding.

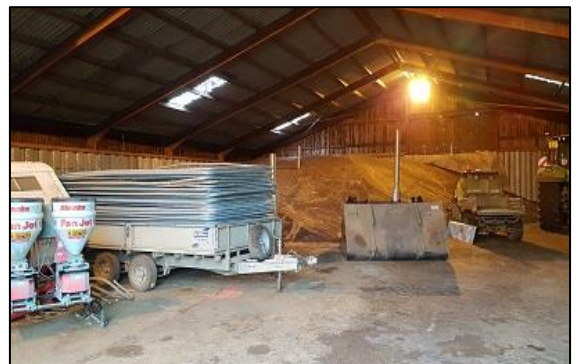
5.2.9 Internally the barn was one open space with an unlined roof and metal supports (Figure 4).

5.2.10 The roof had seven skylights/opaque sheets in and the space was bright and draughty.

Figure 4: Internal view of Building 1.

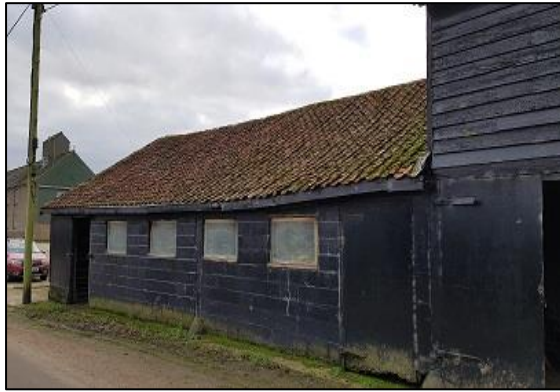
5.2.14 This was single storey building with a pantile roof a breezeblock base with a horizontal wood cladding (Figure 5). The building was in current use as farm storage and was linked to the grain store by an open door increasing the noise and disturbance.

5.2.16 There were some raised tiles on both aspects, with the southern aspect being very damp and mossy. There were gaps at the eaves under the tiles. When the raised tiles on the northern aspect were inspected the underneath was heavily cobwebbed and full of windblown detritus.

Figure 5: Building 2 – northern aspect.

5.2.23 Building 2 was assessed as having **negligible to very low potential** to support roosting bats. The exterior being generally well sealed and any gaps not deemed to offer suitable shelter for roosting bats. The interior was bright, cluttered and heavily disturbed.

Species	Requirement for Further Surveys and Recommendations
Bats	<p>No further surveys required.</p> <p>As a precautionary measure the tiles on Building 2 should be removed by hand only.</p> <p>In the unlikely event bats are found during the works, they should cease, and a licenced bat worker contacted to advise on how to proceed.</p> <p>Any external lights associated with the finished project should be of a low light level to minimise impacts on bats that might forage and commute in the vicinity.</p> <p>Warm white lights should be used at <2700k. This reduces the ultraviolet component or that has high attraction effects on insects which can lead to a reduction in prey availability for some light sensitive bat species.</p>
Birds	<p>To avoid committing an offence under the Wildlife and Countryside Act 1981 (as amended), any site clearance will take place outside of the bird nesting period (i.e. outside of March to August), or failing that, following confirmation by a suitably qualified ecologist that nesting birds are absent from the areas to be cleared.</p>

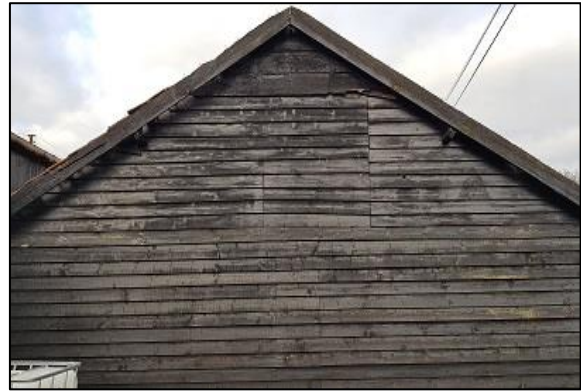
5.2.18 There were gaps in the cladding at the top of the gable end giving access into the interior (Figure 6).

Figure 6: Building 2 – cladded gable end.

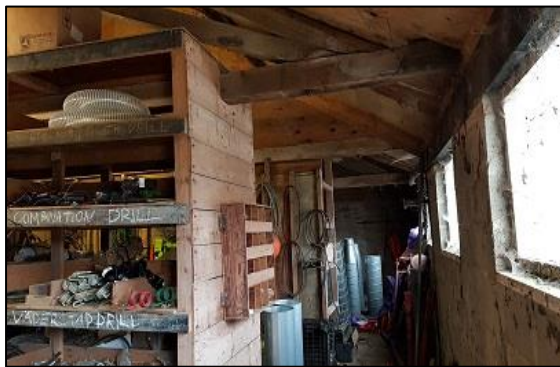
5.2.20 Internally the space was bright from the windows on the northern aspect. The space was full of stored items and shelving and was open to a boarded roof (Figure 7). The boarding was warped and very damp in places.

5.2.21 In one area the boarding was missing allowing for inspection behind. The gap was wide and the tiles were unlined and damp. The wooden beams were narrow and very heavily cobwebbed.

Figure 7: Building 2 – interior view.

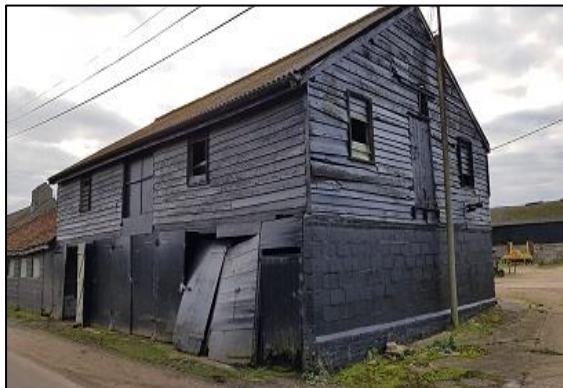
5.2.25 This was a two-storey wooden framed building with a corrugated roof, breezeblock base and wood cladding (Figure 8). The building was currently in use as storage and externally had been sealed with the same black bituminous paint as the other two.

5.2.27 The upper floor was to single-skin wood cladding and there were louvered window openings in both gable ends on the northern aspect. One window was netted the others were open or had gaps, giving access into the interior.

5.2.28 There were large gaps in the cladding giving access inside, rather than creating crevices between the wood.

5.2.30 There were two doors on the ground floor northern aspect which had collapsed inwards.

Figure 8: Building 3 – northern aspects.

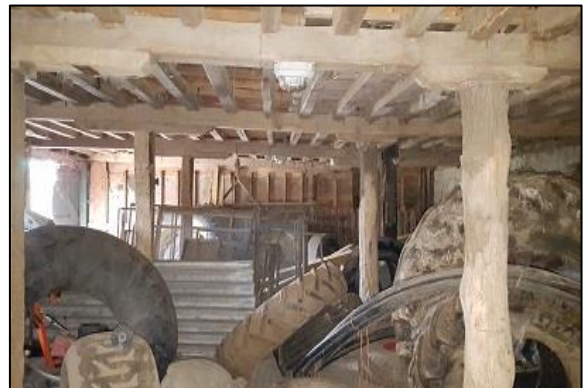
5.2.31 Internally the ground floor had wooden supports and beams (Figure 9). These were thick, but in sound condition with no cracks or splits. Where the ceiling supports overlapped they were tightly fitted.

5.2.32 The space was relatively bright and draughty from the collapsed doors.

Figure 9: Building 3 – Ground floor interior.

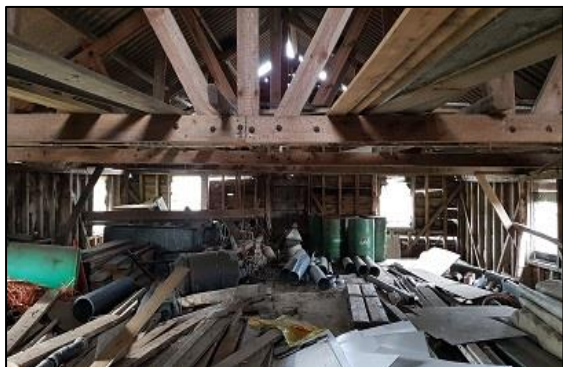
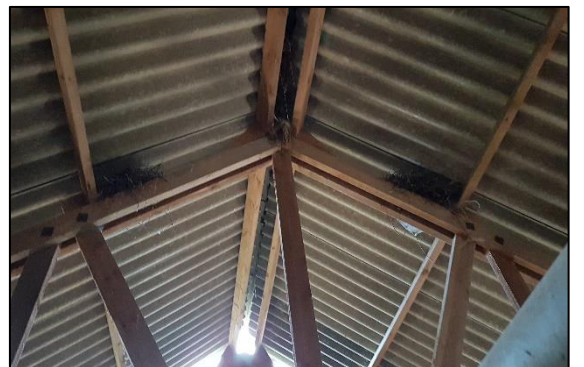
5.2.34 The upper floor was open to the unlined corrugated roof (Figures 10 and 11). This space was very draughty and bright from the open windows and the gaps in the cladding.

5.2.35 The beams were narrow and machine cut with no cracks or splits.

Figure 10: Building 3 – First floor interior.

Figure 11: Building 3 – unlined corrugated roof with narrow beams.

5.3.1 There were four old bird nests in the upper floor of Building 3, most likely pigeon and robin/wren.
