# **Arboricultural Impact Assessment**and Tree Protection Plan

# Dolphin Square Project Future

# **The Dolphin Square Ltd**

2<sup>nd</sup> November 2021

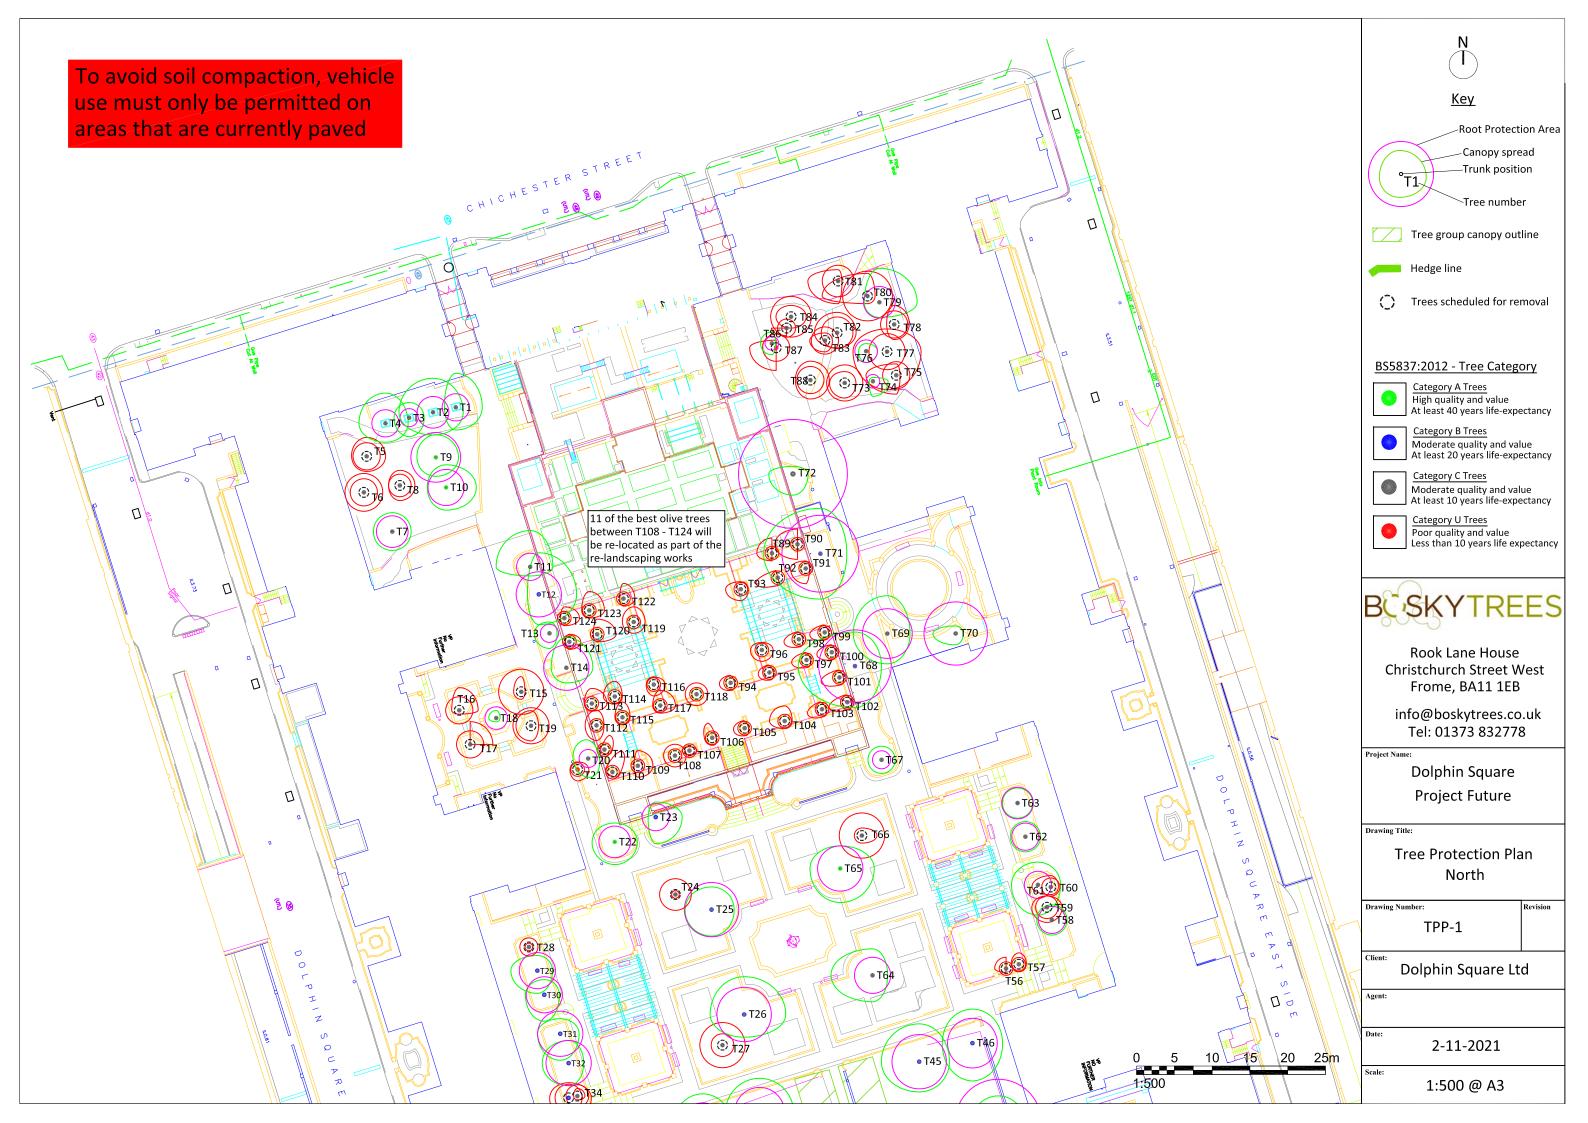
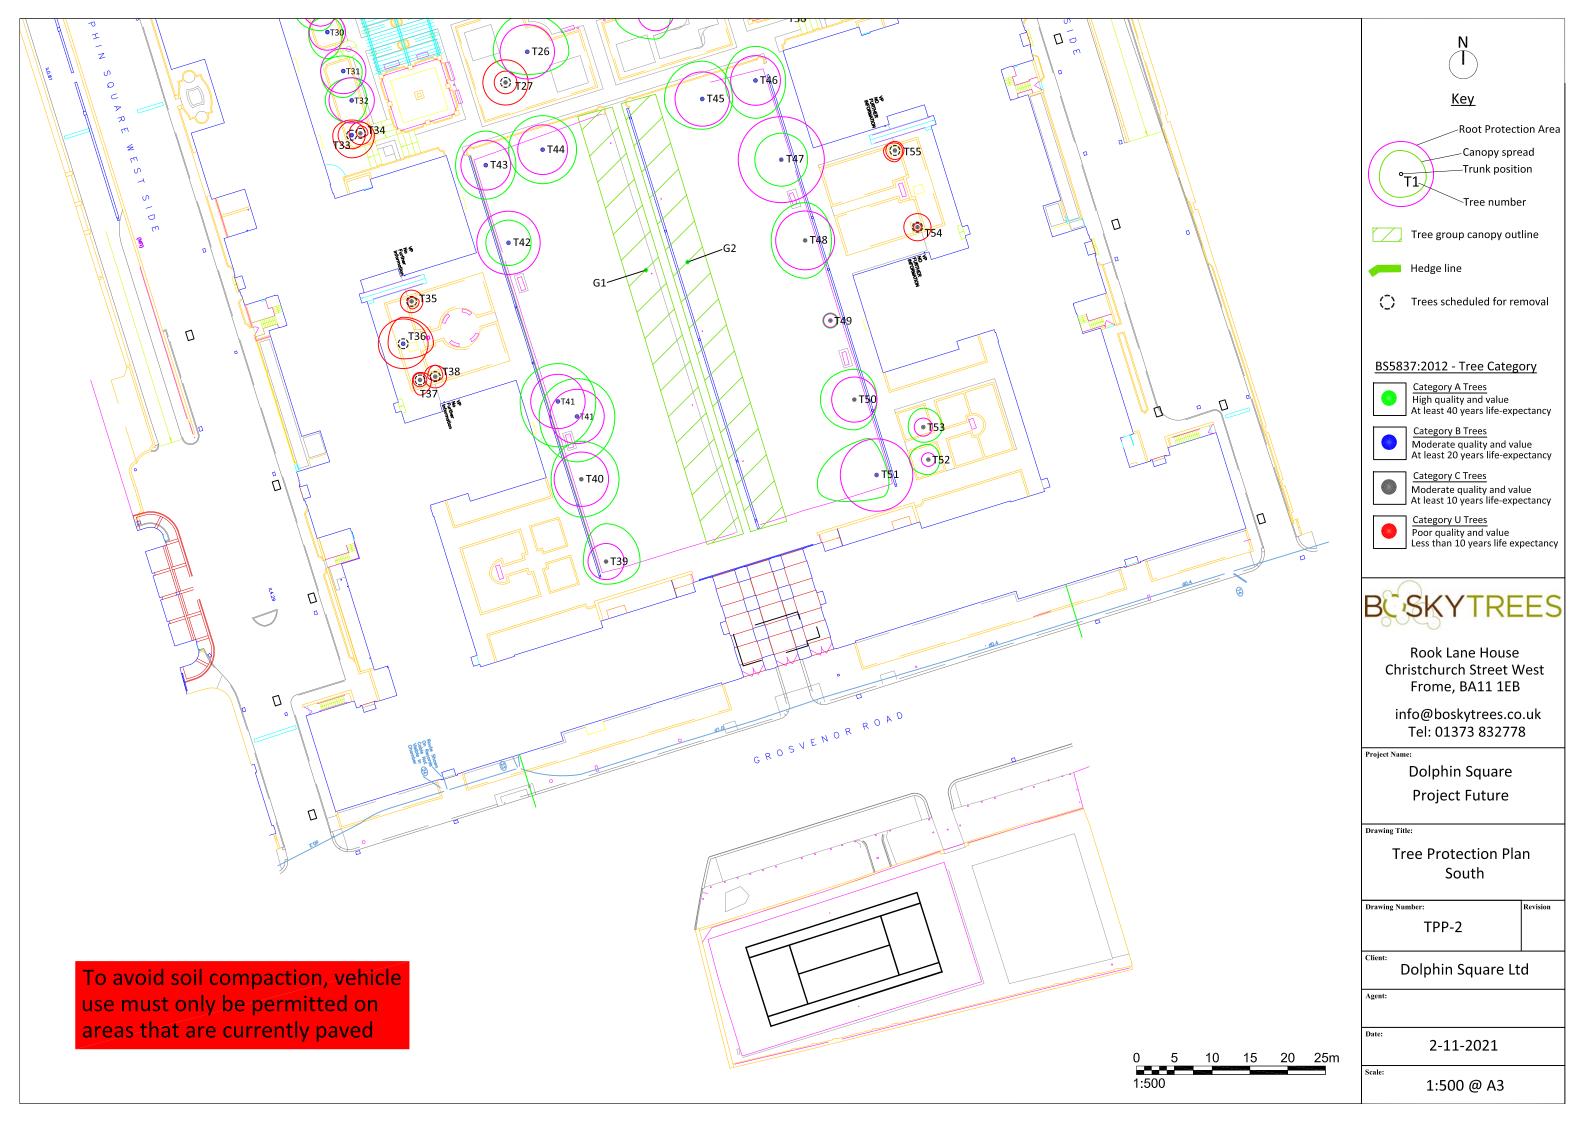
The tree protection plans (TPP-1 and TPP-2) show the root protection areas required by each tree and identifies which trees are to be removed to enable the proposed development.
